Eade Road | New River Leakage

Background

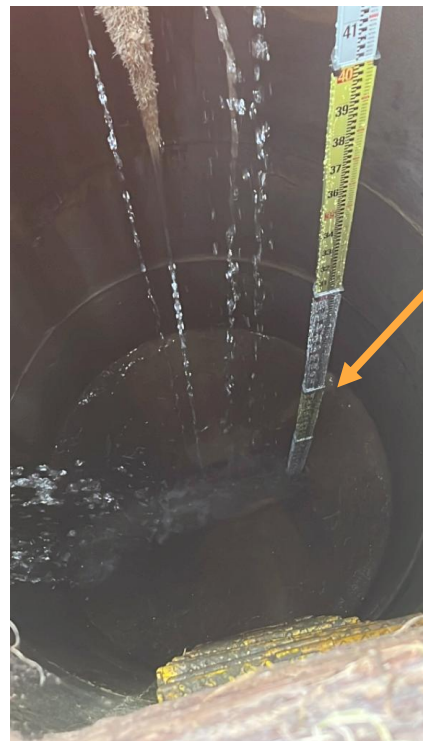
- The West end of the embankment, nearest to 66 Eade Road has a constant significant flow in dry conditions (no recent rainfall).
- Central of the embankment opposite the linkway to Vale, there is evidence of flows with sediment visible in the drain.
- At the East end of the embankment there is slight flow in dry conditions (no recent rainfall) with evidence of sediment.

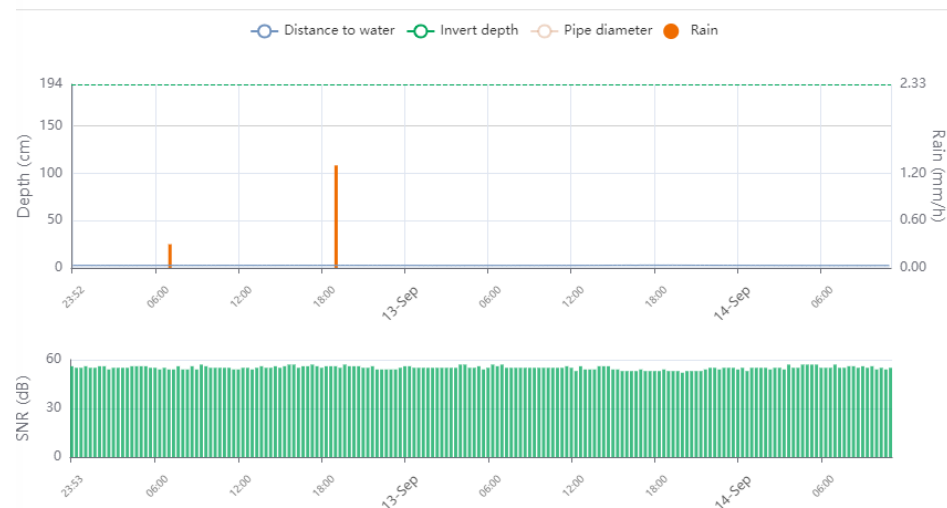
Findings (West Embankment)

- Flow is constant and does not vary with:
 - Rainfall (12/09 - c. 19:00)
 - Common daily usage patterns
- No evidence of pumping pattern.
- Flow measured at **15 l/ps or 1290 M3 day.**
- Likely range is 850 - 1290 M3 day.
- Stability of flow suggests substantial leakage from New River.
- Keen to understand impact of cleaning / sustained rainfall.

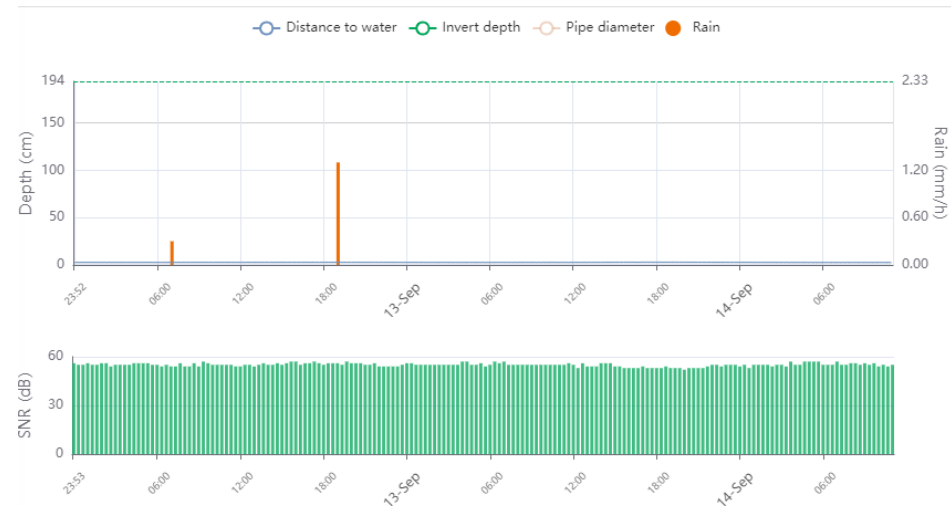
Findings (Centre/East Embankment)

- Sedimented, no water.
- Keen to understand impact of cleaning / sustained rainfall.

- Constant flow, no level change.
- I/ps not measured due to sediment.
- Keen to understand impact of cleaning / sustained rainfall.
