Mogden Sewage Treatment Works

Residents Liaison Meeting

29 April 2021

Sewage discharge in the Duke of Northumberland River - Update

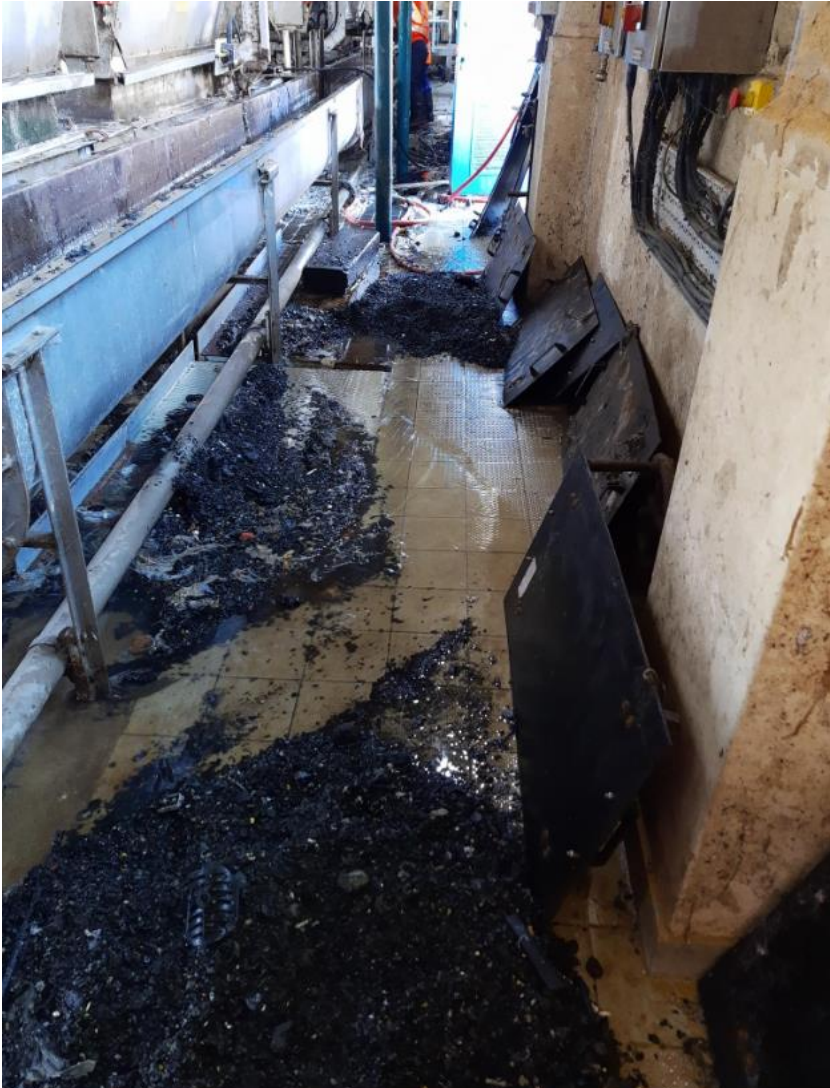
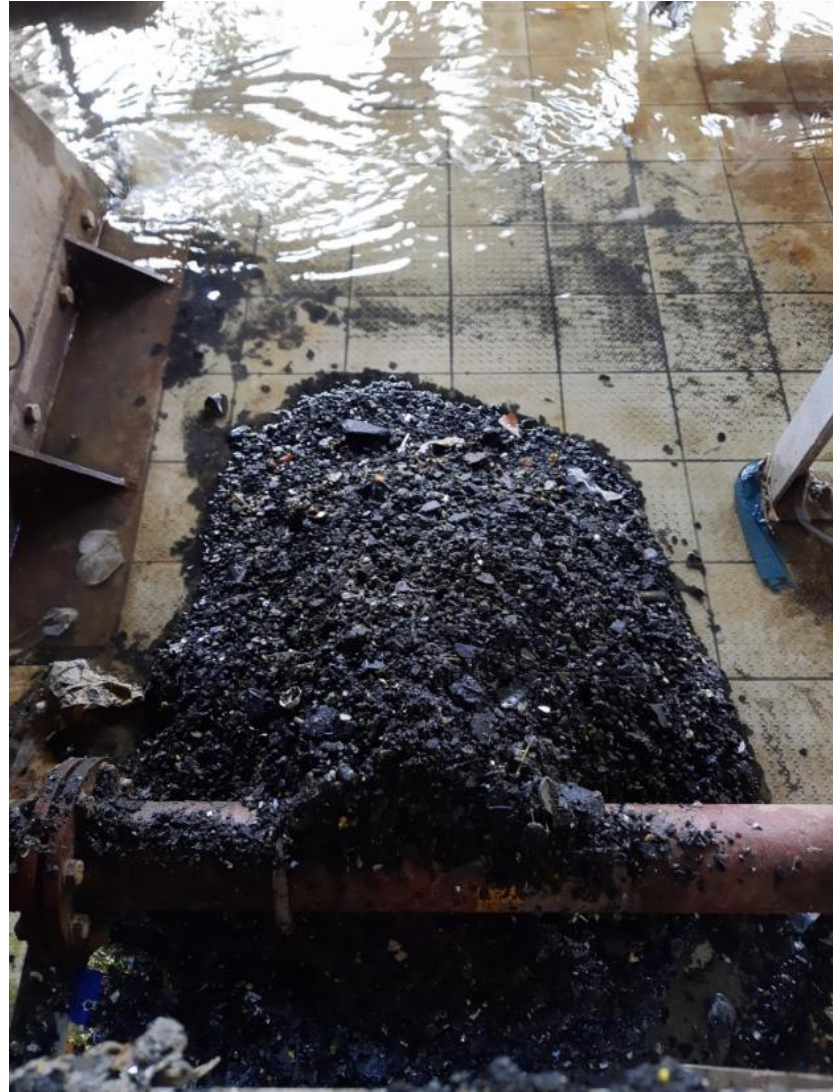
- The root cause of the incident was a significant build up of grit and silt at the East Side Inlet Works. Heavy rain and snow melt in the catchment caused a surge of flows into Mogden STW.
- It is estimated that 10-12 tonnes of grit was cleared from the East Side Inlet Building.
- The build up of grit occurred before the grit removal system in the inlet works and therefore was not linked to any issues with the grit removal system.
- Investigations are ongoing to identify the potential source of the grit in the network.

Grit removed from the inlet

- A clean up has been completed of the areas affected by the flooding.
- The culvert was bricked up in the first week of March and a long term solution is being reviewed by the Asset Management team. Modelling will be carried out to identify the potential spill point if levels in the incoming sewer reached the same height again

- The Environment Agency have been approached regarding the sluice gate operation and future emergency procedures.
- Investigations are being undertaken to identify the potential source of the grit into the sewage treatment works. Additionally, a review of similar issues with grit at other trunk sewer locations across the network is being carried out.

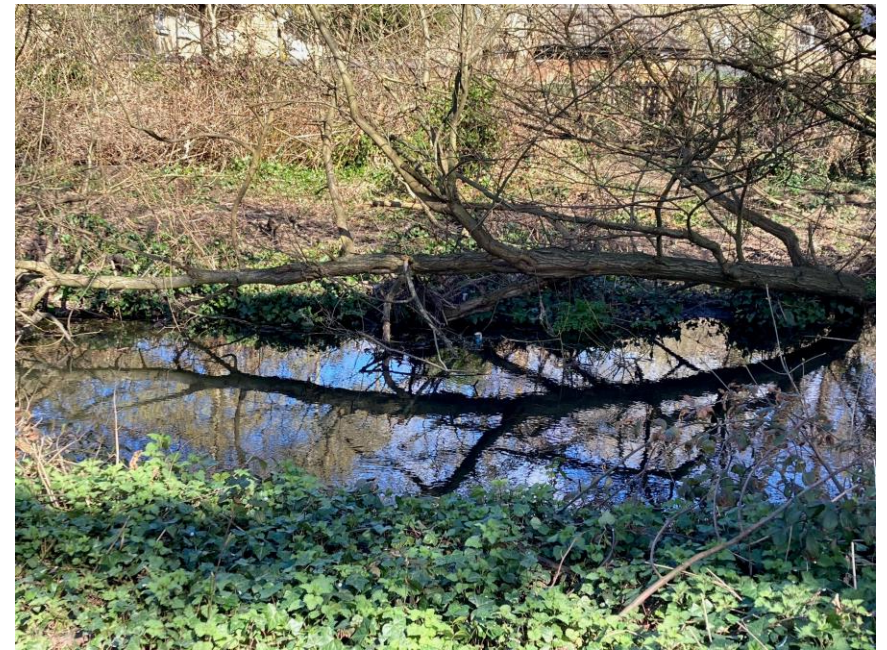
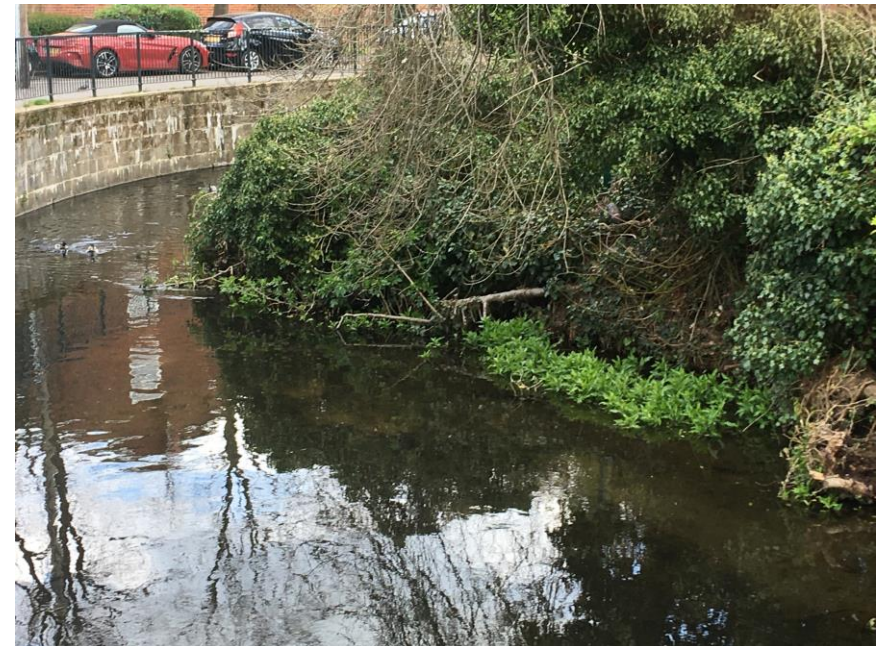
- **Phase 1** of the clean up:
 - Removal of bulk rag around the outfall
 - Precautionary disinfection of hard-standing surfaces from floodwater impact.
 - Began **6 February**.
 - Some initial delays due to sub zero temps restricting working in water.
- **Phase 2** of the clean up:
 - Hand clean of all rubbish (inc general litter) from specialist environmental response company (Adler and Allen)
 - Riverside Walk, Octavia Road and Silverhall Park conducted **3 – 9 March**
 - Behind Mill Plat Av conducted **8-9 April**
 - A+A removed 59 x bags and 10 bulk bags from the main river. Split between 20% sewage waste and 80% general litter
