Groundwater Impacted System Management Plan

Clanfield, Clanfield Brook

January 2021

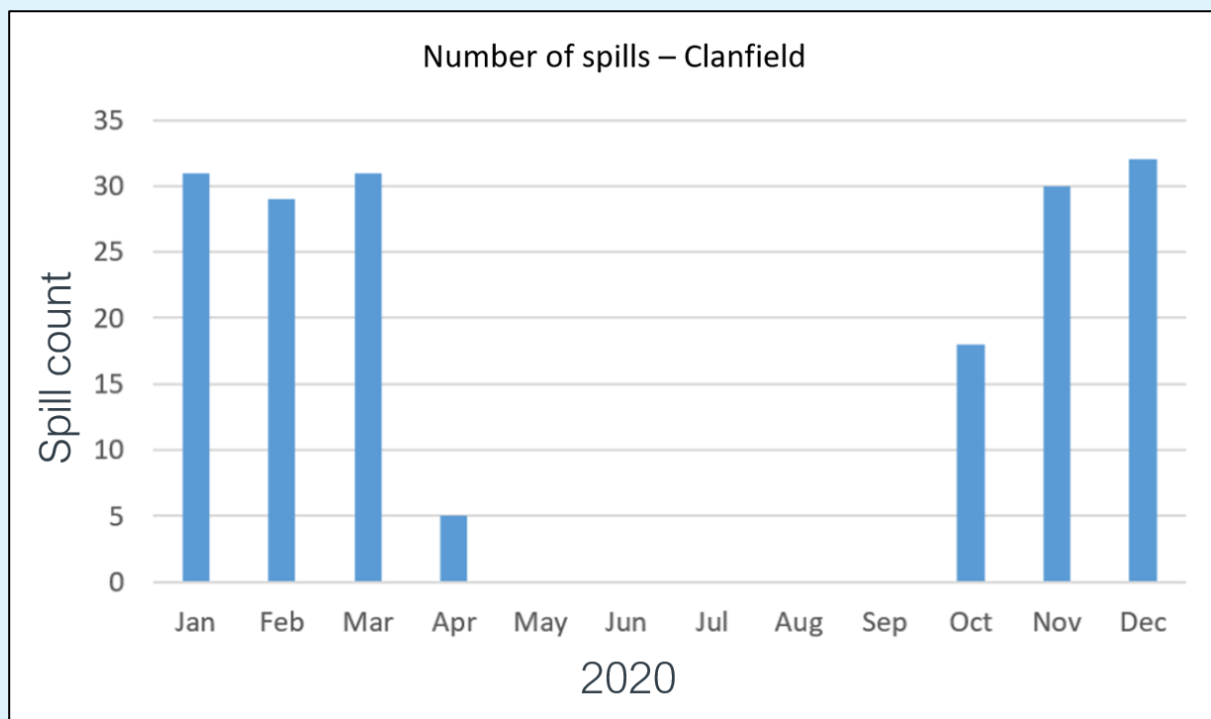
Figure 8 – Number of spills (discharge count) at Clanfield STW (taken from Event Duration Monitor (EDM) Data).*

Figure 8 shows the number of spills per month from the Sewage Treatment Works. The months of January to March and October to December experienced the greatest number of spills. In the summer, no spills were recorded highlighting the influence of groundwater infiltration/winter flows on the system. This Combined Sewer Overflow location has met the trigger for the EA's Storm Outfall Overflow Assessment Framework (SOAF) and is currently under further investigation with regards to root cause and impact.

Impacts of groundwater infiltration in the Clanfield system in this period were seen at the STW in the form of prolonged discharges shown above, there were no performance impacts in the network.

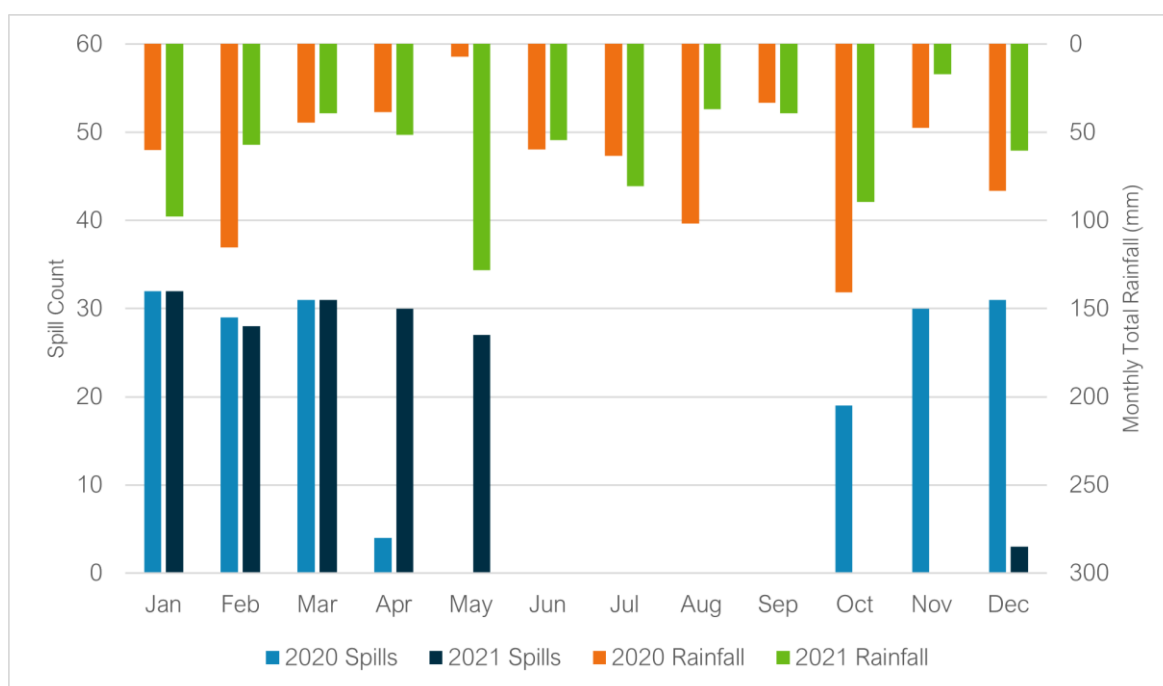
Figure 8 – EDM Monthly Performance

The trend in overflow performance suggests that spill at the overflow site is related to both groundwater level and rainfall. This can be seen in the different spill performance between 2020 and 2021 with comparable rainfall totals in month. It is particularly evident at the start of the hydrological years in October into December where spill frequency was significantly different despite broad similarities in rainfall. Note however, there were also operational issues at the STW in 2020, which may have impacted spill frequency.

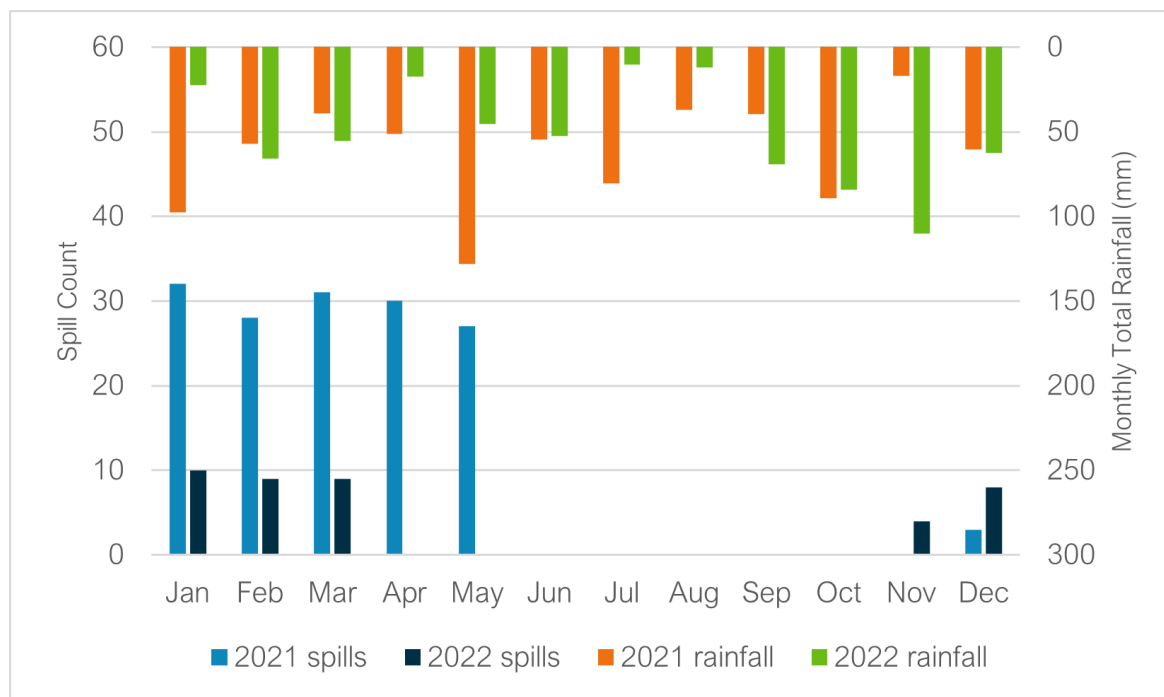
Figure 8 – EDM Monthly Performance

The trend in spill performance does show variation in spills, with a focus on spills during the autumn, winter and spring months. The data suggests a wider relationship between rainfall, elevated groundwater levels and spill frequency. For example, despite broadly similar rainfall totals, significantly more spills were recorded at Clanfield Marsh STW in February and March 2021 compared to the same months in 2022. The Windrush at Worsham indicator site shown in Figure 5, suggests groundwater levels in the catchment were significantly higher in February and March 2021, with Figure 6 suggesting groundwater levels in the catchment were just above or at below normal levels in February and March 2022. Similar trends can be observed for April and May.

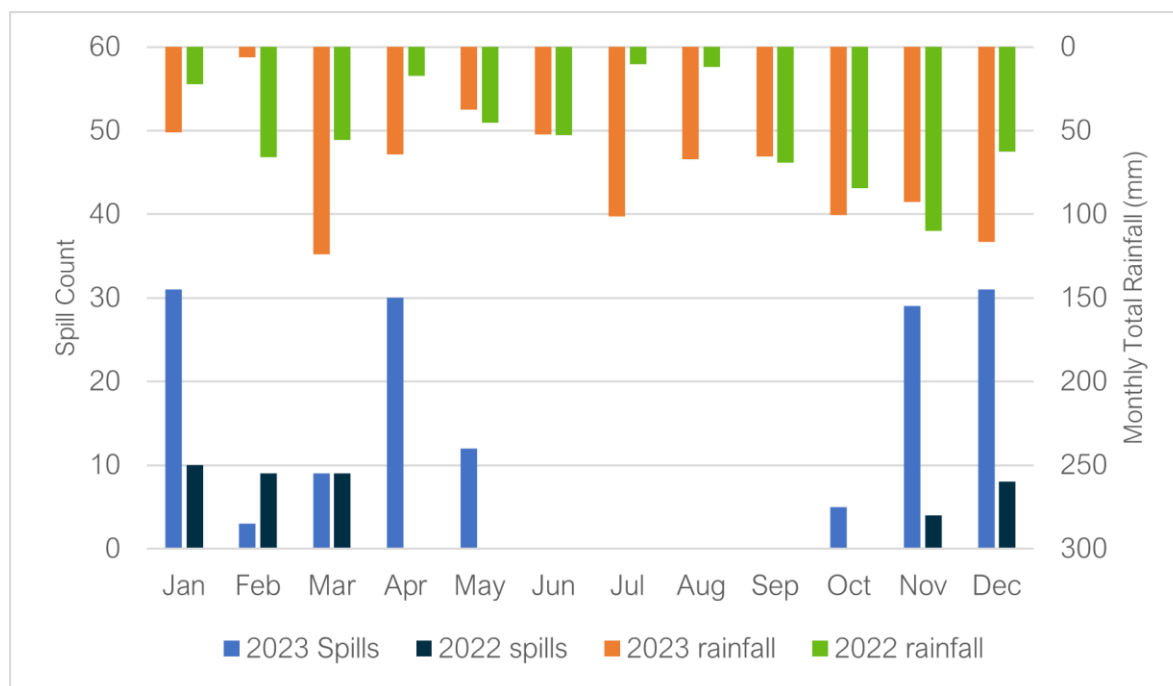
Figure 8 – EDM Monthly Performance

The data suggests a wider relationship between rainfall, elevated groundwater levels and spill frequency, with a focus on spills during the autumn, winter, and spring months. A significantly higher number of spills occurred at Clanfield Marsh STW in January, April and May 2023 compared to the same months in 2022. The indicator site data shown in Figures 5 and 6 suggests that groundwater levels in the catchment became elevated during January, April and May 2023 and reached higher levels than those observed in the same months in 2022. Similarly, a high number of spills occurred at Clanfield Marsh STW in November and December 2023, when the indicator site data shown in Figure 6 suggests groundwater levels in the catchment were at above normal/ notably high levels.
