South East Strategic Reservoir Option (SESRO)

Technical Supporting Document B2
Terrestrial Environmental Appraisal Report

Appendices

Cultural Heritage Desk-Based Assessment

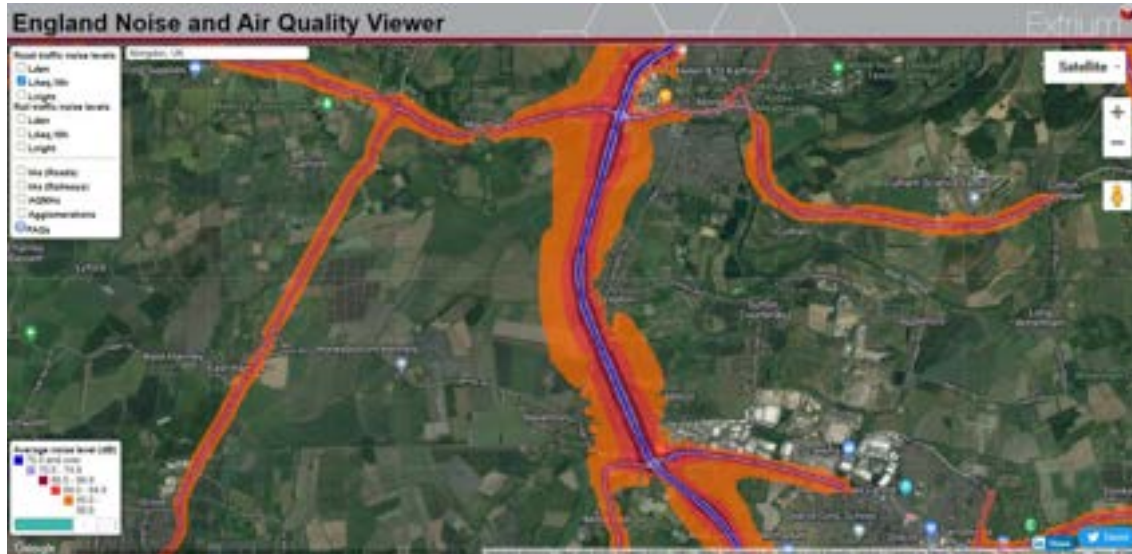
Figure A7.3.1: Strategic Noise Mapping at the Indicative Location for SESRO – Road $L_{Aeq,16hr}$

A7.3.2 The mapping presented below (Figures A7.3.1 to A7.3.14) shows both day ($L_{Aeq,16hr}$) and night-time (L_{night}) noise levels in the vicinity of the indicative location for SESRO.

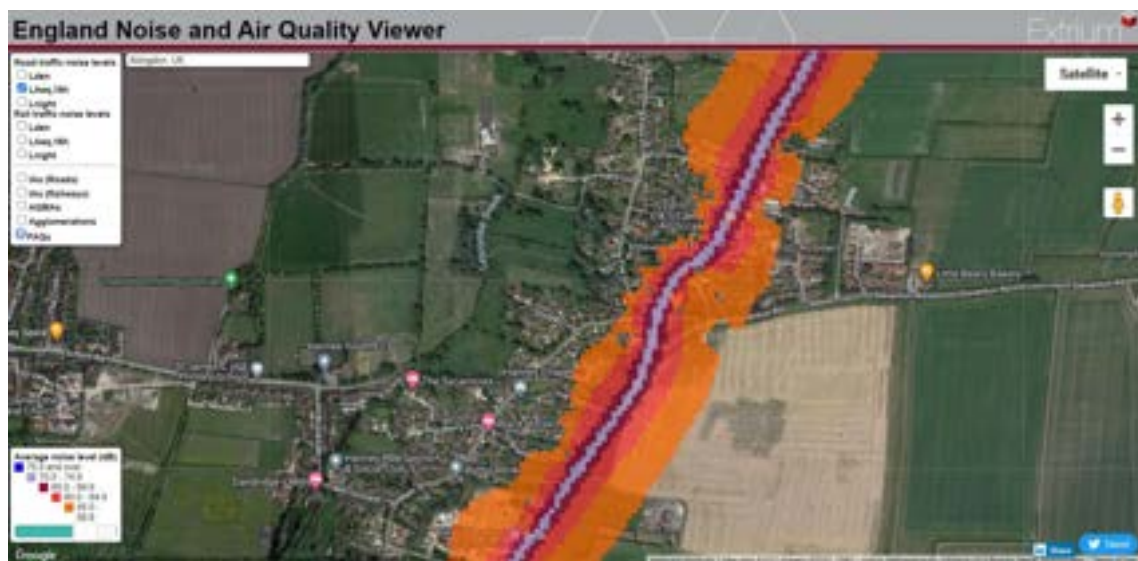
Figure A7.3.5: Strategic Noise Mapping at East Hanney – Road $L_{Aeq,16hr}$

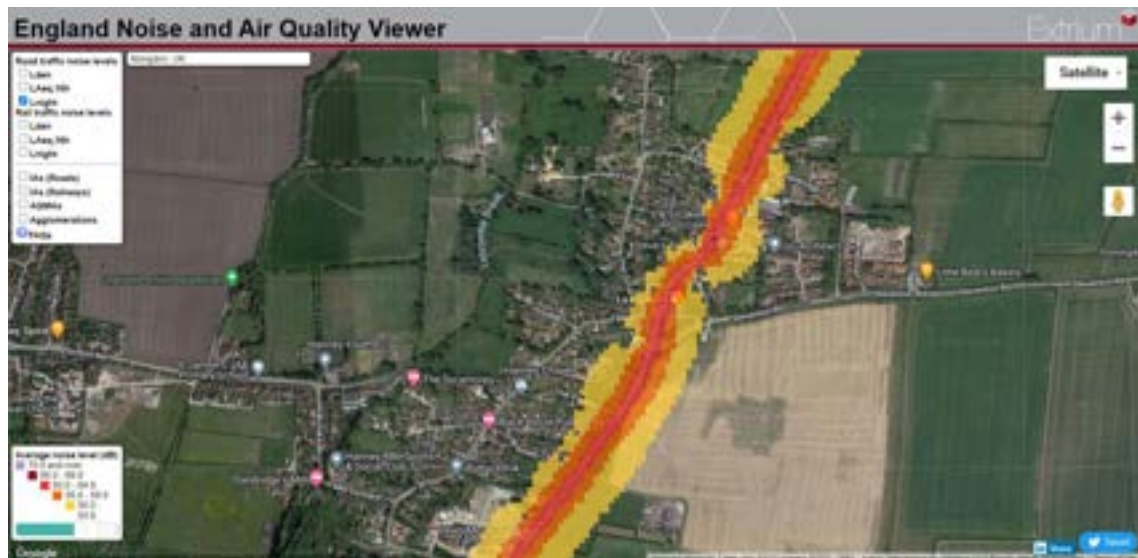
Figure A7.3.6: Strategic Noise Mapping at East Hanney – Road L_{night}

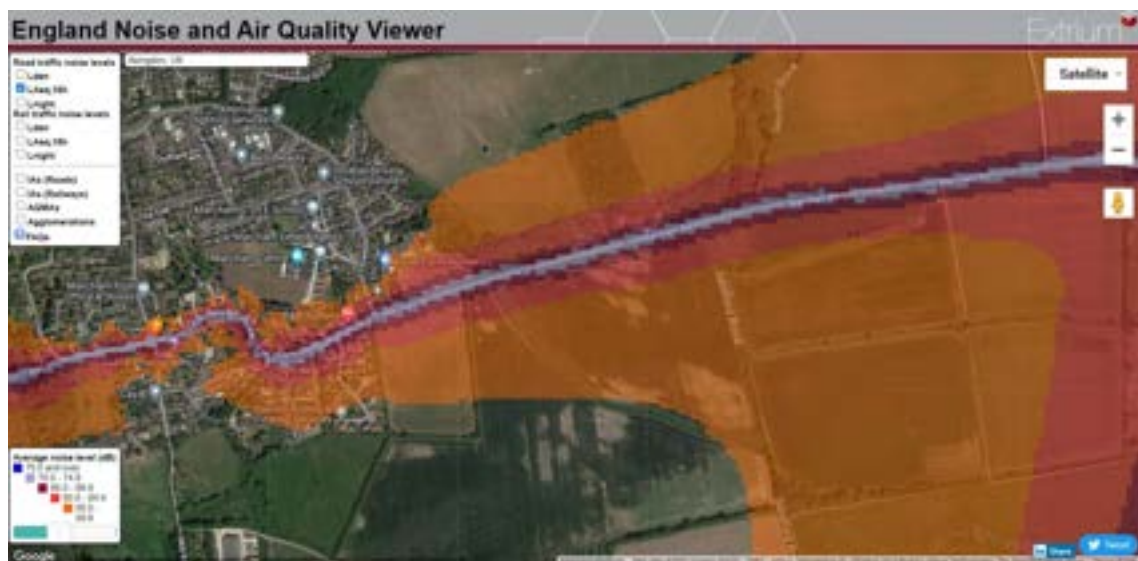
Figure A7.3.11: Strategic Noise Mapping at Marcham – Road $L_{Aeq,16hr}$

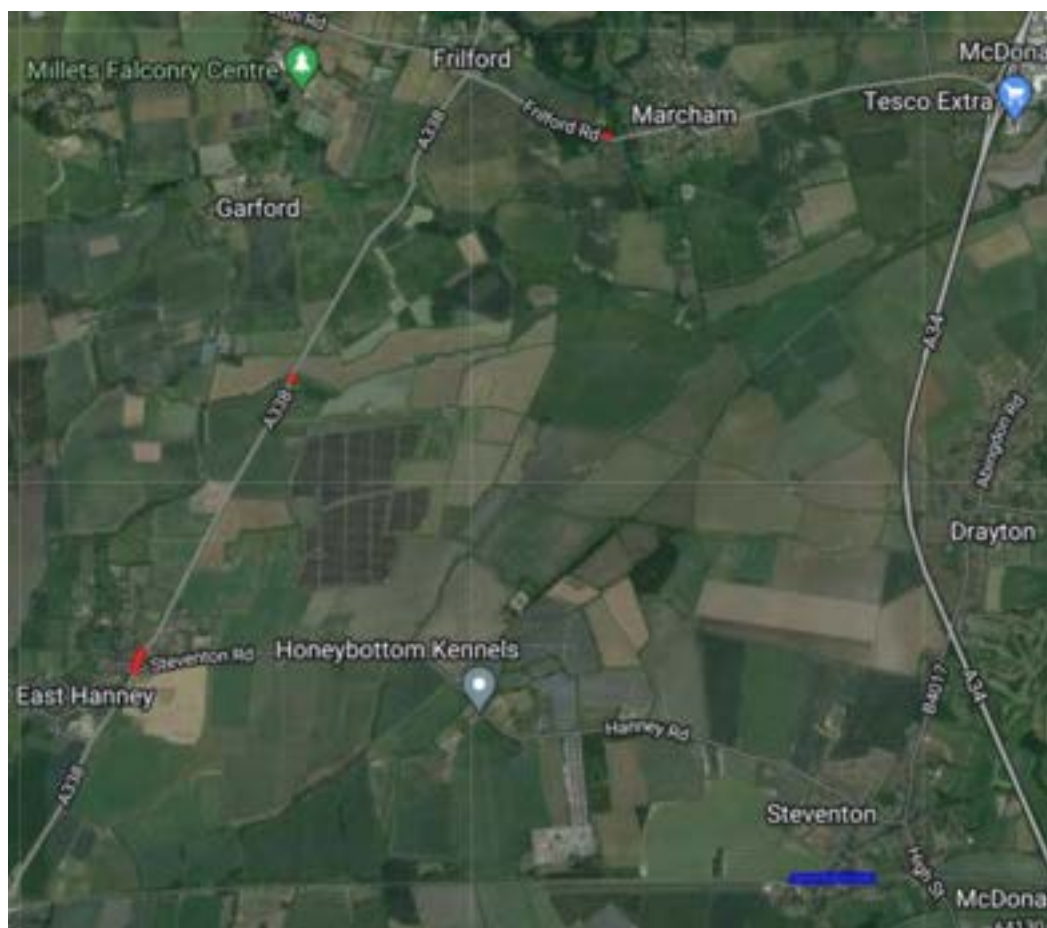
Figure A7.3.14: Strategic Noise Mapping showing noise action planning important areas for road and rail

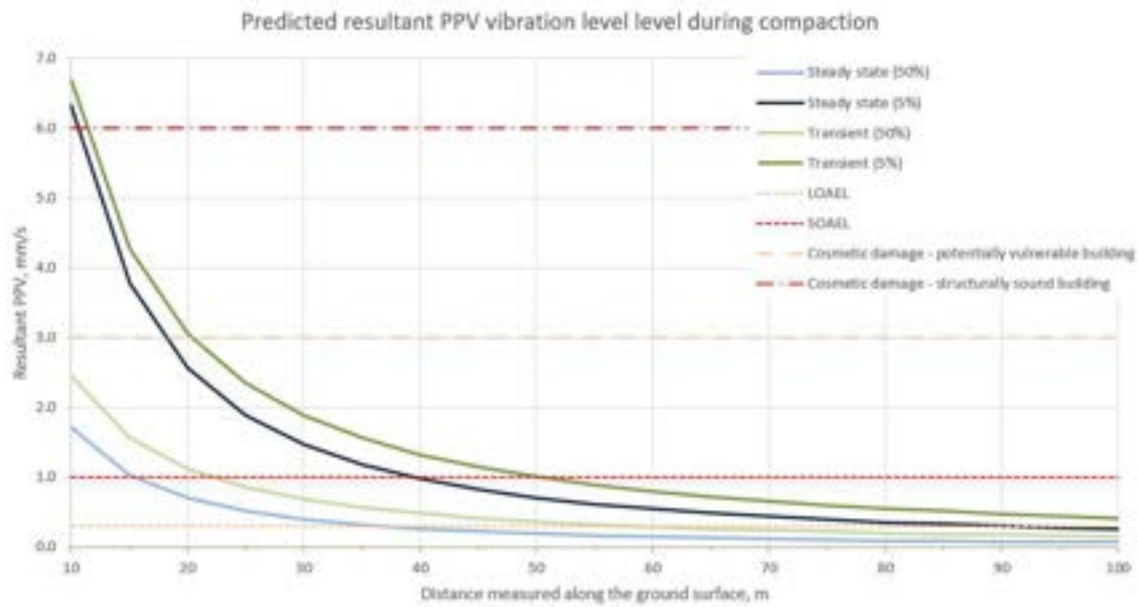
Figure A7.4.1: Predicted vibration levels during vibratory compaction (nominal vibration amplitude 0.98mm)

A7.4.5 When considering low vibration amplitude setting, during steady state working, and at a distance of approximately 15m, there is a 50% probability of 1.0mm/s PPV being exceeded, with a 5% probability of 1.0mm/s PPV being exceeded at a distance of approximately 40m. During the transient start up and run down conditions, the distances at which 1.0mm/s PPV is predicted to be exceeded are approximately 25m (50% probability) and 50m (5% probability).

A7.4.8 The only input parameter for the prediction method adopted (Table E.1 of BS 5228-2²⁴) is the distance measured along the ground surface. All other conditions are included in the constants and scaling factors within the empirical calculation.

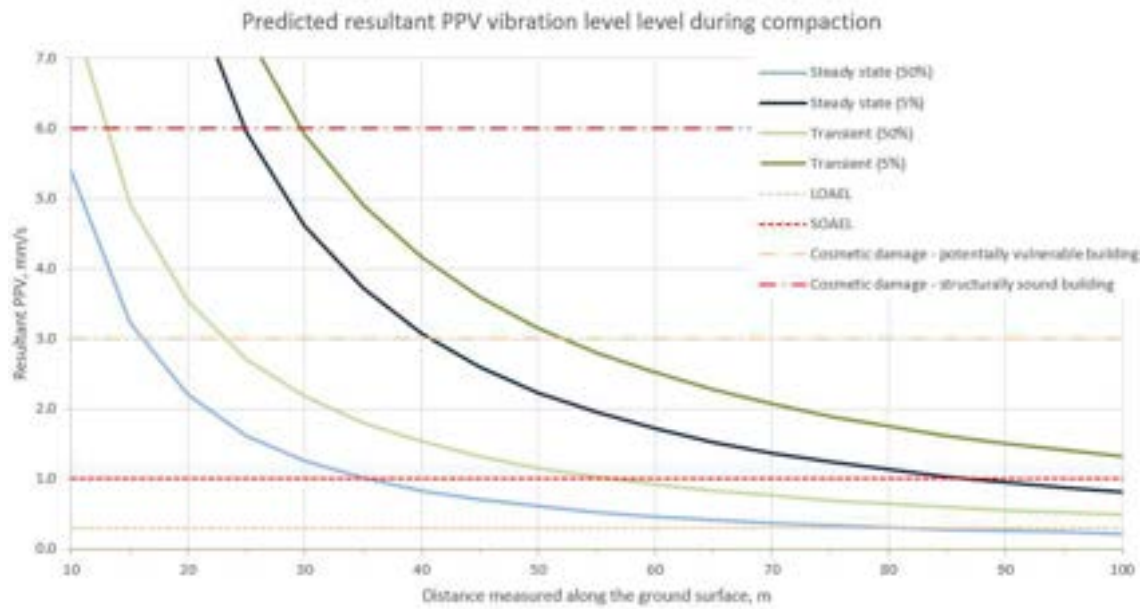
Figure A7.4.2: Predicted vibration levels during vibratory compaction (nominal vibration amplitude 2.1mm)

A7.4.6 At high vibration amplitude setting the potential for adverse impacts are greater. During steady state working, and at a distance of approximately 35m, there is a 50% probability of 1.0mm/s PPV being exceeded, with a 5% probability of 1.0mm/s PPV being exceeded at a distance of approximately 85m. During the transient start up and run down conditions, the distances at which 1.0mm/s PPV is predicted to be exceeded are approximately 55m (50% probability) and 120m²⁵ (5% probability).

²³ 2.1mm vibration amplitude is approximately 0.4mm above the maximum parameter range for the prediction method but has been adopted as a worst-case prediction assumption.

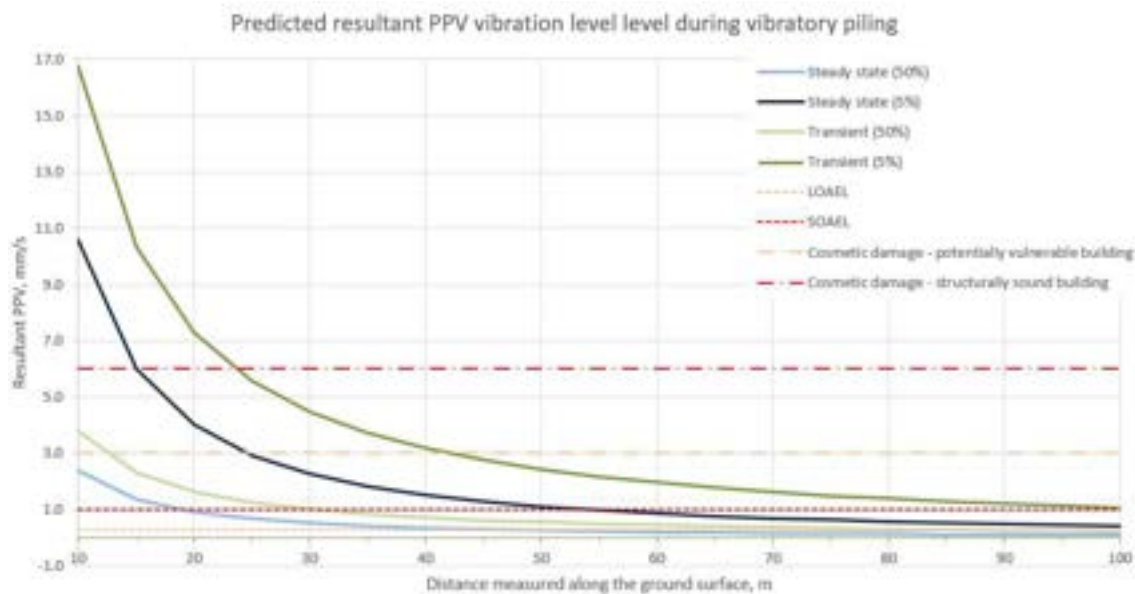
Figure A7.4.3: Predicted vibration levels during vibratory piling

A7.4.9 During steady state working, and at a distance of approximately 18m, there is a 50% probability of 1.0mm/s PPV being exceeded, with a 5% probability of 1.0mm/s PPV being exceeded at a distance of approximately 55m. During the transient start up and run down conditions the distances at which 1.0mm/s PPV is predicted to be exceeded are approximately 30m (50% probability) and 100m (5% probability).

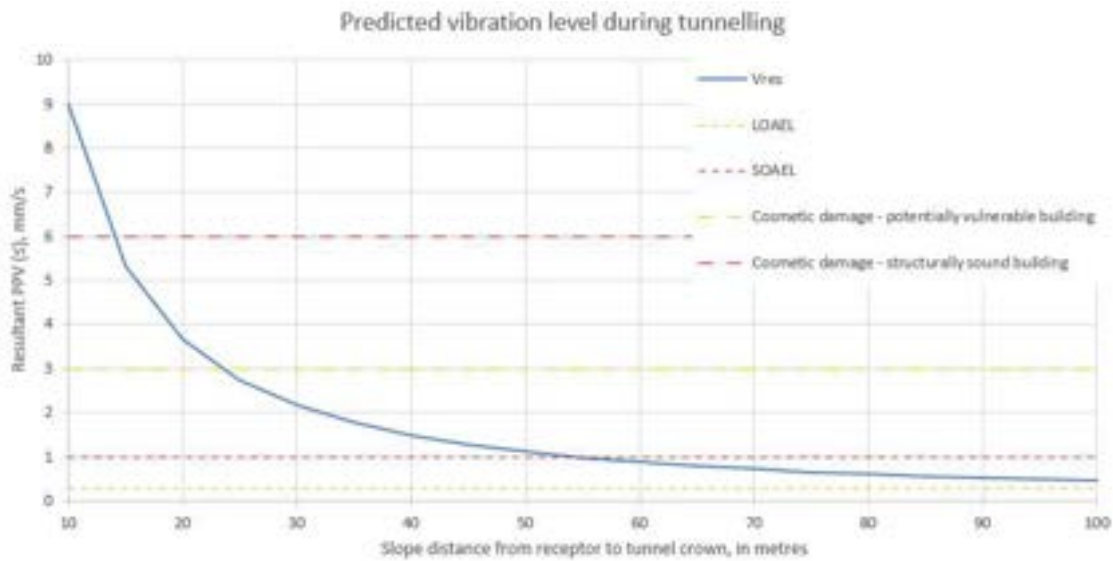
A7.4.10 Figure A7.4.4 presents the resultant Peak Particle Velocity (PPV) vibration levels and room sound pressure levels predicted for tunnelling.

A7.4.11 The only input parameter for the prediction of both groundborne noise and vibration due to tunnelling (Table E.1 of BS 5228-2²⁴) is the slope distance measured from the tunnel crown to the prediction point at the surface (i.e. the receiver location).

Figure A7.4.4: Predicted vibration levels during tunnelling

A7.4.12 The vibration SOAEL (1.0mm/s PPV) is predicted to be experienced at a distance of approximately 55m or less, while the potential for cosmetic building damage at potentially vulnerable buildings (3.0mm/s PPV), would be predicted to occur at a distance of approximately 23m.

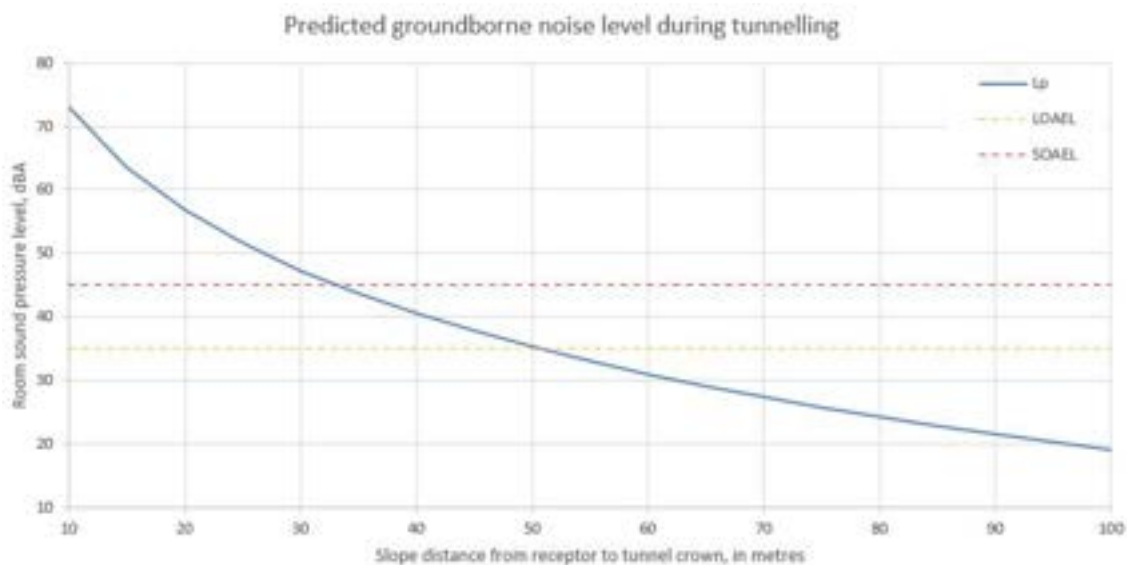
Figure A7.4.5: Predicted room sound pressure levels during tunnelling
