Eade Road | New River Leakage

Background

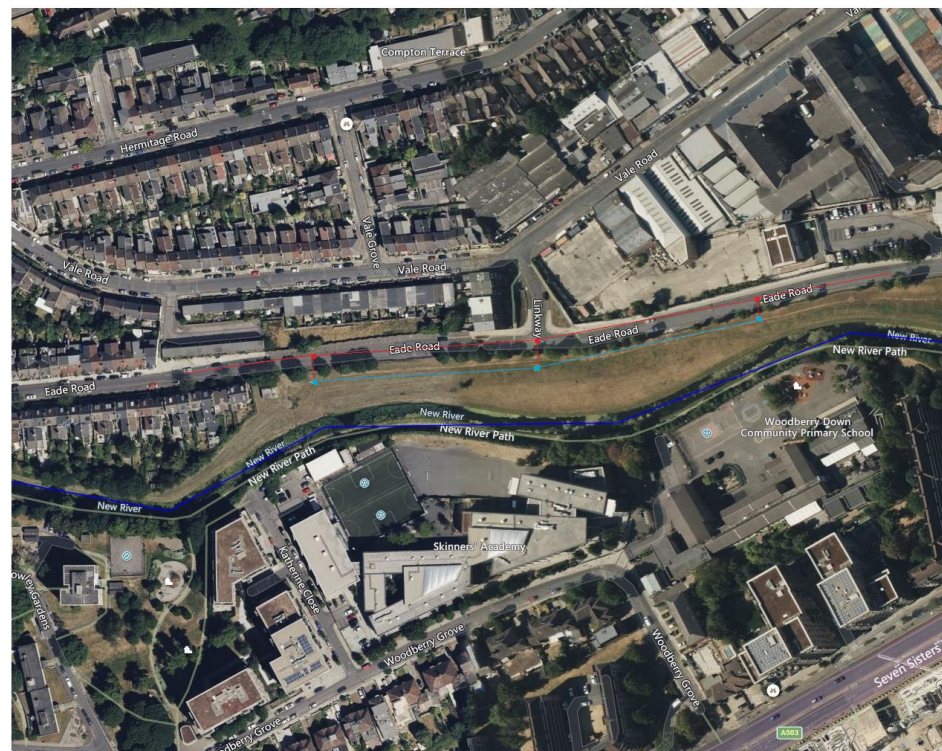
The embankment drainage capacity has been created by adding a drainage conduit in the embankment parallel to Eade Road in the grassy embankment.

The sites of interest are centered along Eade Road East and West of the linkway to Vale Road.

The EA does consider this as a low-risk area for surface flooding arising from rainfall, river or groundwater. Historic flood mapping.

There is no obvious media or social media reporting of flooding in the area.

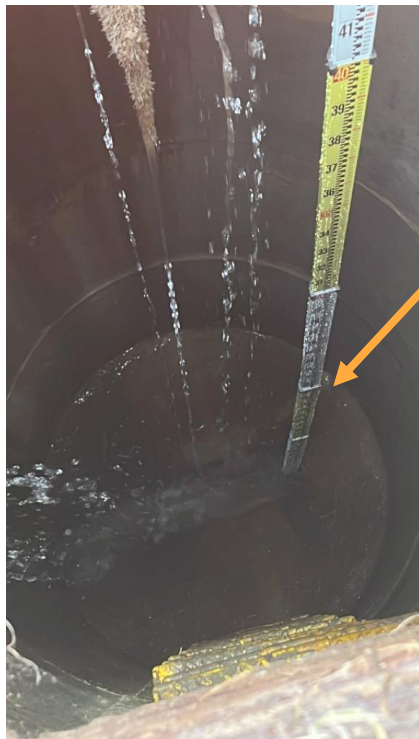
- The West end of the embankment, nearest to 66 Eade Road has a constant significant flow in dry conditions (no recent rainfall).
- Central of the embankment opposite the linkway to Vale, there is evidence of flows with sediment visible in the drain.
- At the East end of the embankment there is slight flow in dry conditions (no recent rainfall) with evidence of sediment.

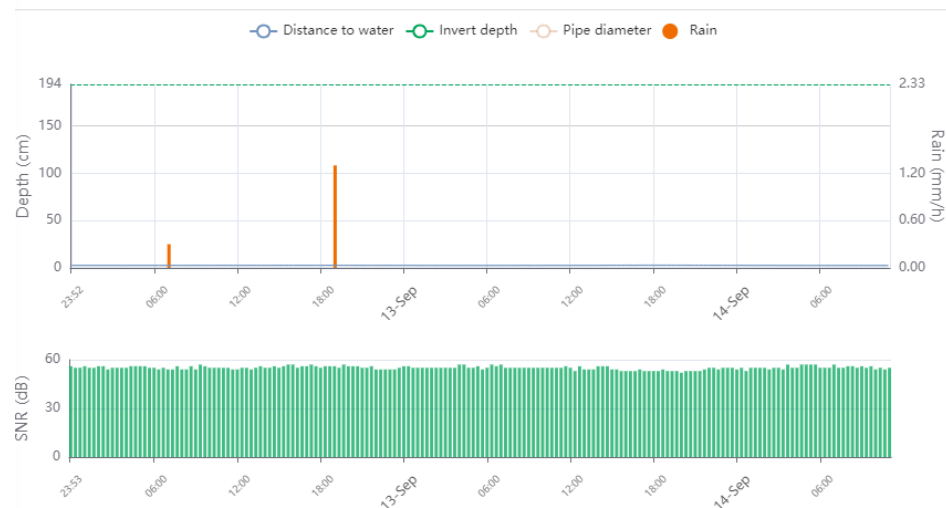
Findings (West Embankment)

Installed on 11th Sept: Early Indications.

- Flow is constant and does not vary with:
 - Rainfall (12/09 - c. 19:00)
 - Common daily usage patterns
- No evidence of pumping pattern.
- Flow measured at **15 l/ps or 1290 M3 day.**
- Likely range is 850 - 1290 M3 day.
- Stability of flow suggests substantial leakage from New River.
- Keen to understand impact of cleaning / sustained rainfall.

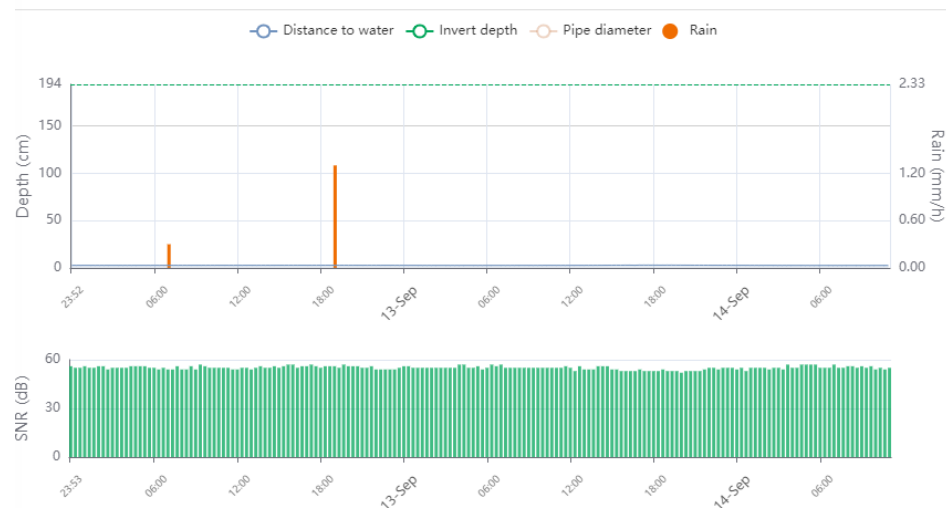
Findings (Centre/East Embankment)

Installed on 11th Sept: Early Indications.

Centre

- Sedimented, no water.
- Keen to understand impact of cleaning / sustained rainfall.

East

- Constant flow, no level change.
- I/ps not measured due to sediment.
- Keen to understand impact of cleaning / sustained rainfall.
