Eade Road | New River Leakage

Background

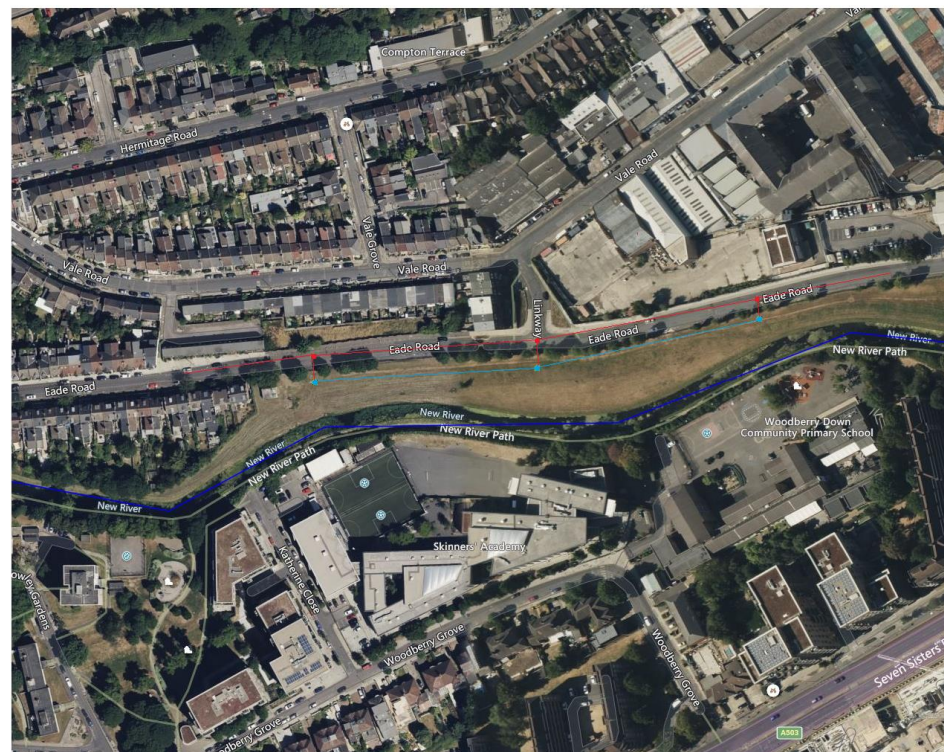
The embankment drainage capacity has been created by adding a drainage conduit in the embankment parallel to Eade Road in the grassy embankment.

The sites of interest are centered along Eade Road East and West of the linkway to Vale Road.

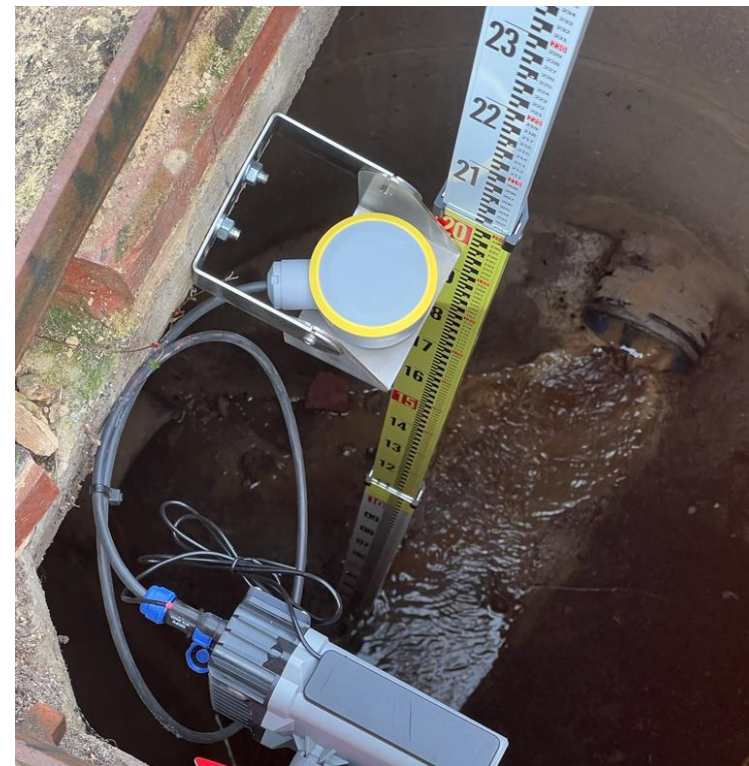
- Establish flows through the drains to assess:
 - Volumes
 - Patterns
- Relationship with:
 - Rainfall
 - Daily Usage Patterns
 - Pumping Patterns
- Long term changes
- Likely Source of water

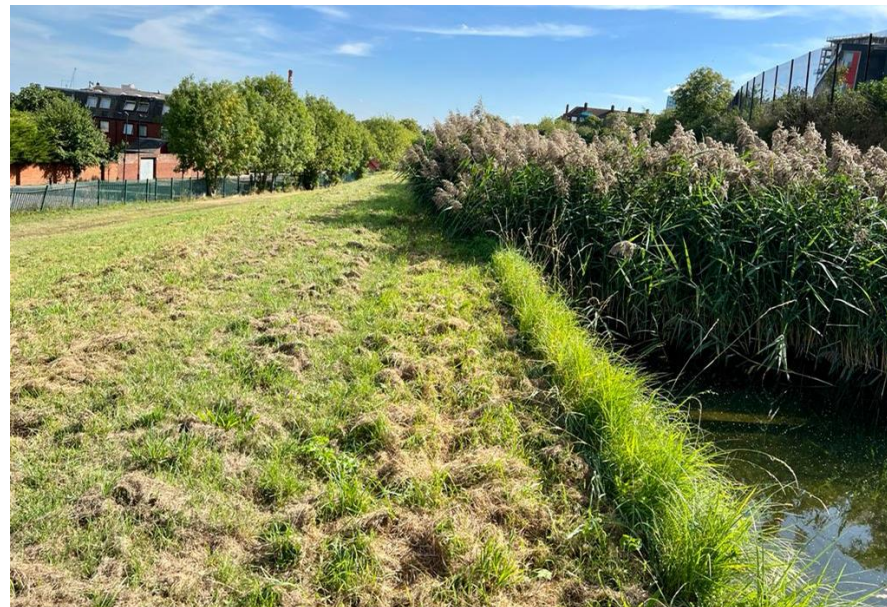
- Constant flow and evidence of sediment show new drainage conduit is well used.
- Lack of indication of other sources of water including rainfall, wastewater network or historic issues.
- **Whilst further monitoring will be useful, initial indication suggest leakage from New River.**
