Groundwater Impacted System Management Plan

Clanfield, Clanfield Brook

January 2021

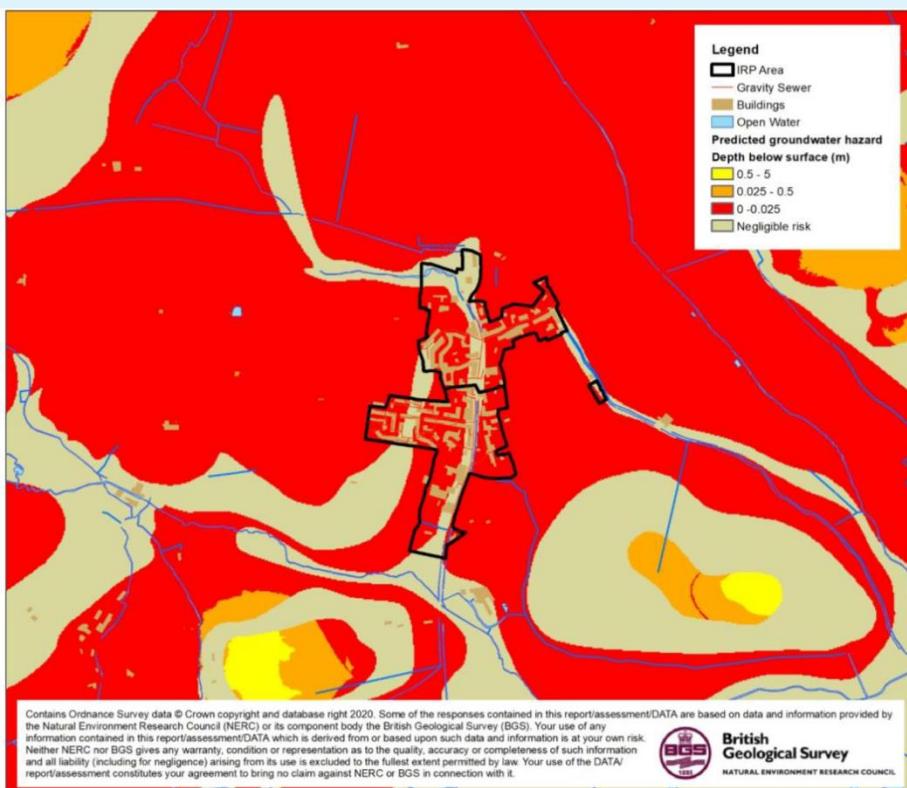
Figure 1.0 – Clanfield catchment

Clanfield is located in Oxfordshire, England, 3 miles South of Carterton and 15 miles West of Oxford. Clanfield serves a population equivalent³ of 900 with a predominantly separate sewerage network totalling some 5 km in length excluding private drains and sewers. The extent of the catchment is shown in Figure 1.0 above.

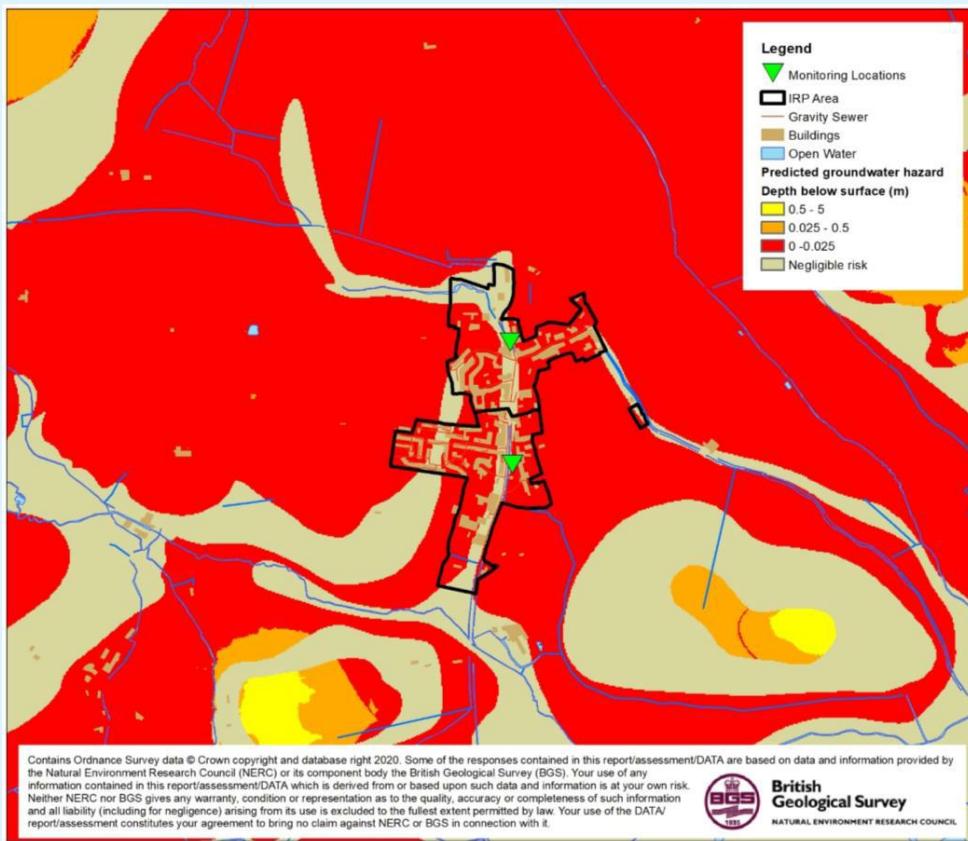
Figure 2.0 – Clanfield monitoring and infiltration zones

Key to bringing the impact of groundwater infiltration under control will be an enhanced monitoring regime. We have identified and have installed several telemetered depth monitor locations around the Clanfield system – see Figure 2.0.

We engaged with JBA Consulting to develop plans for Clanfield that identify zones of groundwater risk, see Figure 2.0. These zones are modelled areas where the groundwater has been determined to be above the sewer and hence pose a potential risk for groundwater ingress.

Sewer Depth Monitors have been installed in the catchment in 2020 (see Figure 2.0). These devices are telemetered and provide real time data on the level of flow in the sewer.

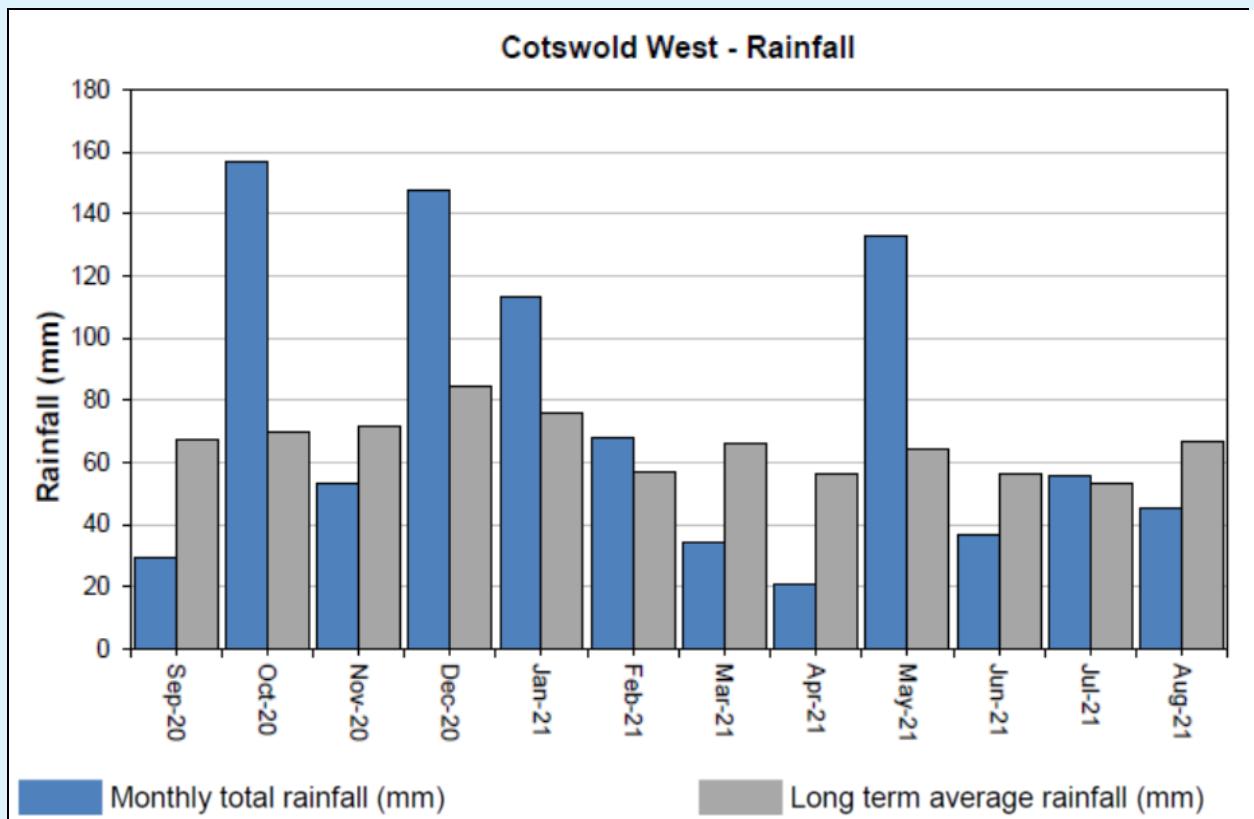
Figure 2 – Monthly rainfall depths local to the system

Clanfield is situated in the Cotswold West water resources area. Figure 2 shows the monthly rainfall total depths against the long-term average rainfall in the location of Clanfield over the period taken from the *Environment Agency Water Situation Report August 2021*.¹

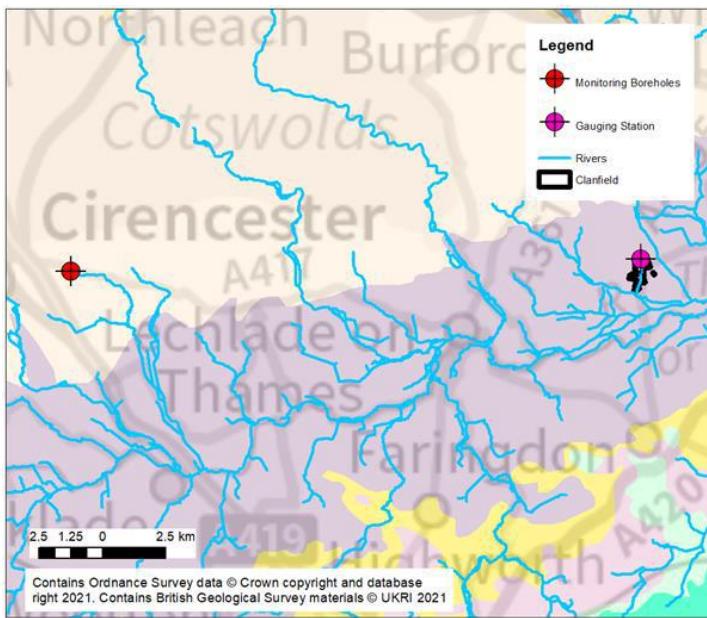
Figure 3 – Location of Ampney Crucis Monitoring Borehole Relative to Clanfield.

Figure 3 shows the location of the British Geological Survey (BGS) monitoring borehole at Ampney Crucis which has been monitoring groundwater since 1959. Figures 4 and 5 show river levels in the Clanfield Brook at Clanfield which are a good indicator of the localised groundwater levels over time. Figure 6 and 7 show the last two and ten years of groundwater level data overlain on expected ranges. This shows how recent groundwater levels have compared against the expected range, they show that generally over the last two winters groundwater levels have been notably higher, with the peak groundwater levels close to or within the exceptional high range.

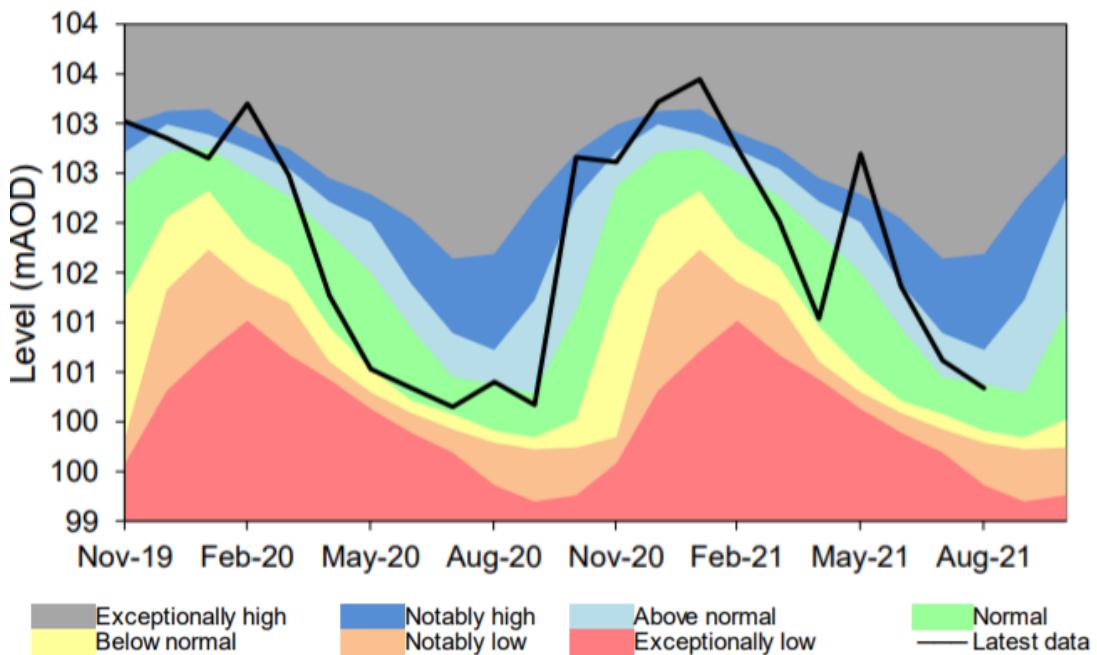
Figure 6 – 2019-2021 Groundwater levels at Ampney Crucis. (Environment Agency Water Situation Report August 2021)

AMPNEY CRUCIS - GREAT OOLITE Ranking derived from data for the period Dec-1958 to Dec-2017

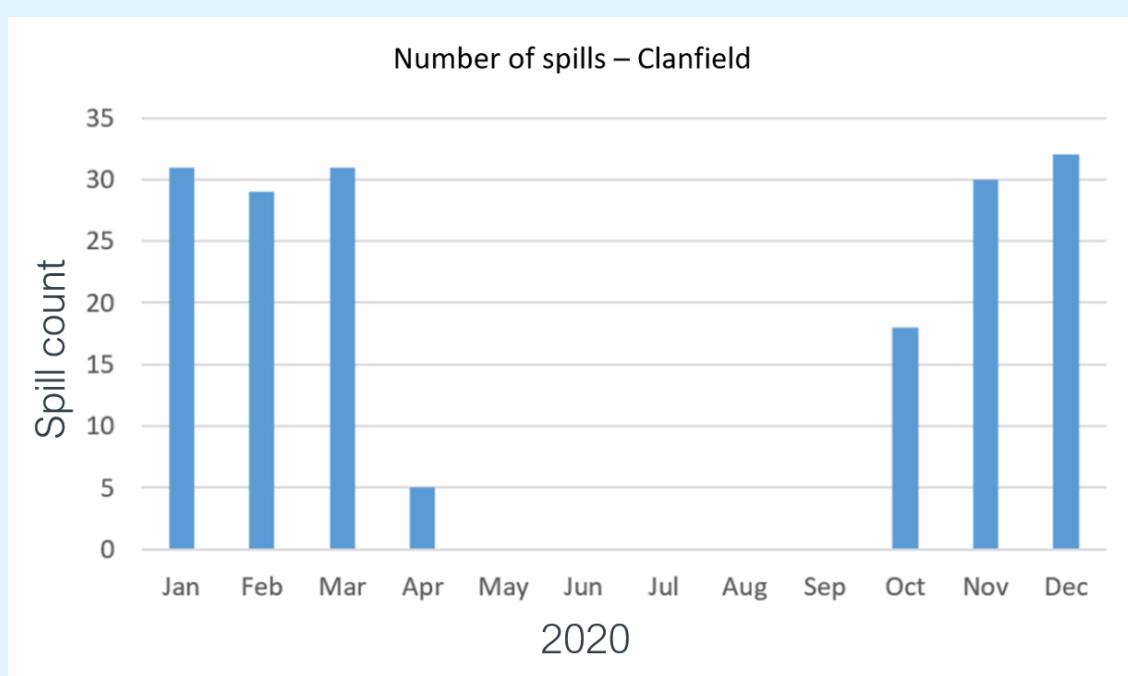
Figure 8 – Number of spills (discharge count) at Clanfield STW (taken from Event Duration Monitor (EDM) Data).*

Figure 8 shows the number of spills per month from the Sewage Treatment Works. The months of January to March and October to December experienced the greatest number of spills. In the summer, no spills were recorded highlighting the influence of groundwater infiltration/winter flows on the system. This Combined Sewer Overflow location has met the trigger for the EA's Storm Outfall Overflow Assessment Framework (SOAF) and is currently under further investigation with regards to root cause and impact.

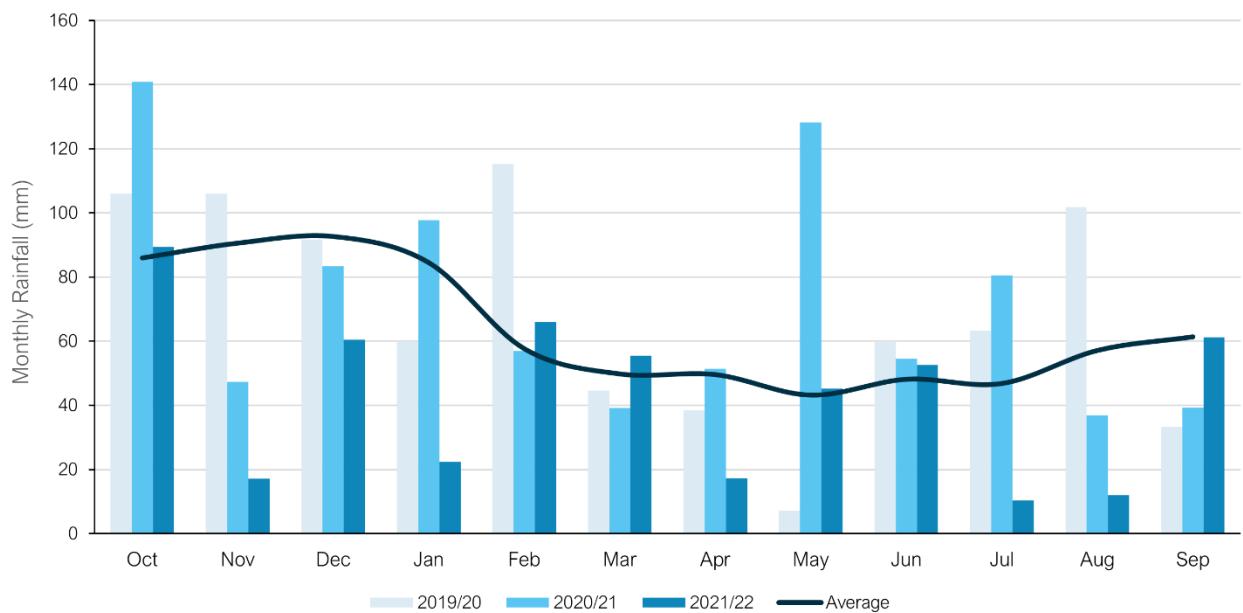
Figure 2 – Monthly Rainfall Performance

Representative Radar rainfall has been used to generate monthly data at catchment level for comparison with average data generated by local Met Office Weather Station Records. Figure 2 presents the comparison of this data for the last three hydrological years to support longer term trends within the local system.

Average Values taken from Met Office Weather Station at Thorney Island based on the period 1991-2020

The total rainfall for the 2021/22 hydrological year is 33% below the annual average total, with winter months generally showing below average totals. Total rainfall values are presented in Table 3 below.

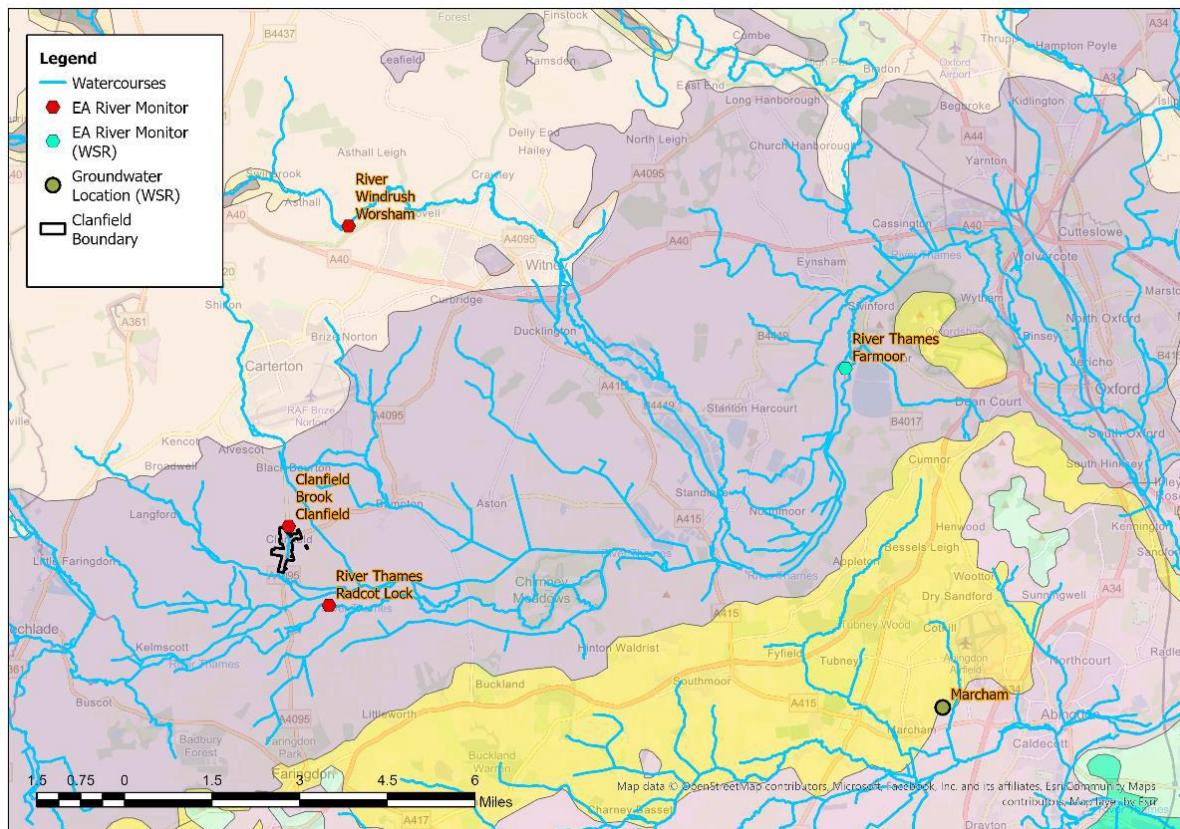
Figure 4 – Local Monitoring Stations

These sites are illustrated in Figure 4 below alongside the closest groundwater reference station and closest gauging station from the Water Situation Report.

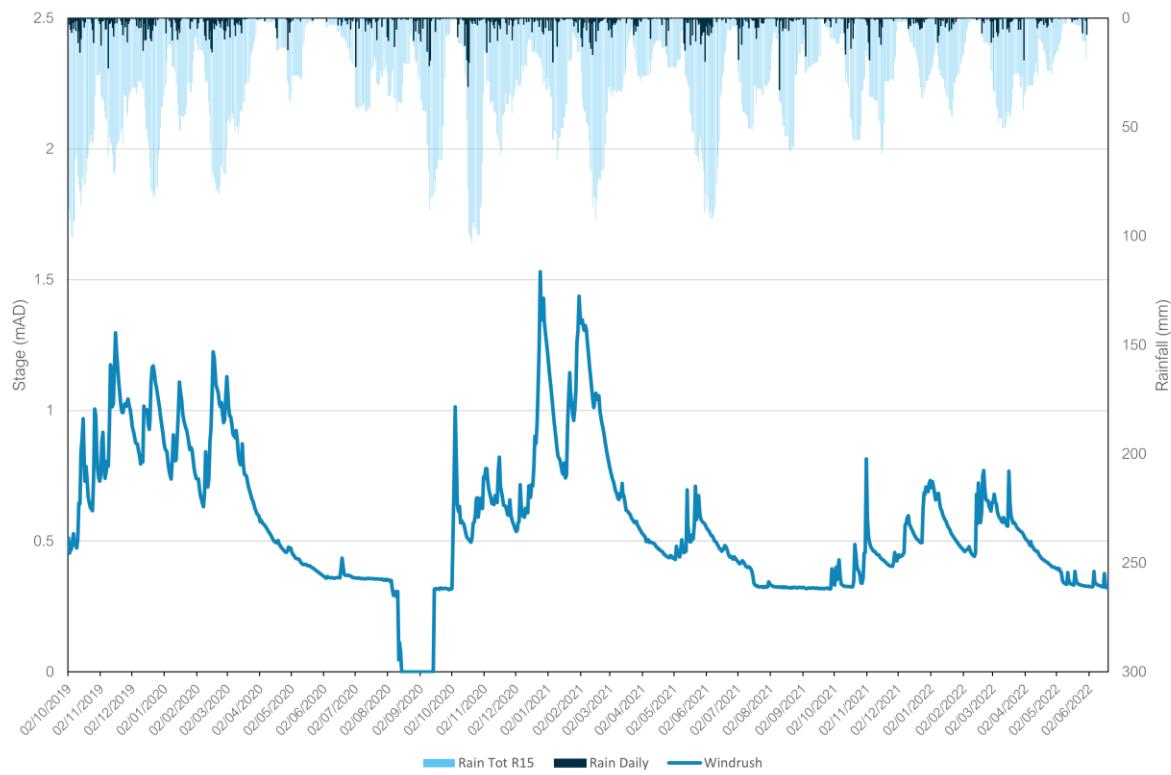
Figure 5A – Windrush at Worsham

The following figures represent the last three hydrological years of level information at the indicator sites to build a picture of the relative conditions prevalent in the current year. It is presented against both the daily total rainfall values for the catchment and a rolling 15 day total rainfall.

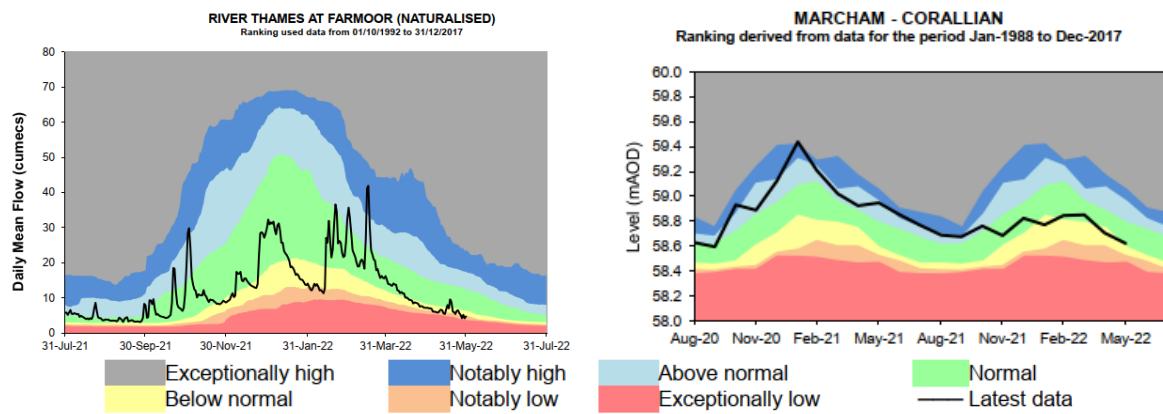
Figure 6 – Water Situation Report

In addition to these specific stations, the wider groundwater context is illustrated in the Water Situation Report for the Upper Thames. Whilst the Clanfield catchment does not sit within a principal aquifer, the closest groundwater reference station is Marcham. This site shows significantly lower overall groundwater than the previous year. This can be seen in the figure below alongside the river indicator location at Farmoor on the River Thames.

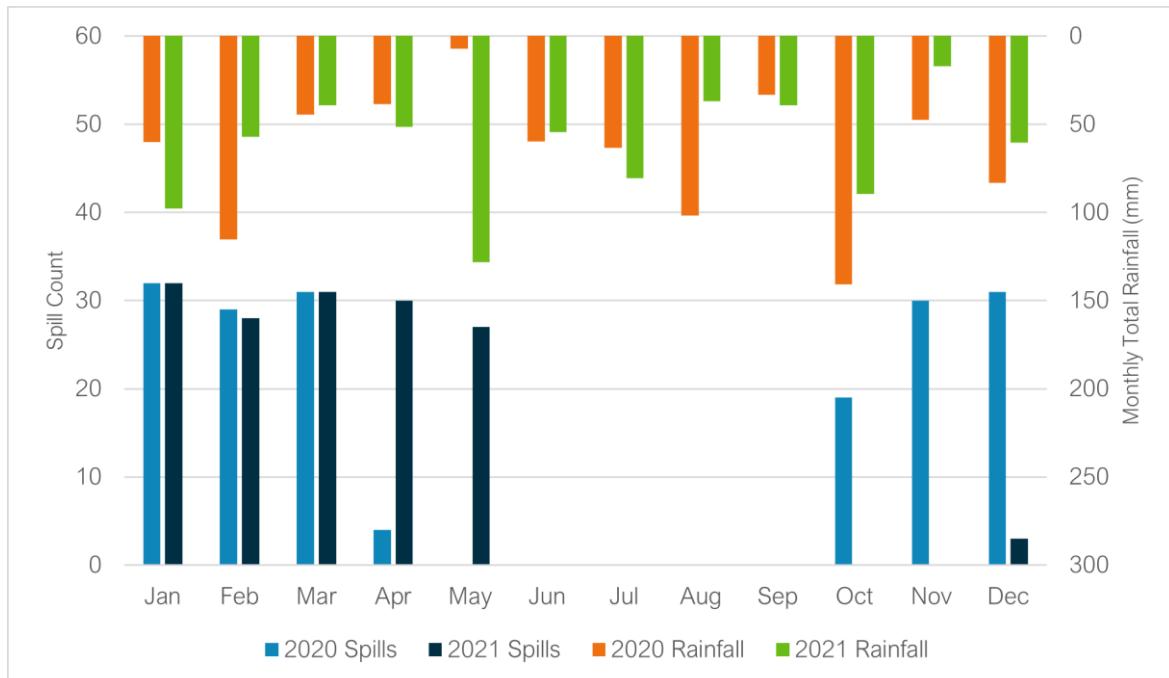
Figure 8 – EDM Monthly Performance

A critical part of the assessment of EDM performance and its relation to groundwater inundation is to review the month-on-month spill performance, against previous years and the monthly total rainfall values to give context to the performance. Figure 8 below presents the EDM performance trend and rainfall for recent years. Note that a spill count of 151 is stated for 2021, which is higher than the reported figure of 148. The spill count has been corrected/ re-validated and the revised figure of 151 will be included in the re-submission to the EA.

The trend in overflow performance suggests that spill at the overflow site is related to both groundwater level and rainfall. This can be seen in the different spill performance between 2020 and 2021 with comparable rainfall totals in month. It is particularly evident at the start of the hydrological years in October into December where spill frequency was significantly different despite broad similarities in rainfall. Note however, there were also operational issues at the STW in 2020, which may have impacted spill frequency.

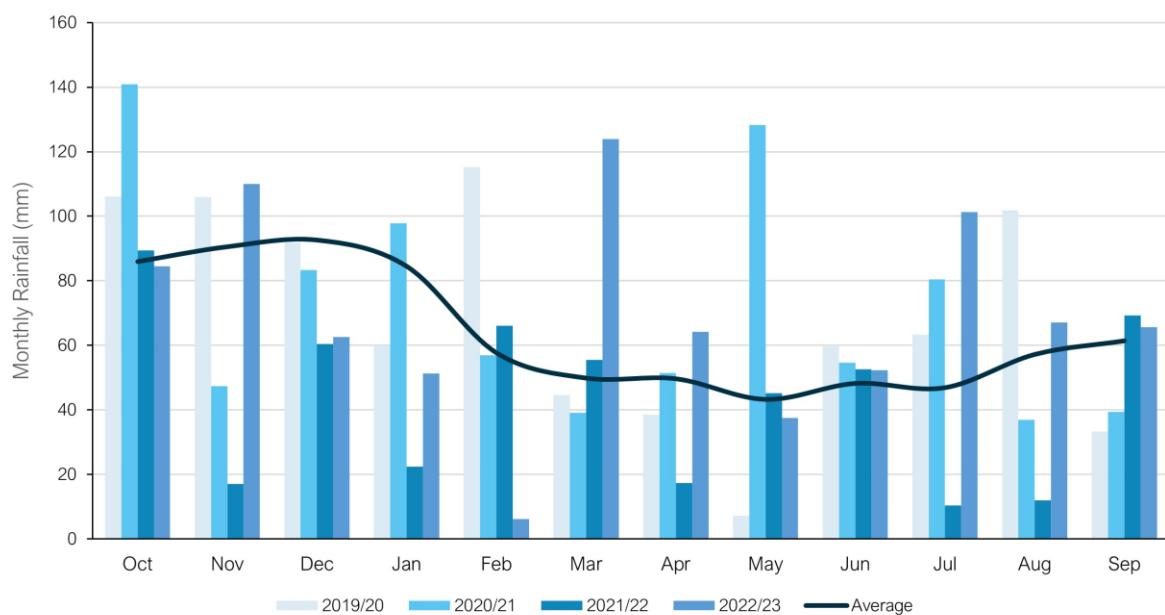
Figure 2 – Monthly Rainfall Performance

Representative Radar rainfall has been used to generate monthly data at catchment level for comparison with average data generated by local Met Office Weather Station Records. Figure 2 presents the comparison of this data for the last four hydrological years to support longer term trends within the local system.

Average Values taken from Met Office Weather Station at Thorney Island based on the period 1991-2020

The total rainfall for the 2022/23 hydrological year is 8% above the annual average total. Total rainfall values are presented in Table 3 below.

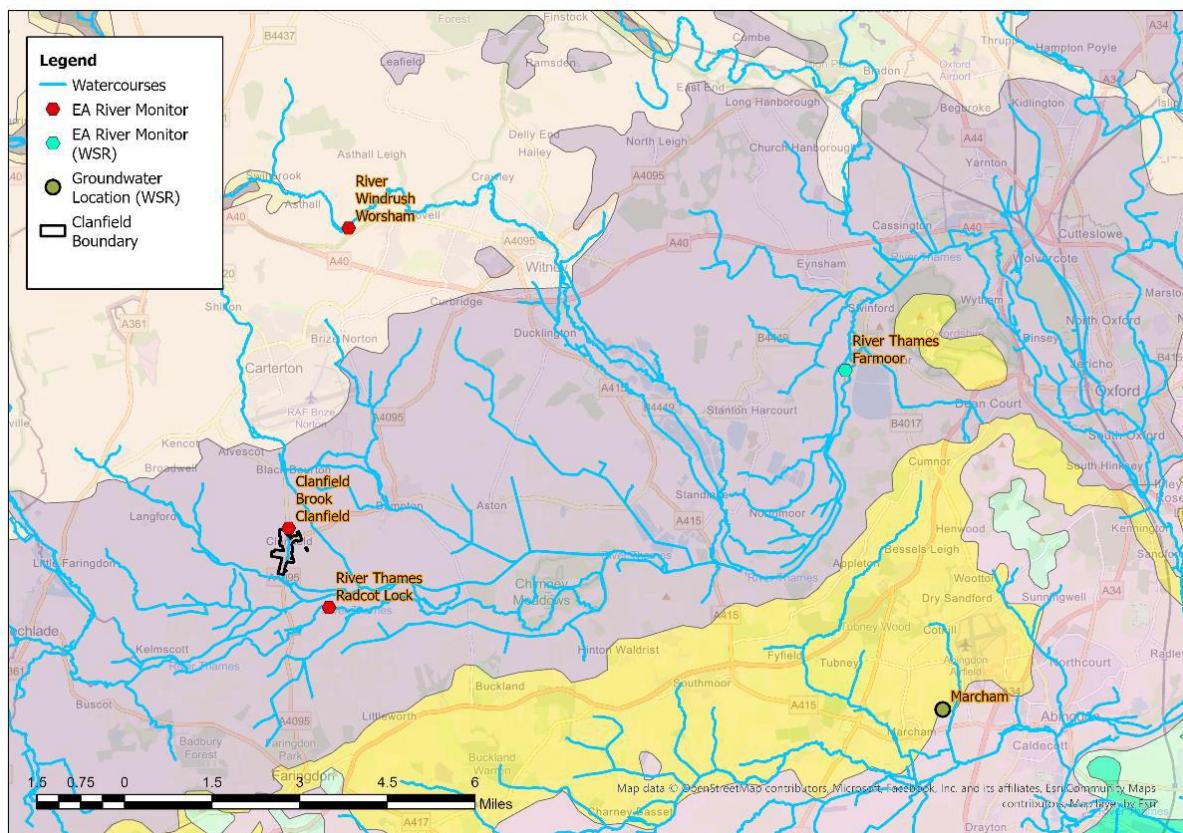
Figure 4 – Local Monitoring Stations

These sites are illustrated in Figure 4 below alongside the closest groundwater reference station and closest gauging station from the Water Situation Report.

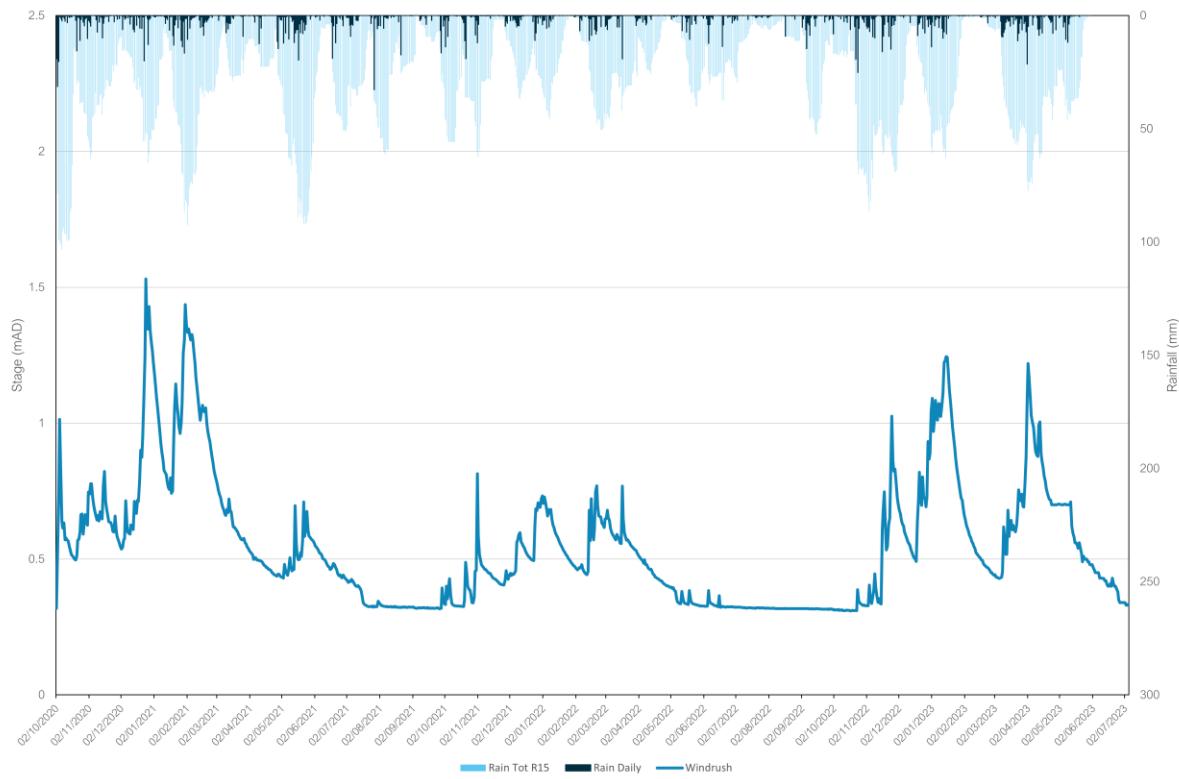
Figure 5A – Windrush at Worsham

The following figures represent the last three hydrological years of level information at the indicator sites to build a picture of the relative conditions prevalent in the current year. It is presented against both the daily total rainfall values for the catchment and a rolling 15-day total rainfall.

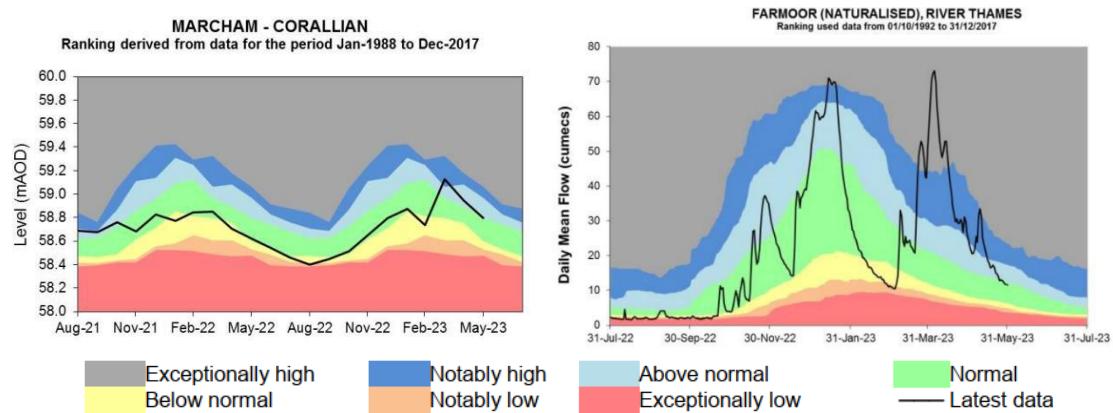
Figure 6 – Water Situation Report

In addition to these specific stations, the wider groundwater context is illustrated in the Water Situation Report for the Upper Thames. Whilst the Clanfield catchment does not sit within a principal aquifer, the closest groundwater reference station is Marcham. This site shows that groundwater levels in the year 2022 were generally at below normal or just above below normal levels. This hydrological year (October 2022 onwards), groundwater levels have generally been higher than the previous hydrological year. This can be seen in the figure below alongside the river indicator location at Farmoor on the River Thames.

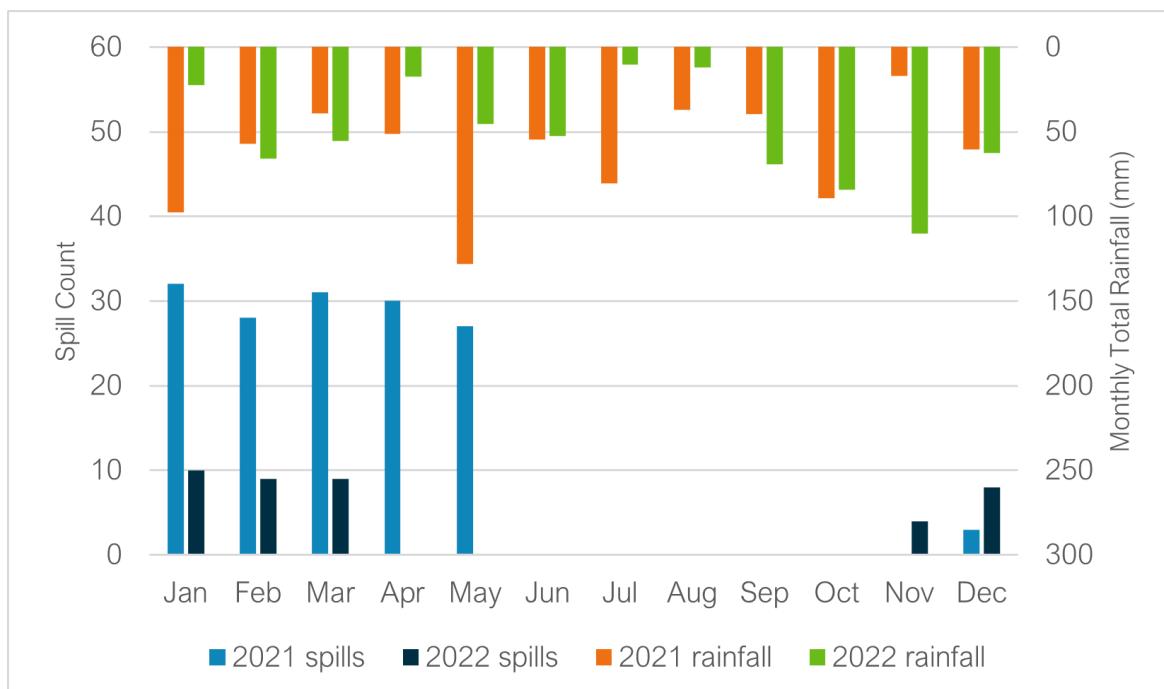
Figure 8 – EDM Monthly Performance

A critical part of the assessment of EDM performance and its relation to groundwater infiltration is to review the month-on-month spill performance, against previous years and the monthly total rainfall values to give context to the performance. Figure 8 below presents the EDM performance trend and rainfall for recent years. Note that a spill count of 151 is stated for 2021, which is higher than the previously published figure of 148. The spill count was revised/ revalidated, and 151 is the post-validation value.

The trend in spill performance does show variation in spills, with a focus on spills during the autumn, winter and spring months. The data suggests a wider relationship between rainfall, elevated groundwater levels and spill frequency. For example, despite broadly similar rainfall totals, significantly more spills were recorded at Clanfield Marsh STW in February and March 2021 compared to the same months in 2022. The Windrush at Worsham indicator site shown in Figure 5, suggests groundwater levels in the catchment were significantly higher in February and March 2021, with Figure 6 suggesting groundwater levels in the catchment were just above or at below normal levels in February and March 2022. Similar trends can be observed for April and May.

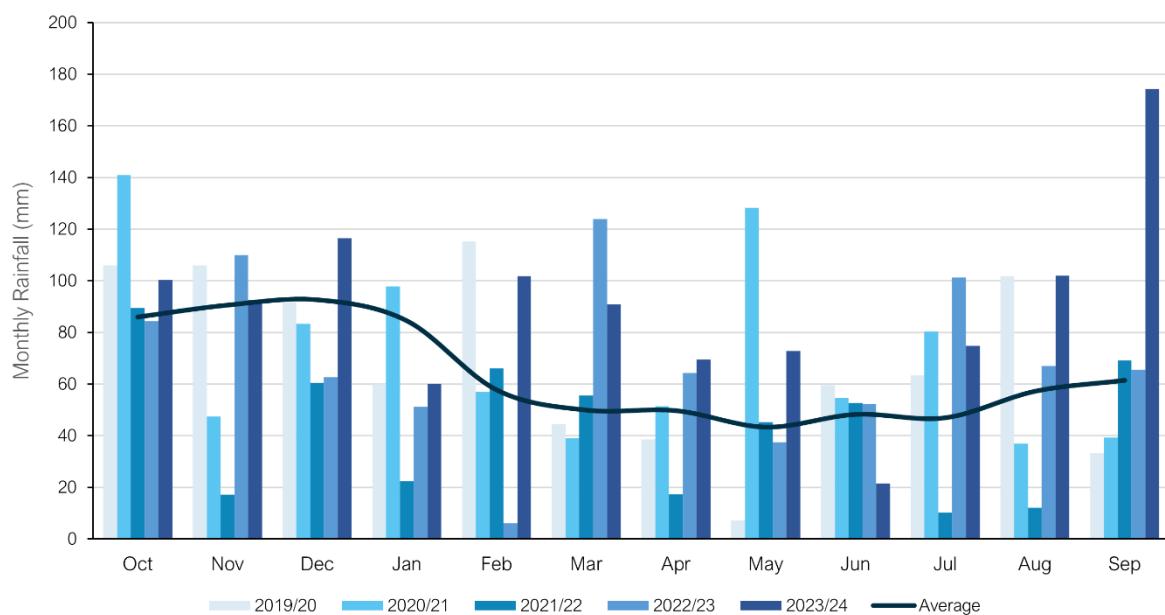
Figure 2 – Monthly Rainfall Data

Representative Radar rainfall has been used to generate monthly data at catchment level for comparison with average data generated by local Met Office Weather Station Records. Figure 2 presents the comparison of this data for the last five hydrological years to support longer term trends within the local system.

Average Values taken from Met Office Weather Station at Thorney Island based on the period 1991-2020

The total rainfall for the 2023/24 hydrological year is 40% above the annual average total. Total rainfall values are presented in Table 3 below.

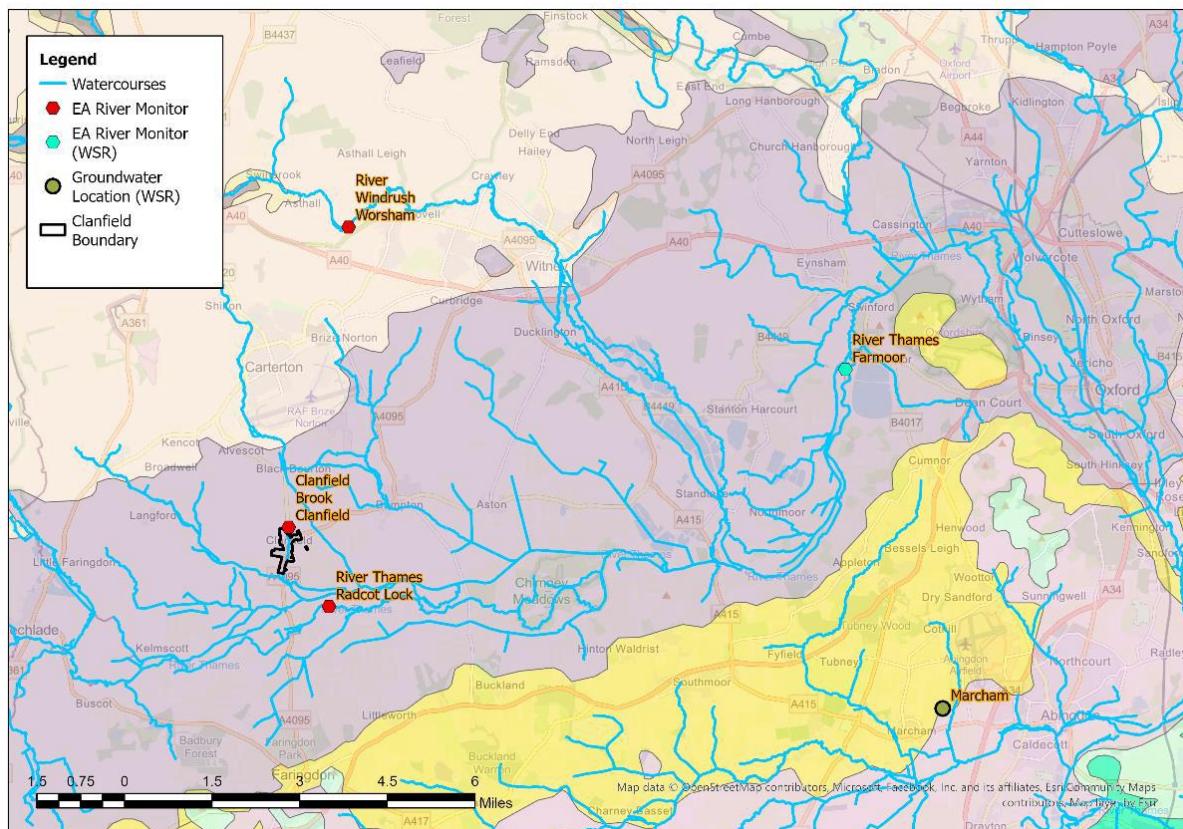
Figure 4 – Local Monitoring Stations

These sites are illustrated in Figure 4 alongside the closest groundwater reference station and closest gauging station from the Water Situation Report.

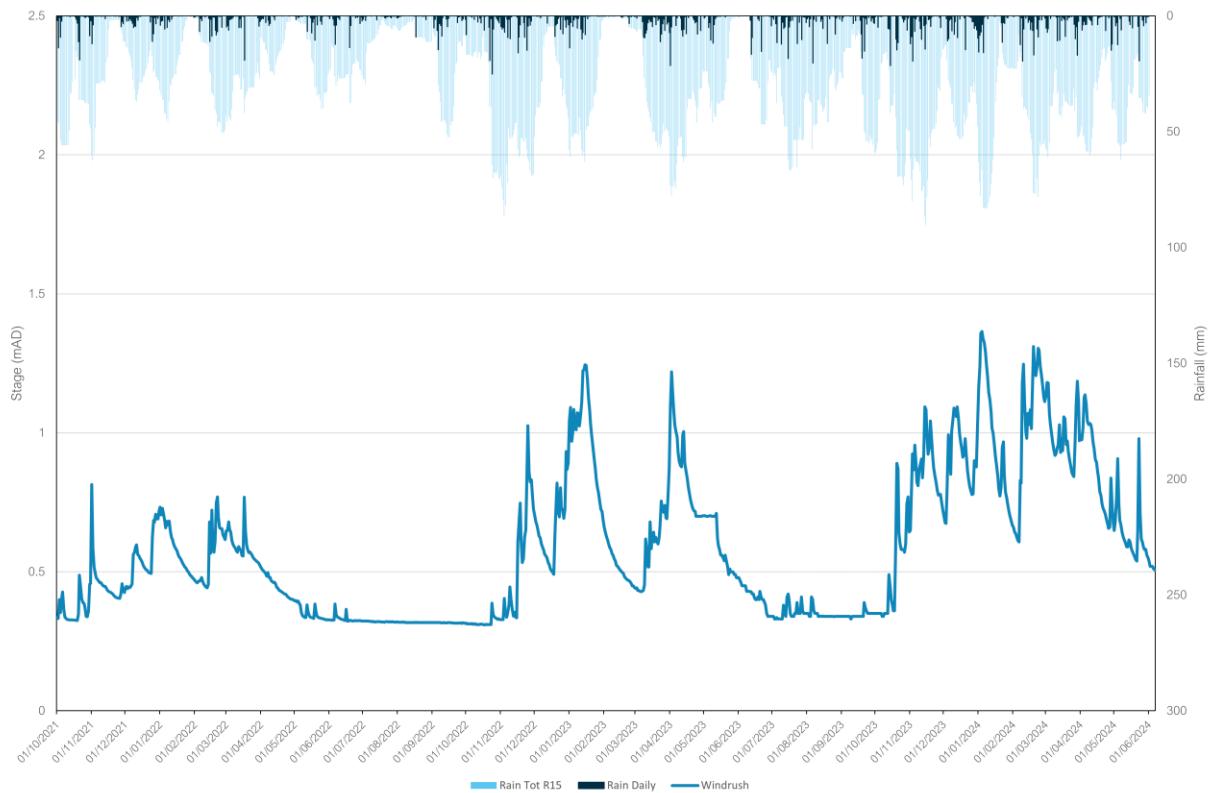
Figure 5A – Windrush at Worsham

Figures 5A-5C represent the last three hydrological years of level information at the indicator sites to build a picture of the relative conditions prevalent in the current year. It is presented against both the daily total rainfall values for the catchment and a rolling 15 day total rainfall.

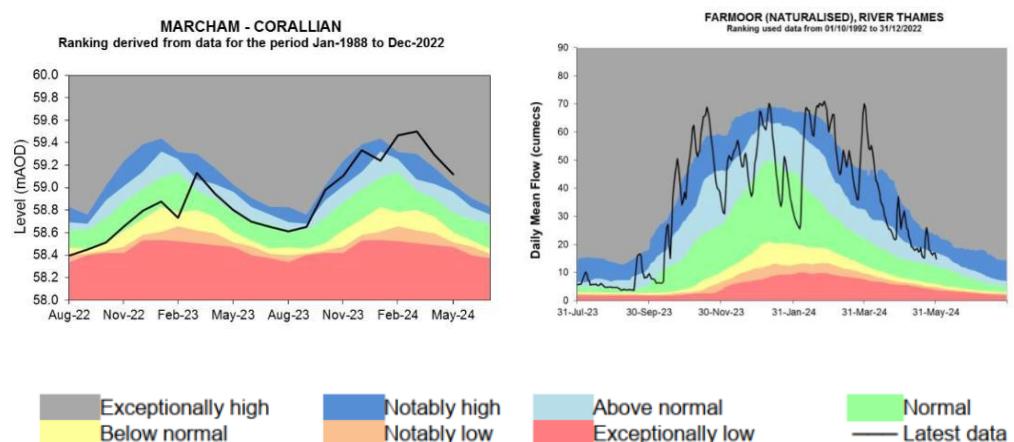
Figure 6 – Water Situation Report

In addition to these specific stations, the wider groundwater context is illustrated in the Water Situation Report for the Upper Thames. Whilst the Clanfield catchment does not sit within a principal aquifer, the closest groundwater reference station is Marcham. Groundwater levels at this site have increased significantly since 2023, reaching exceptionally high levels in 2024, as can be seen in Figure 6 alongside the river indicator Farmoor on the River Thames.

The data suggests a wider relationship between rainfall, elevated groundwater levels and spill frequency, with a focus on spills during the autumn, winter, and spring months. A significantly higher number of spills occurred at Clanfield Marsh STW in January, April and May 2023 compared to the same months in 2022. The indicator site data shown in Figures 5 and 6 suggests that groundwater levels in the catchment became elevated during January, April and May 2023 and reached higher levels than those observed in the same months in 2022. Similarly, a high number of spills occurred at Clanfield Marsh STW in November and December 2023, when the indicator site data shown in Figure 6 suggests groundwater levels in the catchment were at above normal/ notably high levels.

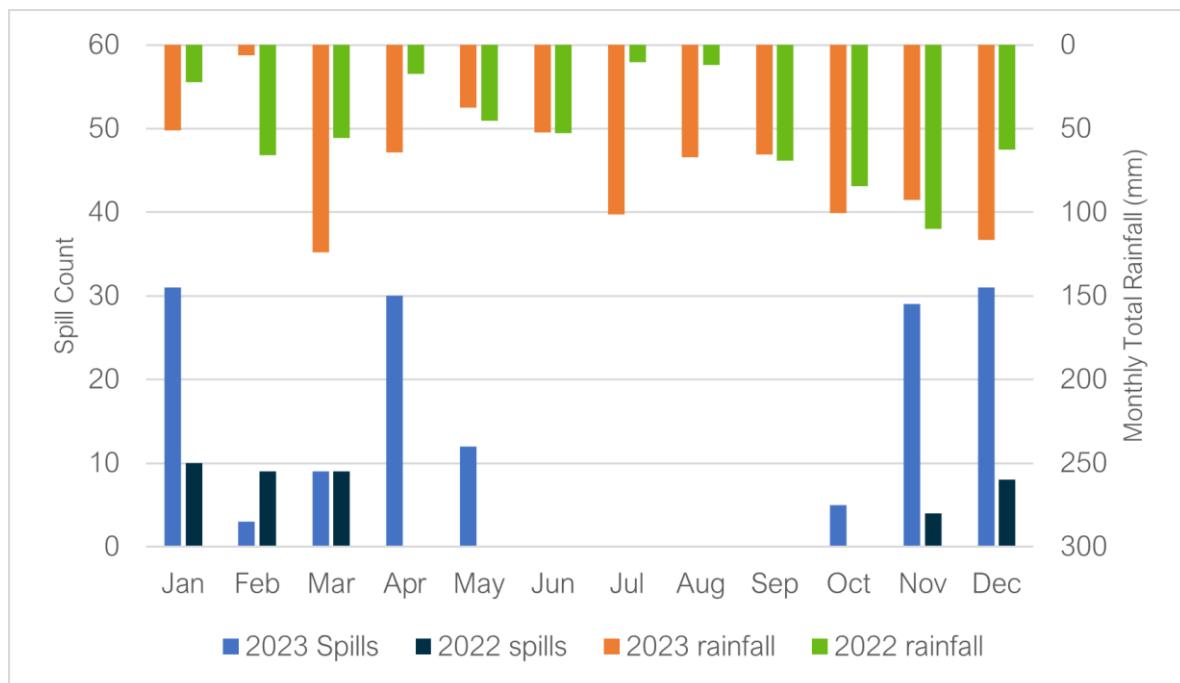
Figure 8 – EDM Monthly Performance

A critical part of the assessment of EDM performance and its relation to groundwater infiltration is to review the month-on-month spill performance, against previous years and the monthly total rainfall values to give context to the performance. Figure 8 below presents the EDM performance trend and rainfall for recent years.

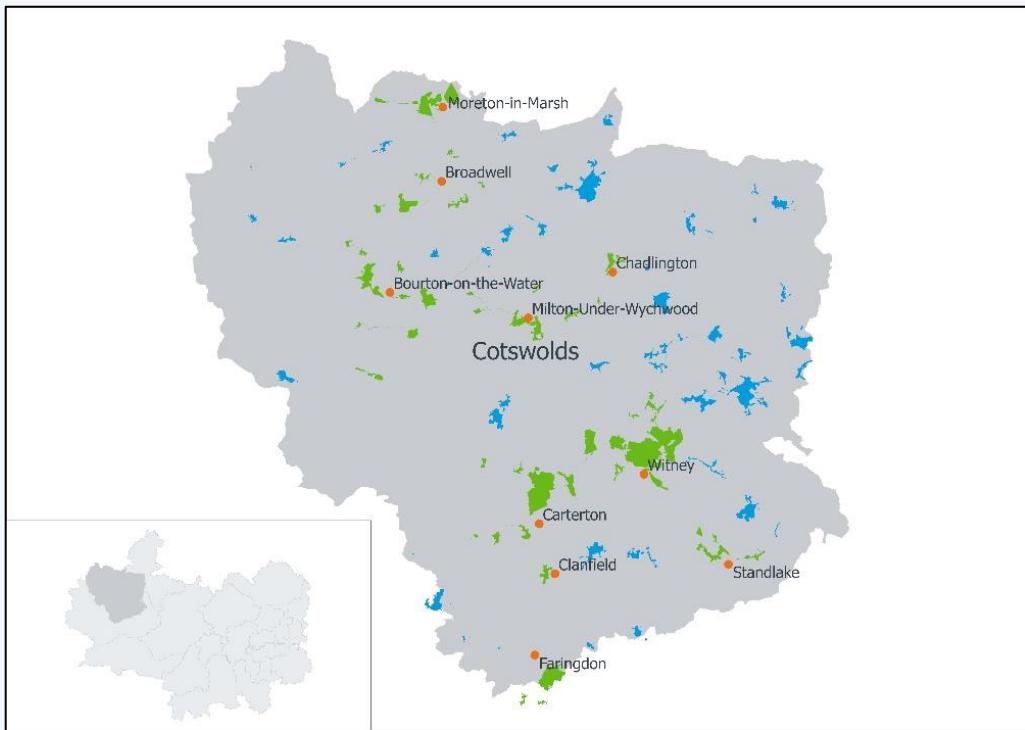
Figure 1: Relationship of the Sewer Systems to Associated Rivers

Sewer System	Associated River / Stream	Relationship to the River Thames
Bourton-on-the-Water STW	River Windrush	Direct tributaries of the River Thames
Broadwell STW	Broadwell Brook	Indirect tributary of the River Thames via Great Brook
Carterton STW	Shill Brook, River Windrush	Shill Brook indirect tributary of the River Thames via Great Brook. River Evenlode direct tributary of the River Thames.
Chadlington STW	River Evenlode	Direct tributary of the River Thames
Clanfield STW	Clanfield Brook	Indirect tributary of the River Thames via Broadwell Brook then Great Brook.
Faringdon STW	Faringdon Brook	Indirect tributary of the River Thames via the River Ock
Milton-Under-Wychwood STW	River Evenlode	Direct tributary of the River Thames
Moreton-in-Marsh STW	River Evenlode	Direct tributary of the River Thames
Standlake STW	River Windrush	Direct tributary of the River Thames
Witney STW	River Windrush	Direct tributary of the River Thames

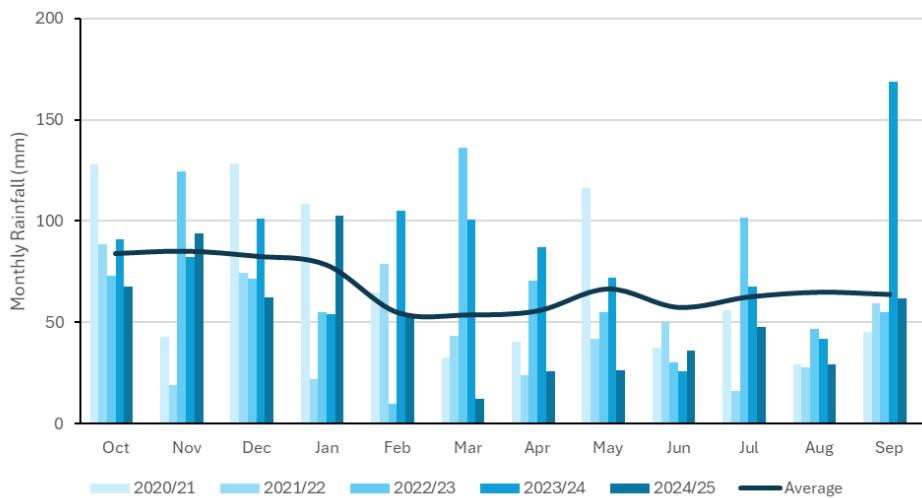
Figure 1: Monthly rainfall data 2020/21 to 2024/25

Figures 1 to 5 illustrate the relationship between rainfall and CSO spills. As shown in Figure 1, the decrease in rainfall from 2023/24 to 2024/25 correlates with reduced river levels (Figures 2 and 3), as well as a decline in the number and duration of CSO spills shown in Figure 5.

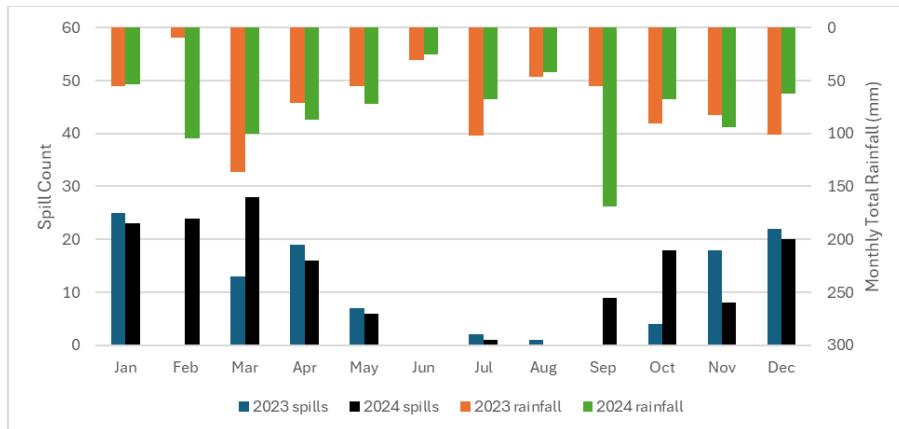
Figure 5: Monthly rainfall data versus monthly spill count for 2023 and 2024 – Bourton-on-the-Water STW

Table 1 below details the last 2 years performance of overflows in the catchment. To assess EDM performance and its relation to groundwater infiltration, a review of the month-on-month spill performance in 2023 and 2024 against the monthly total rainfall values has been undertaken, as observed in Figure 5.

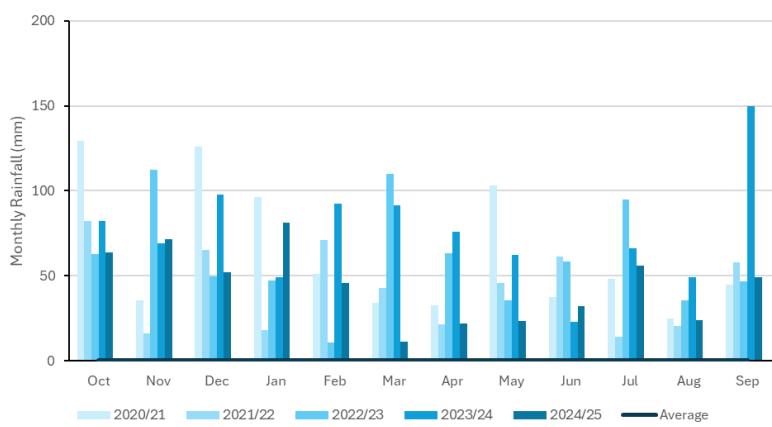
Figure 1: Monthly rainfall data 2020/21 to 2024/25

Figures 1 and 2 illustrate the relationship between rainfall and spills at CSOs. Figure 1 displays the reduced rainfall recorded in 2024/25 compared to 2023/24. Figure 2 represents a decreased number and duration of CSO spills from 2023/24 to 2024/25

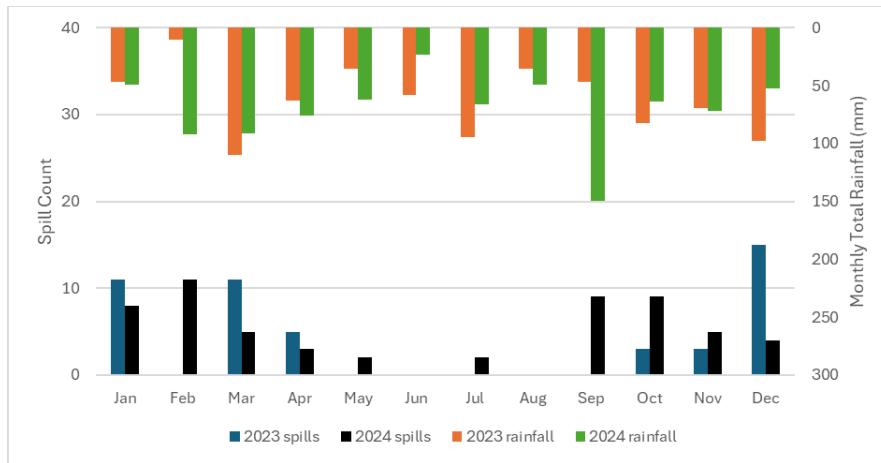
Figure 2: Monthly rainfall data versus monthly spill count for 2023 and 2024 – Broadwell STW

Table 1 below details the last 2 years performance of overflows in the catchment. To assess EDM performance and its relation to groundwater infiltration, a review of the month-on-month spill performance in 2023 and 2024 against the monthly total rainfall values has been undertaken, as observed in Figure 2.

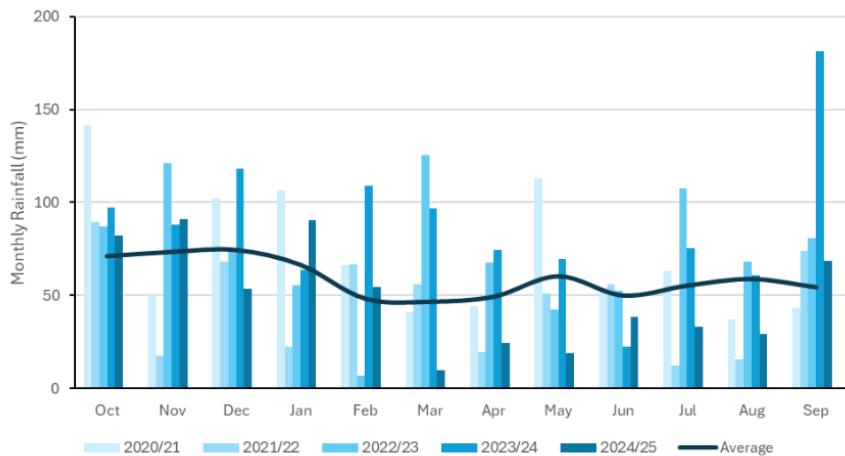
Figure 1: Monthly rainfall data 2020/21 to 2024/25

Figures 1 to 5 illustrate the relationship between rainfall and CSO spills at indicator sites. As shown in Figure 1, the decrease in rainfall from 2023/24 to 2024/25 correlates with the decline in the number and duration of CSO spills shown in Figure 5. However, river and groundwater levels (Figures 2 and 3) have remained consistent with previous years.
