Groundwater Impacted System Management Plan

Clanfield, Clanfield Brook

January 2021

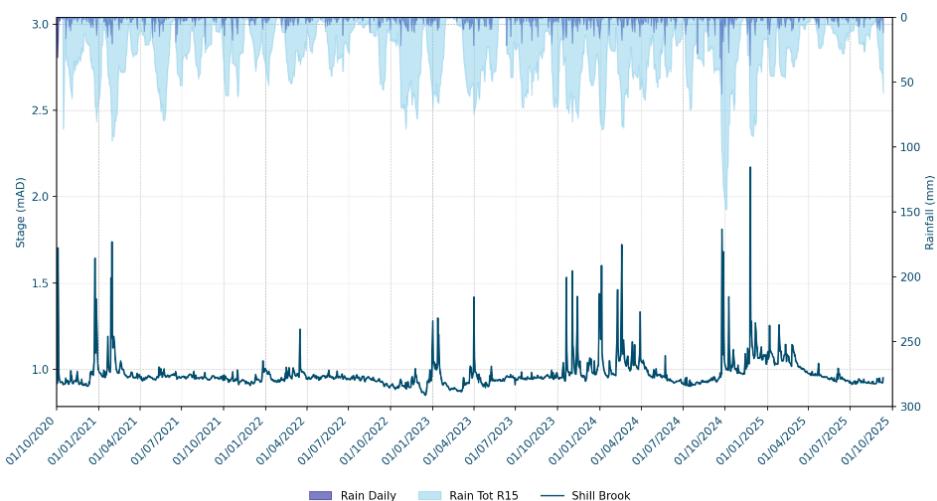
Figure 2: River Level data for Shill Brook, Bampton

Figures 1 to 5 illustrate the relationship between rainfall and CSO spills at indicator sites. As shown in Figure 1, the decrease in rainfall from 2023/24 to 2024/25 correlates with the decline in the number and duration of CSO spills shown in Figure 5. However, river and groundwater levels (Figures 2 and 3) have remained consistent with previous years.

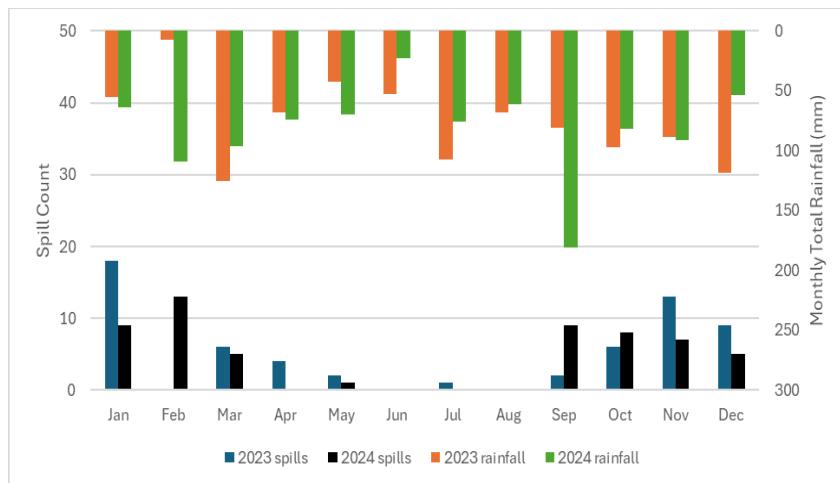
Figure 5: Monthly rainfall data versus monthly spill count for 2023 and 2024 – Carterton STW

Table 1 below details the last 2 years performance of overflows in the catchment. To assess EDM performance and its relation to groundwater infiltration, a review of the month-on-month spill performance in 2023 and 2024 against the monthly total rainfall values has been undertaken, as observed in Figure 5.

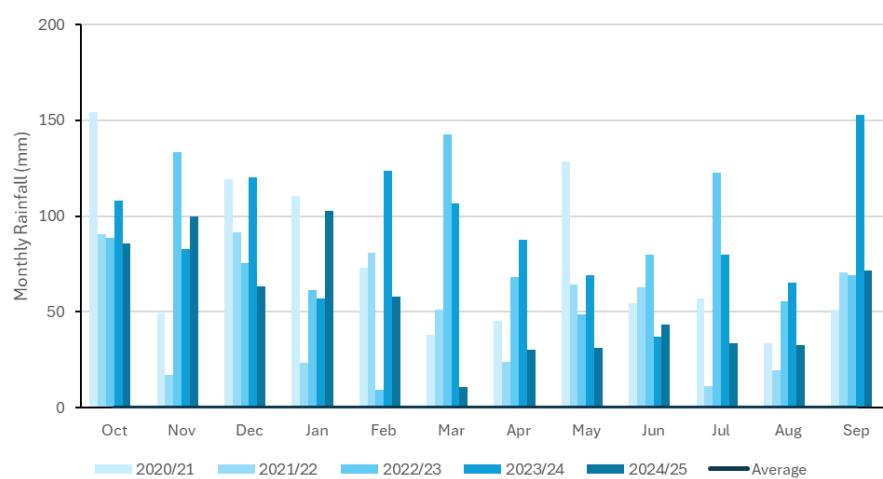
Figure 1: Monthly rainfall data 2020/20 to 2024/25

Figures 1 and 2 illustrate the relationship between rainfall and spills at CSOs. There is a decrease in rainfall from 2023/24 to 2024/25 shown in Figure 1; this broadly correlates to fewer and shorter spills at the CSOs, shown in Figure 2.

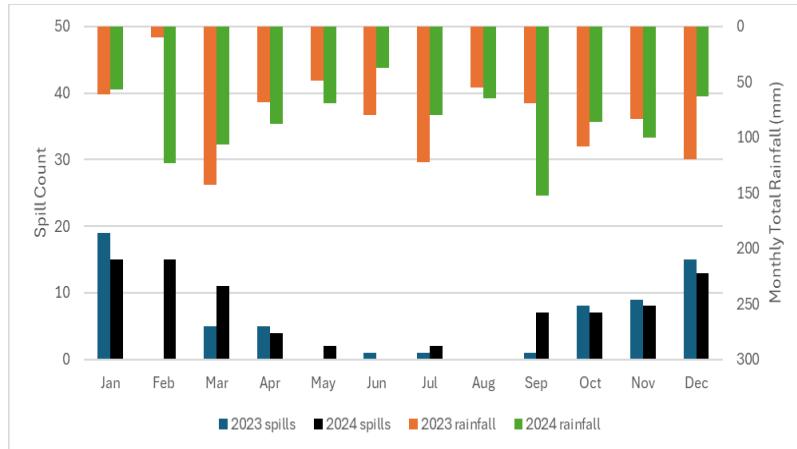
Figure 2: Monthly rainfall data versus monthly spill count for 2023 and 2024 – Chadlington STW

Table 1 below details the last 2 years performance of overflows in the catchment. To assess EDM performance and its relation to groundwater infiltration, a review of the month-on-month spill performance in 2023 and 2024 against the monthly total rainfall values has been undertaken, as observed in Figure 2.

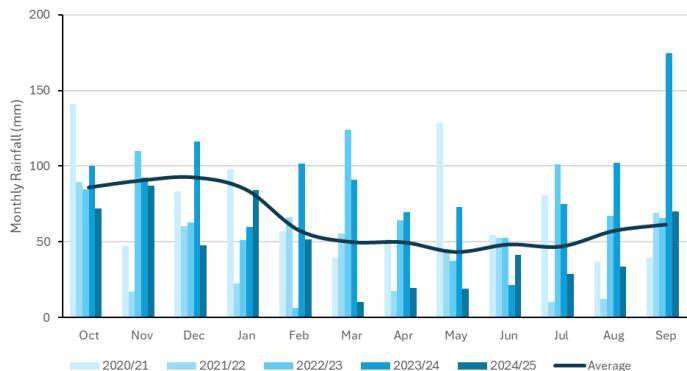
Figure 1: Monthly rainfall data 2020/21 to 2024/25

Figures 1 to 6 illustrate the relationship between rainfall and CSO spills at indicator sites. As shown in Figure 1, rainfall decreases from 2023/24 to 2024/25, however river levels remain fairly consistent (Figures 2 to 4). There is a reduction in both the frequency and duration of CSO spills shown in Figure 6.

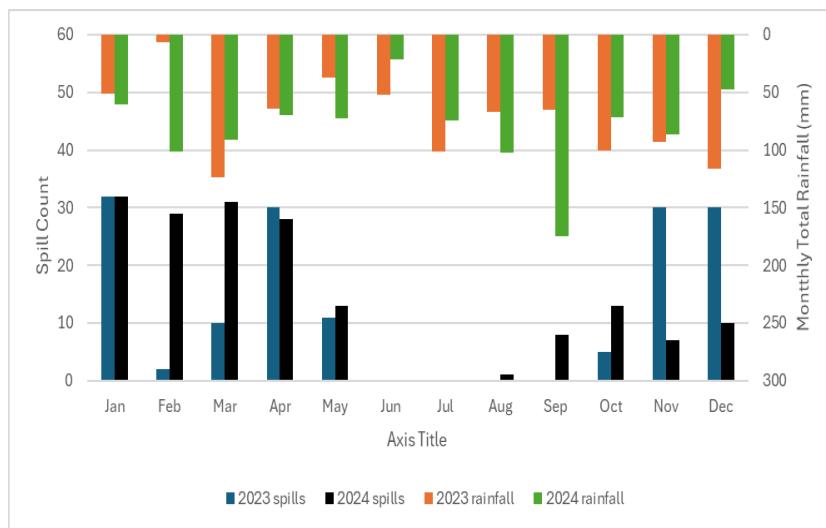
Figure 6: Monthly rainfall data versus monthly spill count for 2023 and 2024 – Clanfield STW

Table 1 below details the last 2 years performance of overflows in the catchment. To assess EDM performance and its relation to groundwater infiltration, a review of the month-on-month spill performance in 2023 and 2024 against the monthly total rainfall values has been undertaken, as observed in Figure 6.

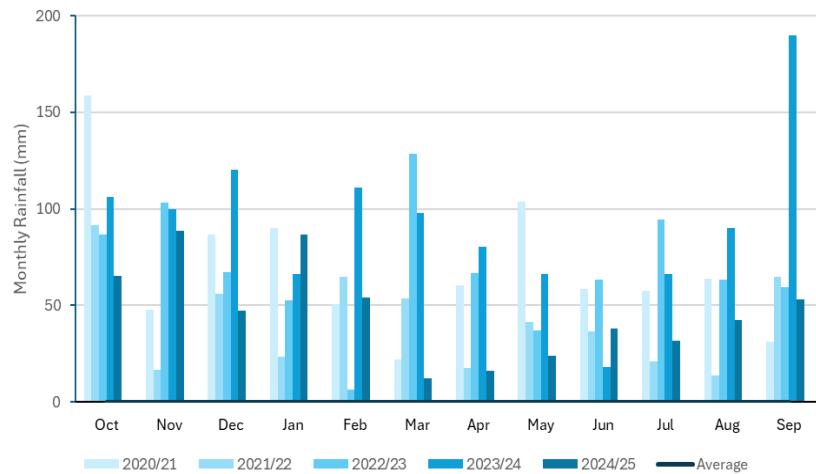
Figure 1: Monthly rainfall data 2020/21 to 2024/25

Figures 1 to 2 illustrate the relationship between rainfall and spills at CSOs. Figure 1 shows a decrease in rainfall from 2023/24 into 2024/25, correlating to fewer and shorter spills at the CSOs, shown in Figure 2.

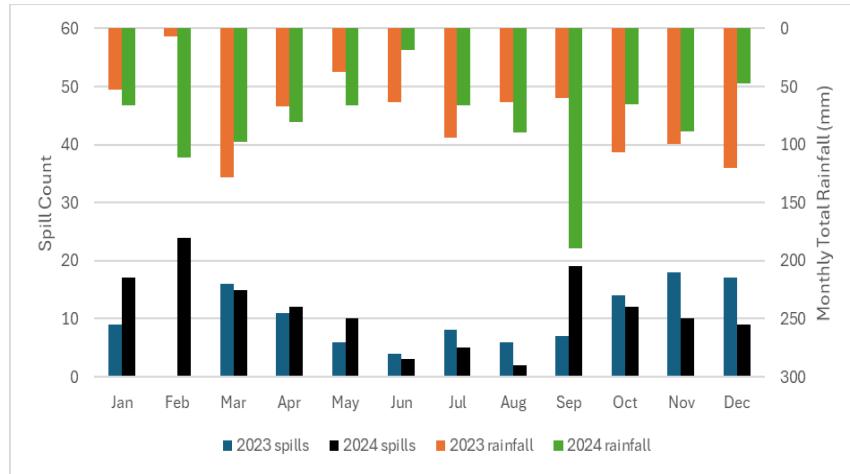
Figure 2: Monthly rainfall data versus monthly spill count for 2023 and 2024 – Faringdon STW

Table 1 below details the last 2 years performance of overflows in the catchment. To assess EDM performance and its relation to groundwater infiltration, a review of the month-on-month spill performance in 2023 and 2024 against the monthly total rainfall values has been undertaken, as observed in Figure 2.

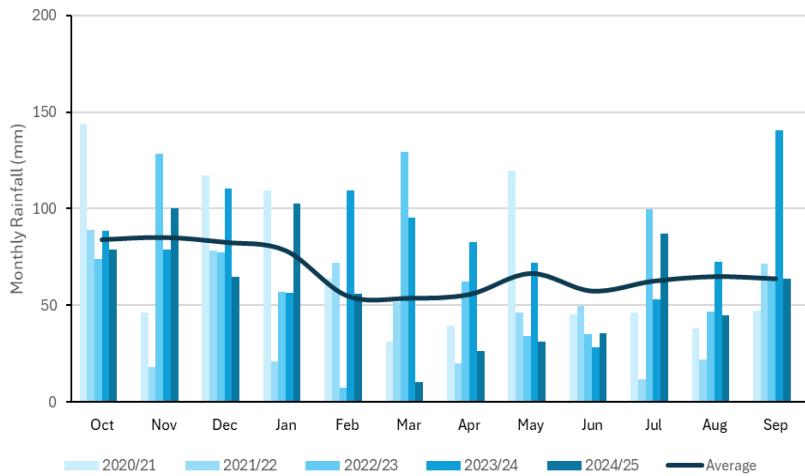
Figure 1: Monthly rainfall data 2020/21 to 2024/25

Figures 1 and 4 illustrate the relationship between rainfall and CSO spills at indicator sites. As shown in Figure 1, the decrease in rainfall from 2023/24 to 2024/25 correlates with decrease in the number and duration of CSO spill events shown in Figure 4. River levels remain consistent between 2023/24 and 2024/25 observing Figure 2.

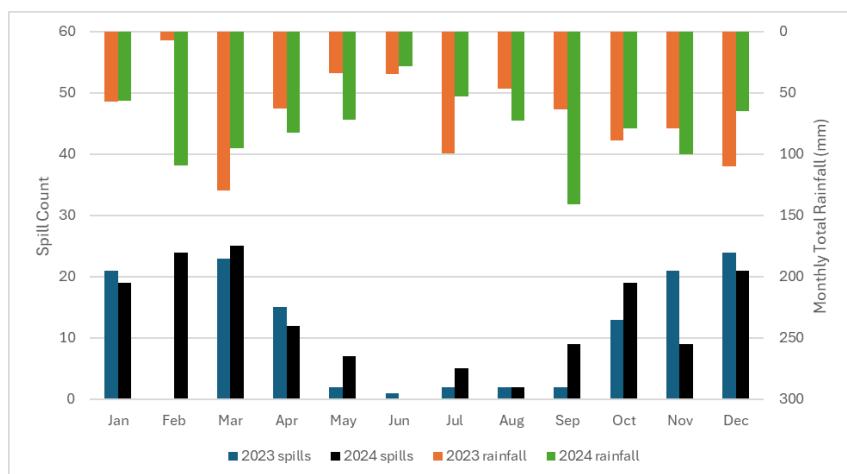
Figure 4: Monthly rainfall data versus monthly spill count for 2023 and 2024 – Milton-under-Wychwood STW

Table 1 below details the last 2 years performance of overflows in the catchment. To assess EDM performance and its relation to groundwater infiltration, a review of the month-on-month spill performance in 2023 and 2024 against the monthly total rainfall values has been undertaken, as observed in Figure 4.

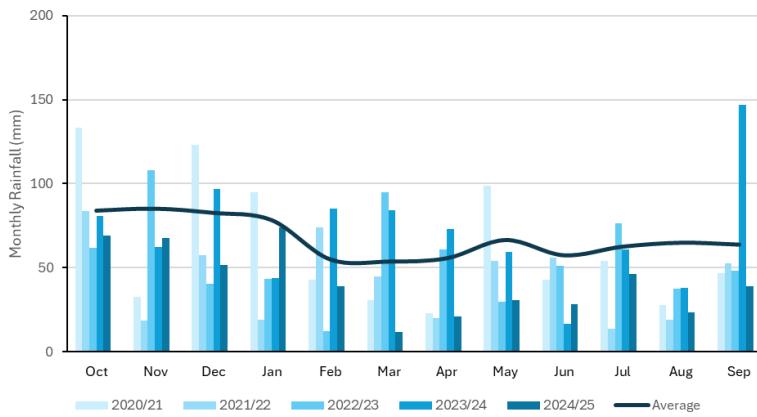
Figure 1: Monthly rainfall data 2020/21 to 2024/25

Figures 1 to 6 illustrate the relationship between rainfall and CSO spills at indicator sites. As observed in Figure 1, there is a decrease in rainfall from 2023/24 to 2024/25. However, recorded river level data follows a similar profile between 2023/24 and 2024/25 observing Figures 2 and 3. Additionally, there is no spills data for 2025.

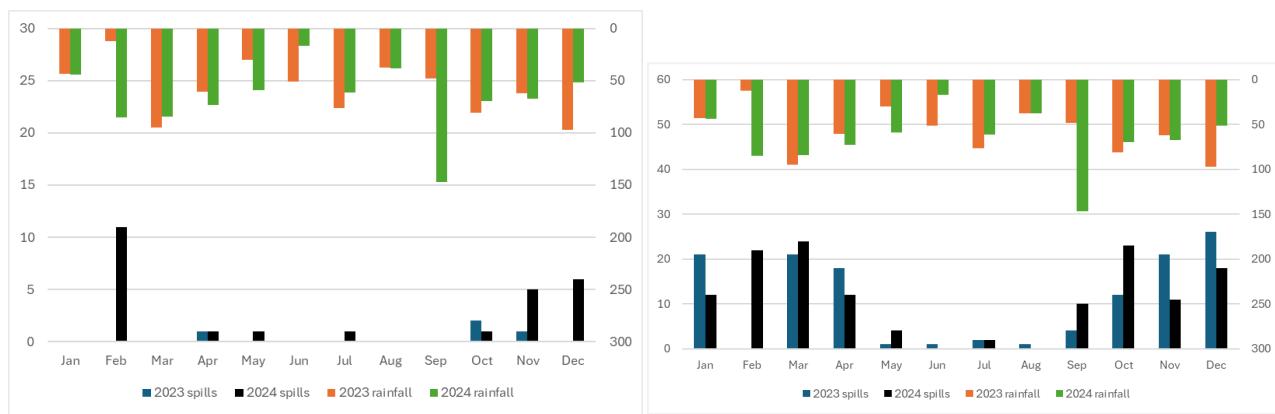
Figure 5: EDM Monthly Performance – CSO at Moreton in Marsh SPS / Figure 6: EDM Monthly Performance – Storm Sewage Irrigation Area (Primrose Court SPS)

Table 1 below details the last 2 years performance of overflows in the catchment. To assess EDM performance and its relation to groundwater infiltration, a review of the month-on-month spill performance in 2023 and 2024 against the monthly total rainfall values has been undertaken, as observed in Figure 5 and 6.

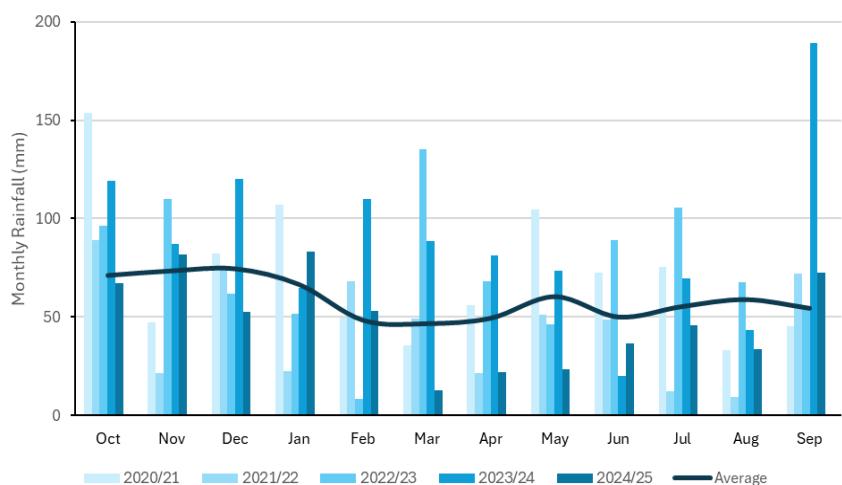
Figure 1: Monthly rainfall data 2020/21 to 2024/25

Figures 1 to 4 illustrate the relationship between rainfall and CSO spills at indicator sites. As shown in Figure 1, the decrease in rainfall from 2023/24 to 2024/25 correlates with fewer CSO spills, as shown in Figure 4. Observing the river levels in Figure 2, there is a slight decrease in 2024/25 from 2023/24.

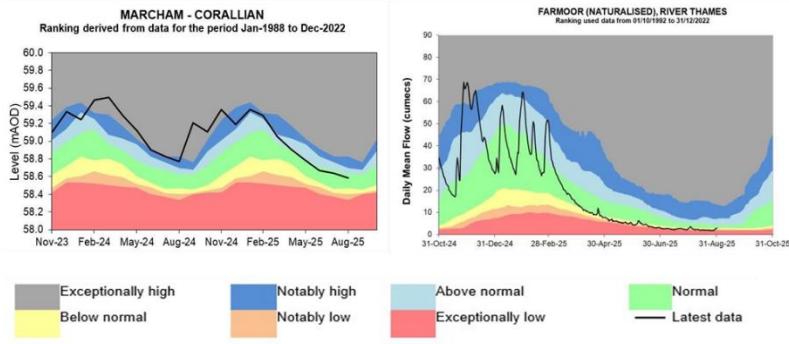
Figure 3: Ground Water situation Report

Extract from - [Water Situation Report \(publishing.service.gov.uk\)](https://publishing.service.gov.uk)

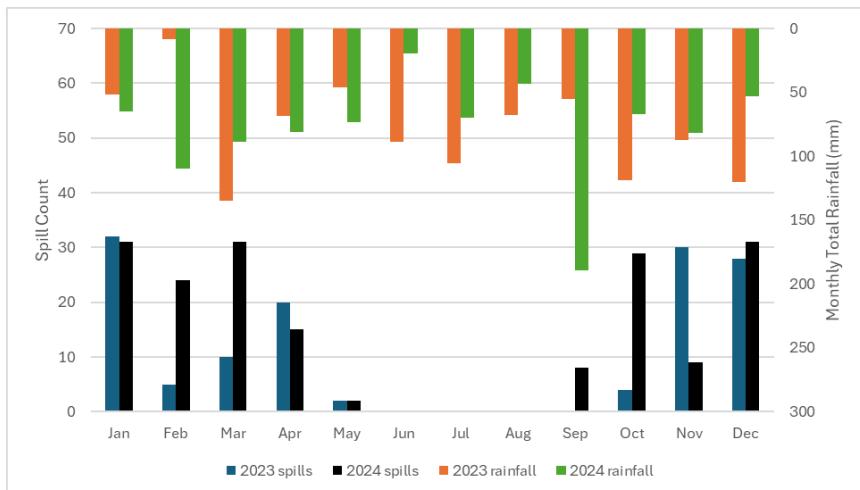
Figure 4: Monthly rainfall data versus monthly spill count for 2023 and 2024 – Standlake STW

Table 1 below details the last 2 years performance of overflows in the catchment. To assess EDM performance and its relation to groundwater infiltration, a review of the month-on-month spill performance in 2023 and 2024 against the monthly total rainfall values has been undertaken, as observed in Figure 4.

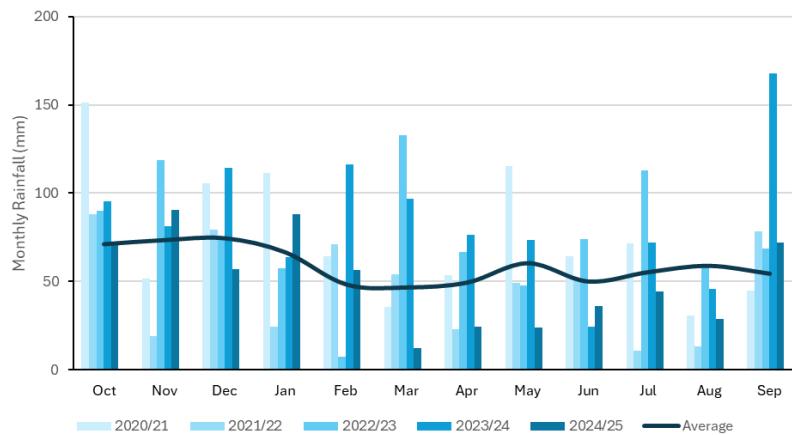
Figure 1: Monthly rainfall data 2020/21 to 2024/25

Figures 1 to 5 illustrate the relationship between rainfall and CSO spills at indicator sites. As shown in Figure 1, the decrease in rainfall from 2023/24 to 2024/25 correlates with fewer CSO spills, as presented in Figure 5. River levels (Figures 2 and 3) remained consistent.

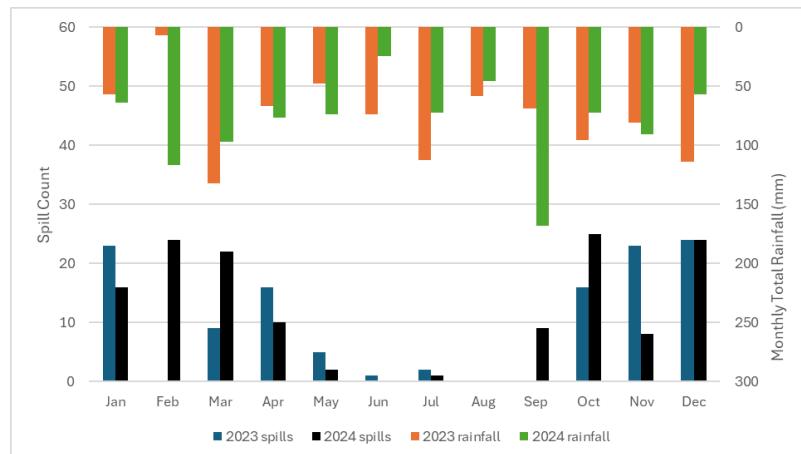
Figure 5: Monthly rainfall data versus monthly spill count for 2023 and 2024 – Witney STW

Table 1 below details the last 2 years performance of overflows in the catchment. To assess EDM performance and its relation to groundwater infiltration, a review of the month-on-month spill performance in 2023 and 2024 against the monthly total rainfall values has been undertaken, as observed in Figure 5.
