Groundwater Impacted System Management Plan

Benson, River Thames

July 2021

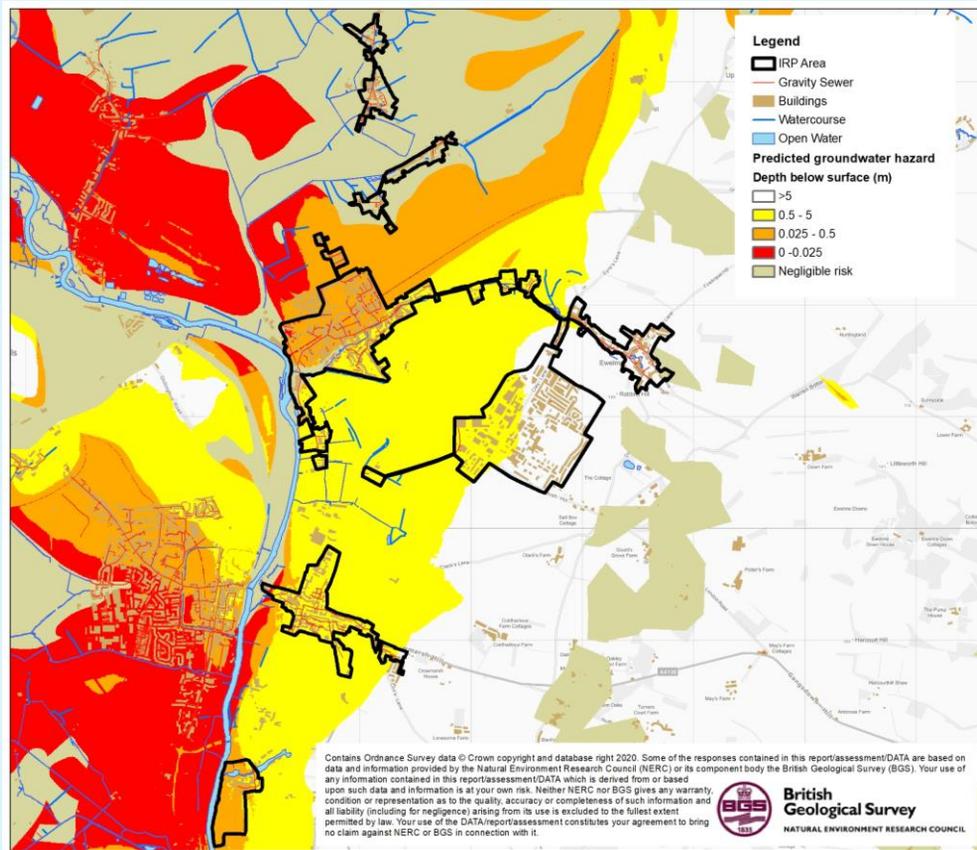
Figure 1.0 – Benson catchment

Benson is located in South Oxfordshire, England, approximately a mile and half north of Wallingford. Benson serves a population equivalent³ of 8269 with a partially separate sewerage network totaling some 48.95 km in length excluding private drains and sewers. The extent of the catchment is shown in Figure 1.0 above.

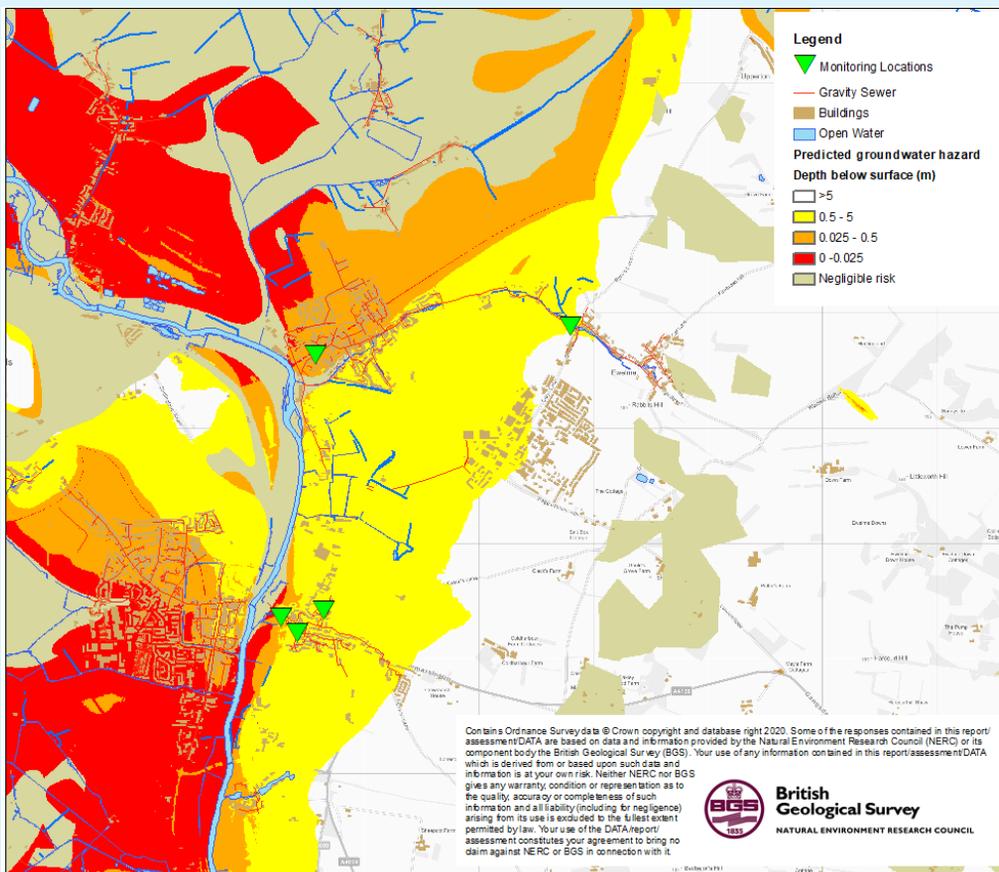
Figure 2.0 – Benson monitoring and infiltration zones

Key to bringing the impact of groundwater infiltration under control is an enhanced monitoring regime. We have identified and have installed several telemetered depth monitor locations around the Benson system – see Figure 2.0.

We engaged with JBA Consulting to develop plans for Benson that identify zones of groundwater risk, see Figure 2.0. These zones are modelled areas where the groundwater has been determined to be above the sewer and hence pose a potential risk for groundwater ingress.

Sewer Depth Monitors have now been installed in the catchment in 2020 (see Figure 2.0). These devices are telemetered and provide real time data on the level of flow in the sewer.

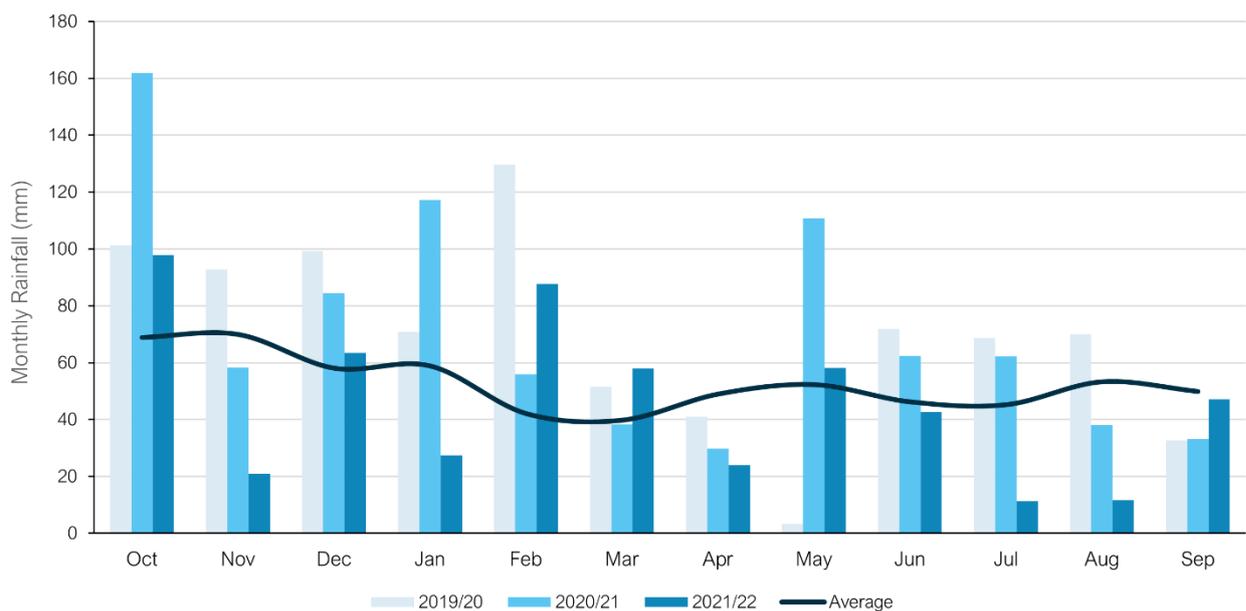
Figure 2 – Monthly Rainfall Performance

Representative Radar rainfall has been used to generate monthly data at catchment level for comparison with average data generated by local Met Office Weather Station Records. Figure 2 presents the comparison of this data for the last three hydrological years to support longer term trends within the local system.

Average Values taken from Met Office Weather Station at Benson based on the period 1991-2020

The total rainfall for the 2021/22 hydrological year is 11% below the annual average total. Total rainfall values are presented in Table 3 below.

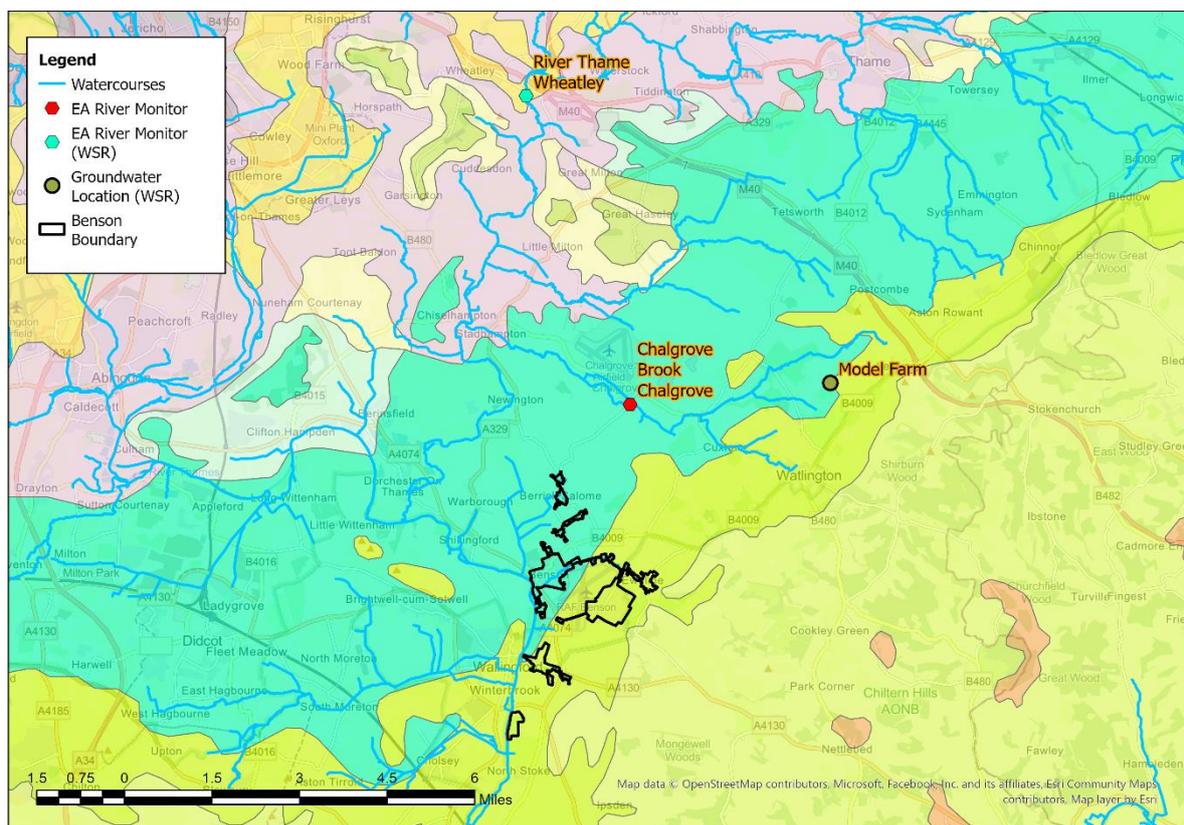
Figure 4 – Local Monitoring Stations

This site is illustrated in the figure below, alongside the closest groundwater reference station and closest gauging station from the Water Situation Report.

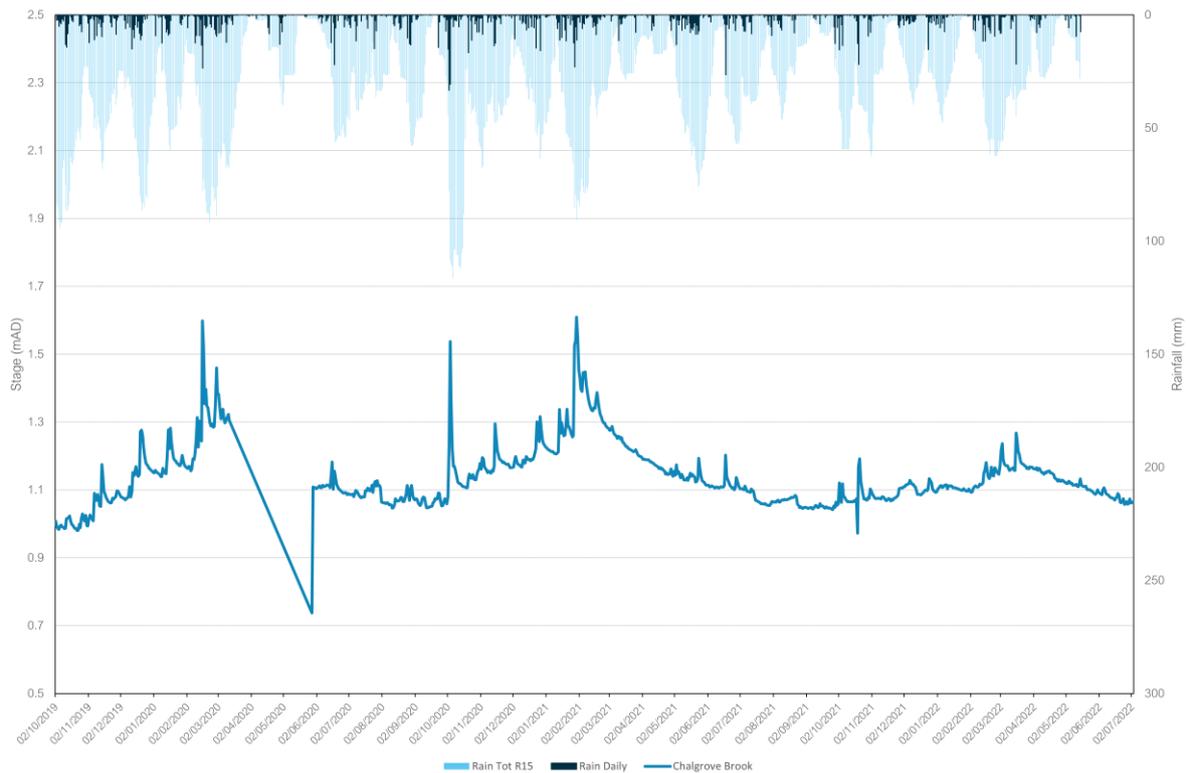
Figure 5A – Chalgrove Brook, Chalgrove

The following figures represent the last three hydrological years of level information at the indicator sites to build a picture of the relative conditions prevalent in the current year. It is presented against both the daily total rainfall values for the catchment and a rolling 15 day total rainfall.

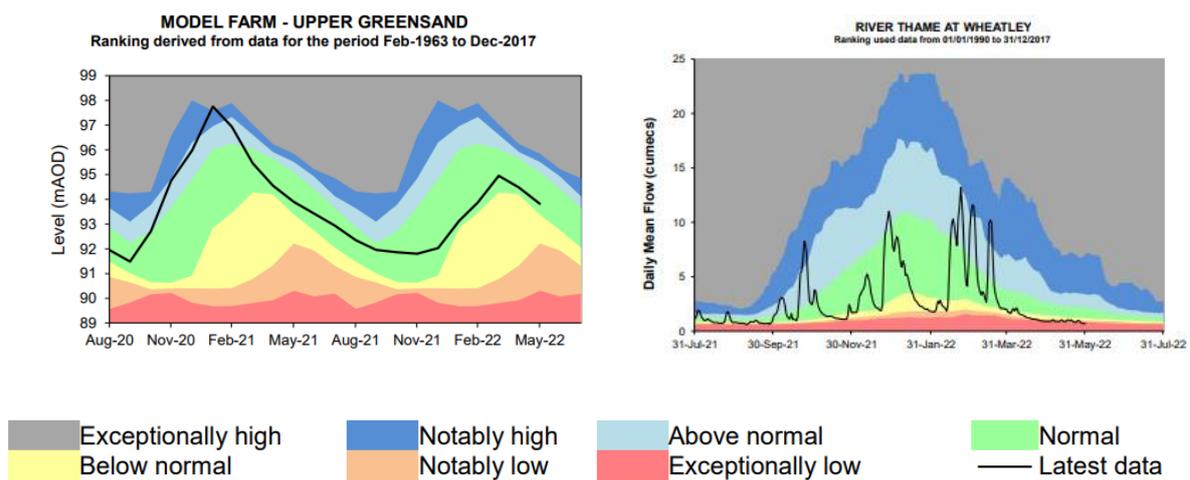
Figure 6 – Water Situation Report

In addition to this specific station, the wider groundwater context is illustrated in the Water Situation Report for the Ock. The nearest groundwater reference station is Model Farm. This site shows significantly lower overall groundwater than the previous year. This can be seen in the figure below alongside the river indicator location at Wheatley on the River Thames.

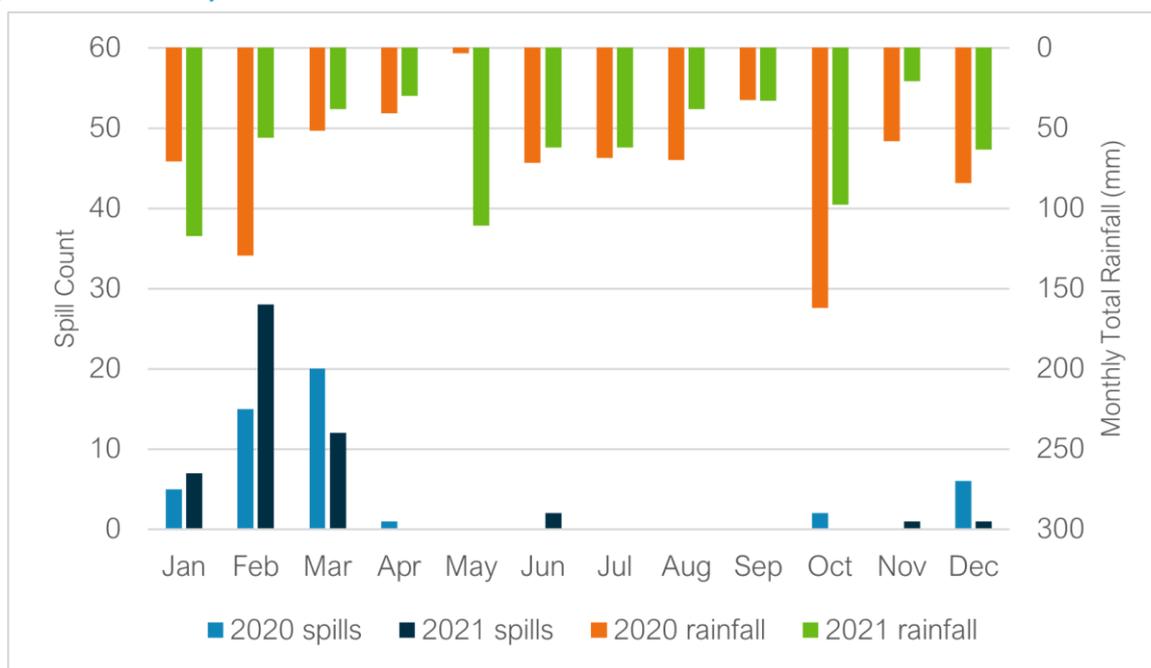
Figure 8 – EDM Monthly Performance

A critical part of the assessment of EDM performance and its relation to groundwater inundation is to review the month-on-month spill performance, against previous years and the monthly total rainfall values to give context to the performance. Figure 8 below presents the EDM performance trend and rainfall for recent years.

The trend in spill performance across the two recorded years does show variation in spills, with a focus on spills during the autumn and winter months. The data suggests a wider relationship between rainfall, elevated groundwater levels and spill frequency, with a slower tail off in spills evident within the first half of 2020, when the Chalgrove Brook indicator site suggests groundwater levels in the catchment were higher than within the first half of 2021. The higher spill frequency in December 2020, which had broadly similar rainfall to December 2021, is also indicative of the role of elevated groundwater levels, as the indicator sites suggest groundwater levels were higher in December 2020.

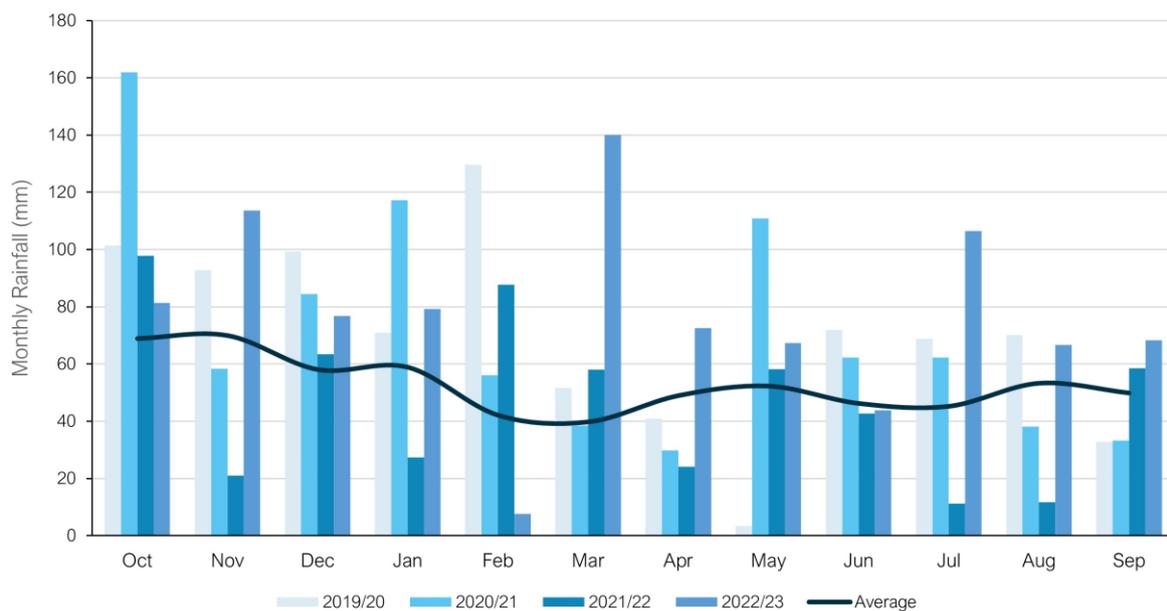
Figure 2 – Monthly Rainfall Performance

Representative Radar rainfall has been used to generate monthly data at catchment level for comparison with average data generated by local Met Office Weather Station Records. Figure 2 presents the comparison of this data for the last four hydrological years to support longer term trends within the local system.

Average Values taken from Met Office Weather Station at Benson based on the period 1991-2020

The total rainfall for the 2022/23 hydrological year is 46% above the annual average total. Total rainfall values are presented in Table 3 below.

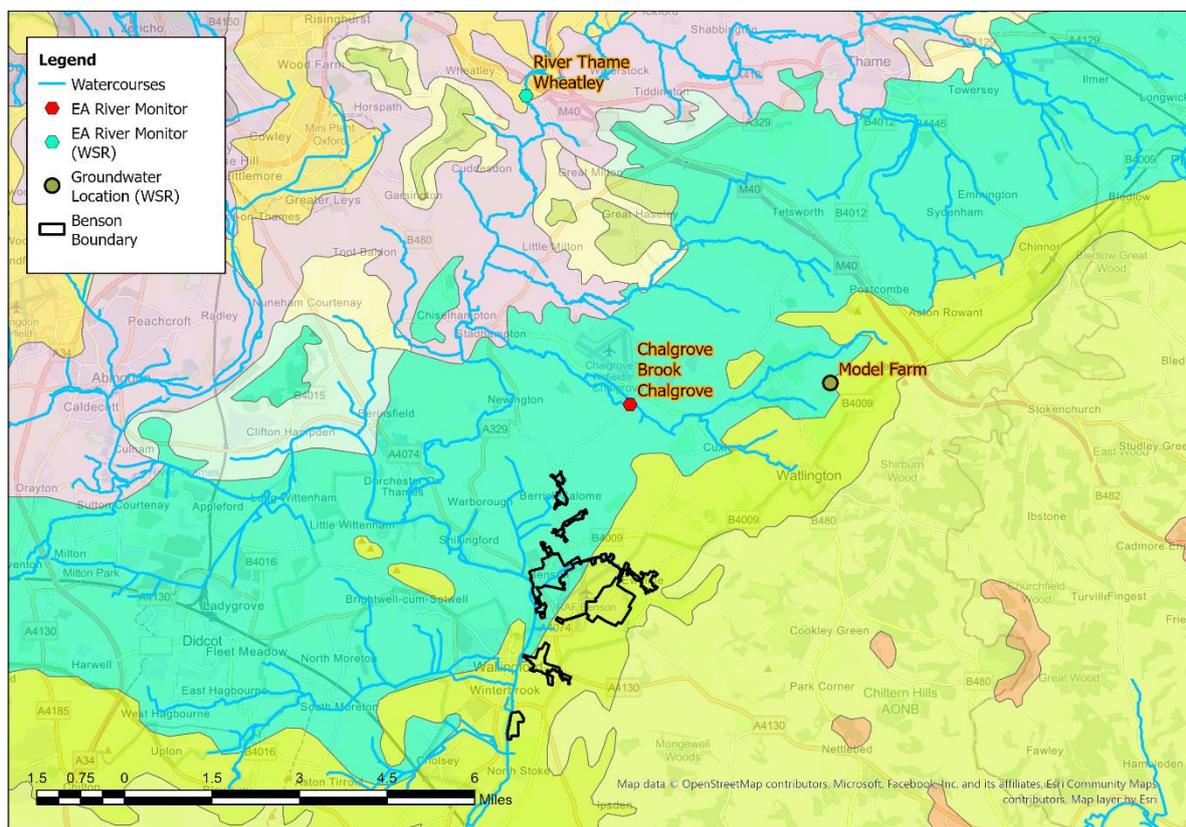
Figure 4 – Local Monitoring Stations

This site is illustrated in the figure below, alongside the closest groundwater reference station and closest gauging station from the Water Situation Report.

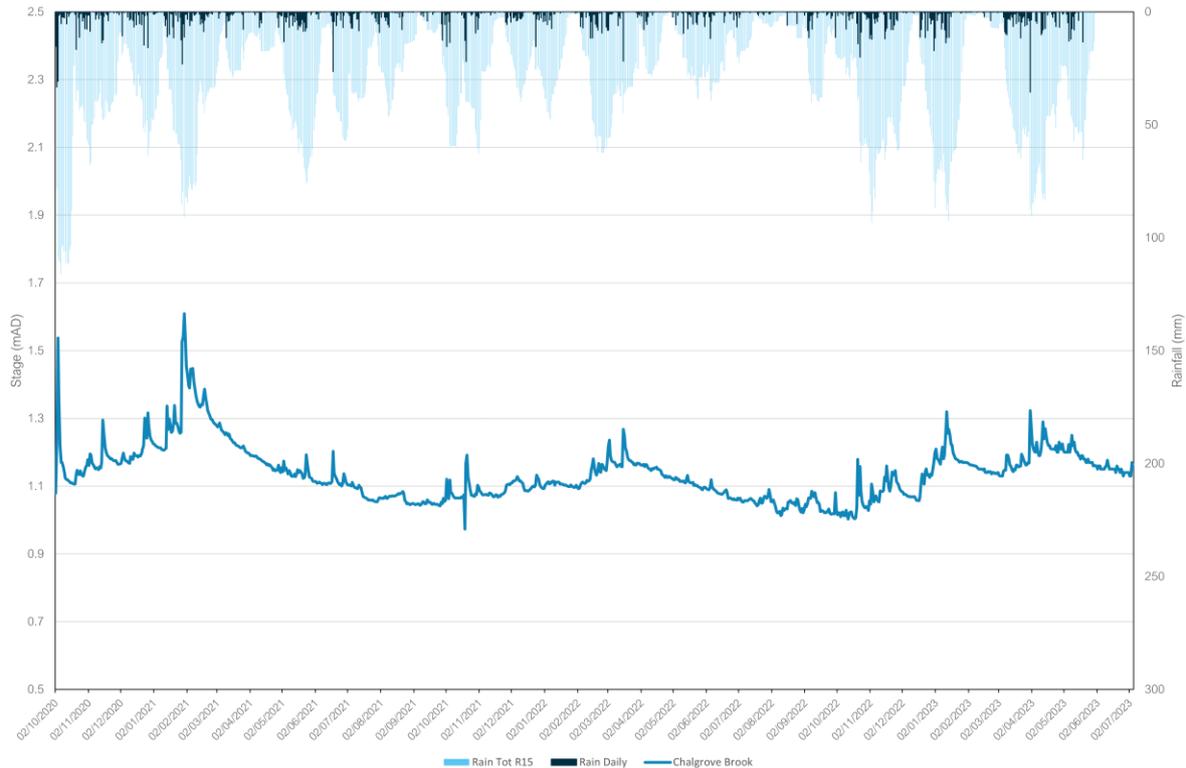
Figure 5A – Chalgrove Brook, Chalgrove

The following figures represent the last three hydrological years of level information at the indicator sites to build a picture of the relative conditions prevalent in the current year. It is presented against both the daily total rainfall values for the catchment and a rolling 15 day total rainfall.

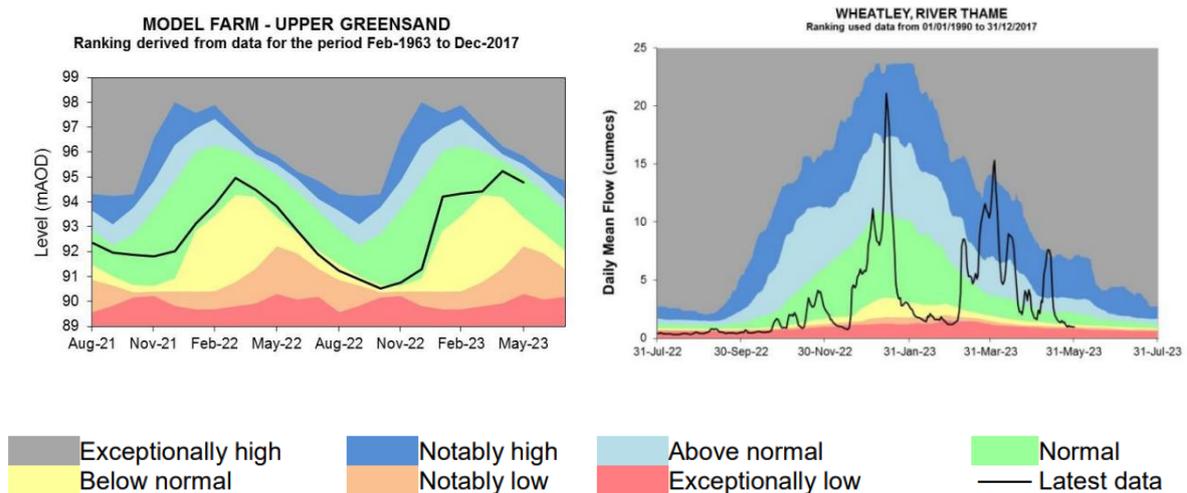
Figure 6 – Water Situation Report

In addition to this specific station, the wider groundwater context is illustrated in the Water Situation Report for the Ock. The nearest groundwater reference station is Model Farm. This site shows groundwater levels were mainly in the normal range during 2022, with periods when groundwater levels were below normal. Groundwater levels are observed at normal level during 2023. This can be seen in the figure below alongside the river indicator location at Wheatley on the River Thames.

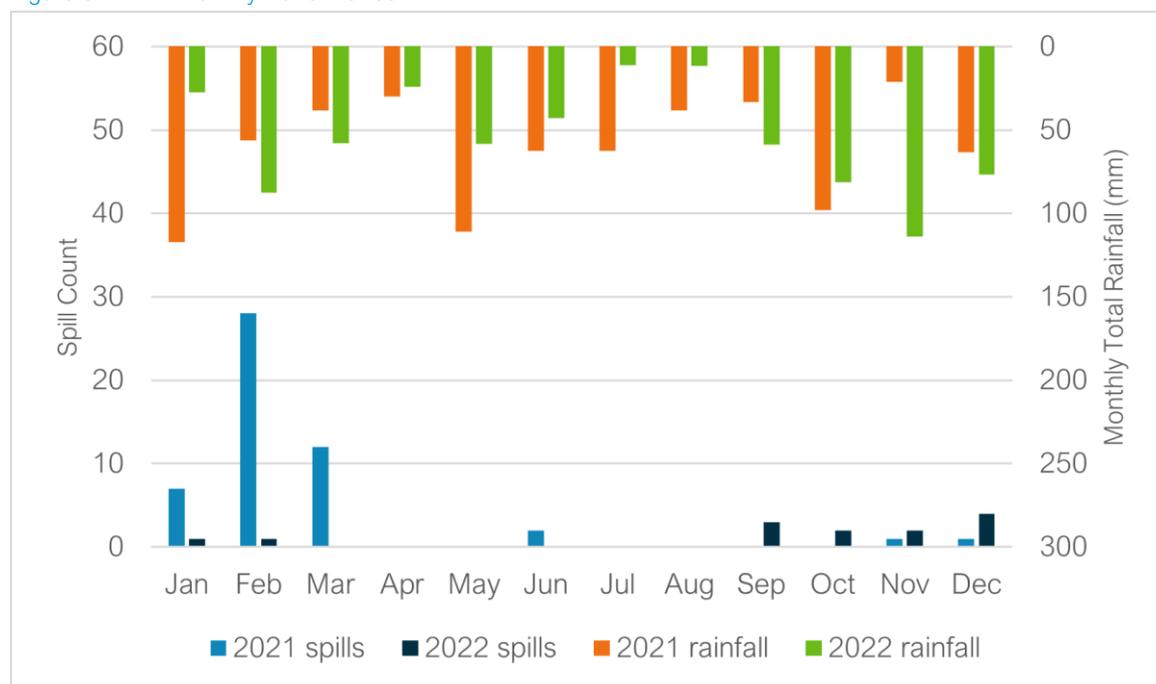
Figure 8 – EDM Monthly Performance

A critical part of the assessment of EDM performance and its relation to groundwater infiltration is to review the month-on-month spill performance, against previous years and the monthly total rainfall values to give context to the performance. Figure 8 below presents the EDM performance trend and rainfall for recent years.

The trend in spill performance across the two recorded years does show variation in spills, with a focus on spills during the winter months. The data suggests a wider relationship between rainfall, elevated groundwater levels and spill frequency. Despite a higher rainfall total in February 2022 compared to February 2021, only one spill was recorded at Benson STW in February 2022, compared to twenty-eight in February 2021. The Chalgrove Brook indicator site shown in Figure 5, suggests groundwater levels in the catchment were higher in February 2021 compared to February 2022. A similar comparison can be made between March 2022 and March 2021.

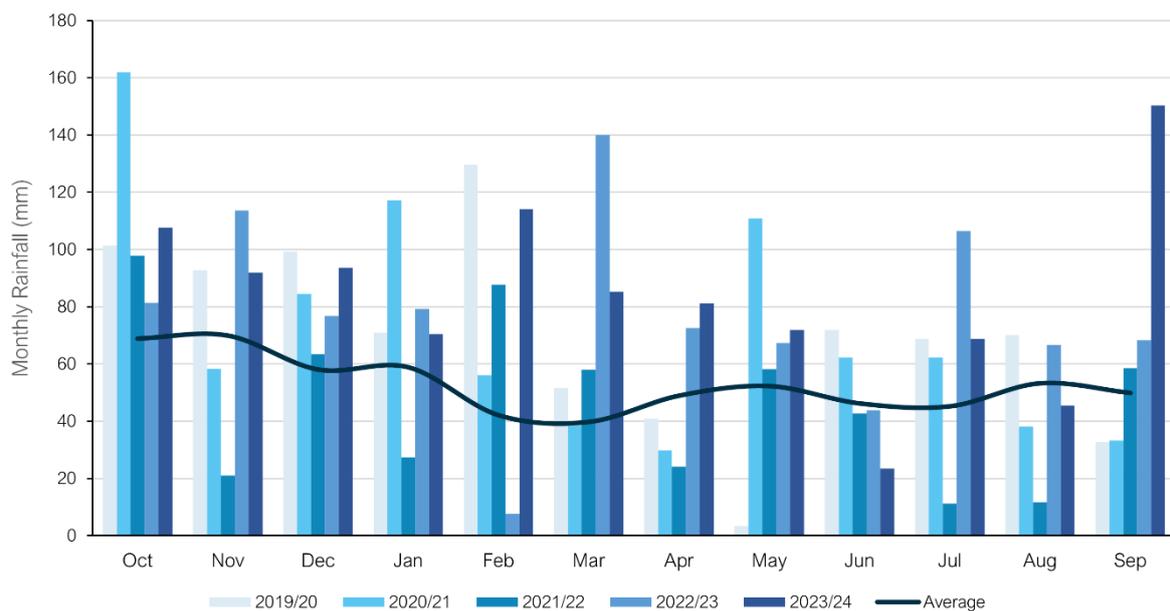
Figure 2 – Monthly Rainfall Data

Representative Radar rainfall has been used to generate monthly data at catchment level for comparison with average data generated by local Met Office Weather Station Records. Figure 2 presents the comparison of this data for the last five hydrological years to support longer term trends within the local system.

Average Values taken from Met Office Weather Station at Benson based on the period 1991-2020

The total rainfall for the 2023/24 hydrological year is 58% above the annual average total. Total rainfall values are presented in Table 3 below.

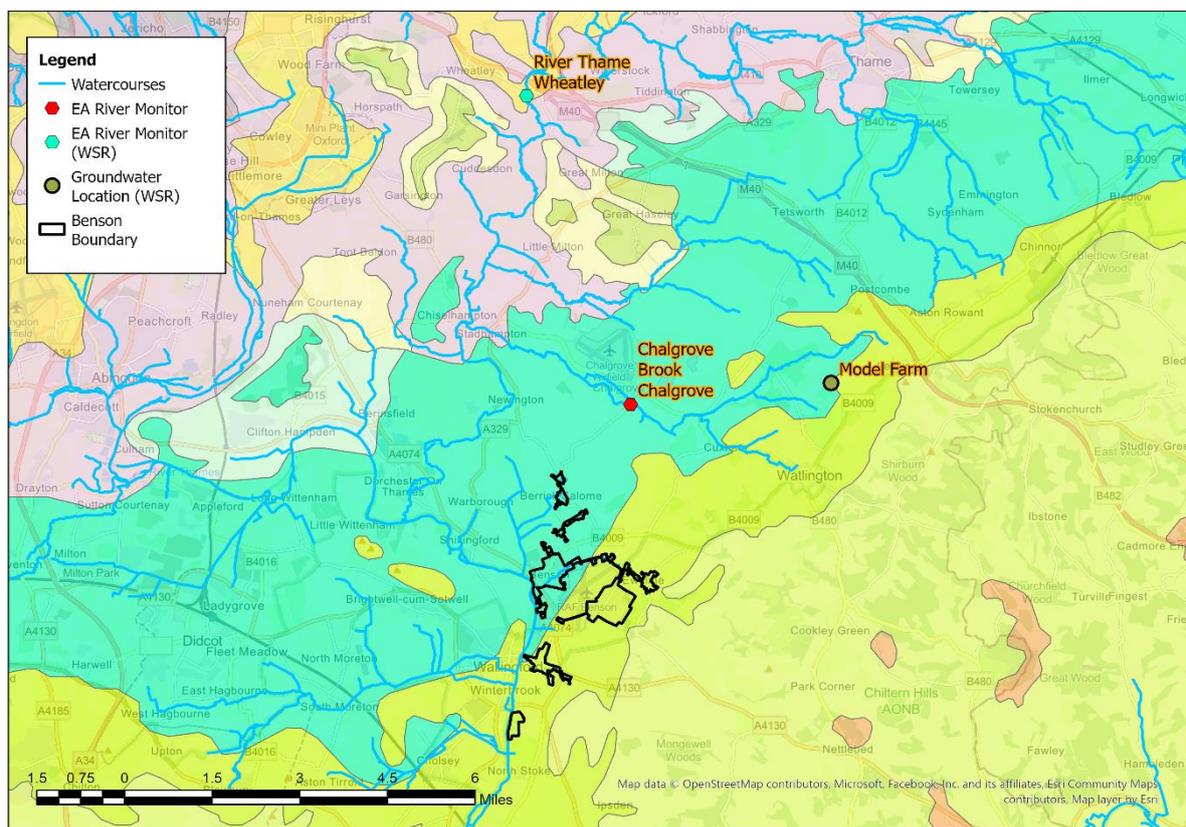
Figure 4 – Local Monitoring Stations

This site is illustrated in Figure 4, alongside the closest groundwater reference station and closest gauging station from the Water Situation Report.

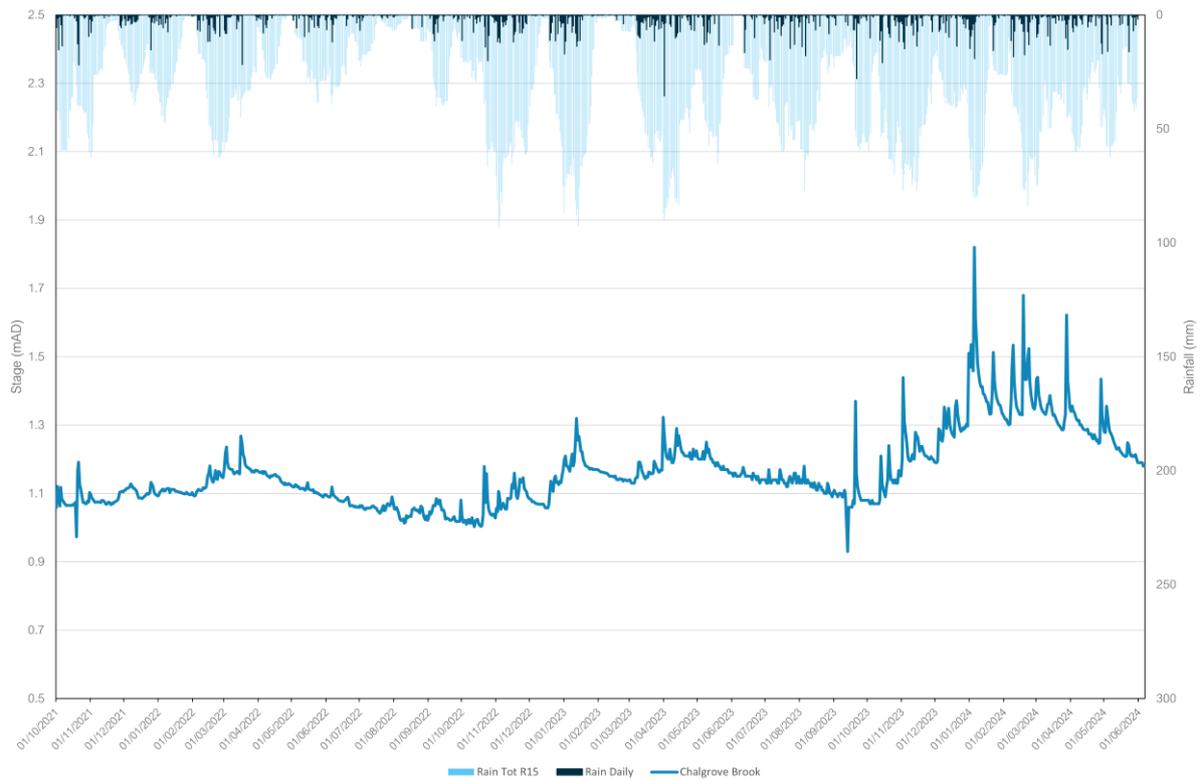
Figure 5A – Chalgrove Brook, Chalgrove

Figure 5A represents the last three hydrological years of level information at the indicator site to build a picture of the relative conditions prevalent in the current year. It is presented against both the daily total rainfall values for the catchment and a rolling 15 day total rainfall.

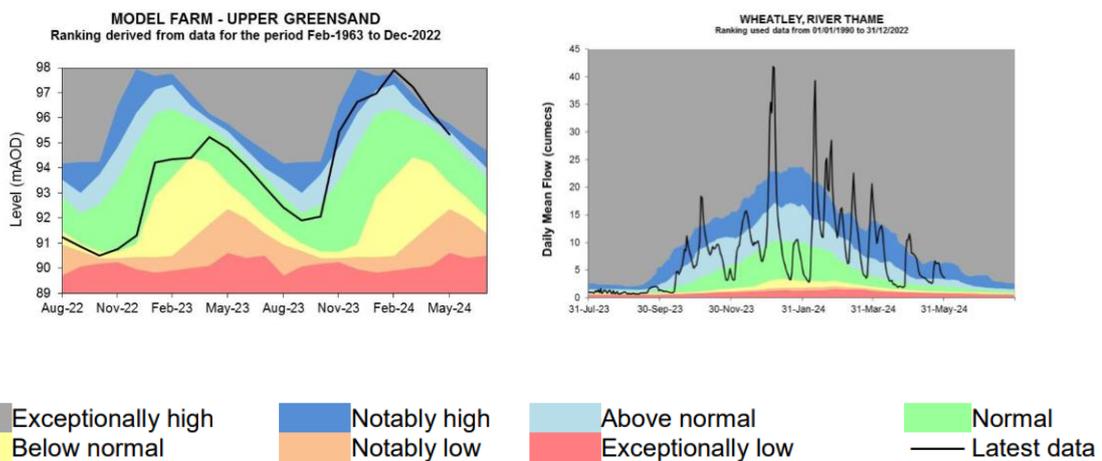
Figure 6 – Water Situation Report

In addition to this specific station, the wider groundwater context is illustrated in the Water Situation Report for the Ock. The nearest groundwater reference station is Model Farm. This site shows groundwater levels in 2023 to be at normal levels until November/December when notably high levels are observed. Groundwater levels in 2024 are mostly at above normal / notably high levels, peaking at exceptionally high levels. This can be seen in Figure 6 alongside the river indicator location at Wheatley on the River Thames.

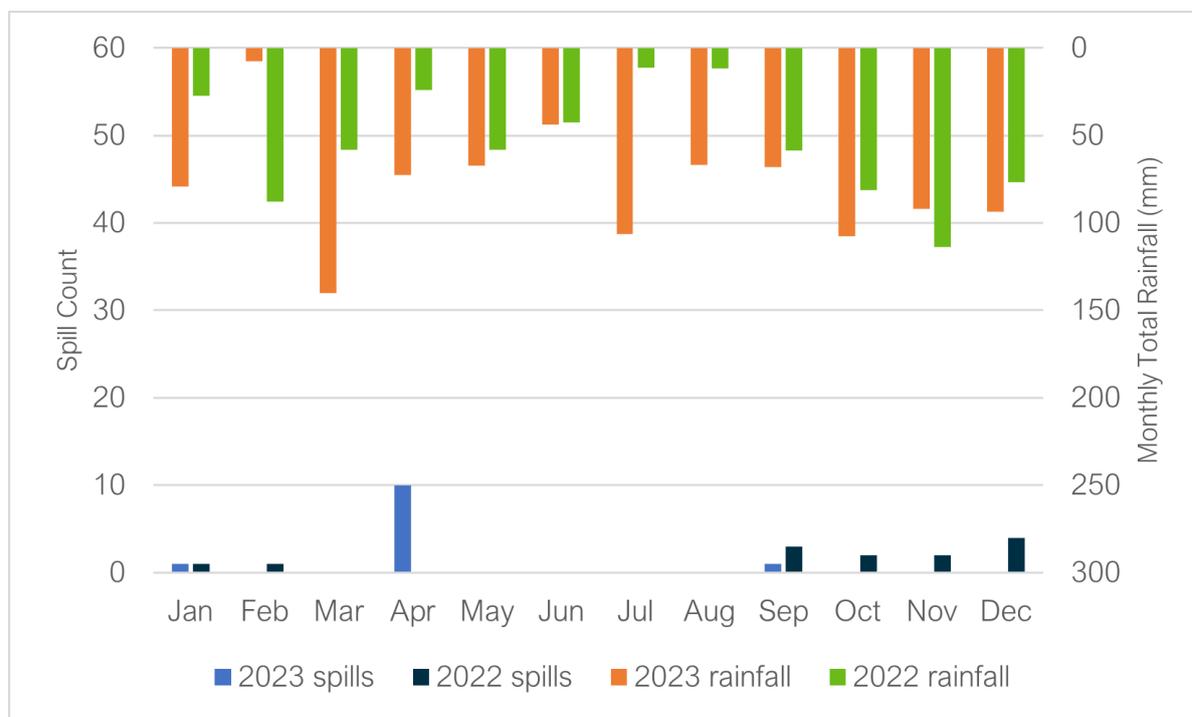
Figure 8 – EDM Monthly Performance

A critical part of the assessment of EDM performance and its relation to groundwater infiltration is to review the month-on-month spill performance, against previous years and the monthly total rainfall values to give context to the performance. Figure 8 below presents the EDM performance trend and rainfall for recent years.

The trend in spill performance across the two recorded years does show variation in spills. The data suggests a wider relationship between rainfall, elevated groundwater levels and spill frequency. The majority of the spills that occurred at Benson STW in 2023, were in April, despite higher rainfall totals being observed in other months. The indicator site data shown in Figure 6, suggests that groundwater levels in the catchment peaked during this period. This is a strong indicator of groundwater impacting spills at Benson STW. Of note also, is that despite very similar spill counts in 2022 and 2023, the total spill duration recorded in 2023 is much higher than 2022. This is also indicative of the role of groundwater infiltration on spills in the catchment, as groundwater infiltration often results in longer duration spills, compared to spills that occur only in response to rainfall events.
