# Groundwater Impacted System Management Plan

Cirencester (including South Cerney)  
River Churn

January 2021

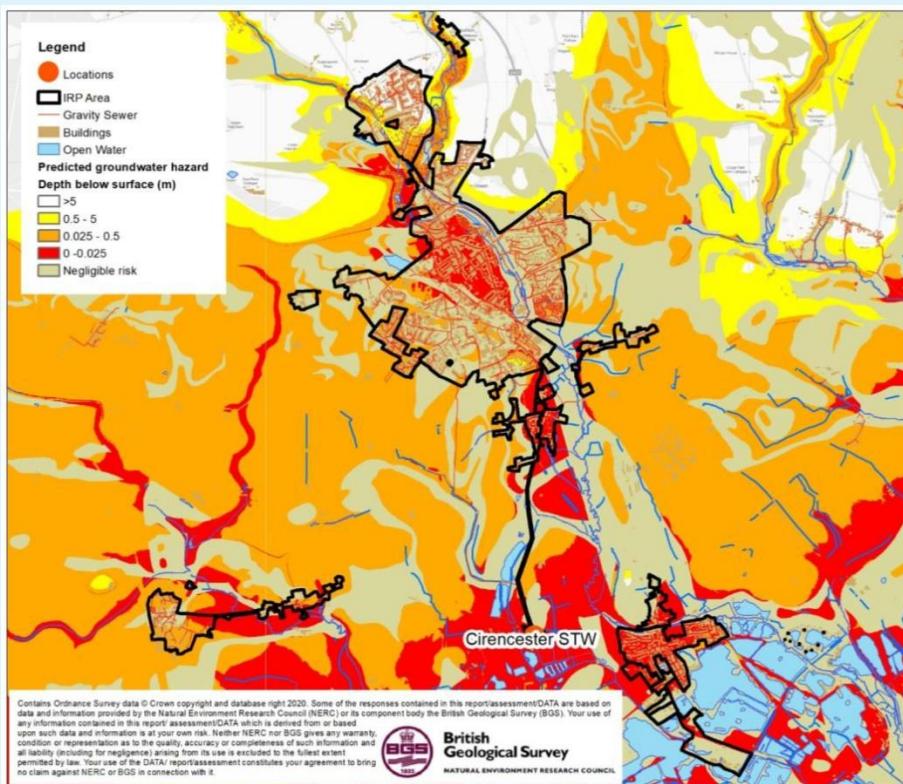
Figure 1.0 – Cirencester catchment

Cirencester lies on the River Churn in Gloucestershire, England, 13 miles North West of Swindon and 16 miles South East of Gloucester. Cirencester serves a population equivalent<sup>3</sup> of 31,720 with a predominantly separate sewerage network totalling some 131 km in length excluding private drains and sewers. The extent of the catchment is shown in Figure 1.0 above.

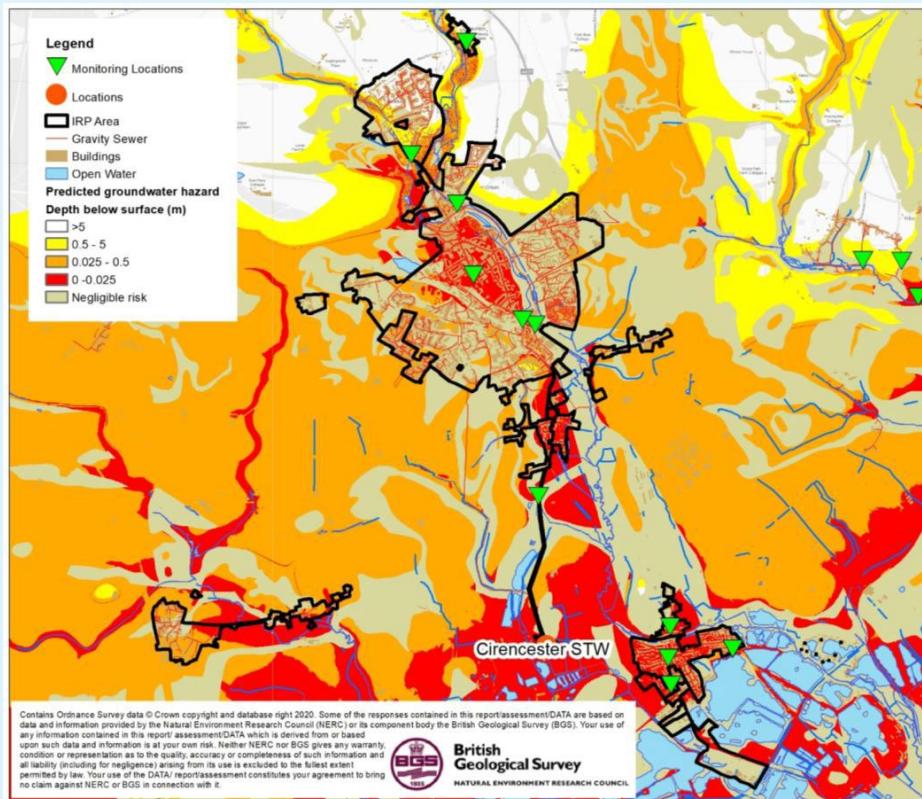
Figure 2.0 – Cirencester monitoring and infiltration zones

Key to bringing the impact of groundwater infiltration under control will be an enhanced monitoring regime. We have identified and have installed several telemetered depth monitor locations around the Cirencester system – see Figure 2.0.

We engaged with JBA Consulting to develop plans for Cirencester that identify zones of groundwater risk, see Figure 2.0. These zones are modelled areas where the groundwater has been determined to be above the sewer and hence pose a potential risk for groundwater ingress.

Sewer Depth Monitors have been installed in the catchment in 2020 (see Figure 2.0). These devices are telemetered and provide real time data on the level of flow in the sewer. The purpose of these units is to act as alerts for high groundwater impact in the sewer, calibration of the zones of infiltration risk and to demonstrate benefit gained from work undertaken to reduce infiltration.

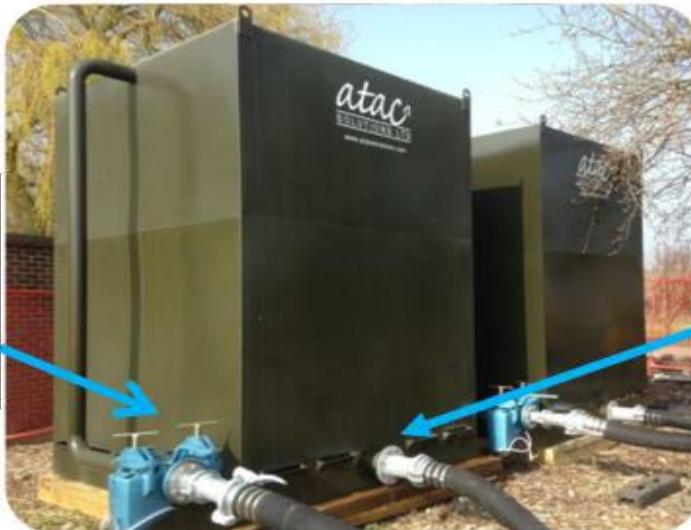
Outside view:

Dirty water entering the filter unit to be treated and then pumped to the top of the unit

Treated water leaving the unit and returning to the environment

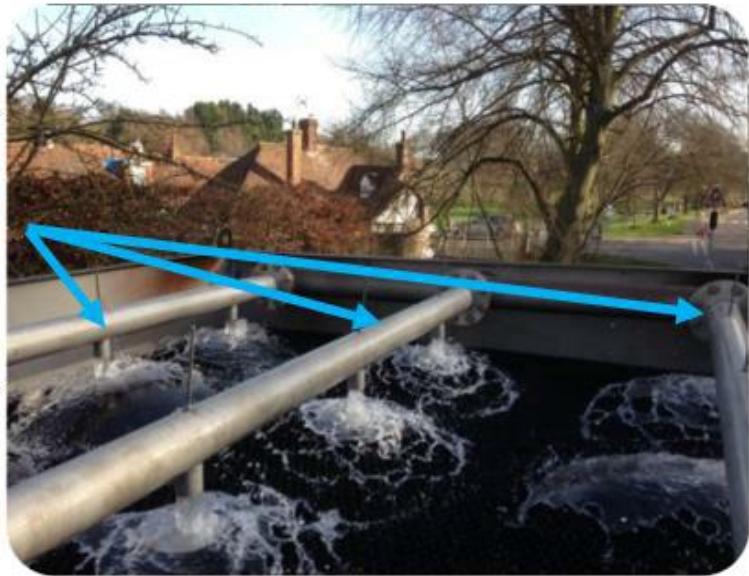
Inside view:

Dirty water  
being  
pumped into  
the unit and  
working its  
way through  
the filter  
system.

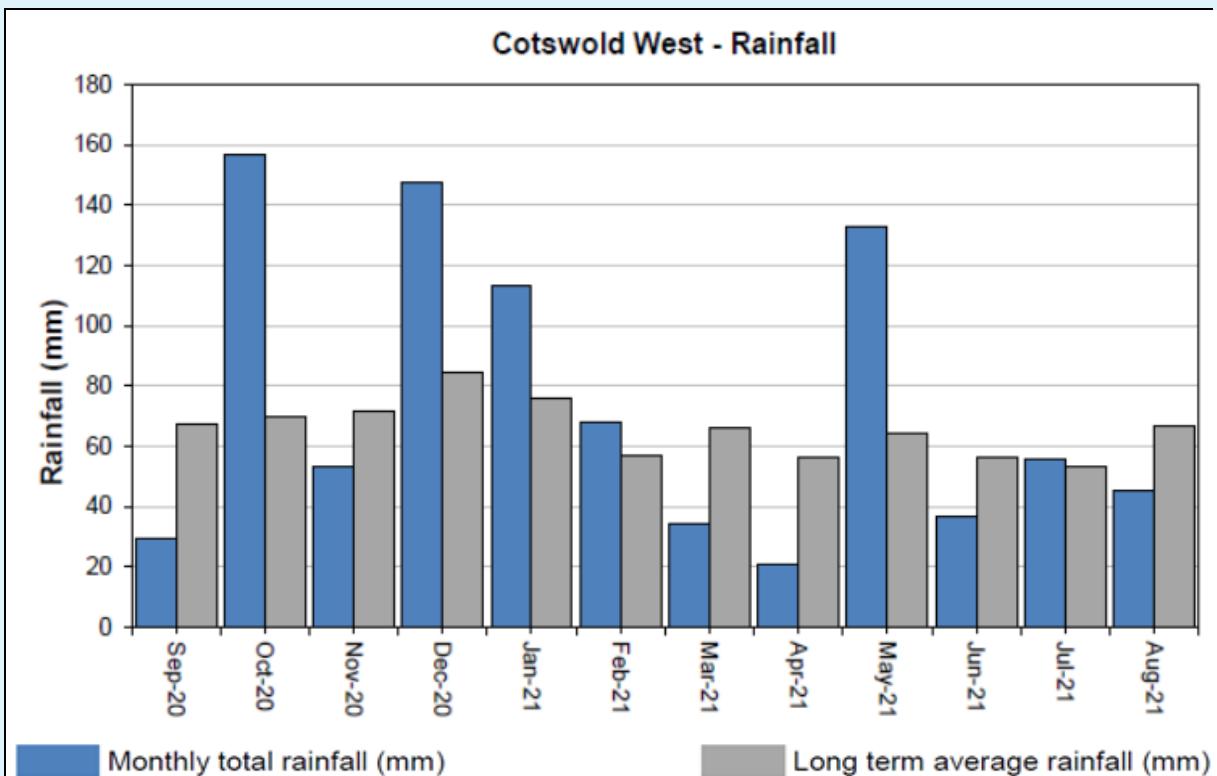
Figure 2 – Monthly rainfall depths local to the system

Cirencester is situated in the Cotswold West water resources area. Figure 2 shows the monthly rainfall total depths against the long-term average rainfall in the location of Cirencester over the period taken from the *Environment Agency Water Situation Report August 2021*<sup>8</sup>

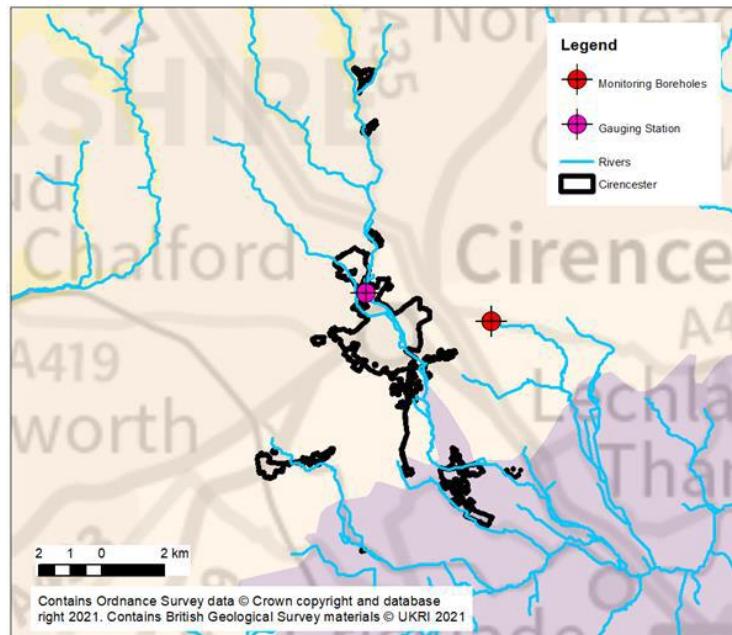
Figure 3 – Location of Ampney Crucis Monitoring Borehole Relative to Cirencester

Figure 3 shows the location of the British Geological Survey (BGS) monitoring borehole at Ampney Crucis which has been monitoring groundwater since 1959. Figures 4 and 5 show river levels in the River Churn at Cirencester which are a good indication of local groundwater levels over time. Figure 6 and 7 present the last two and last ten years of groundwater level data overlain on expected ranges. This shows how recent groundwater levels have compared against the expected range, they show that generally over the last two winters groundwater levels have been notably higher, with the peak groundwater levels close to or within the exceptional high range.

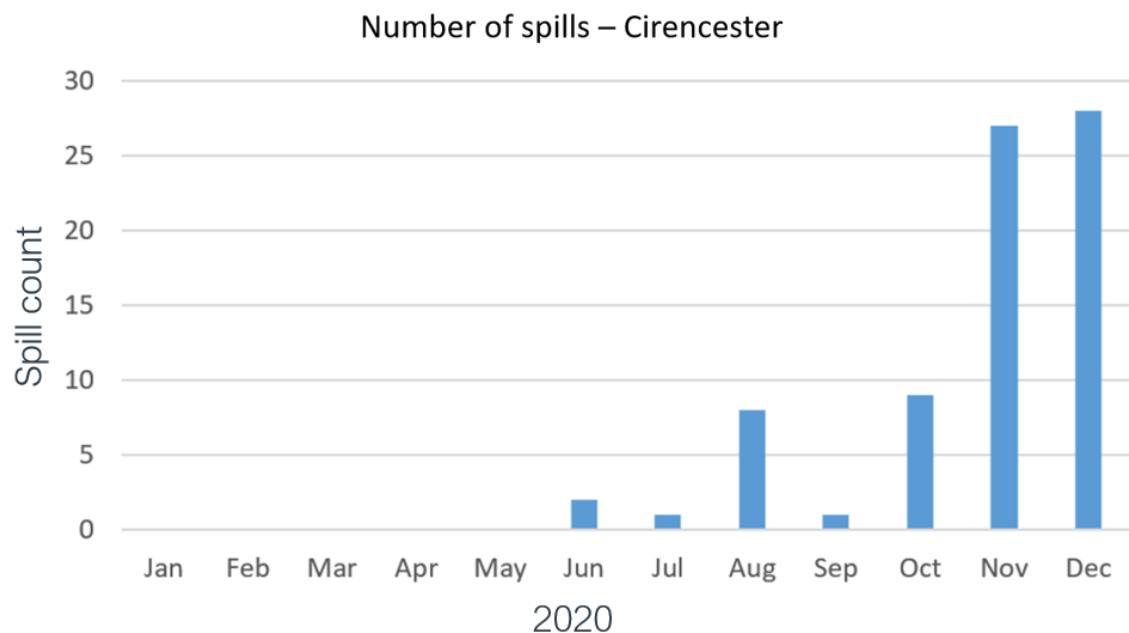
Figure 8 – Number of spills (discharge count) at Cirencester STW (taken from Event Duration monitor (EDM) Data).\*

Figure 8 shows the number of spills per month the from Cirencester Sewage Treatment Works (STW). November and December saw the greatest number of discharges (spills). In the summer, the number of spills were significantly less, highlighting the influence of groundwater infiltration/winter flows on the system. This Combined Sewer Overflow location has met the trigger for the EA's Storm Outfall Overflow Assessment Framework (SOAF) and is currently under further investigation with regards to root cause and impact.

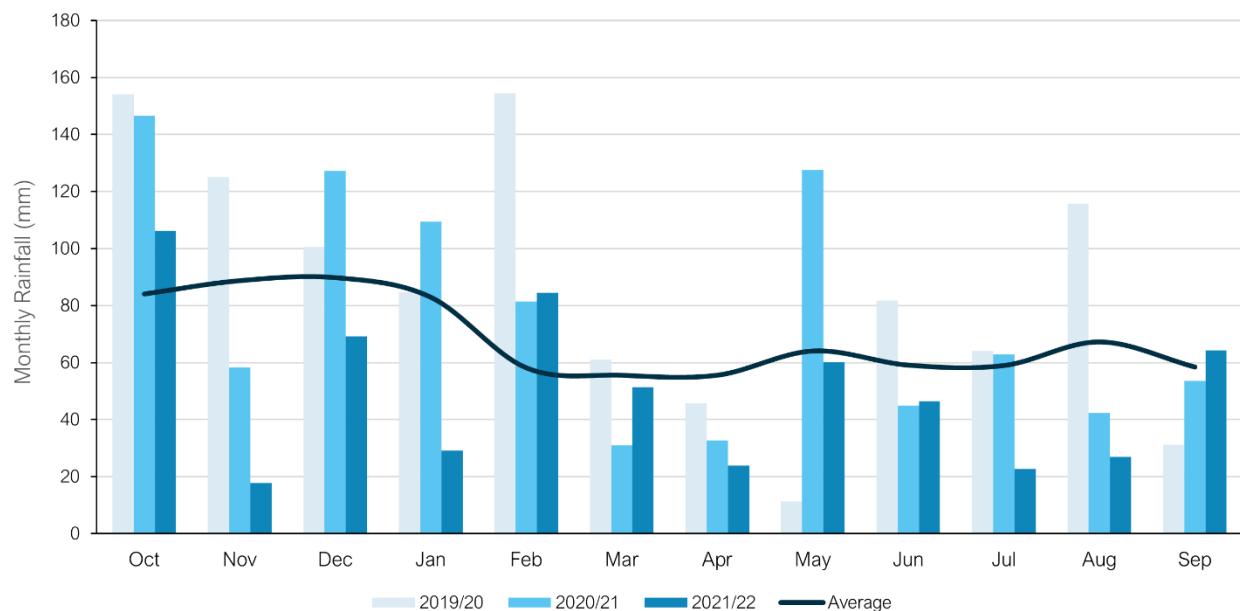
Figure 2 – Monthly Rainfall Performance

Representative Radar rainfall has been used to generate monthly data at catchment level for comparison with average data generated by local Met Office Weather Station Records. Figure 2 presents the comparison of this data for the last three hydrological years to support longer term trends within the local system.

Average Values taken from Met Office Weather Station at Cirencester based on the period 1991-2020

The total rainfall for the 2021/22 hydrological year is 26% below the annual average total. Total rainfall values are presented in Table 3 below.

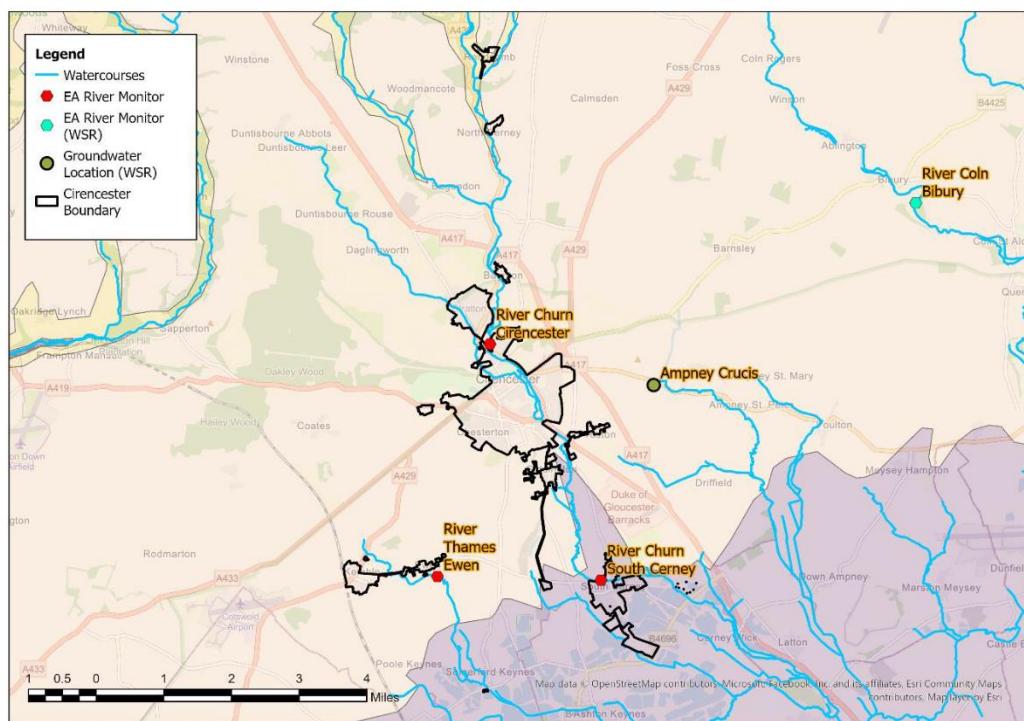
Figure 4 – Local Monitoring Stations

These sites are illustrated in the figure below, alongside the closest groundwater reference station and closest gauging station from the Water Situation Report.

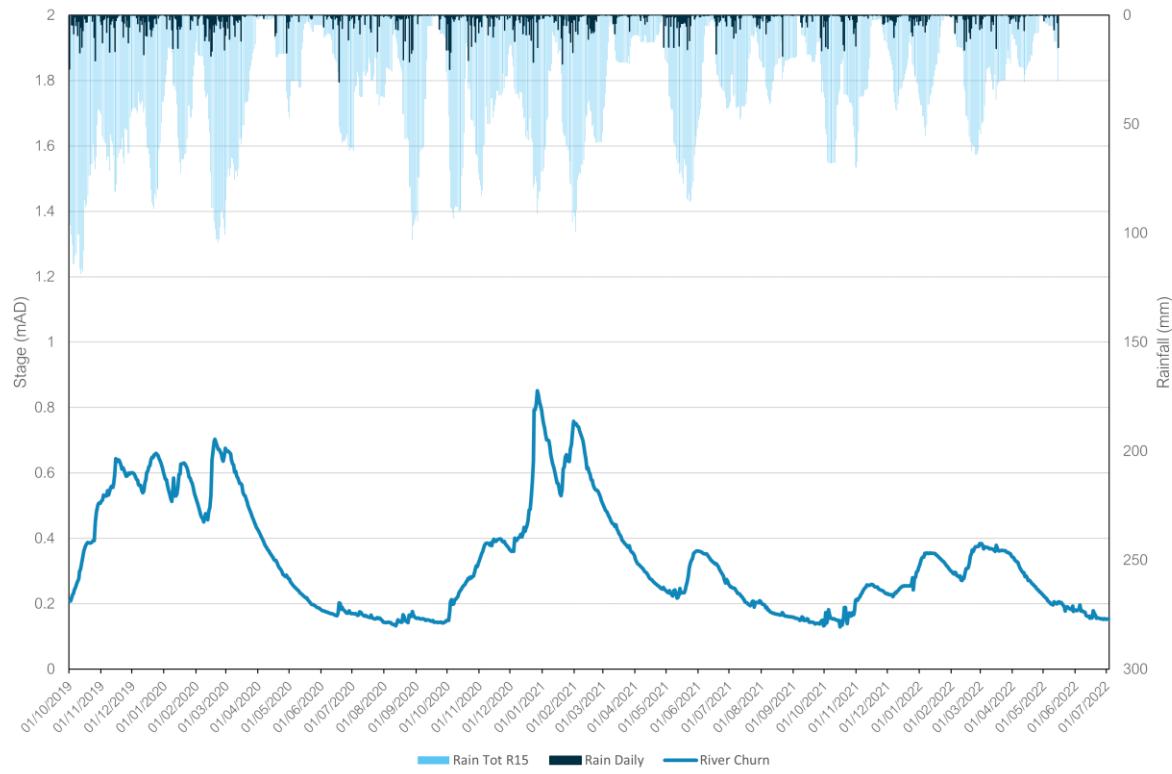
Figure 5A – River Churn, Cirencester

The following figures represent the last three hydrological years of level information at the indicator sites to build a picture of the relative conditions prevalent in the current year. It is presented against both the daily total rainfall values for the catchment and a rolling 15 day total rainfall.

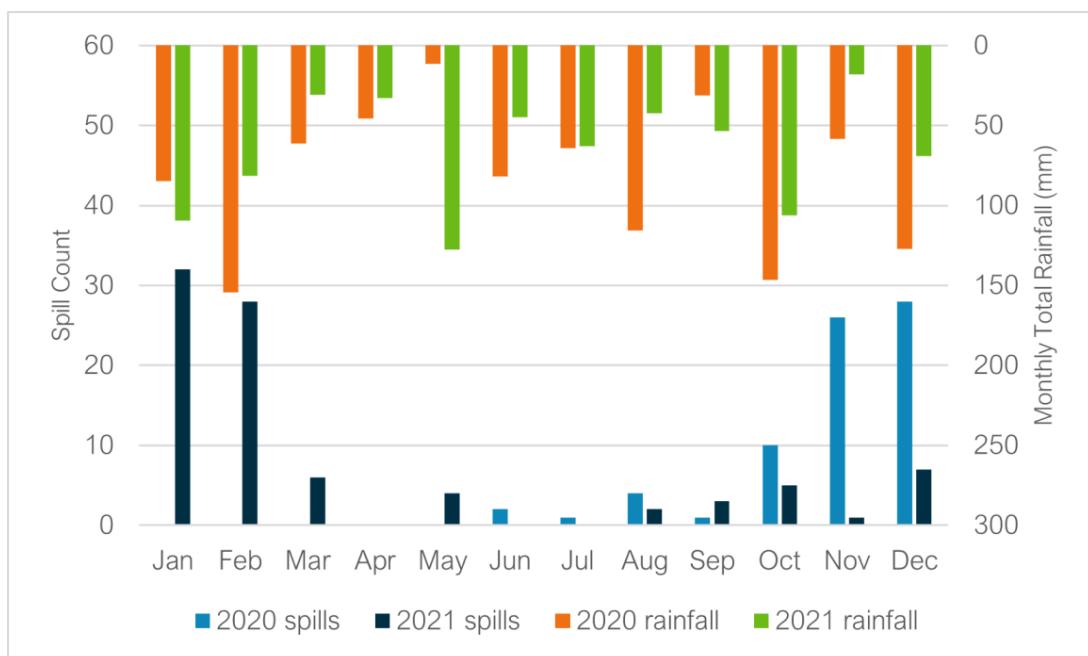
Figure 8 – EDM Monthly Performance

A critical part of the assessment of EDM performance and its relation to groundwater inundation is to review the month-on-month spill performance, against previous years and the monthly total rainfall values to give context to the performance. Figure 8 below presents the EDM performance trend and rainfall for recent years. Note that as the EDM monitor was installed in 2020, the 2020 spill count only includes spills from April 2020.

The trend in spill performance across the two recorded years does show variation in spills, with an overall focus on spills during the autumn and winter months. The data suggests a wider relationship between rainfall, elevated groundwater levels and spill frequency. The number of EDM spills recorded at Cirencester STW in November 2020 (26 spills) was similar to December 2020 (28 spills), despite December 2020 having a significantly greater total rainfall amount. As the indicator sites suggest groundwater levels in the catchment were similar across both months, the relatively high number of spills recorded in November 2020 is indicative of the role of groundwater infiltration.

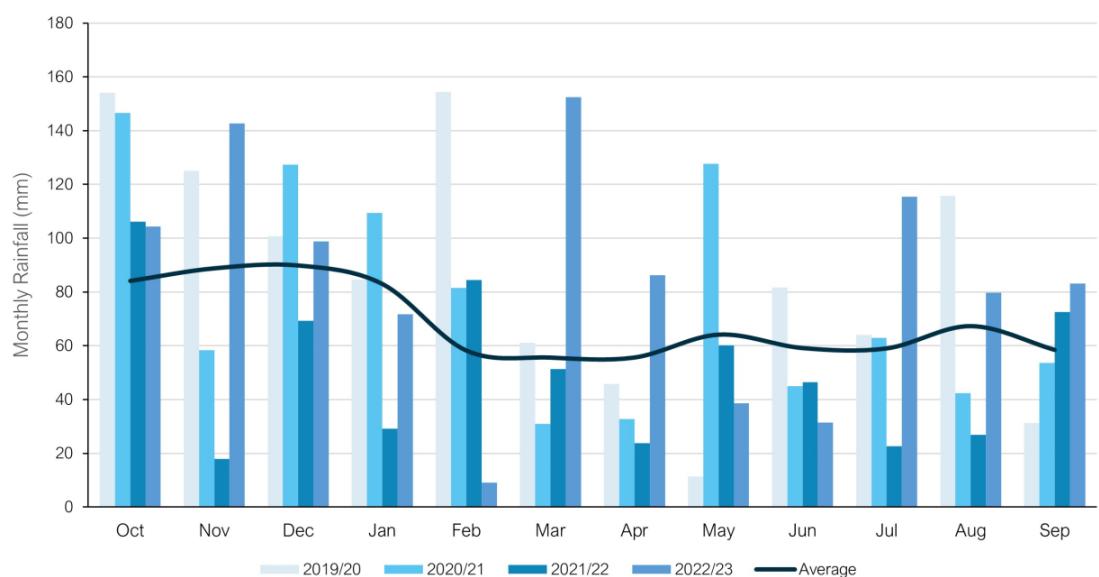
Figure 2 – Monthly Rainfall Performance

Representative Radar rainfall has been used to generate monthly data at catchment level for comparison with average data generated by local Met Office Weather Station Records. Figure 2 presents the comparison of this data for the last four hydrological years to support longer term trends within the local system.

Average Values taken from Met Office Weather Station at Cirencester based on the period 1991-2020

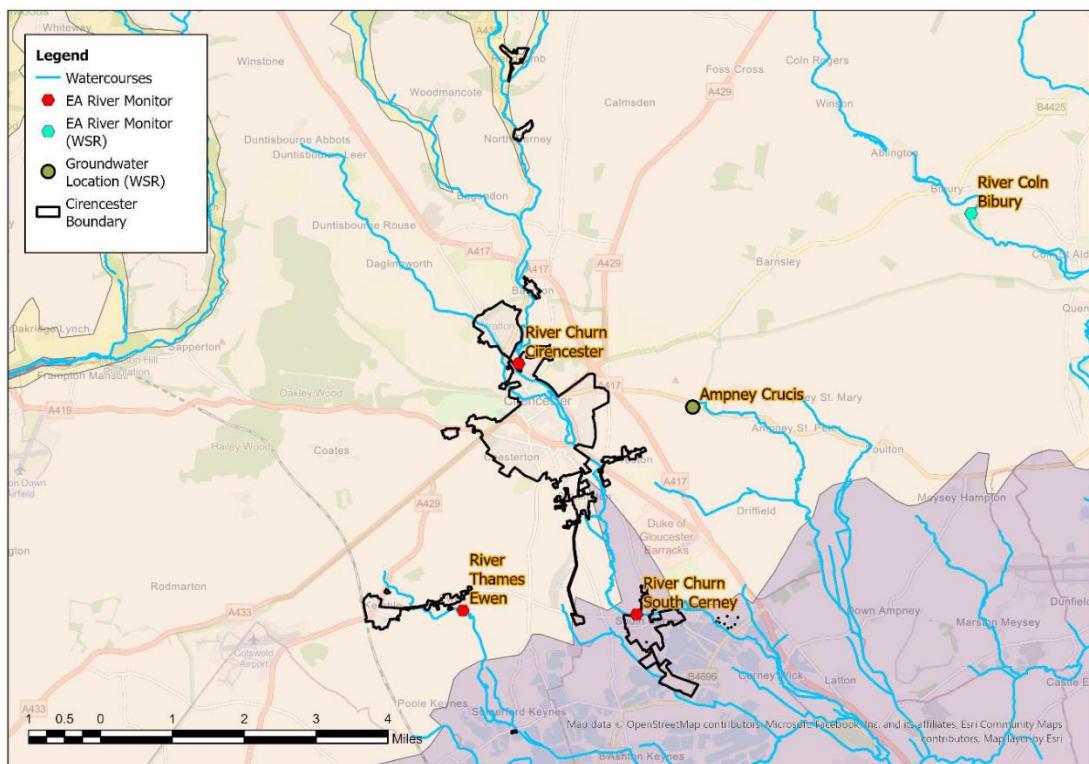
Figure 4 – Local Monitoring Stations

These sites are illustrated in the figure below, alongside the closest groundwater reference station and closest gauging station from the Water Situation Report.

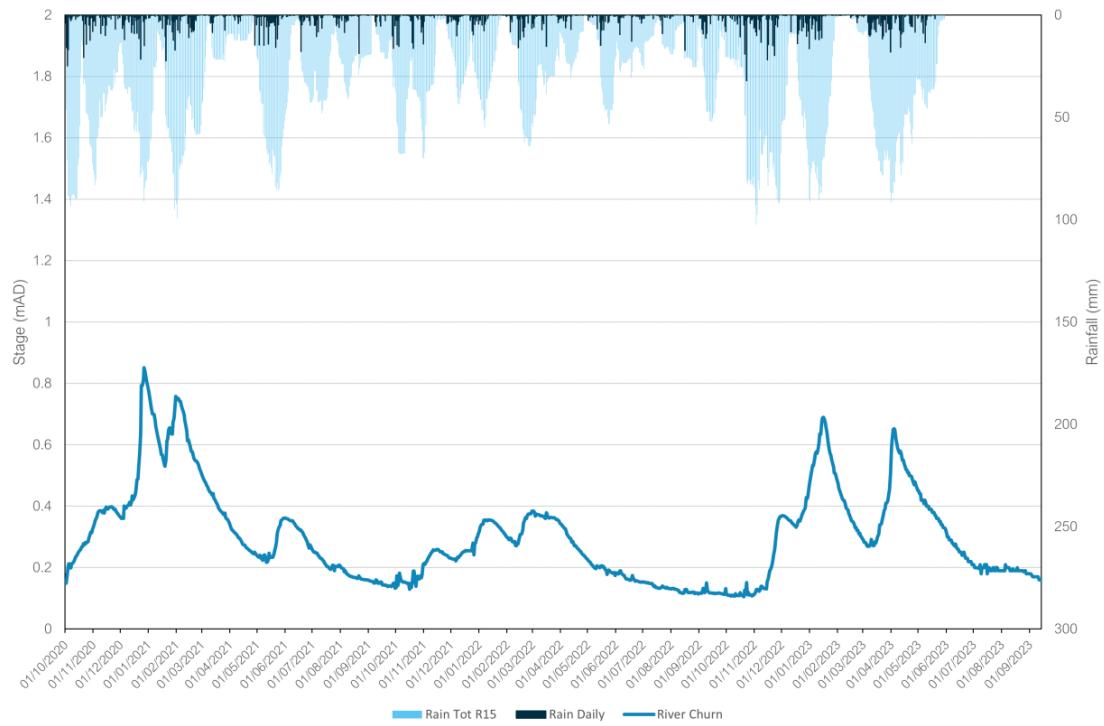
Figure 5A – River Churn, Cirencester

The following figures represent the last three hydrological years of level information at the indicator sites to build a picture of the relative conditions prevalent in the current year. It is presented against both the daily total rainfall values for the catchment and a rolling 15-day total rainfall.

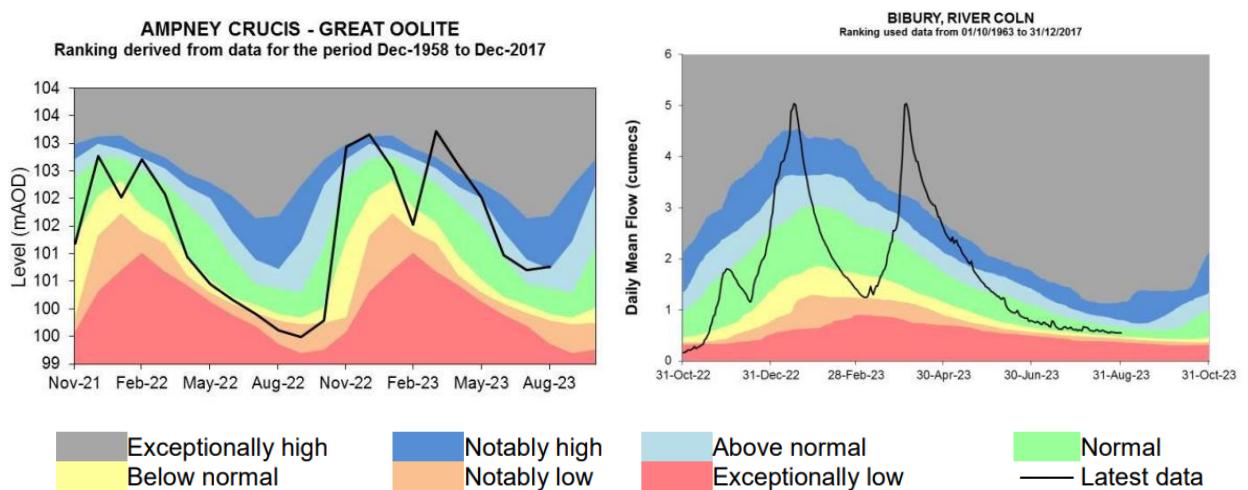
Figure 6 – Water Situation Report

In addition to these specific stations, the wider groundwater context is illustrated in the Water Situation Report for Cotswolds West. The nearest groundwater reference station is Ampney Crucis. This site shows groundwater levels generally at normal, below normal and notably low levels in 2022. Groundwater levels are observed to rise towards the end of the year to reach above normal and notably high levels. For 2023, observed groundwater levels have been higher than the equivalent periods in 2022.

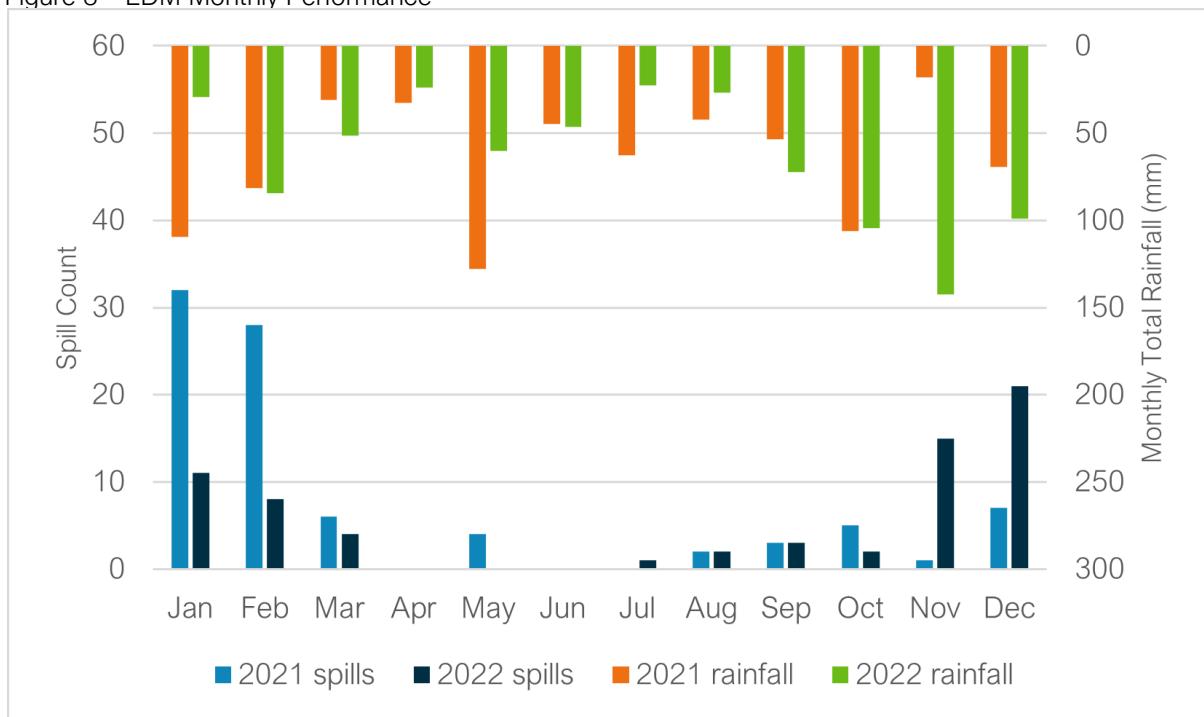
Figure 8 – EDM Monthly Performance

A critical part of the assessment of EDM performance and its relation to groundwater infiltration is to review the month-on-month spill performance, against previous years and the monthly total rainfall values to give context to the performance. Figure 8 below presents the EDM performance trend and rainfall for recent years.

The trend in spill performance across the two recorded years does show variation in spills, with an overall focus on spills during the autumn and winter months. The data suggests a wider relationship between rainfall, elevated groundwater levels and spill frequency. A significant number of spills were recorded at Cirencester STW in November and December 2022. The indicator site data shown in Figure 5, suggests groundwater levels in the catchment became elevated during this period, with Figure 6 suggesting that they reached notably high levels. Similarly, despite similar rainfall totals, significantly more spills were recorded at Cirencester STW in February 2021 compared to February 2022. The indicator site data shown in Figure 5, suggests groundwater levels in the catchment were higher in February 2021.

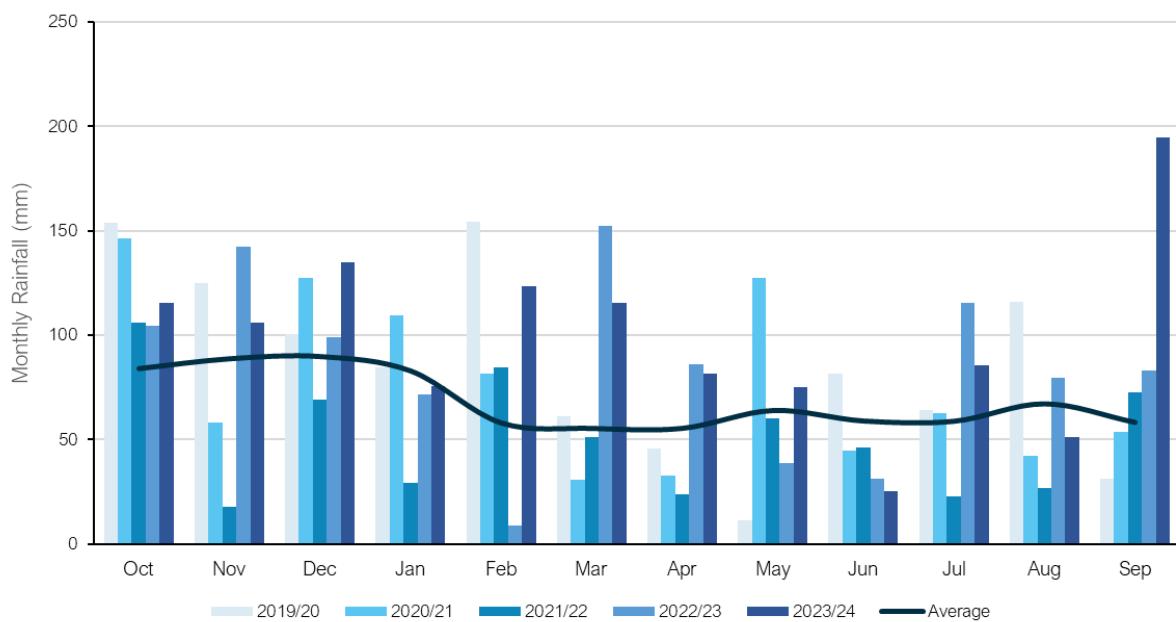
Figure 2 – Monthly Rainfall Data

Representative Radar rainfall has been used to generate monthly data at catchment level for comparison with average data generated by local Met Office Weather Station Records. Figure 2 presents the comparison of this data for the last five hydrological years to support longer term trends within the local system.

Average Values taken from Met Office Weather Station at Cirencester based on the period 1991-2020

The total rainfall for the 2023/24 hydrological year is 44% above the annual average total. Total rainfall values are presented in Table 3 below.

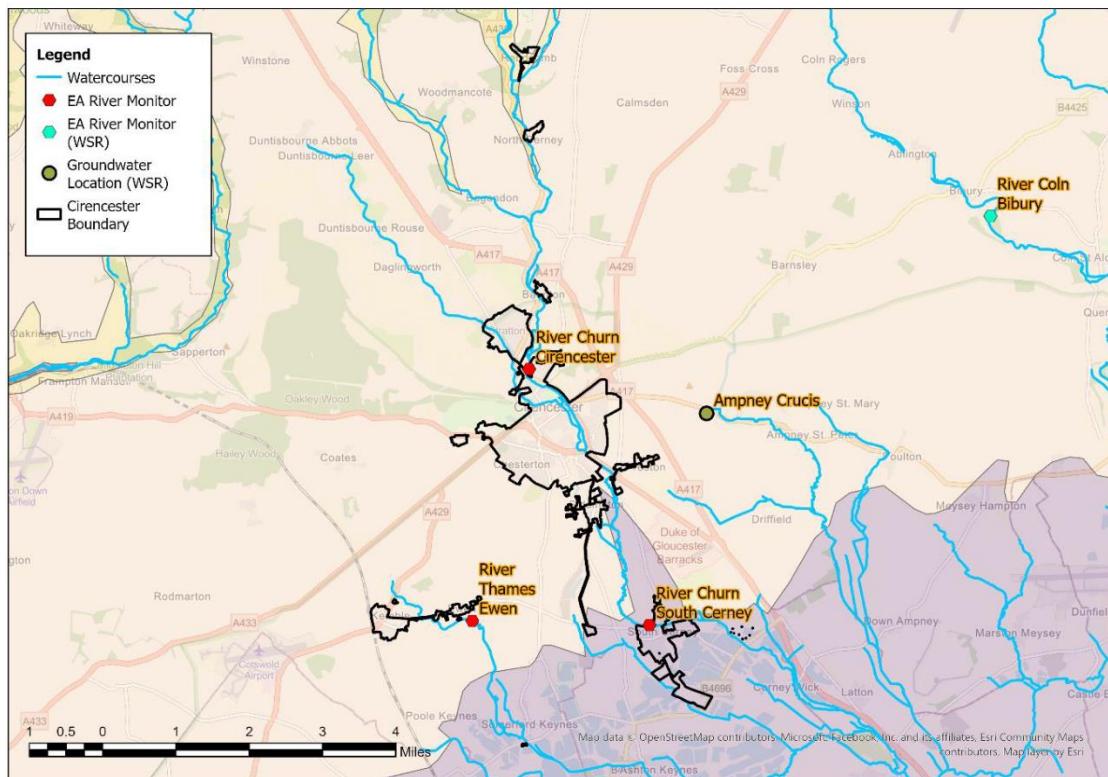
Figure 4 – Local Monitoring Stations

These sites are illustrated in Figure 4, alongside the closest groundwater reference station and closest gauging station from the Water Situation Report.

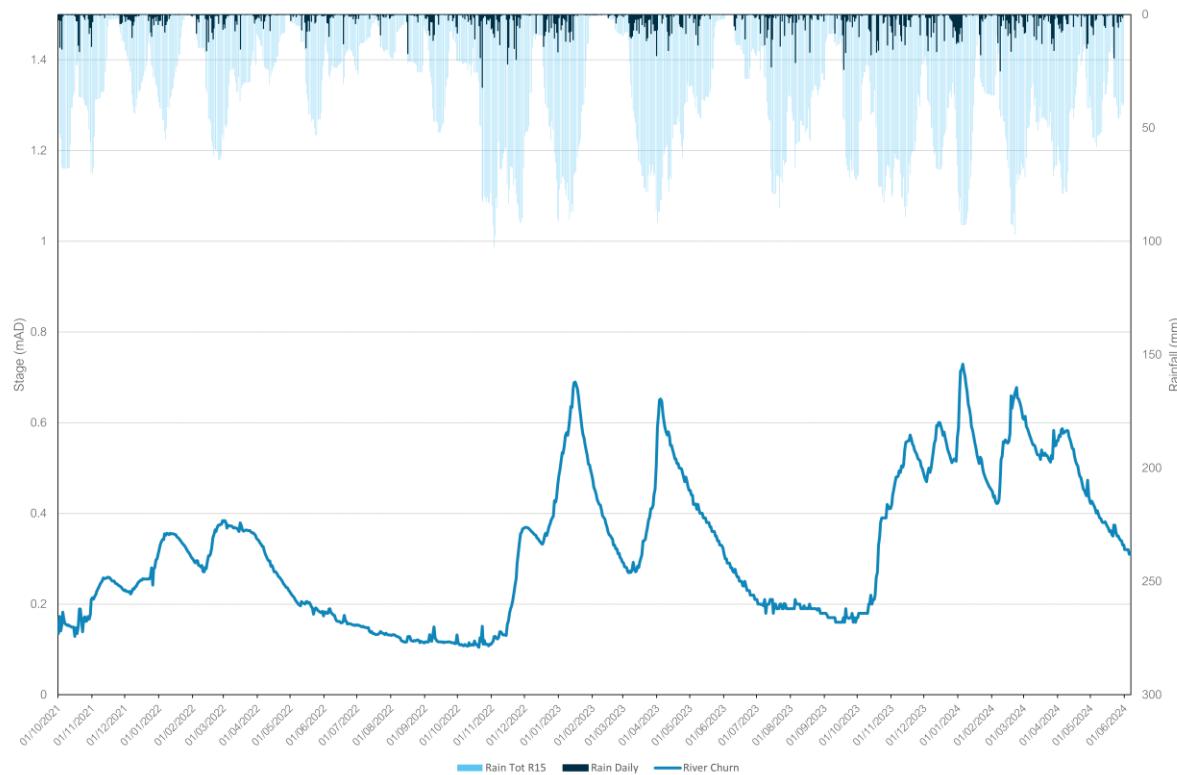
Figure 5A – River Churn, Cirencester

Figures 5A-5C represent the last three hydrological years of level information at the indicator sites to build a picture of the relative conditions prevalent in the current year. It is presented against both the daily total rainfall values for the catchment and a rolling 15 day total rainfall.

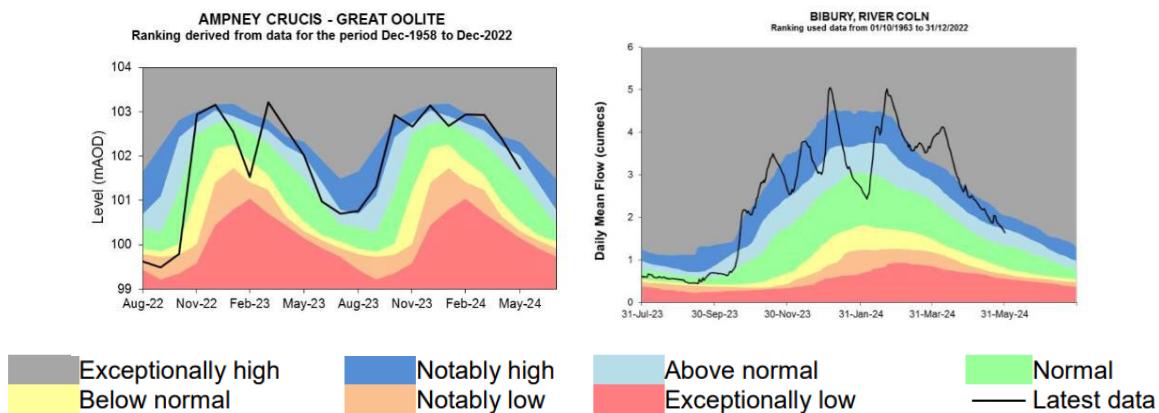
Figure 6 – Water Situation Report

In addition to these specific stations, the wider groundwater context is illustrated in the Water Situation Report for Cotswolds West. The nearest groundwater reference station is Ampney Crucis. This site shows groundwater levels from March through to the end of year in 2023 to be at above normal, notably high and exceptionally high levels. Groundwater levels in 2024 can be observed to sustain above normal / notably high levels throughout the January – May period. This can be seen in Figure 6 alongside the river indicator location at Bibury on the River Coln.

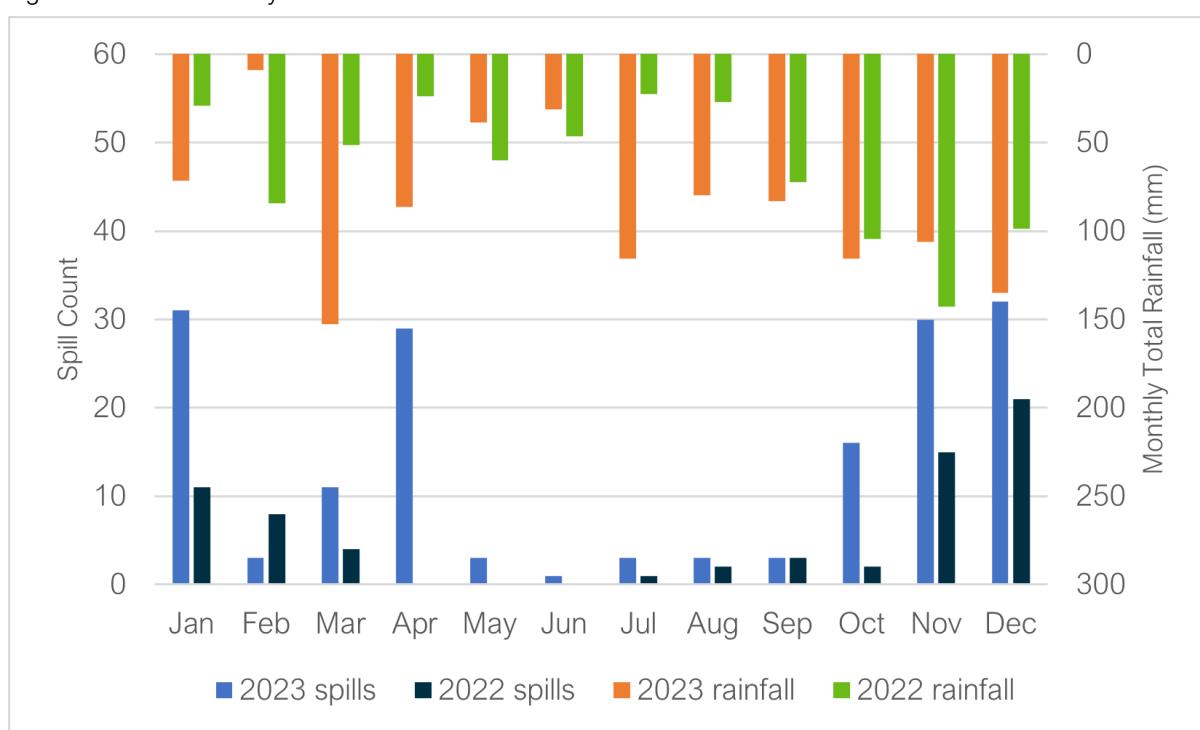
Figure 8 – EDM Monthly Performance

A critical part of the assessment of EDM performance and its relation to groundwater infiltration is to review the month-on-month spill performance, against previous years and the monthly total rainfall values to give context to the performance. Figure 8 below presents the EDM performance trend and rainfall for recent years.

The trend in spill performance across the two recorded years does show variation in spills, with an overall focus on spills during the winter, spring and autumn months. A high number of spills were recorded in January and April 2023, coinciding with periods of elevated groundwater levels (see Figures 5 and 6). Additionally, despite rainfall totals being similar in October / November 2022, compared to the same months in 2023, a significantly higher number of spills were recorded across November and December 2023. The indicator site data shown in Figure 5, suggests groundwater levels were generally more elevated during these months in 2023. Overall, the data suggests a wider relationship between rainfall, elevated groundwater levels and spill frequency in the catchment. The fact that spills occurred through the summer months in 2022 and 2023, also suggests spills occurring in the catchment as a direct response to rainfall, outside of periods of elevated groundwater levels.

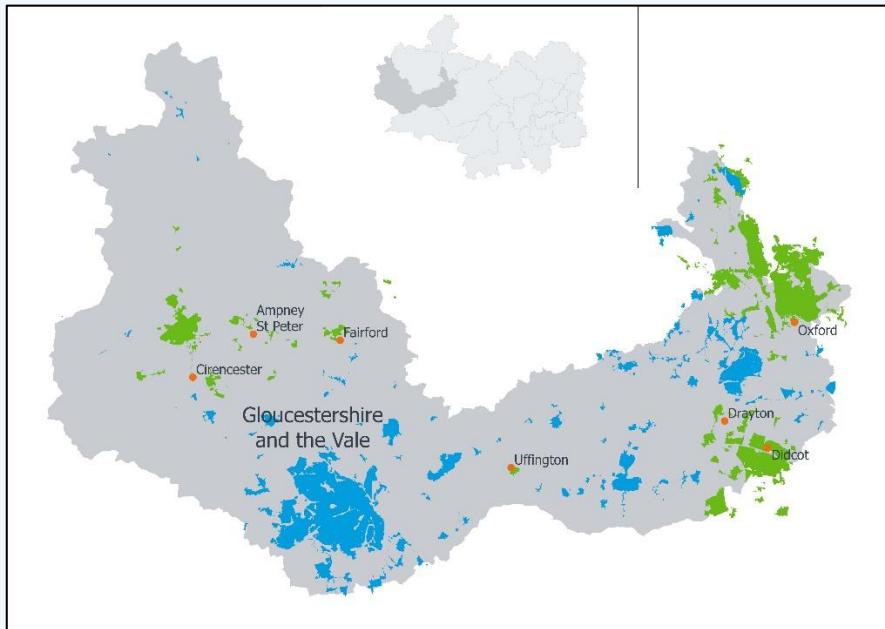
Figure 1: Relationship of the Sewer Systems to Associated Rivers

Sewer System	Associated River / Stream	Relationship to the River Thames
Ampney St Peter STW	Ampney Brook, River Coln	Both direct tributaries of the River Thames
Cirencester STW	River Churn	Direct tributaries of the River Thames
Didcot STW	Moor Ditch, Hakka's Brook	Moor Ditch indirect tributary of the River Thames via Boveney Ditch. Hakka's Brook indirect tributary of the River Thames, via Mill Brook.
Drayton STW	River Ock	Direct tributary of the River Thames
Fairford STW	River Coln	Direct tributary of the River Thames
Oxford STW	River Thames, River Cherwell, Castle Mill Stream	River Thames. River Cherwell direct tributary of the River Thames. Castle Mill Stream direct tributary of the River Thames.
Uffington STW	Stutfield Brook	Indirect tributary of the River Thames via River Ock

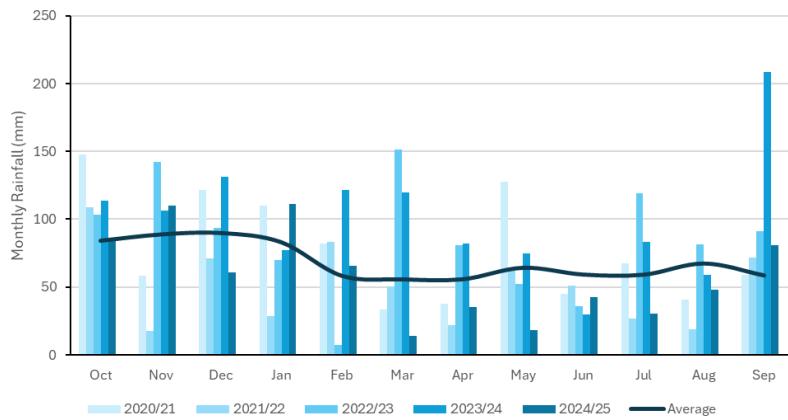
Figure 1: Monthly rainfall data 2020/21 to 2024/25

Figures 1 to 5 illustrate the relationship between rainfall and CSO spills. As shown in Figure 1, the decrease in rainfall from 2023/24 to 2024/25 correlates with a decrease in both the number and duration of CSO spills, as shown in Figure 5. However, Figure 2 shows an increase in the river levels, whereas Figure 3 indicates a decrease.

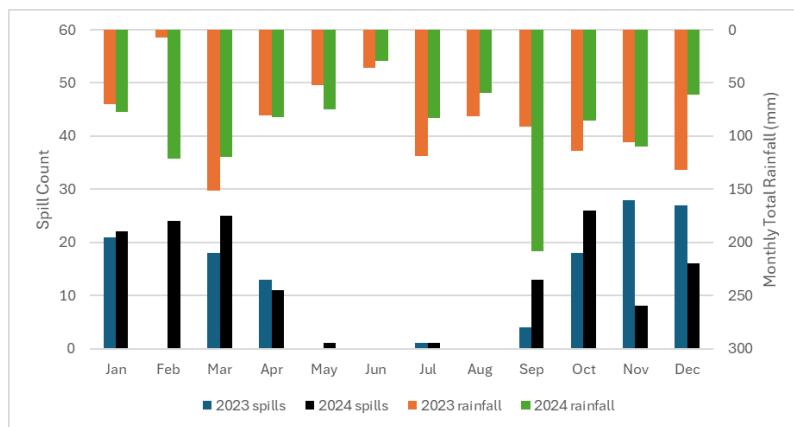
Figure 5: Monthly rainfall data versus monthly spill count for 2023 and 2024 – Ampney St Peter STW

Table 1 below details the last 2 years performance of overflows in the catchment. To assess EDM performance and its relation to groundwater infiltration, a review of the month-on-month spill performance in 2023 and 2024 against the monthly total rainfall values has been undertaken, as observed in Figure 5.

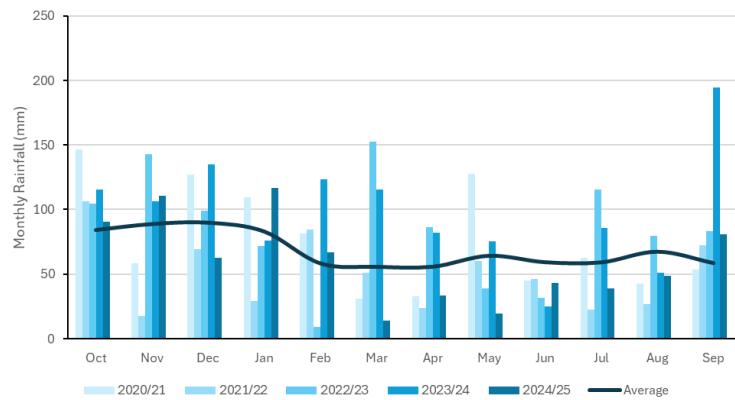
Figure 1: Monthly rainfall data 2020/21 to 2024/25

Figures 1 to 6 illustrate the relationship between rainfall and CSO spills. As shown in Figure 1, the reduction in rainfall from 2023/24 to 2024/25 correlates with the decrease in both the number and duration of CSO spills, as presented in Figure 6. However, the river levels remain consistent (Figures 2 to 4).

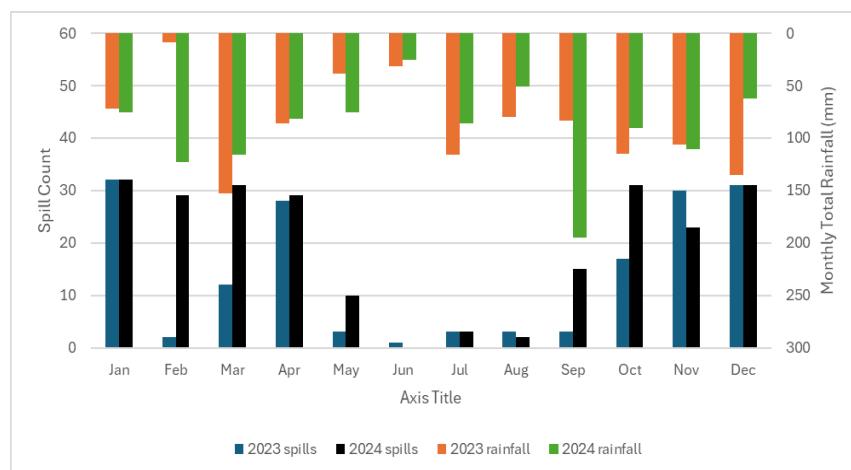
Figure 6: Monthly rainfall data versus monthly spill count for 2023 and 2024 – Cirencester STW

Table 1 below details the last 2 years performance of overflows in the catchment. To assess EDM performance and its relation to groundwater infiltration, a review of the month-on-month spill performance in 2023 and 2024 against the monthly total rainfall values has been undertaken, as observed in Figure 6.

A review of river level data over 2023/2024 shows a similar pattern being followed compared to previous years. The number and duration of spills have increased in 2024 compared to 2023. The higher number of annual spills could be a result of the increased rainfall in 2024 (seen in Figure 6). Moreover, groundwater levels for 2024/2025 have stayed relatively similar to the groundwater levels of the previous year, but the effect of this will be analysed when 2025 spill data is published.

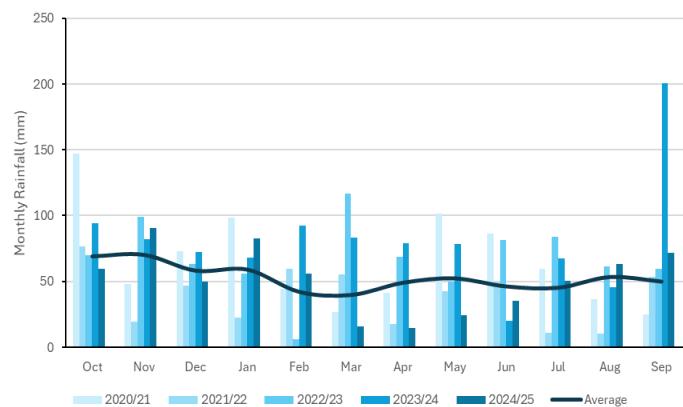
Figure 1: Monthly rainfall data 2020/21 to 2024/25

Figures 1 to 5 illustrate the relationship between rainfall and CSO spills. As shown in Figure 1, the decrease in rainfall from 2023/24 to 2024/25 correlates with reduced groundwater levels (Figures 3), however, the river level remains consistent (Figure 2). While a decrease in rainfall typically correlates with a corresponding reduction in the number and duration of CSO spills, the observed reduction in spills for 2025 may be misleading. This is primarily due to the absence of data for the last quarter of 2025. In fact, spill levels during the first three quarters of 2025 are comparable to those in the same period of 2024, suggesting no significant reduction as presented in Figure 5.

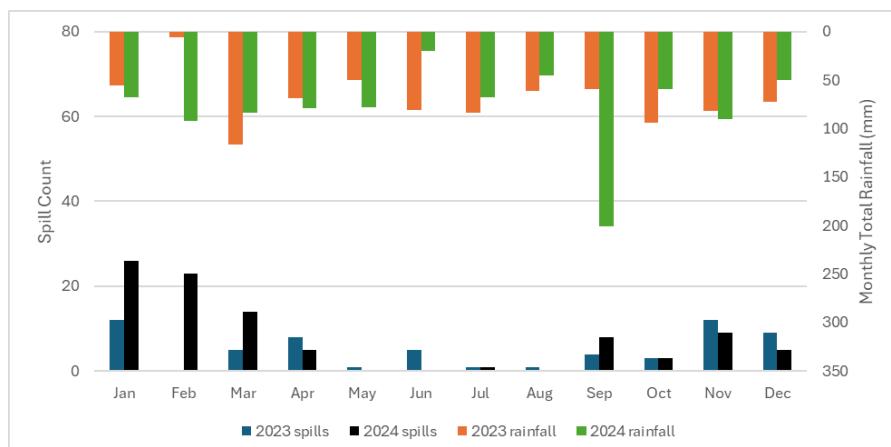
Figure 5: Monthly rainfall data versus monthly spill count for 2023 and 2024 – Didcot STW

Table 1 below details the last 2 years performance of overflows in the catchment. To assess EDM performance and its relation to groundwater infiltration, a review of the month-on-month spill performance in 2023 and 2024 against the monthly total rainfall values has been undertaken, as observed in Figure 5.

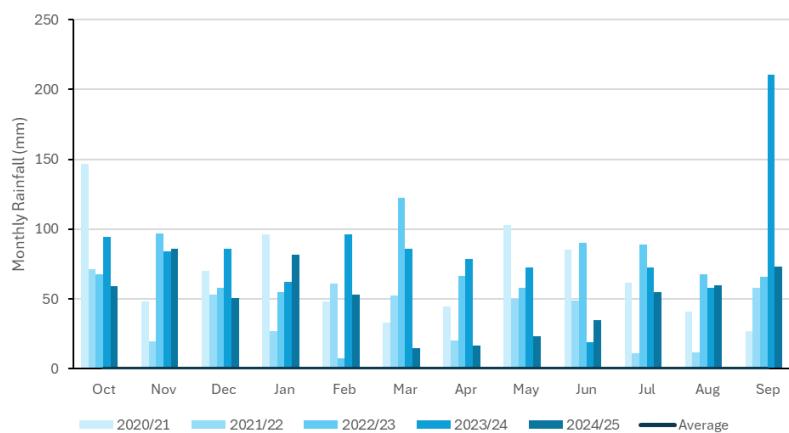
Figure 1: Monthly rainfall data 2020/21 to 2024/25

Figures 1 and 2 illustrate the relationship between rainfall and spills at CSOs. Figure 1 displays the reduced rainfall in 2024/25 compared to 2023/24, this corresponds to fewer and less duration or spills in 2025, compared to 2024. There is no data available for river or groundwater levels.
