# Groundwater Impacted System Management Plan

Cirencester (including South Cerney)  
River Churn

January 2021

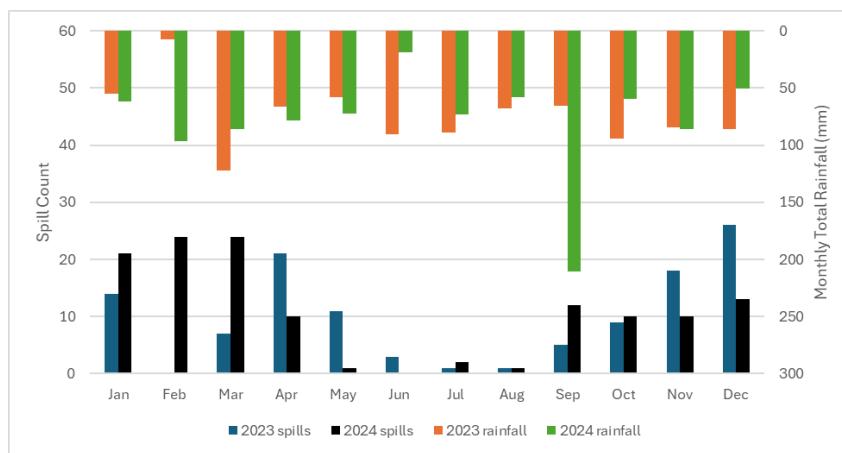
Figure 2: Monthly rainfall data versus monthly spill count for 2023 and 2024 – Drayton STW

Figures 1 and 2 illustrate the relationship between rainfall and spills at CSOs. Figure 1 displays the reduced rainfall in 2024/25 compared to 2023/24, this corresponds to fewer and less duration or spills in 2025, compared to 2024. There is no data available for river or groundwater levels.

Table 1 below details the last 2 years performance of overflows in the catchment. To assess EDM performance and its relation to groundwater infiltration, a review of the month-on-month spill performance in 2023 and 2024 against the monthly total rainfall values has been undertaken, as observed in Figure 2.

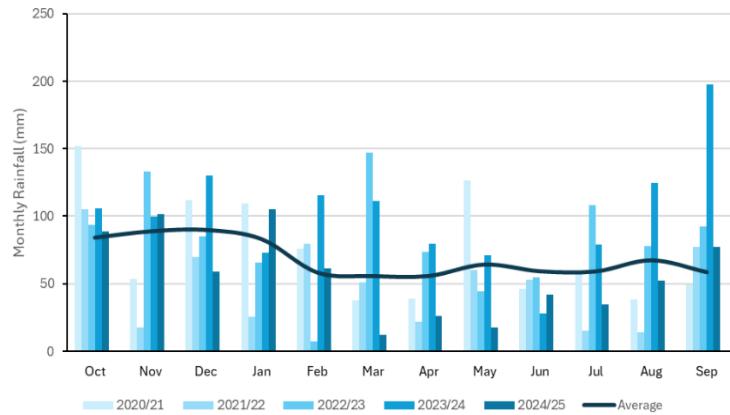
Figure 1: Monthly rainfall data 2020/21 to 2024/25

Figures 1 to 5 illustrate the relationship between rainfall and CSO spills. Figure 1 outlined the decrease in rainfall from 2023/24 to 2024/25, that correlates with reduced river levels displayed in Figures 2 and 3. There is also fewer and a shorter duration of CSO spills in 2025 compared to 2024 when observing Figure 5.

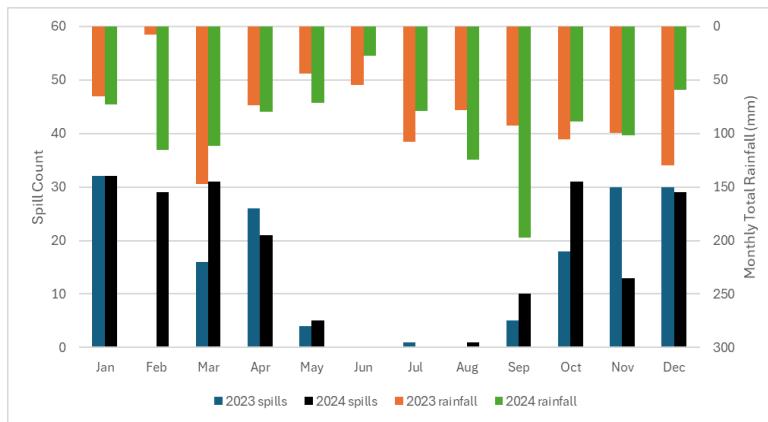
Figure 5: Monthly rainfall data versus monthly spill count for 2023 and 2024 – Fairford STW

Table 1 below details the last 2 years performance of overflows in the catchment. To assess EDM performance and its relation to groundwater infiltration, a review of the month-on-month spill performance in 2023 and 2024 against the monthly total rainfall values has been undertaken, as observed in Figure 5.

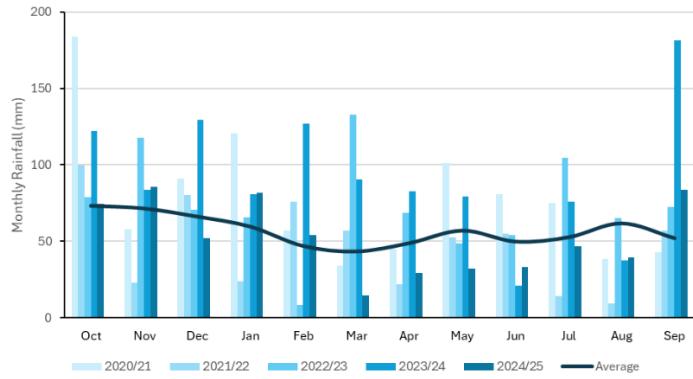
Figure 1: Monthly rainfall data 2020/21 to 2024/25

Figures 1 to 7 illustrate the relationship between rainfall and CSO spills. As shown in Figure 1, the decrease in rainfall from 2023/24 to 2024/25 correlates with a corresponding decrease in both the number and duration of CSO spills, as presented in Figure 7. However, the river levels remain consistent throughout the years, as seen in (Figures 2 to 5).

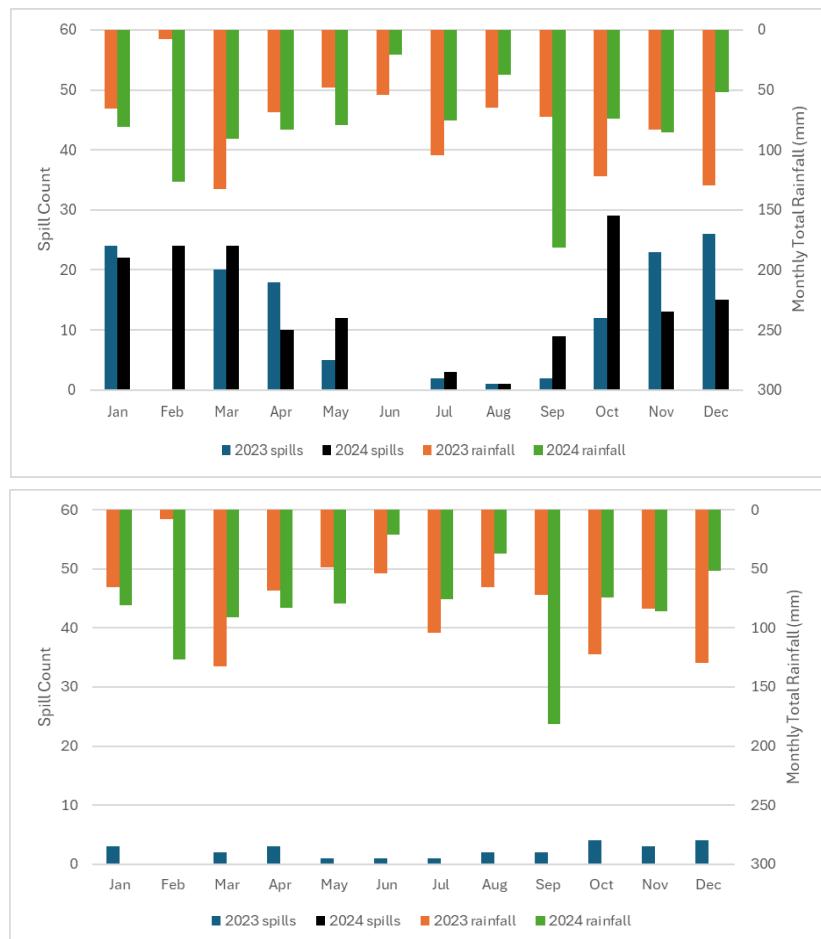
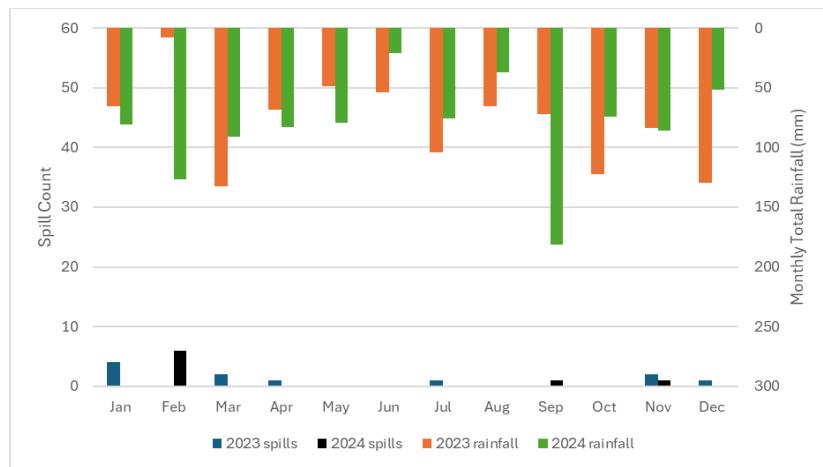
Figure 7: Monthly rainfall data versus monthly spill count for 2023 and 2024 – Oxford STW

Table 1 below details the last 2 years performance of overflows in the catchment. To assess EDM performance and its relation to groundwater infiltration, a review of the month-on-month spill performance in 2023 and 2024 against the monthly total rainfall values has been undertaken, as observed in Figure 7.

Figure 8: Monthly rainfall data versus monthly spill count for 2023 and 2024 – Botley Road CSO

A review of river level data over 2023/24 has increased compared to previous years. The number and duration of spills have increased in 2024 compared to 2023 for Oxford STW, whereas it has decreased for Botley Road CSO and North Hinksey Lane CSO. The higher number of annual spills for Oxford STW and river levels could be a result of the increased rainfall in 2024 (seen in Figure 7). This suggests that rainfall directly correlates to spill events. However, there is insufficient evidence to support the validity of this correlation, as the highest number of spills for 2024 (October) does not occur during one of the wettest months (September), seen in Figure 7. Moreover, there is a slight drop in groundwater levels for 2024/2025 compared to the groundwater levels of the previous year, but the effect of this decrease will be analysed when 2025 spill data is published.

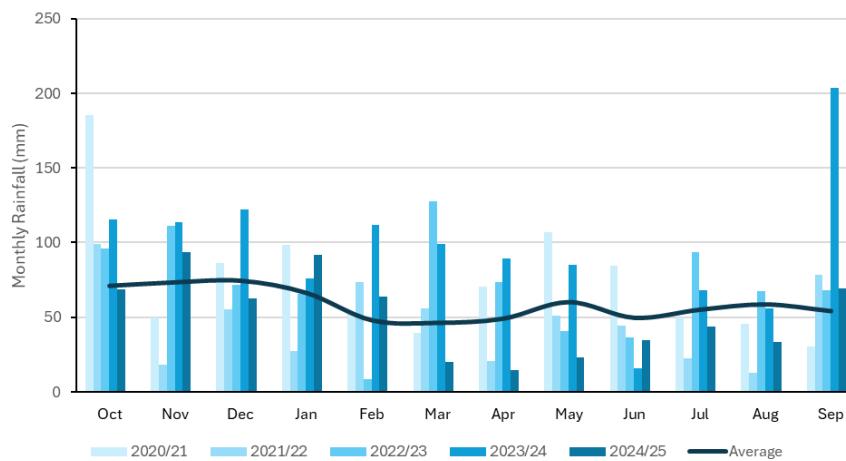
Figure 1: Monthly rainfall data 2020/21 to 2024/25

Figures 1 to 4 illustrate the relationship between rainfall and spills at CSOs. As can be seen the decrease in rainfall from 2023/24 into 2024/25, shown in Figure 1; shows a correlation in decreased number and duration of CSO spills shown in Figure 4. However, river levels remain consistent (Figure 2).

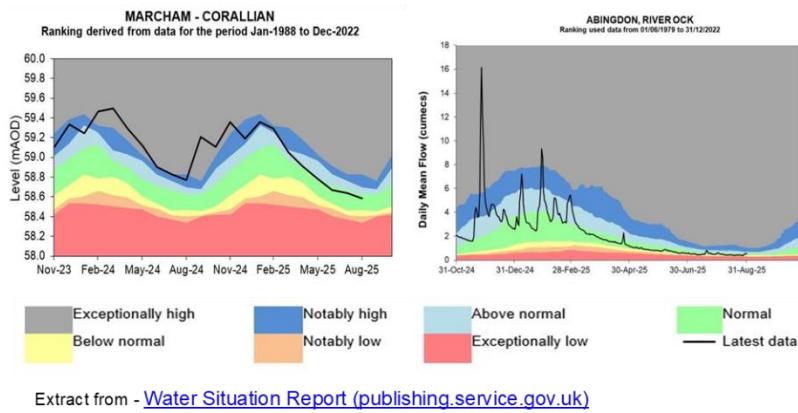
Figure 3: Ground Water situation Report

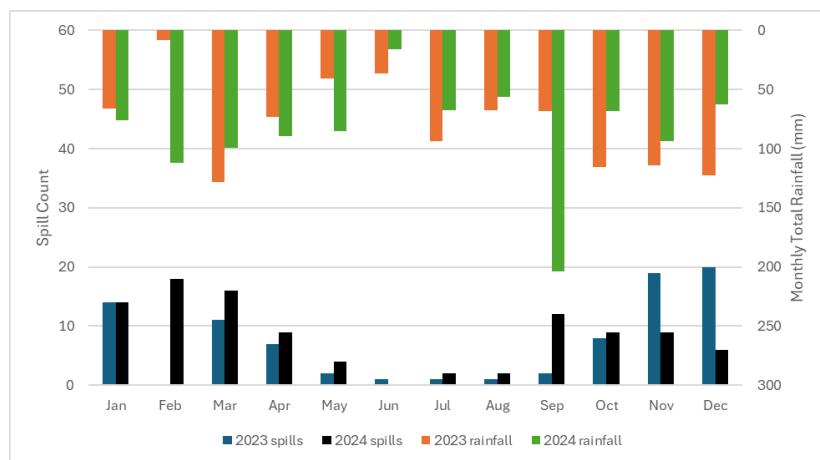
Figure 4: Monthly rainfall data versus monthly spill count for 2023 and 2024 – Uffington STW

Table 1 below details the last 2 years performance of overflows in the catchment. To assess EDM performance and its relation to groundwater infiltration, a review of the month-on-month spill performance in 2023 and 2024 against the monthly total rainfall values has been undertaken, as observed in Figure 4.

A review of river level data over 2023/24 has increased compared to previous years. The number and duration of spills have increased in 2024 compared to 2023. The higher number of annual spills and river levels could be a result of the increased rainfall in 2024 (seen in Figure 4). Moreover, there is a slight drop in groundwater levels for 2024/2025 compared to the groundwater levels of the previous year, but the effect of this decrease will be analysed when 2025 spill data is published.
