Groundwater Impacted System Management Plan

Alton, Caker Stream

November 2021

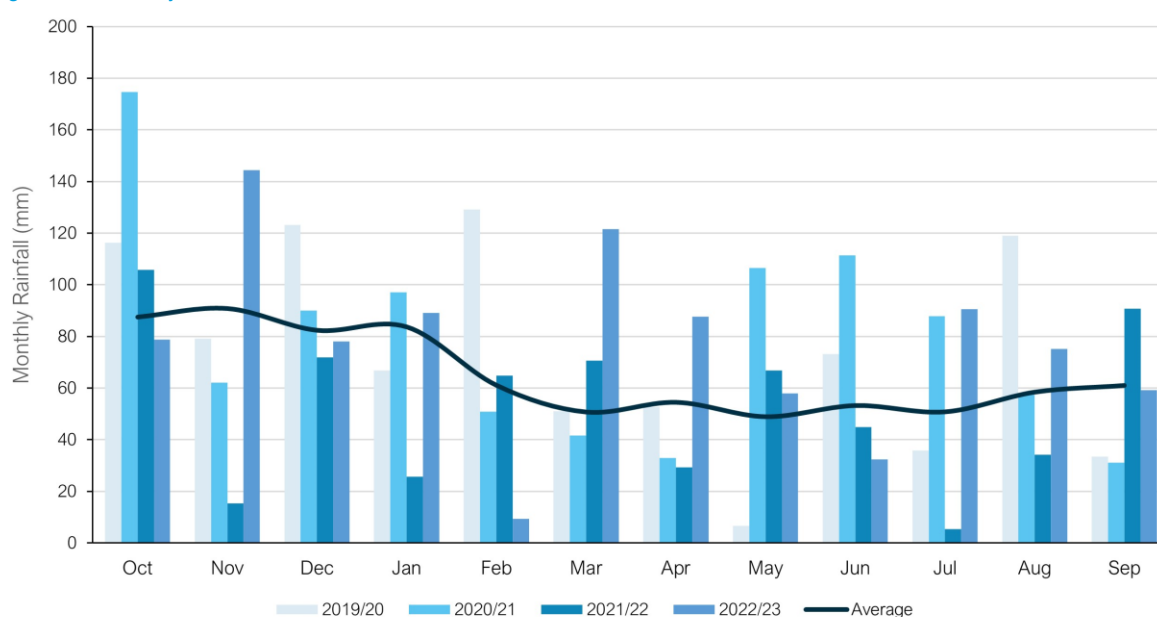
Figure 2 – Monthly Rainfall Performance

Representative Radar rainfall has been used to generate monthly data at catchment level for comparison with average data generated by local Met Office Weather Station Records. Figure 2 presents the comparison of this data for the last four hydrological years to support longer term trends within the local system.

Average Values taken from Met Office Weather Station at Odiham based on the period 1991-2020

The total rainfall for the 2022/23 hydrological year is 18% above the annual average total. Total rainfall values are presented in Table 3 below.

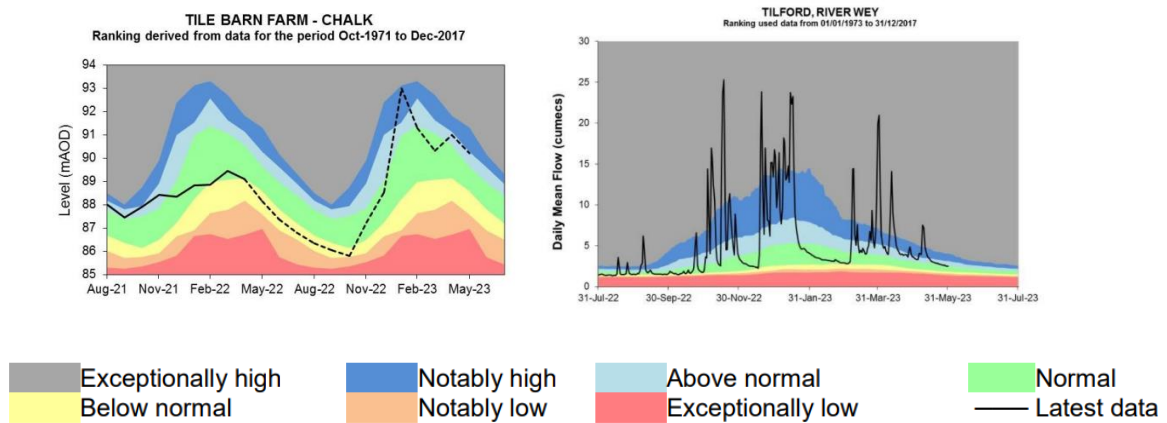
Figure 6 – Water Situation Report

In addition to these specific stations, the wider groundwater context is illustrated in the Water Situation Report for North Downs – Hampshire. The nearest groundwater reference station is Tile Barn Farm. This site shows groundwater levels at normal or below normal in the year 2022. Groundwater levels rise towards the end of 2022 and are observed at normal, above normal, and notably high levels in 2023. This can be seen in the figure below alongside the river indicator Tilford on the River Wey. Note recent groundwater levels at Tile Barn Farm have been estimated based on nearby boreholes due to site monitoring issues.

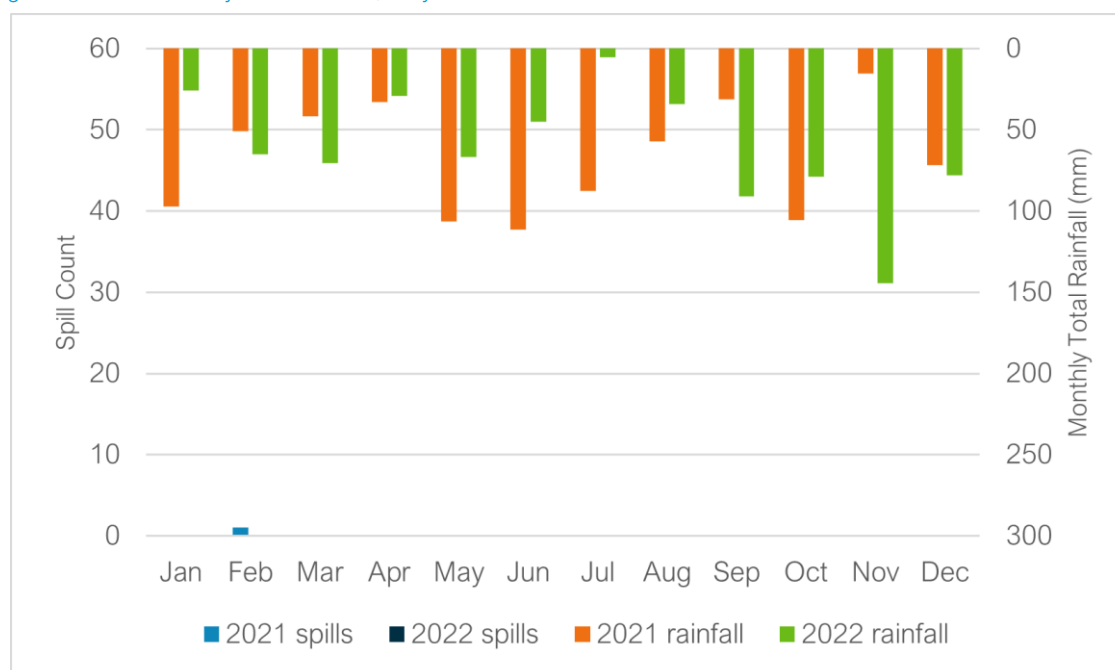
Figure 8 – EDM Monthly Performance, Holybourne SPS

A critical part of the assessment of EDM performance and its relation to groundwater infiltration is to review the month-on-month spill performance, against previous years and the monthly total rainfall values to give context to the performance. Figure 8 below presents the EDM performance trend and rainfall for recent years.

The data suggests a wider relationship between rainfall, elevated groundwater levels and spill frequency. Only one spill was recorded was recorded at Holybourne SPS across the two years, in February 2021, when the indicator site data shown in Figure 5 suggests groundwater levels in the catchment were particularly elevated, and higher than in the same period in 2022.

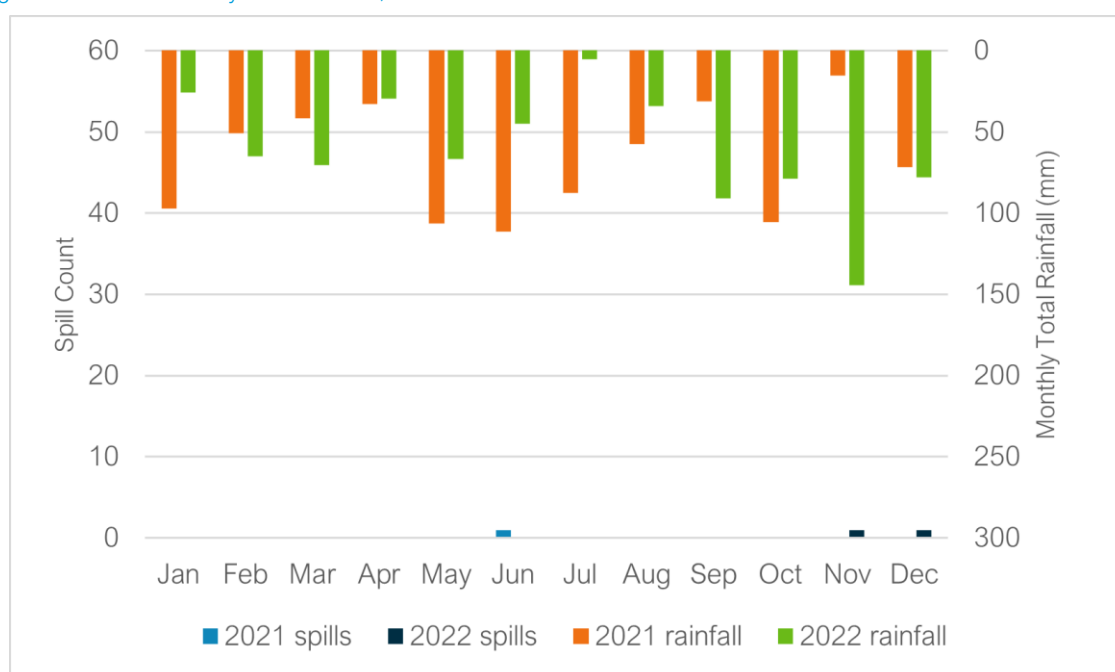
Figure 10 – EDM Monthly Performance, Newmans Lane SPS

A critical part of the assessment of EDM performance and its relation to groundwater infiltration is to review the month-on-month spill performance, against previous years and the monthly total rainfall values to give context to the performance. Figure 10 below presents the EDM performance trend and rainfall for recent years. Note that in 2022, the EDM was only operational for 16% of the year, which may have impacted recorded spill frequency.

Due to the low number of spills recorded at the overflow in 2021 and 2022, the utility of the data to suggest a wider relationship between rainfall, elevated groundwater levels and spill frequency is limited. However, the occurrence of spills outside of periods of significantly elevated groundwater levels, as suggested by the indicator site data shown in Figure 5, does indicate some spills at the site occurring as a direct response to intense rainfall events, outside of periods of significantly elevated groundwater levels.
