# Groundwater Impacted System Management Plan

Alton, Caker Stream

November 2021

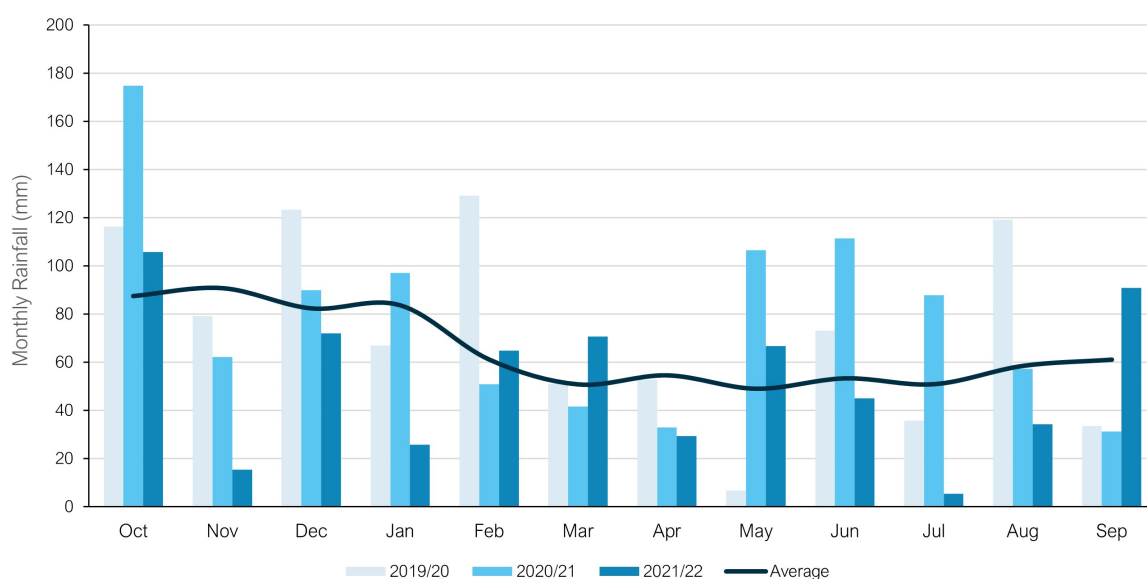
Figure 2 – Monthly Rainfall Performance

Representative Radar rainfall has been used to generate monthly data at catchment level for comparison with average data generated by local Met Office Weather Station Records. Figure 2 presents the comparison of this data for the last three hydrological years to support longer term trends within the local system.

Average Values taken from Met Office Weather Station at Odiham based on the period 1991-2020

The total rainfall for the 2021/22 hydrological year is 20% below the annual average total. Total rainfall values are presented in Table 3 below.

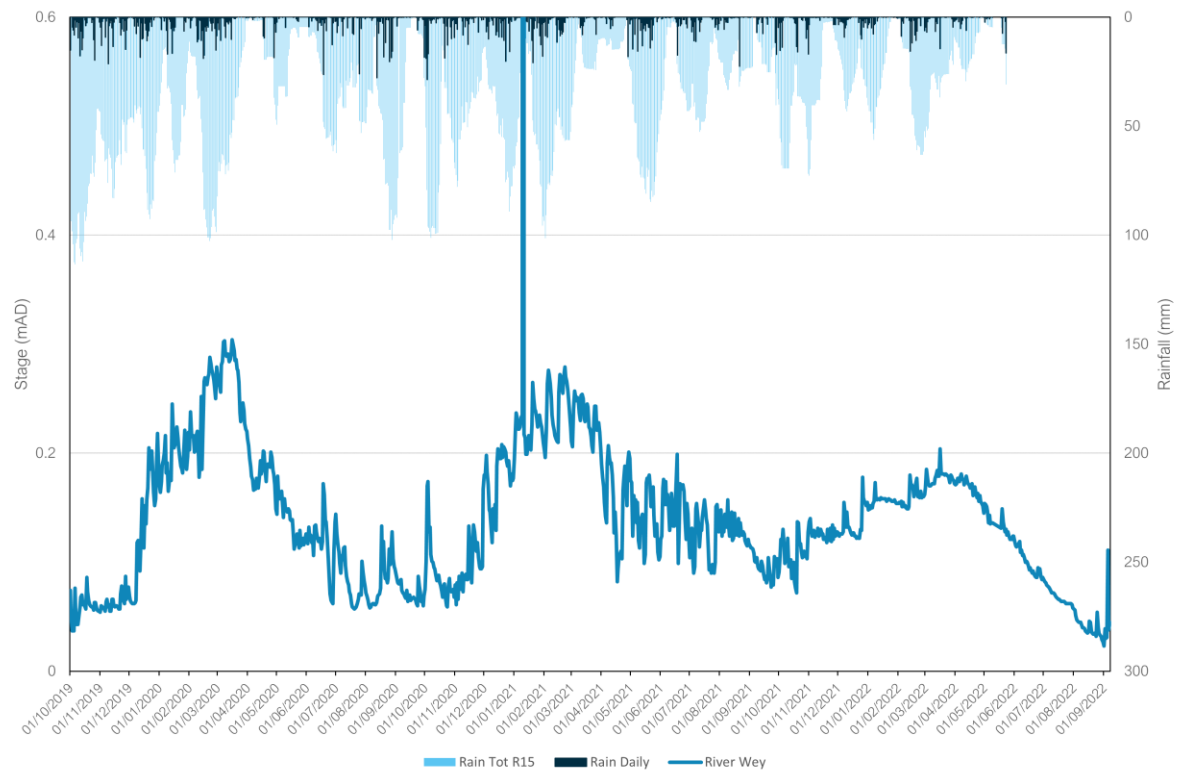
Figure 5A – River Wey, Kings Pond

The following figures represent the last three hydrological years of level information at the indicator sites to build a picture of the relative conditions prevalent in the current year. It is presented against both the daily total rainfall values for the catchment and a rolling 15 day total rainfall.

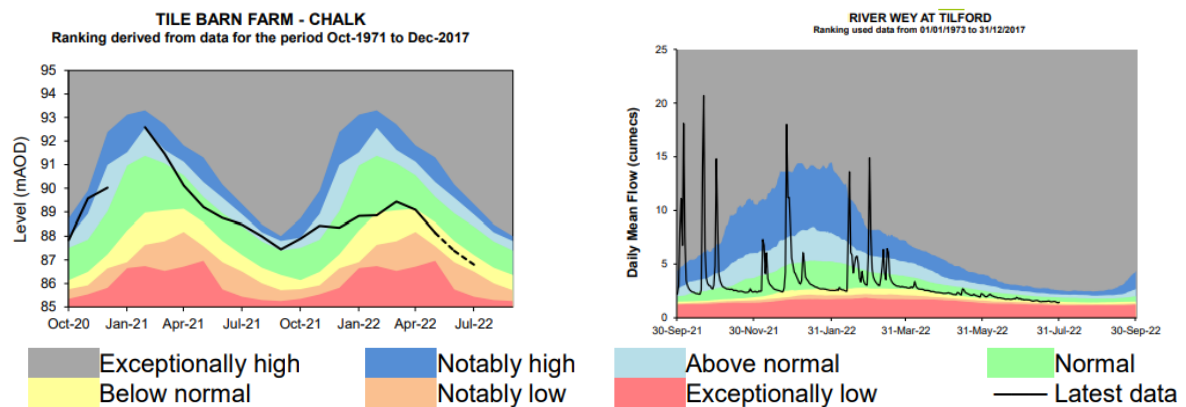
Figure 6 – Water Situation Report

In addition to these specific stations, the wider groundwater context is illustrated in the Water Situation Report for North Downs – Hampshire. The nearest groundwater reference station is Tile Barn Farm. This site shows significantly lower overall groundwater than the previous year. This can be seen in the figure below alongside the river indicator Tilford on the River Wey. Note recent groundwater levels at Tile Barn Farm have been estimated based on nearby boreholes due to site monitoring issues.

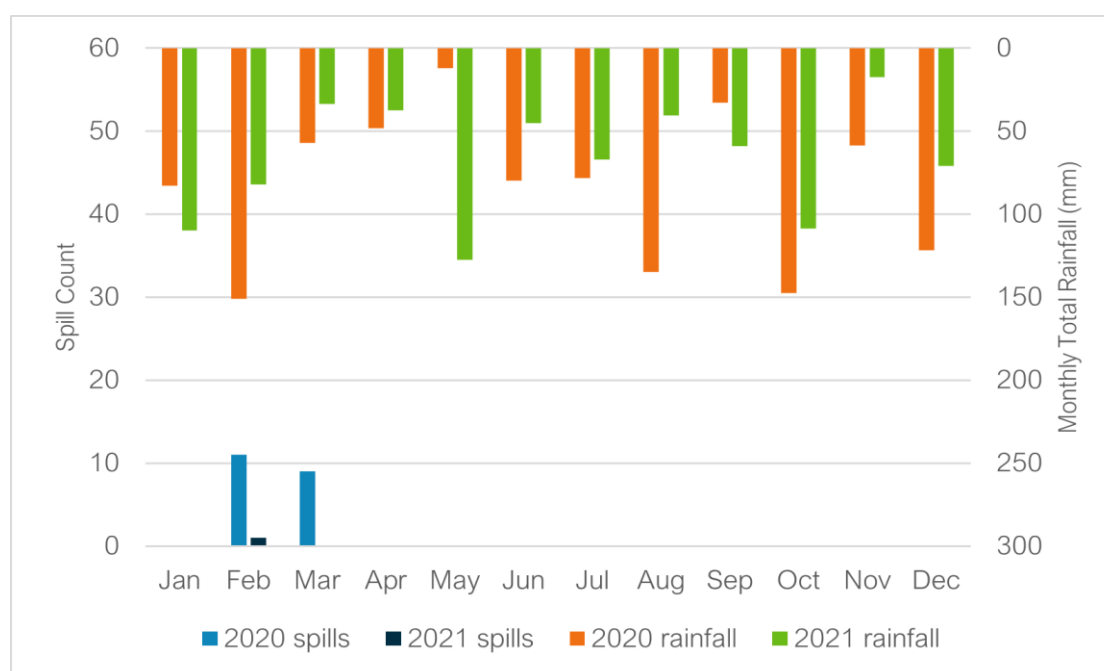
Figure 8 – EDM Monthly Performance, Holybourne SPS

A critical part of the assessment of EDM performance and its relation to groundwater inundation is to review the month-on-month spill performance, against previous years and the monthly total rainfall values to give context to the performance. Figure 8 below presents the EDM performance trend and rainfall for recent years.

The data suggests a wider relationship between rainfall, elevated groundwater levels and spill frequency. There is a focus on spills in February and March 2020, when the indicator sites shown in Figure 5 suggest groundwater levels in the catchment were particularly elevated. Despite significantly lower rainfall in March 2020 compared to February 2020, the spill count for March is equal to February, indicative of the role of groundwater infiltration as the indicator sites shown in Figure 5 suggest groundwater levels in the catchment remained high through most of March 2020.

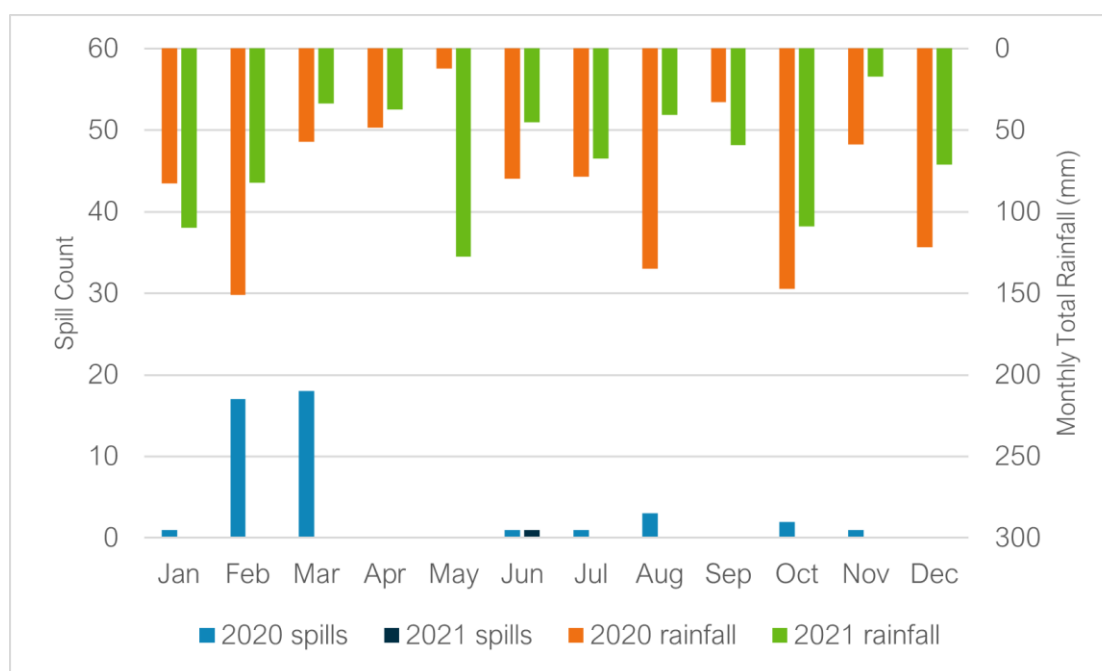
Figure 10 – EDM Monthly Performance, Newmans Lane SPS

A critical part of the assessment of EDM performance and its relation to groundwater inundation is to review the month-on-month spill performance, against previous years and the monthly total rainfall values to give context to the performance. Figure 10 below presents the EDM performance trend and rainfall for recent years.

As per the data for overflow 'Holybourne SPS', presented in Figure 8, the data suggests a wider relationship between rainfall, elevated groundwater levels and spill frequency. The trend in spill performance is similar to that shown for 'Holybourne SPS', with a focus on spills in February and March 2020, when the indicator sites shown in Figure 5 suggest groundwater levels in the catchment were particularly elevated. Despite significantly lower rainfall in March 2020 compared to February 2020, the spill count for March is higher than for February, indicative of the role of groundwater infiltration as the indicator sites shown in Figure 5 suggest groundwater levels in the catchment remained high through most of March 2020.

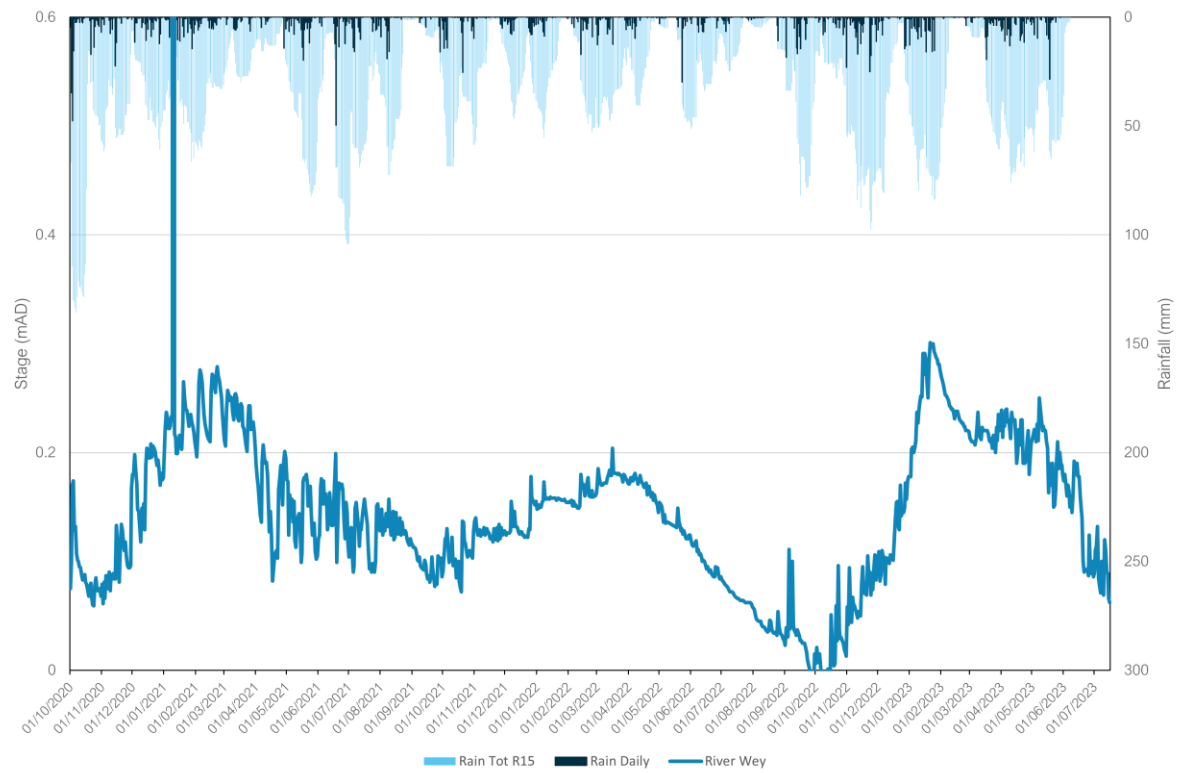
Figure 5A – River Wey, Kings Pond

The following figures represent the last three hydrological years of level information at the indicator sites to build a picture of the relative conditions prevalent in the current year. It is presented against both the daily total rainfall values for the catchment and a rolling 15 day total rainfall.
