Groundwater Impacted System Management Plan

Benson, River Thames

July 2021

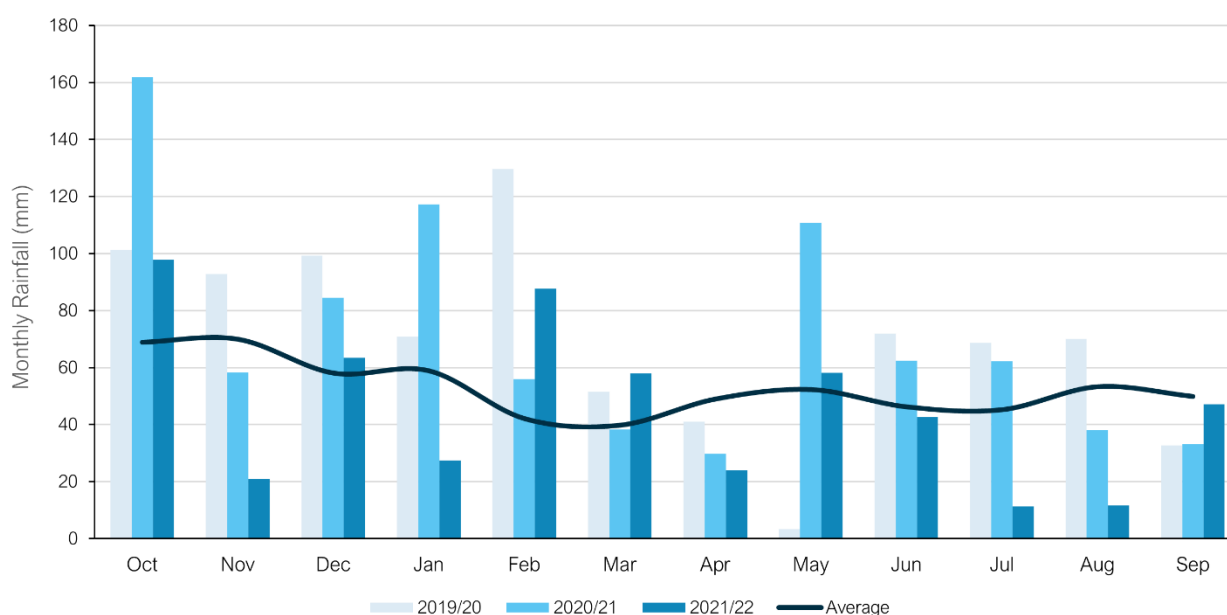
Figure 2 – Monthly Rainfall Performance

Representative Radar rainfall has been used to generate monthly data at catchment level for comparison with average data generated by local Met Office Weather Station Records. Figure 2 presents the comparison of this data for the last three hydrological years to support longer term trends within the local system.

Average Values taken from Met Office Weather Station at Benson based on the period 1991-2020

The total rainfall for the 2021/22 hydrological year is 11% below the annual average total. Total rainfall values are presented in Table 3 below.

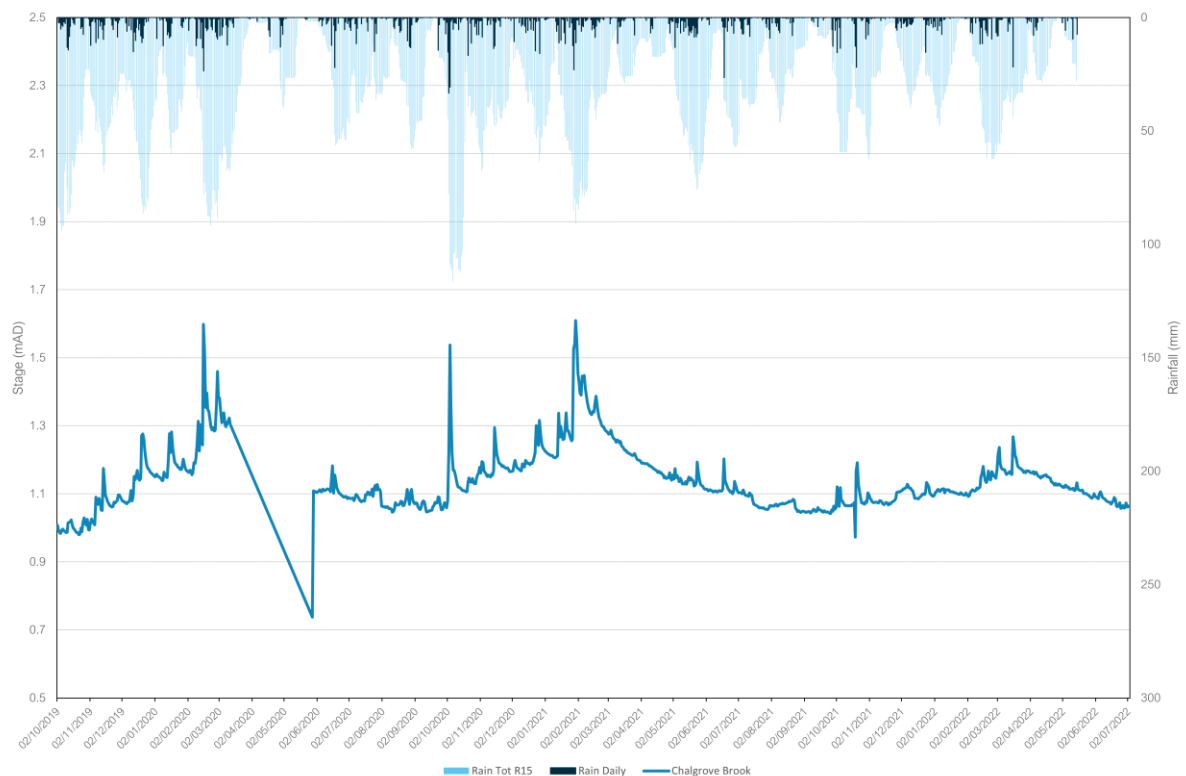
Figure 5A – Chalgrove Brook, Chalgrove

The following figures represent the last three hydrological years of level information at the indicator sites to build a picture of the relative conditions prevalent in the current year. It is presented against both the daily total rainfall values for the catchment and a rolling 15 day total rainfall.

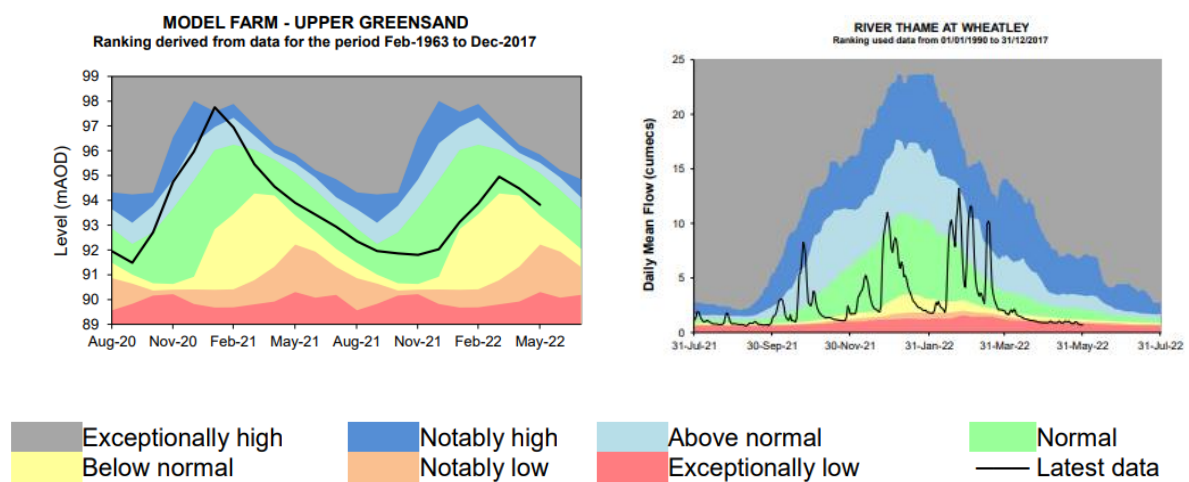
Figure 6 – Water Situation Report

In addition to this specific station, the wider groundwater context is illustrated in the Water Situation Report for the Ock. The nearest groundwater reference station is Model Farm. This site shows significantly lower overall groundwater than the previous year. This can be seen in the figure below alongside the river indicator location at Wheatley on the River Thames.

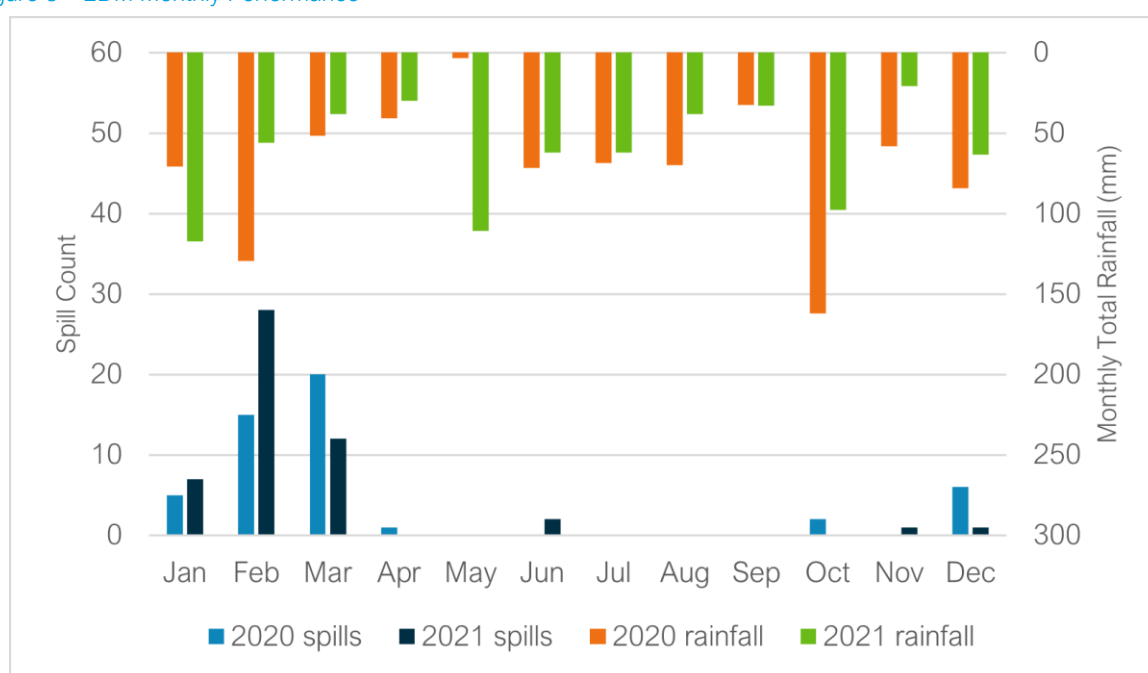
Figure 8 – EDM Monthly Performance

A critical part of the assessment of EDM performance and its relation to groundwater inundation is to review the month-on-month spill performance, against previous years and the monthly total rainfall values to give context to the performance. Figure 8 below presents the EDM performance trend and rainfall for recent years.

The trend in spill performance across the two recorded years does show variation in spills, with a focus on spills during the autumn and winter months. The data suggests a wider relationship between rainfall, elevated groundwater levels and spill frequency, with a slower tail off in spills evident within the first half of 2020, when the Chalgrove Brook indicator site suggests groundwater levels in the catchment were higher than within the first half of 2021. The higher spill frequency in December 2020, which had broadly similar rainfall to December 2021, is also indicative of the role of elevated groundwater levels, as the indicator sites suggest groundwater levels were higher in December 2020.

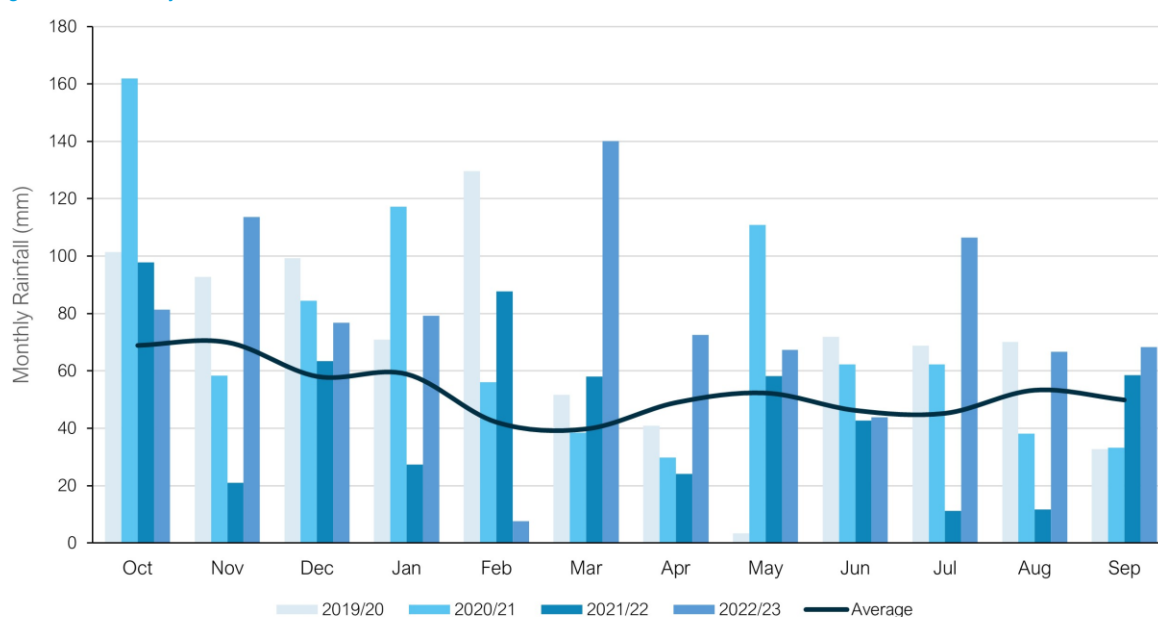
Figure 2 – Monthly Rainfall Performance

Representative Radar rainfall has been used to generate monthly data at catchment level for comparison with average data generated by local Met Office Weather Station Records. Figure 2 presents the comparison of this data for the last four hydrological years to support longer term trends within the local system.

Average Values taken from Met Office Weather Station at Benson based on the period 1991-2020

The total rainfall for the 2022/23 hydrological year is 46% above the annual average total. Total rainfall values are presented in Table 3 below.

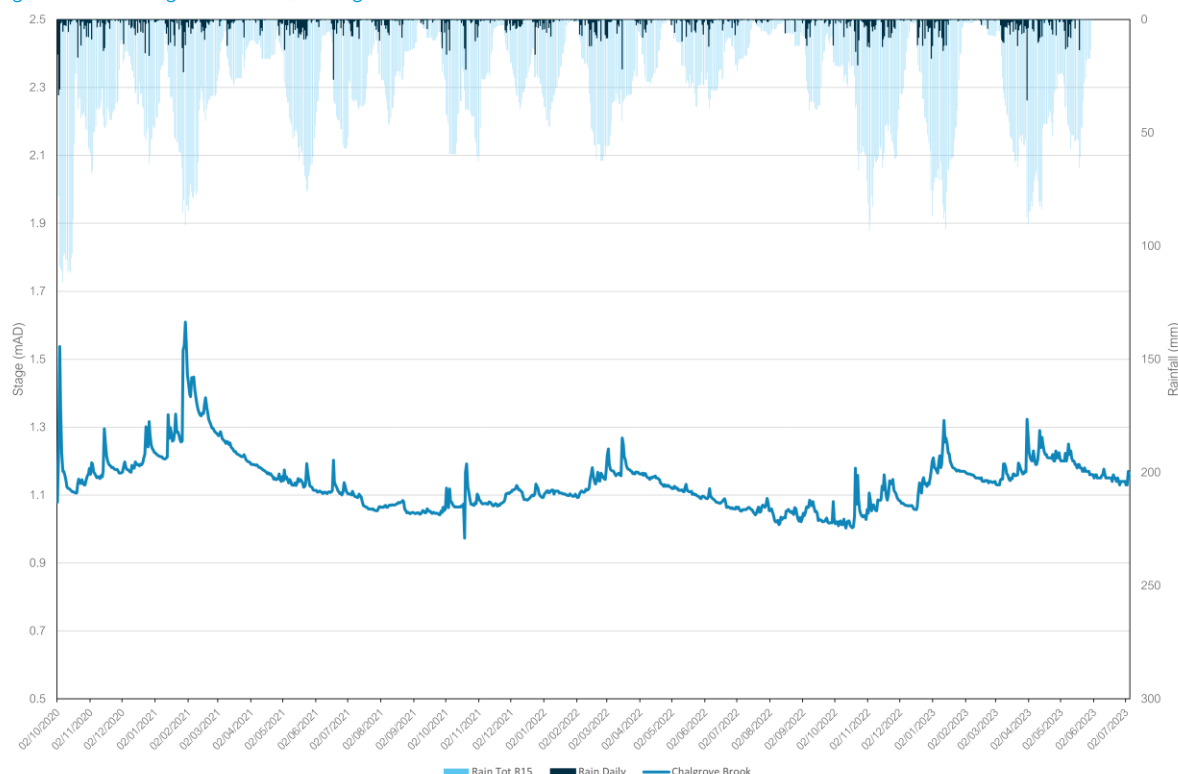
Figure 5A – Chalgrove Brook, Chalgrove

The following figures represent the last three hydrological years of level information at the indicator sites to build a picture of the relative conditions prevalent in the current year. It is presented against both the daily total rainfall values for the catchment and a rolling 15 day total rainfall.

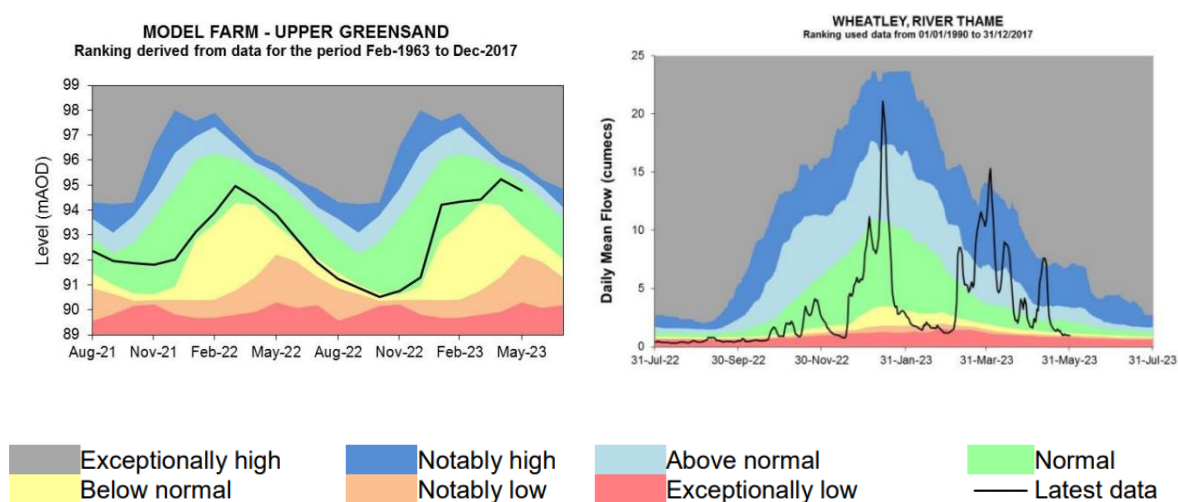
Figure 6 – Water Situation Report

In addition to this specific station, the wider groundwater context is illustrated in the Water Situation Report for the Ock. The nearest groundwater reference station is Model Farm. This site shows groundwater levels were mainly in the normal range during 2022, with periods when groundwater levels were below normal. Groundwater levels are observed at normal level during 2023. This can be seen in the figure below alongside the river indicator location at Wheatley on the River Thames.

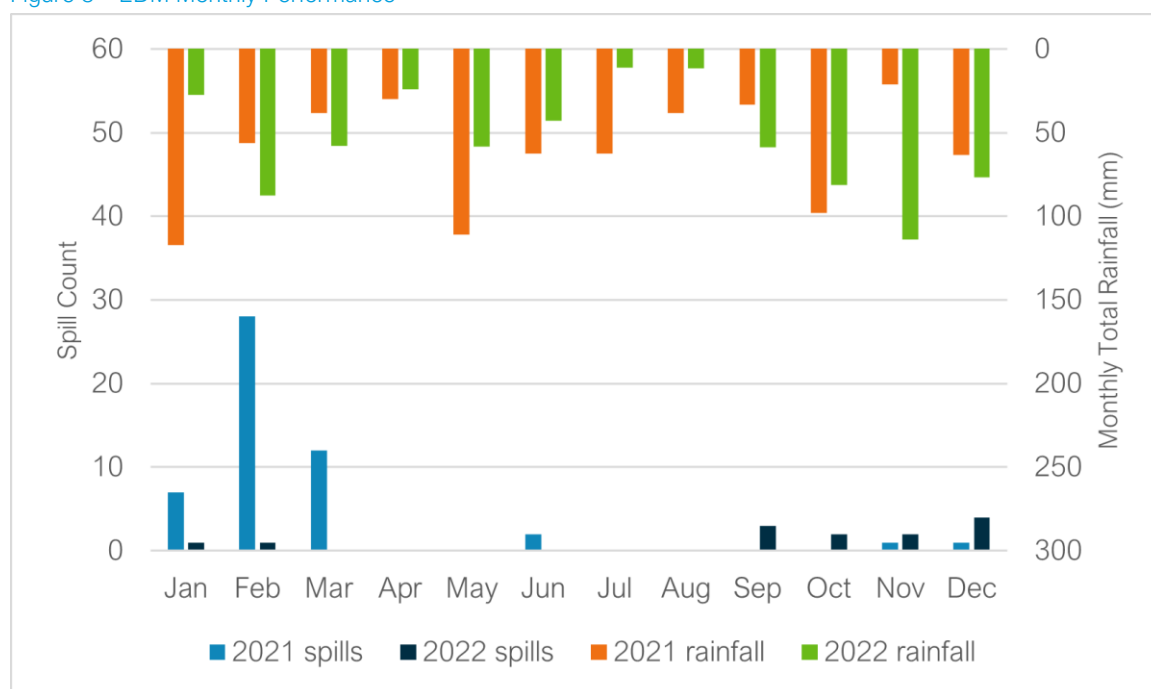
Figure 8 – EDM Monthly Performance

A critical part of the assessment of EDM performance and its relation to groundwater infiltration is to review the month-on-month spill performance, against previous years and the monthly total rainfall values to give context to the performance. Figure 8 below presents the EDM performance trend and rainfall for recent years.

The trend in spill performance across the two recorded years does show variation in spills, with a focus on spills during the winter months. The data suggests a wider relationship between rainfall, elevated groundwater levels and spill frequency. Despite a higher rainfall total in February 2022 compared to February 2021, only one spill was recorded at Benson STW in February 2022, compared to twenty-eight in February 2021. The Chalgrove Brook indicator site shown in Figure 5, suggests groundwater levels in the catchment were higher in February 2021 compared to February 2022. A similar comparison can be made between March 2022 and March 2021.

Indicator site data suggests groundwater levels in the Benson catchment were generally lower in 2022 than in 2021, with trends in the EDM data indicative of the role of groundwater infiltration on spills in the catchment. This hydrological year, indicator site data suggests groundwater levels in the catchment have been within the normal range. The EDM data for 2023 will be analysed once available to continue to examine the relationship between groundwater levels and overflow spills.
