Groundwater Impacted System Management Plan

Bentley, River Wey

April 2021

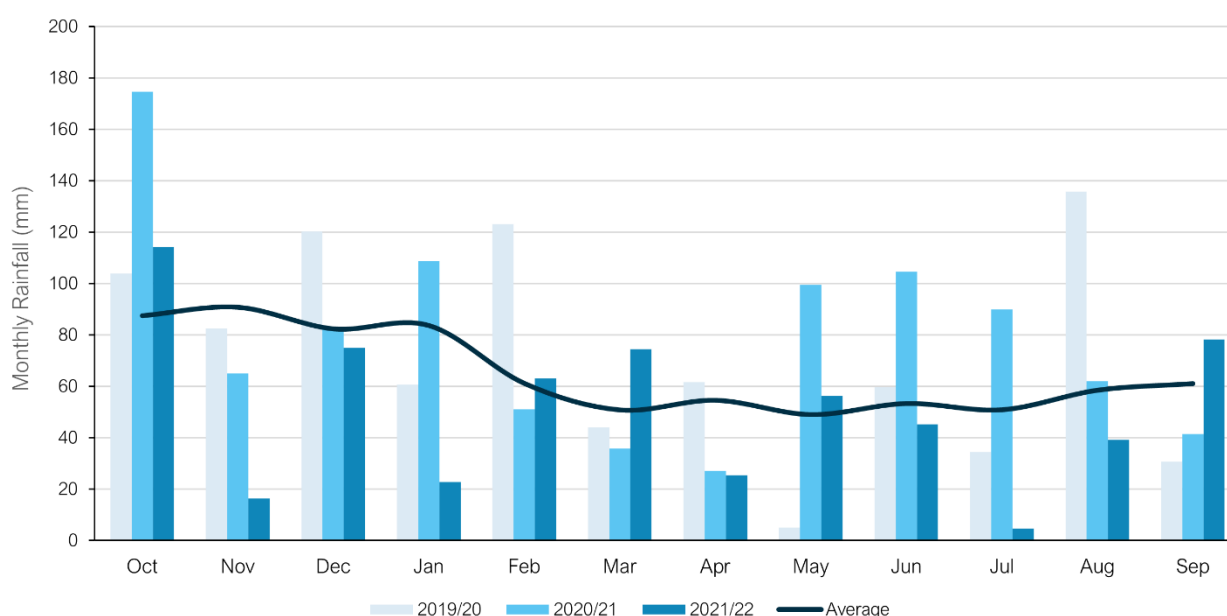
Figure 2 – Monthly Rainfall Performance

Representative Radar rainfall has been used to generate monthly data at catchment level for comparison with average data generated by local Met Office Weather Station Records. Figure 2 presents the comparison of this data for the last three hydrological years to support longer term trends within the local system.

Average Values taken from Met Office Weather Station at Odiham based on the period 1991-2020

The total rainfall for the 2021/22 hydrological year is 21% below the annual average total. Total rainfall values are presented in Table 3 below.

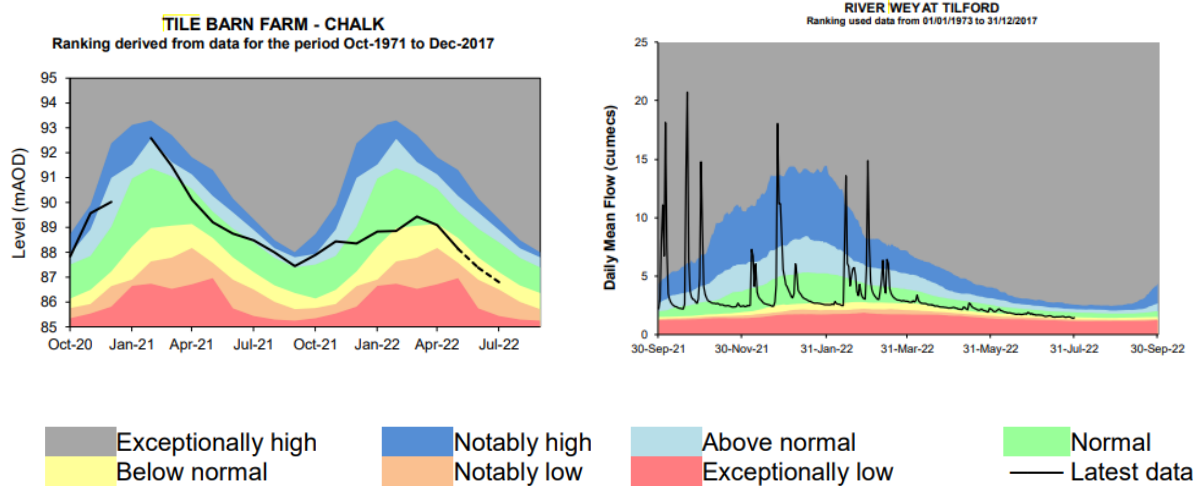
Figure 6 – Water Situation Report

In addition to this specific station, the wider groundwater context is illustrated in the Water Situation Report for Wey - Greensand. The nearest groundwater reference station is Tile Barn Farm. This site shows significantly lower overall groundwater than the previous year. This can be seen in the figure below alongside the river indicator location at Tilford on the River Wey. Note recent groundwater levels at Tile Barn farm have been estimated based on nearby boreholes due to site issues.

Extract from - [Water Situation Report \(publishing.service.gov.uk\)](https://publishing.service.gov.uk)

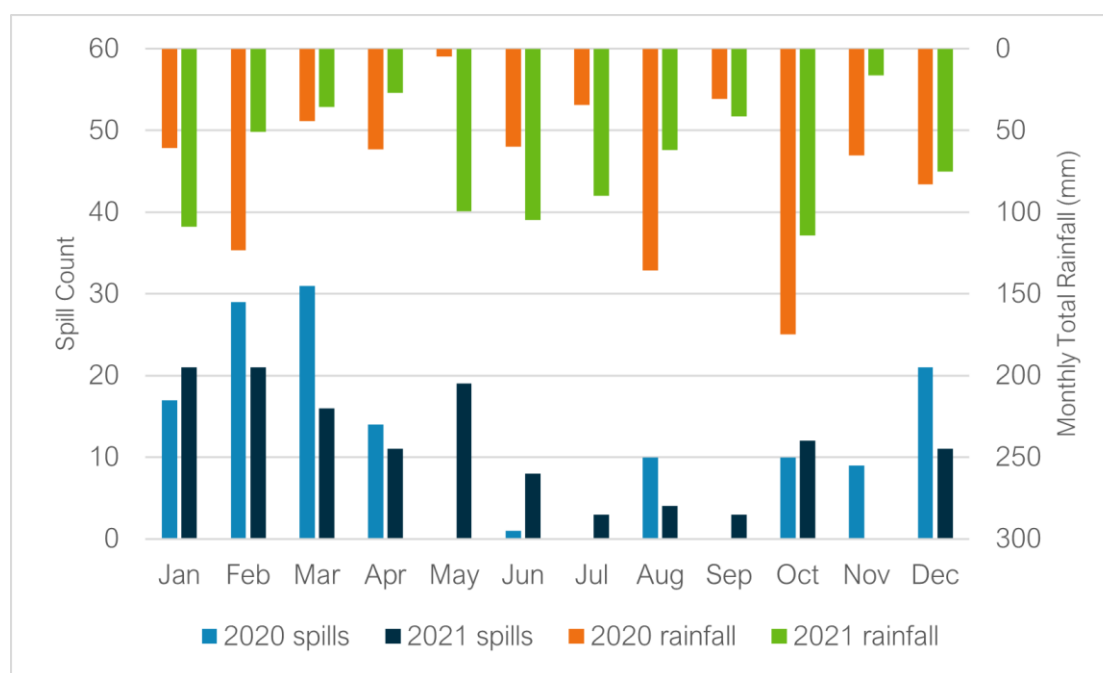
Figure 8 – EDM Monthly Performance

A critical part of the assessment of EDM performance and its relation to groundwater inundation is to review the month-on-month spill performance, against previous years and the monthly total rainfall values to give context to the performance. Figure 8 below presents the EDM performance trend and rainfall for recent years.

The trend in spill performance across the two recorded years does show variation in spills, with a focus on spills during the autumn and winter months. The data suggests a wider relationship between rainfall, elevated groundwater levels and spill frequency, particularly evident at the start of the hydrological years (October – December). Despite broadly similar rainfall, significantly more spills were recorded at Bentley STW in December 2020 compared to December 2021. The indicator sites suggest groundwater levels in the catchment were higher in December 2020. A slower tail off in spills is also evident within the first three months of 2020 when the indicator sites shown in Figure 5 suggest groundwater levels in the catchment were higher.

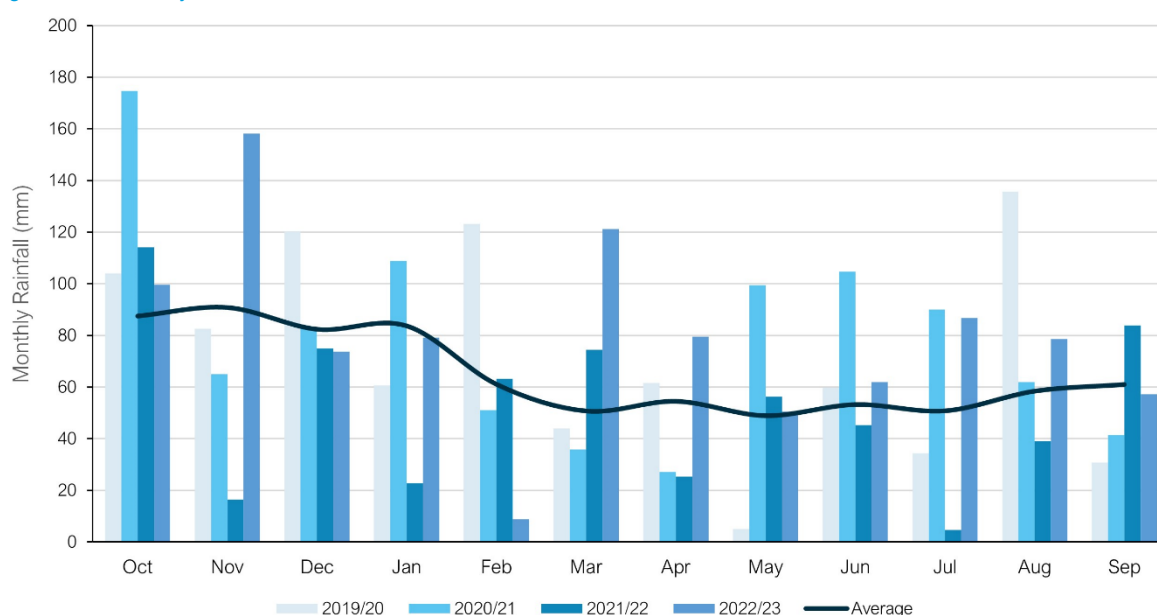
Figure 2 – Monthly Rainfall Performance

Representative Radar rainfall has been used to generate monthly data at catchment level for comparison with average data generated by local Met Office Weather Station Records. Figure 2 presents the comparison of this data for the last four hydrological years to support longer term trends within the local system.

Average Values taken from Met Office Weather Station at Odiham based on the period 1991-2020

The total rainfall for the 2022/23 hydrological year is 22% above the annual average total. Total rainfall values are presented in Table 3 below.

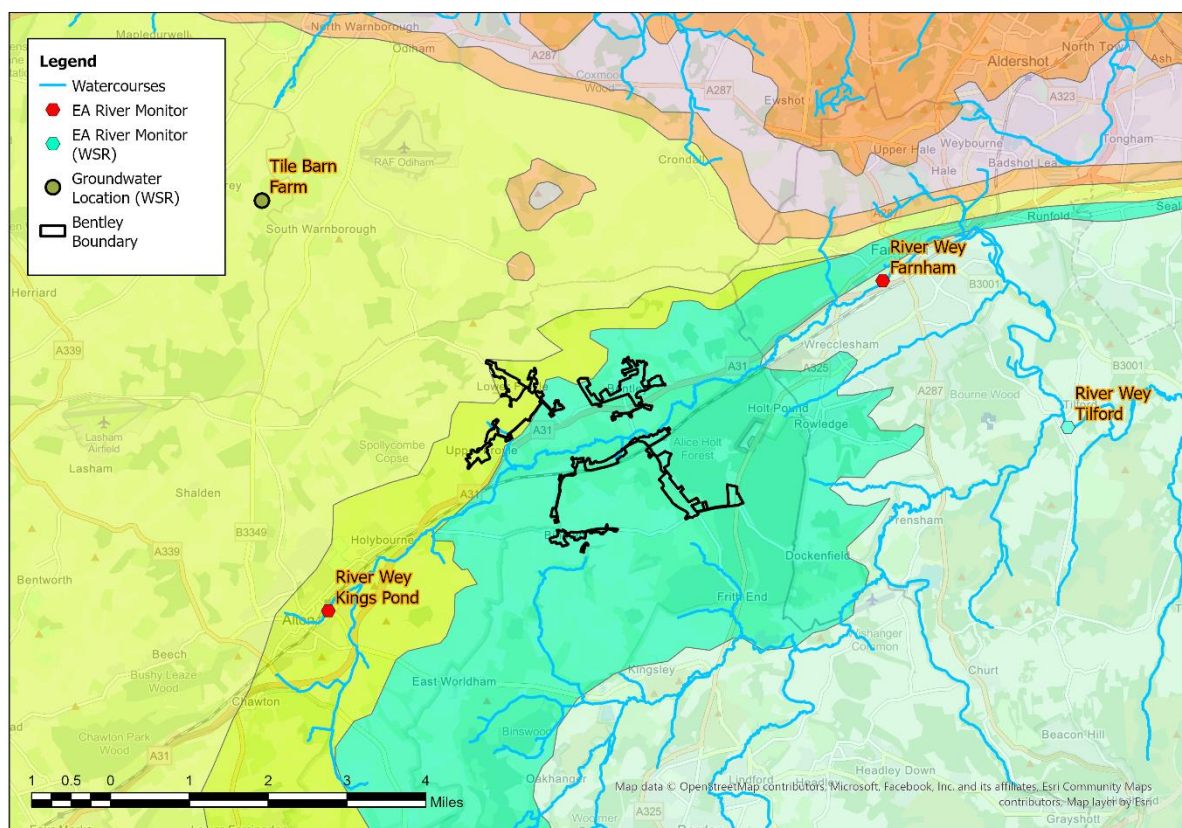
Figure 4 – Local Monitoring Stations

These sites are illustrated in the figure below, alongside the closest groundwater reference station and closest gauging station from the Water Situation Report.

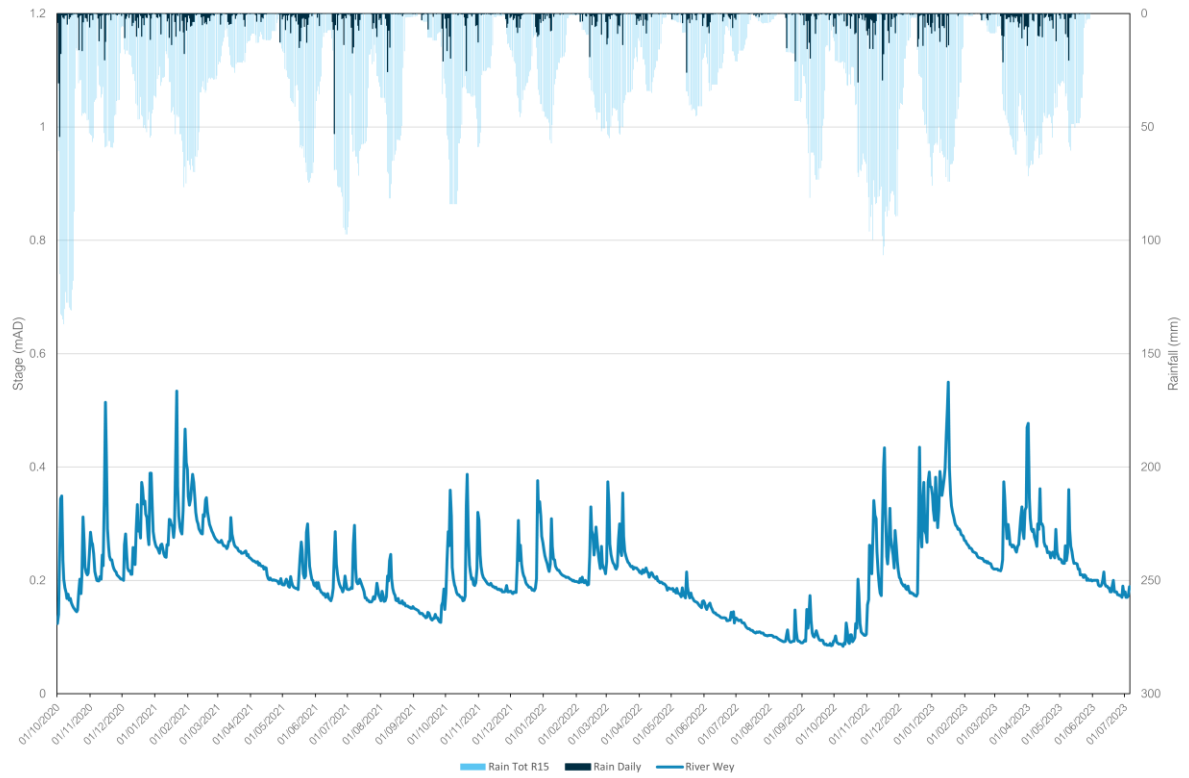
Figure 5A – River Wey, Farnham

The following figures represent the last three hydrological years of level information at the indicator sites to build a picture of the relative conditions prevalent in the current year. It is presented against both the daily total rainfall values for the catchment and a rolling 15 day total rainfall.

Indicator site data suggests groundwater levels in the Bentley catchment were at or below normal levels during 2022, and generally lower than in 2021, with trends in the EDM data indicative of the role of groundwater infiltration on spills in the catchment. This hydrological year (October 2022 – September 2023), groundwater levels in the catchment have generally been higher than the previous hydrological year, and EDM data for 2023 will be analysed once available to continue to examine the relationship between groundwater levels and overflow spills.

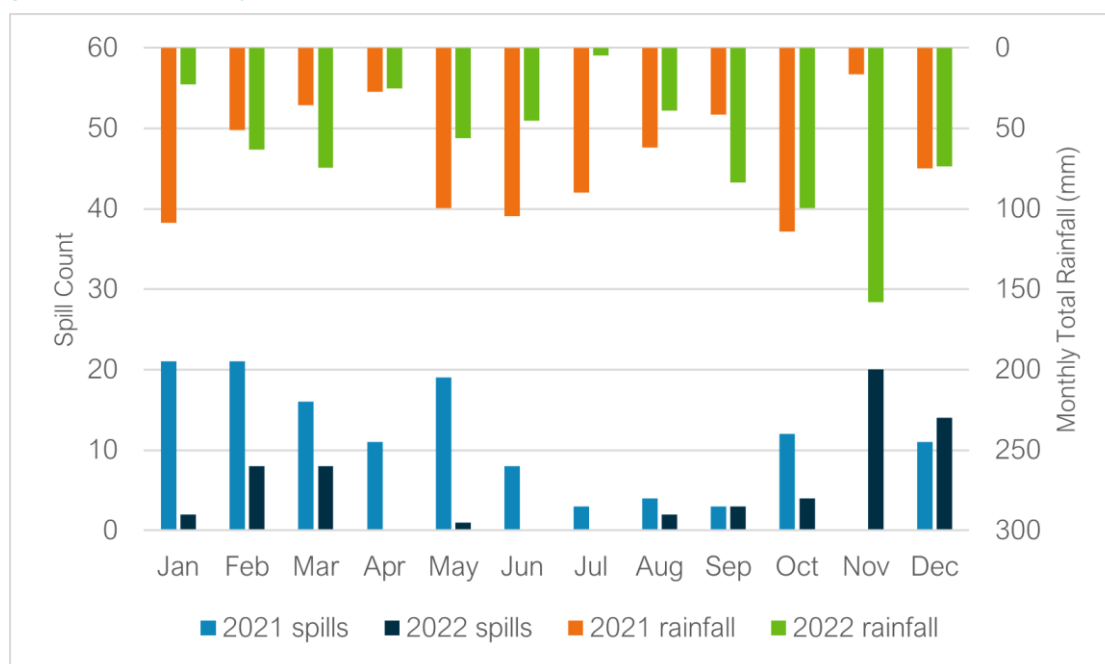
Figure 8 – EDM Monthly Performance

A critical part of the assessment of EDM performance and its relation to groundwater infiltration is to review the month-on-month spill performance, against previous years and the monthly total rainfall values to give context to the performance. Figure 8 below presents the EDM performance trend and rainfall for recent years.

The trend in spill performance across the two recorded years does show variation in spills, with an overall focus on spills during the autumn and winter months. The data suggests a wider relationship between rainfall, elevated groundwater levels and spill frequency. Despite broadly similar rainfall totals, significantly more spills were recorded at Bentley STW in February 2021 compared to February 2022. The indicator site graphs shown in Figure 5, suggest groundwater levels in the catchment were higher in February 2021. Similarly, in March 2022, a higher rainfall total was recorded for the catchment compared to March 2021, however significantly more spills were recorded in March 2021, with the indicator site data suggesting higher groundwater levels in March 2021. The significant number of spills recorded during the spring and summer months, is also indicative of spills occurring as a direct response to rainfall in the catchment, outside of periods of elevated groundwater levels.

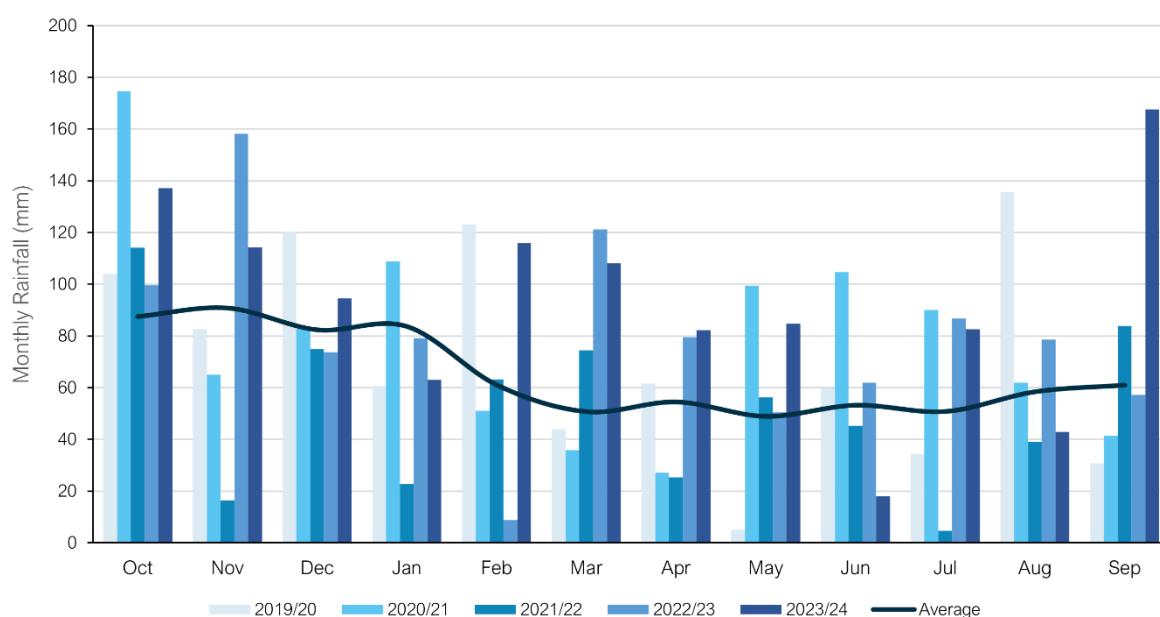
Figure 2 – Monthly Rainfall Data

Representative Radar rainfall has been used to generate monthly data at catchment level for comparison with average data generated by local Met Office Weather Station Records. Figure 2 presents the comparison of this data for the last five hydrological years to support longer term trends within the local system.

Average Values taken from Met Office Weather Station at Odiham based on the period 1991-2020

The total rainfall for the 2023/24 hydrological year is 42% above the annual average total. Total rainfall values are presented in Table 3 below.

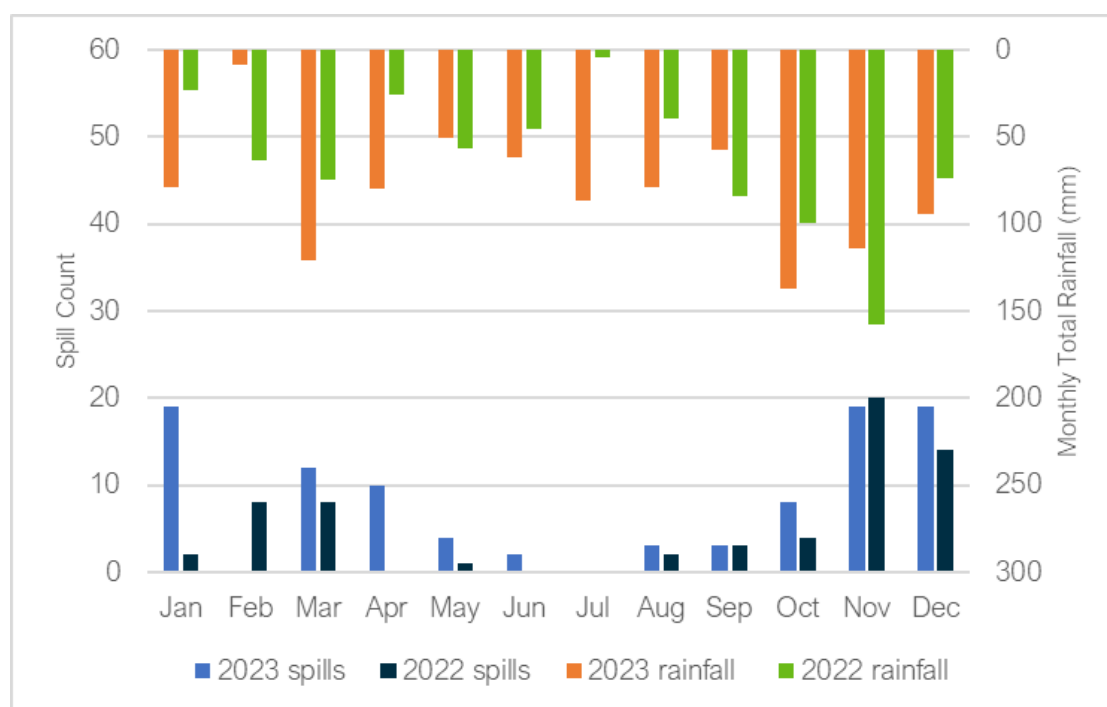
Figure 8 – EDM Monthly Performance

A critical part of the assessment of EDM performance and its relation to groundwater infiltration is to review the month-on-month spill performance, against previous years and the monthly total rainfall values to give context to the performance. Figure 8 below presents the EDM performance trend and rainfall for recent years.

The trend in spill performance across the two recorded years does show variation in spills. The data suggests a wider relationship between rainfall, elevated groundwater levels and spill frequency. For example, despite significantly more rainfall in November 2022, similar spills were recorded in both years. Indicator sites suggest groundwater levels to be higher at this time in 2023 (see Figures 5 and 6). Similarly, a high number of spills were recorded in January and April 2023, when the indicator site data shown in Figures 5 and 6 suggests that peaks in groundwater levels occurred in the catchment. The EDM data for 2024, once available, will be analysed to further understand the relationship between groundwater levels and overflow spills at Bentley STW.
