Groundwater Impacted System Management Plan

Bentley, River Wey

April 2021

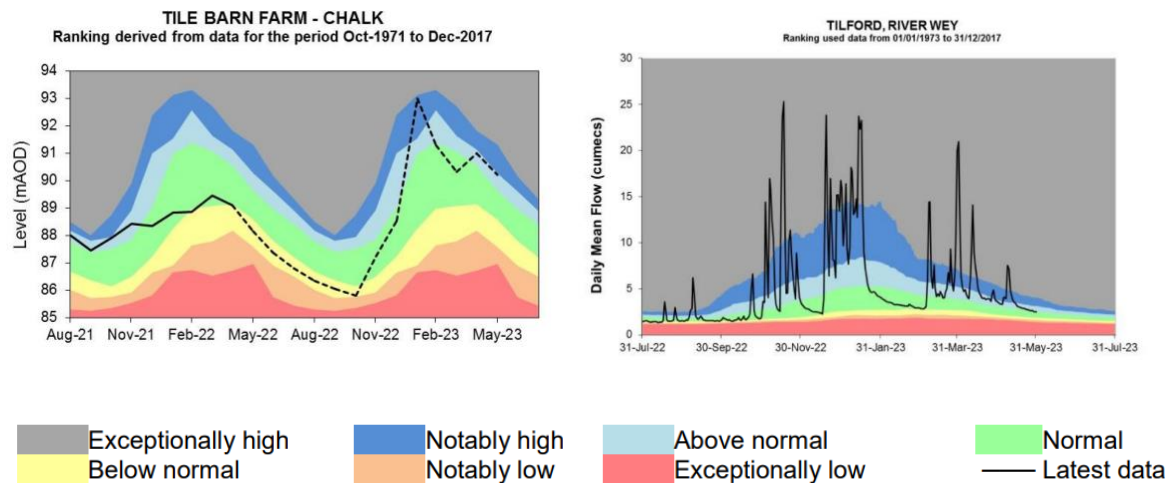
Figure 6 – Water Situation Report

In addition to these specific stations, the wider groundwater context is illustrated in the Water Situation Report for Wey - Greensand. The nearest groundwater reference station is Tile Barn Farm. This site shows groundwater levels to be at normal levels at the start of 2022, dropping to below normal levels for a significant period. Groundwater levels are observed to increase towards the end of 2022 and are at normal, above normal, and notably high levels in 2023. This can be seen in the figure below alongside the river indicator location at Tilford on the River Wey. Note recent groundwater levels at Tile Barn farm have been estimated based on nearby boreholes due to site issues.

Extract from - [Water Situation Report \(publishing.service.gov.uk\)](https://publishing.service.gov.uk)
