# Groundwater Impacted System Management Plan

Berkhamsted, River Bulbourne

January 2021

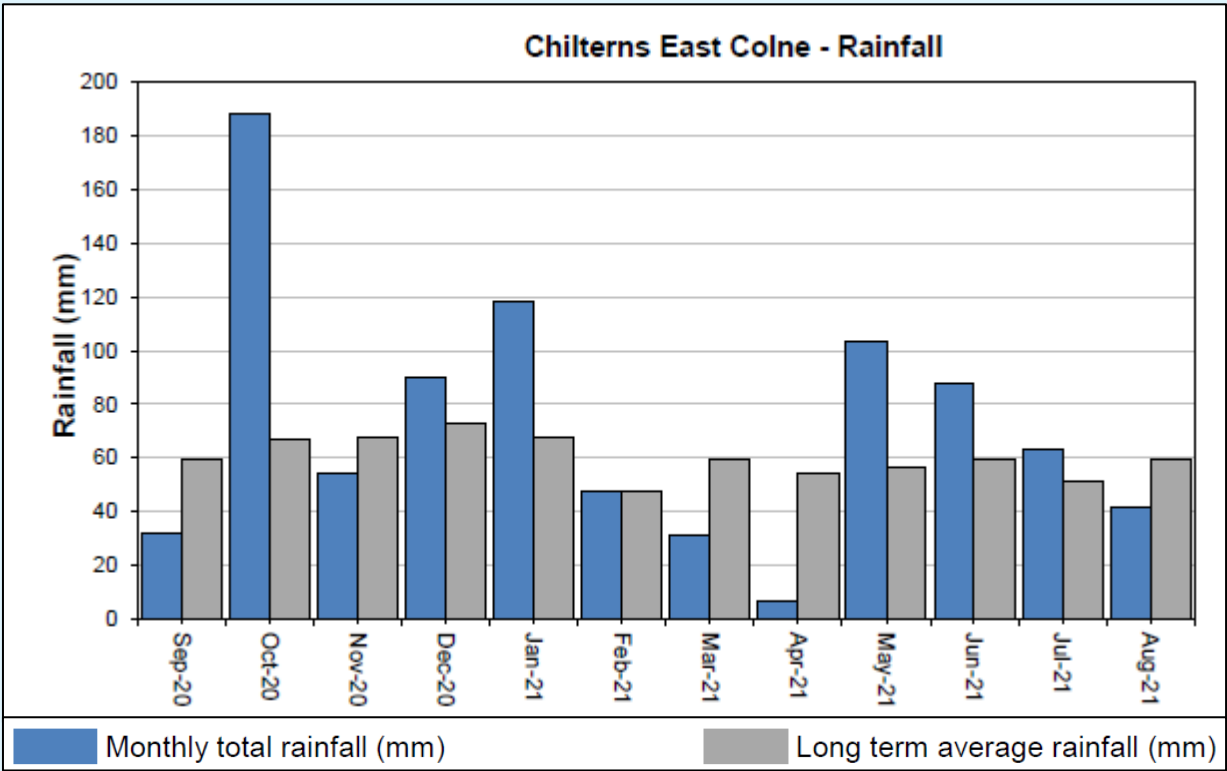
Figure 2 – Monthly rainfall depths local to the system

Berkhamsted is situated in the Chilterns East Colne water resources area. Figure 2 shows the monthly rainfall total depths against the long-term average rainfall in the location of Berkhamsted over the period taken from the *Environment Agency Water Situation Report August 2021*<sup>1</sup>

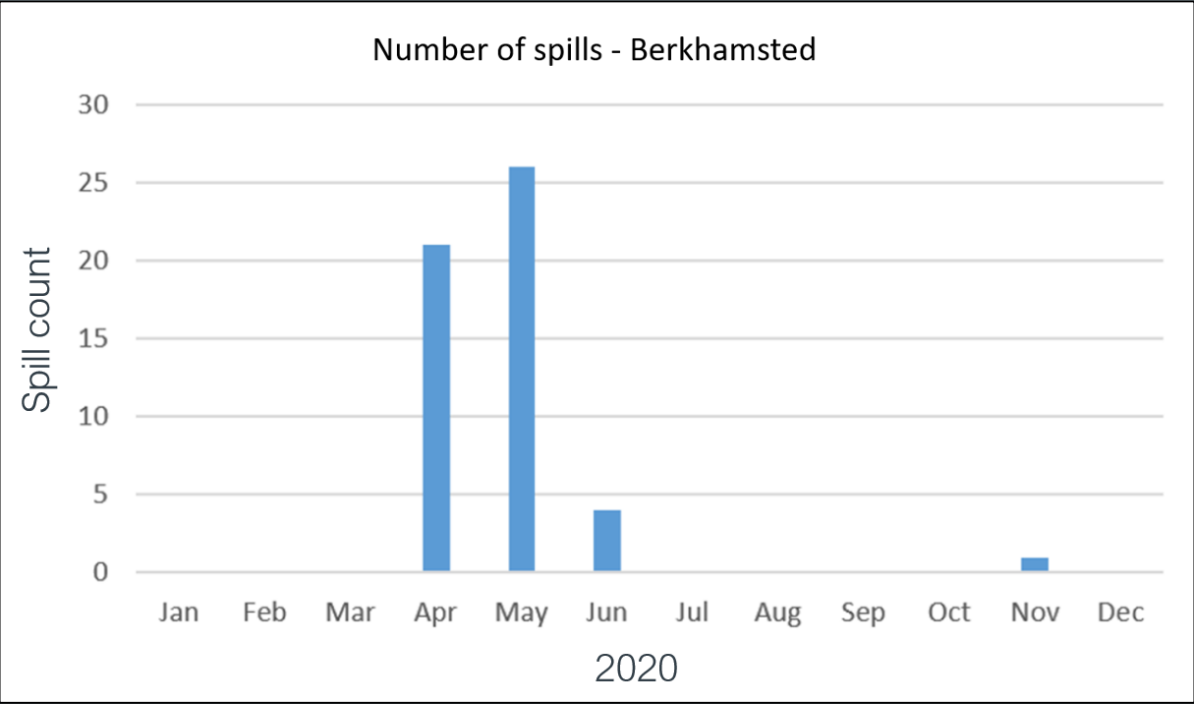
Figure 8 – Number of spills (discharge count) at Berkhamsted STW (taken from Event Duration Monitor (EDM) Data\*).

Figure 8 shows the number spills per month from Berkhamsted Sewage Treatment Works (STW). April and May experienced the greatest number of spills. There is a lag between high rainfall and high flows in the Berkhamsted system that arrive at the STW. We are still investigating this lag between groundwater level and spills, it may be indicative of a combination of surface water and groundwater combining to trigger problems as opposed to one of the other mechanism being more dominant.

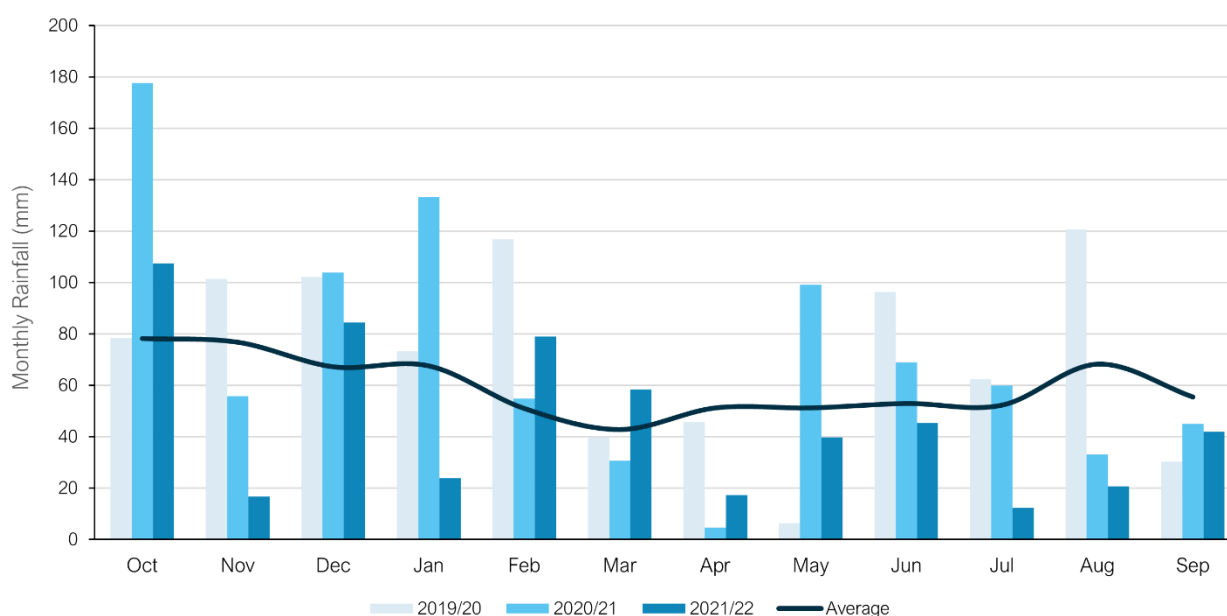
Figure 2 – Monthly Rainfall Performance

Representative Radar rainfall has been used to generate monthly data at catchment level for comparison with average data generated by local Met Office Weather Station Records. Figure 2 presents the comparison of this data for the last three hydrological years to support longer term trends within the local system.

Average Values taken from Met Office Weather Station at Rothamsted based on the period 1991-2020

The total rainfall for the 2021/22 hydrological year is 22% below the annual average total. Total rainfall values are presented in Table 3 below.

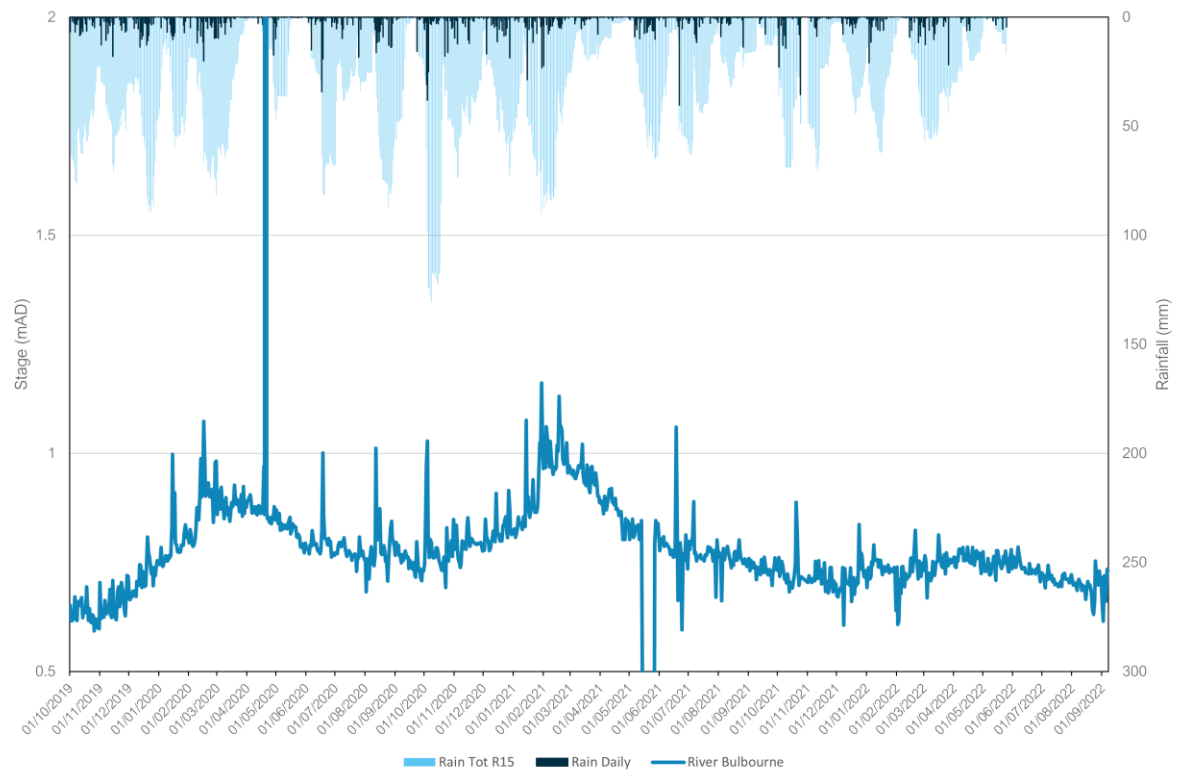
Figure 5A – River Bulbourne, Hemel Hempstead, Old Fishery Lane

The following figures represent the last three hydrological years of level information at the indicator sites to build a picture of the relative conditions prevalent in the current year. It is presented against both the daily total rainfall values for the catchment and a rolling 15 day total rainfall.

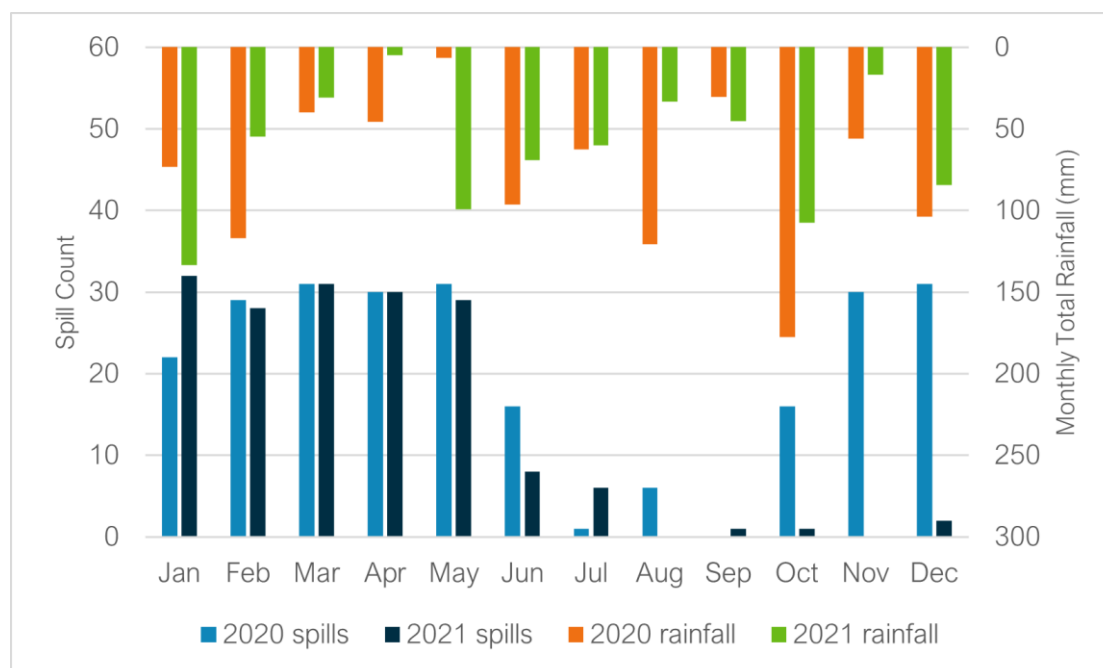
Figure 8 – EDM Monthly Performance

A critical part of the assessment of EDM performance and its relation to groundwater inundation is to review the month-on-month spill performance, against previous years and the monthly total rainfall values to give context to the performance. Note a spill frequency of 243 is stated for 2020, which is higher than the published spill count of 52. The data has been revalidated/ corrected and the revised spill count of 243 will be included in re-submission to the EA. Figure 8 below presents the EDM performance trend and rainfall for recent years.

The data suggests a wider relationship between groundwater/river level, rainfall, and network performance. Despite broadly similar rainfall, significantly more spills were recorded at Berkhamsted STW in December 2020, compared to December 2021. The indicator sites suggest groundwater levels in the catchment were higher in December 2020.

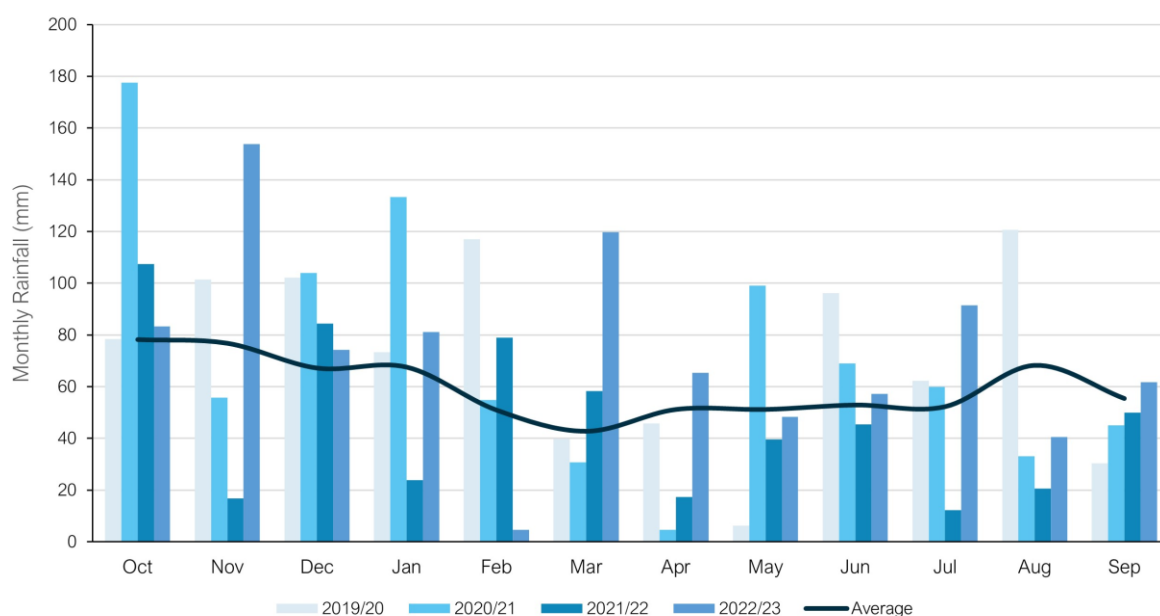
Figure 2 – Monthly Rainfall Performance

Representative Radar rainfall has been used to generate monthly data at catchment level for comparison with average data generated by local Met Office Weather Station Records. Figure 2 presents the comparison of this data for the last four hydrological years to support longer term trends within the local system.

Average Values taken from Met Office Weather Station at Rothamsted based on the period 1991-2020

The total rainfall for the 2022/23 hydrological year is 23% above the annual average total. Total rainfall values are presented in Table 3 below.

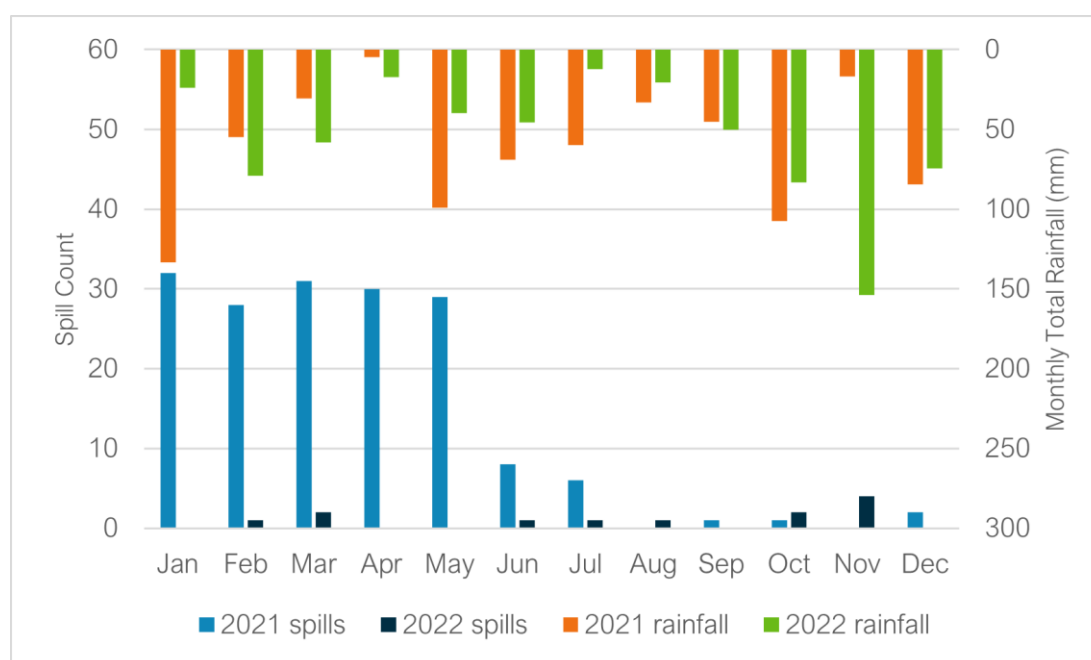
Figure 8 – EDM Monthly Performance

Figure 8 below presents the EDM performance trend and rainfall for recent years.

The data suggests a wider relationship between rainfall, elevated groundwater levels, and spill frequency. Significantly more spills were recorded at Berkhamsted STW between the months of January to June 2021, compared to the same period in 2022. The indicator site data shown in Figure 5, suggests groundwater levels in the catchment were higher January – June 2021, compared to the same period in 2022. Only 12 spills were recorded in the year 2022, compared to 168 in 2021, with Figure 6 suggesting groundwater levels in the catchment were at normal or below normal levels throughout 2022.
