# Groundwater Impacted System Management Plan

Berkhamsted, River Bulbourne

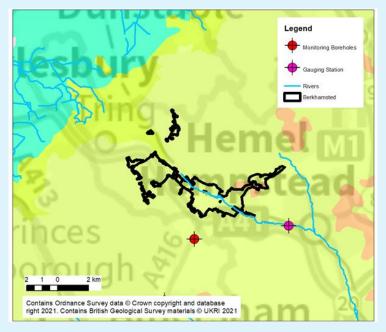
Figure 3 – Location of Ashley Green Monitoring Borehole Relative to Berkhamsted

Figure 3 shows the location of the British Geological Survey (BGS) monitoring borehole at Ashley Green, which has been recording groundwater levels since 1961. Figures 4 and 5 show river levels in the River Bulbourne at Hemel Hempstead (the closest river gauging station to Berkhamsted) which provide a good indicator of the local groundwater levels over time. Figure 6 and 7 show the last two and ten years of groundwater level data overlain on expected ranges. This shows how recent groundwater levels have compared against the expected range, they show that generally over the last two winters groundwater levels have been notably higher, with the peak groundwater levels close to the exceptionally high range.

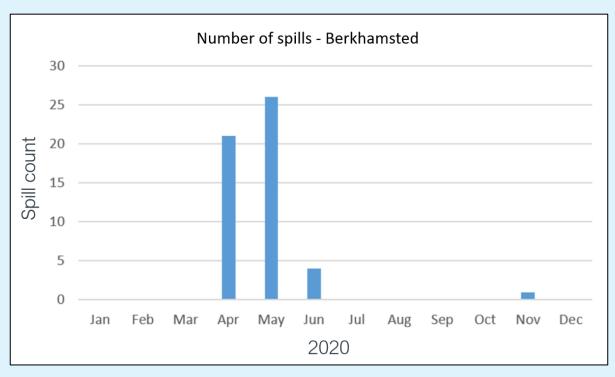
Figure 8 – Number of spills (discharge count) at Berkhamsted STW (taken from Event Duration Monitor (EDM) Data\*).

Figure 8 shows the number spills per month from Berkhamsted Sewage Treatment Works (STW). April and May experienced the greatest number of spills. There is a lag between high rainfall and high flows in the Berkhamsted system that arrive at the STW. We are still investigating this lag between groundwater level and spills, it may be indicative of a combination of surface water and groundwater combining to trigger problems as opposed to one of the other mechanism being more dominant.

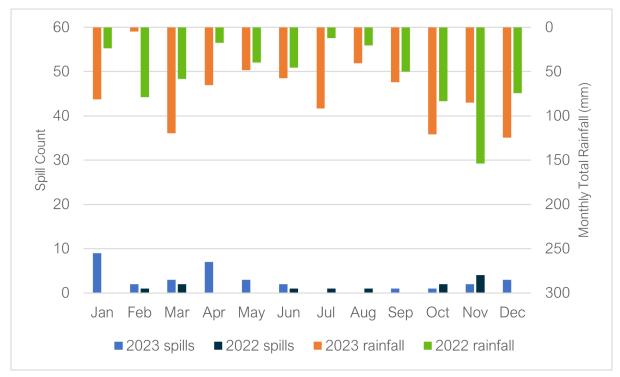
Figure 8 – EDM Monthly Performance 'Berkhamsted STW'

Figure 8 below presents the EDM performance trend and rainfall for recent years.

The data suggests a wider relationship between rainfall, elevated groundwater levels, and spill frequency. Significantly more spills were recorded January – May 2023, compared to the same period in 2022. The indicator site data shown in Figures 5 and 6, suggests that groundwater levels in the catchment were higher over these months in 2023. Furthermore, despite significantly more rainfall in February 2022, more spills were recorded in February 2023 and groundwater levels were higher in this month than in 2022. Spills were recorded across the summer months in both 2022 and 2023, indicating spills occurring in the catchment during prolonged or intense rainfall events, outside of periods of elevated groundwater levels.

Note that an upgrade was completed at Berkhamsted STW in 2023 to provide a major increase in treatment capacity. The number of spills that occurred in December 2023 does appear to be relatively low, considering that the indicator site data shown in Figures 5 and 6 suggests that groundwater levels in the catchment became elevated during this period. Overall, however, limited data is currently available to understand the potential impact of the upgrade on spill frequency at Berkhamsted STW. The EDM data for 2024 will be analysed once available to provide an improved understanding, as the indicator site data shown in Figures 5 and 6, suggests that groundwater levels in the catchment reached high levels during 2024.
