# Groundwater Impacted System Management Plan

Bibury, River Coln

July 2021

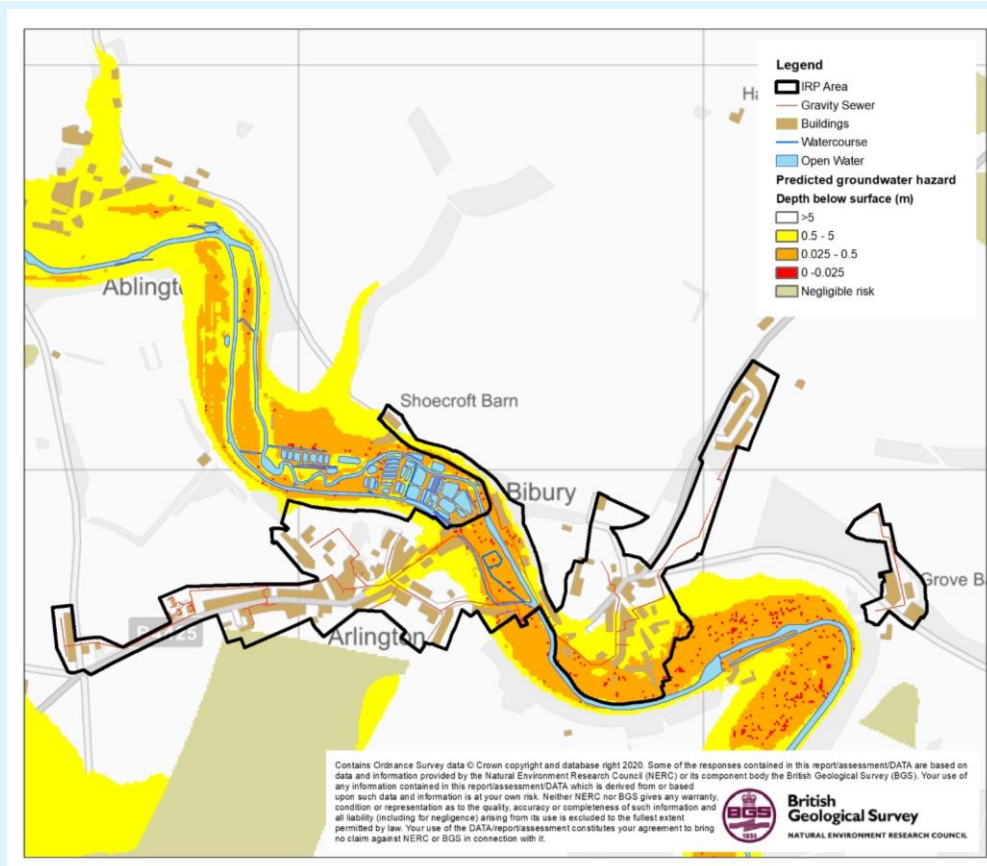
1.0 – Bibury catchment

Bibury is located in Gloucester, England, approximately 6 miles north-east of Cirencester. Bibury serves a population equivalent<sup>3</sup> of 647 with a partially separate sewerage network totaling some 6.61 km in length excluding private drains and sewers. The extent of the catchment is shown in Figure 1.0 above.

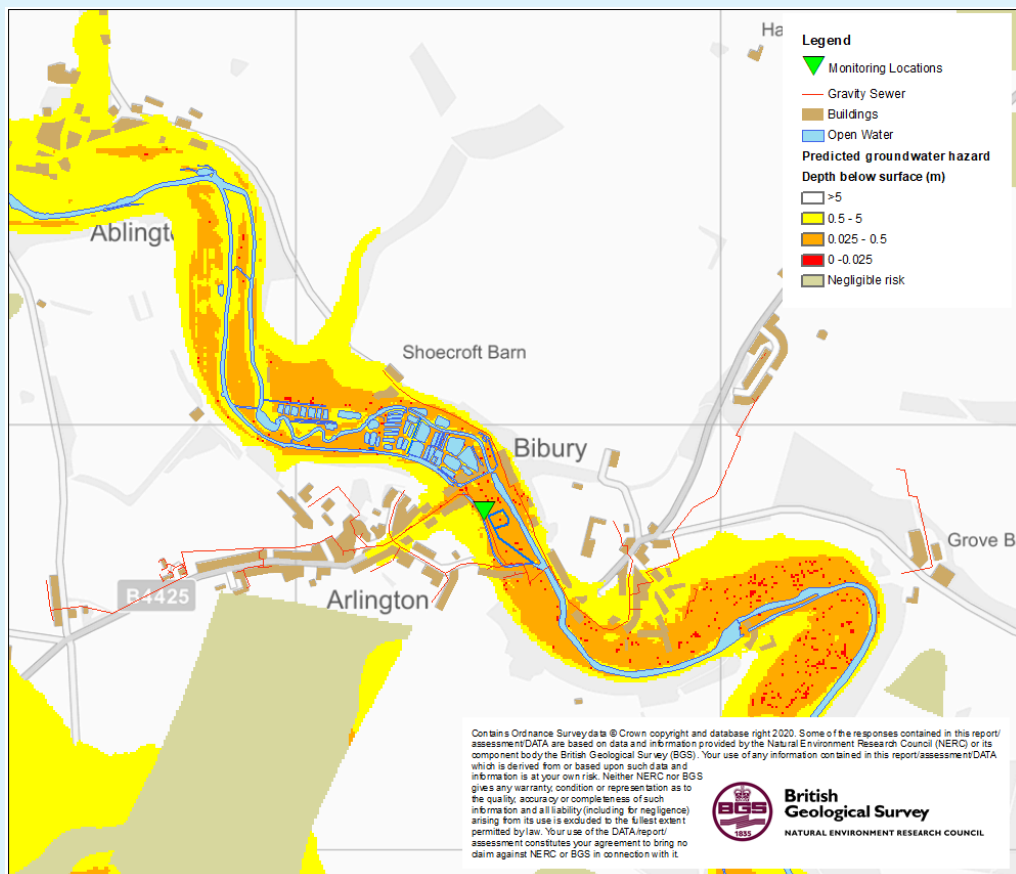
Figure 2.0 – Bibury monitoring and infiltration zones

Key to bringing the impact of groundwater infiltration under control is an enhanced monitoring regime. We have identified and have installed a telemetered depth monitor location in the Bibury system – see Figure 2.0.

We engaged with JBA Consulting to develop plans for Bibury that identify zones of groundwater risk, see Figure 2.0. These zones are modelled areas where the groundwater has been determined to be above the sewer and hence pose a potential risk for groundwater ingress.

Sewer Depth Monitors have now been installed in the catchment in 2020 (see Figure 2.0). These devices are telemetered and provide real time data on the level of flow in the sewer.

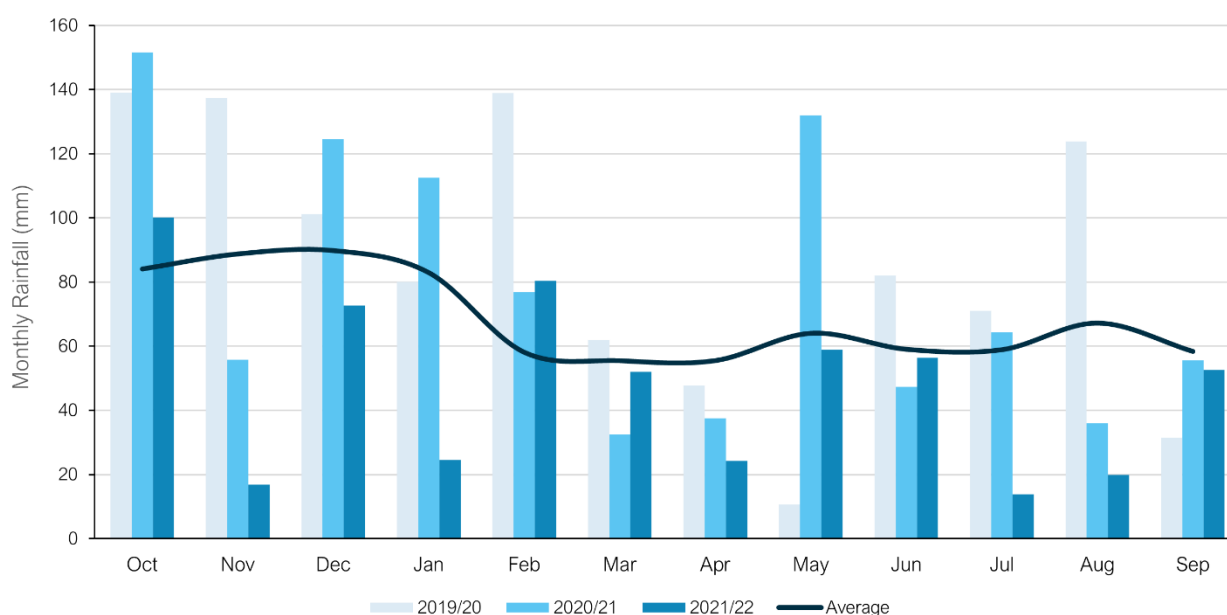
Figure 2 – Monthly Rainfall Performance

Representative Radar rainfall has been used to generate monthly data at catchment level for comparison with average data generated by local Met Office Weather Station Records. Figure 2 presents the comparison of this data for the last three hydrological years to support longer term trends within the local system.

Average Values taken from Met Office Weather Station at Cirencester based on the period 1991-2020

The total rainfall for the 2021/22 hydrological year is 29% below the annual average total. Total rainfall values are presented in Table 3 below.

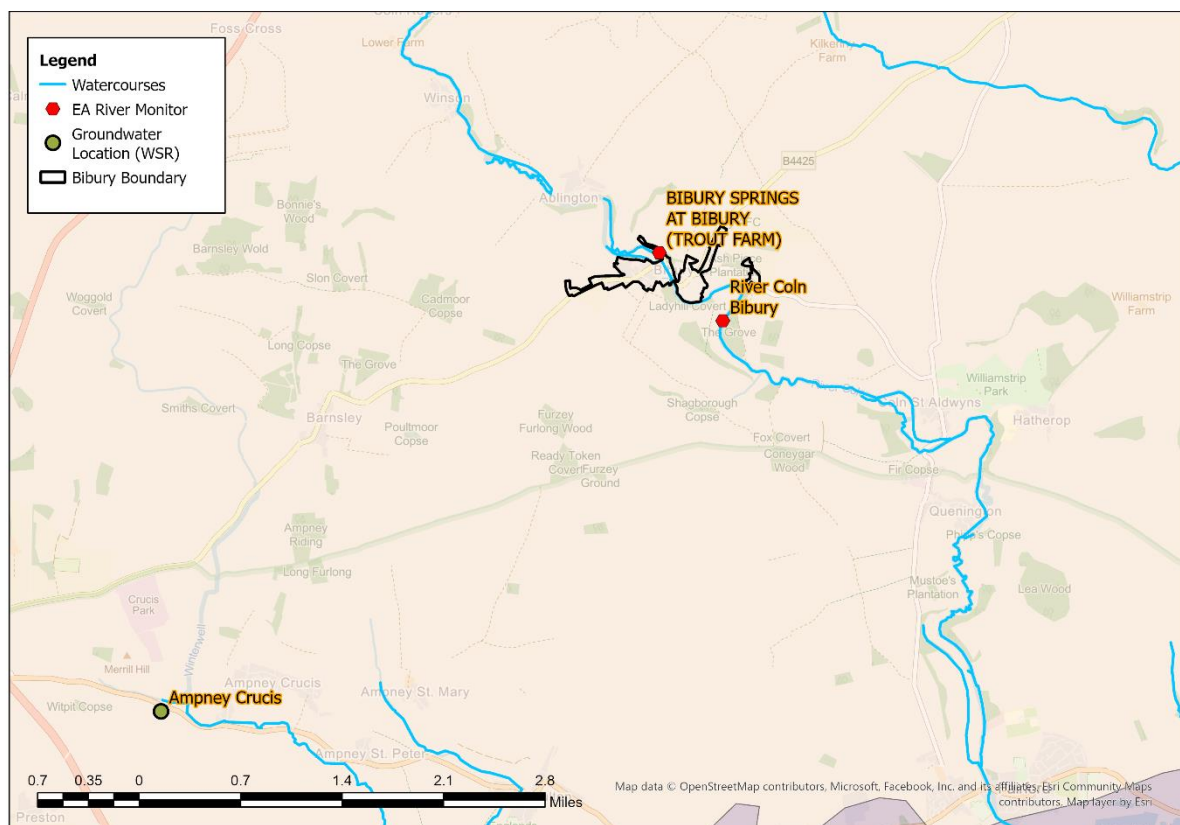
Figure 4 – Local Monitoring Stations

These sites are illustrated in the figure below, alongside the closest groundwater reference station and closest gauging station from the Water Situation Report. The closest gauging station from the WSR is also the River Coln at Bibury.

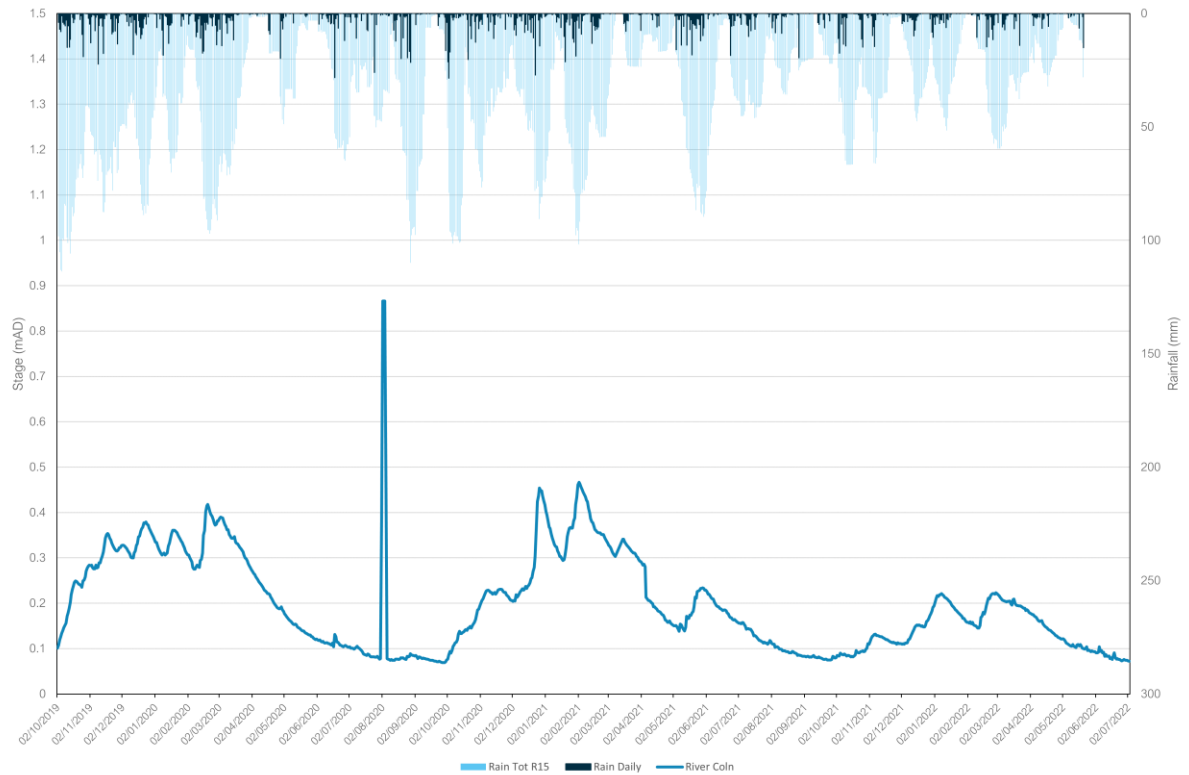
Figure 5A – River Coln, Bibury

The following figures represent the last three hydrological years of level information at the indicator sites to build a picture of the relative conditions prevalent in the current year. It is presented against both the daily total rainfall values for the catchment and a rolling 15 day total rainfall.

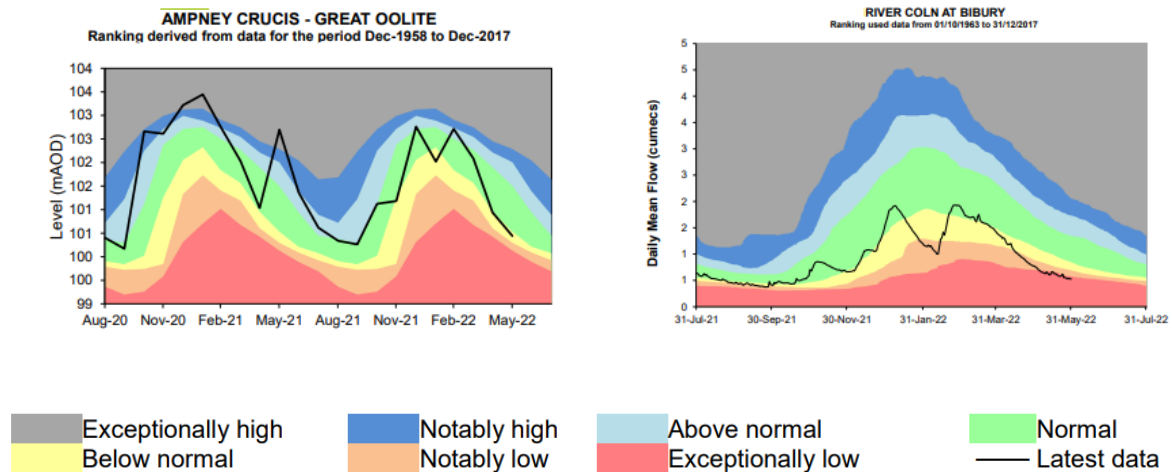
Figure 6 – Water Situation Report

In addition to these specific stations, the wider groundwater context is illustrated in the Water Situation Report for the Cotswold West. The nearest groundwater reference station is Ampney Crucis. This site shows lower overall groundwater levels than the previous year, particularly evident during the winter months. This can be seen in the figure below alongside the river indicator location at Bibury on the River Coln.

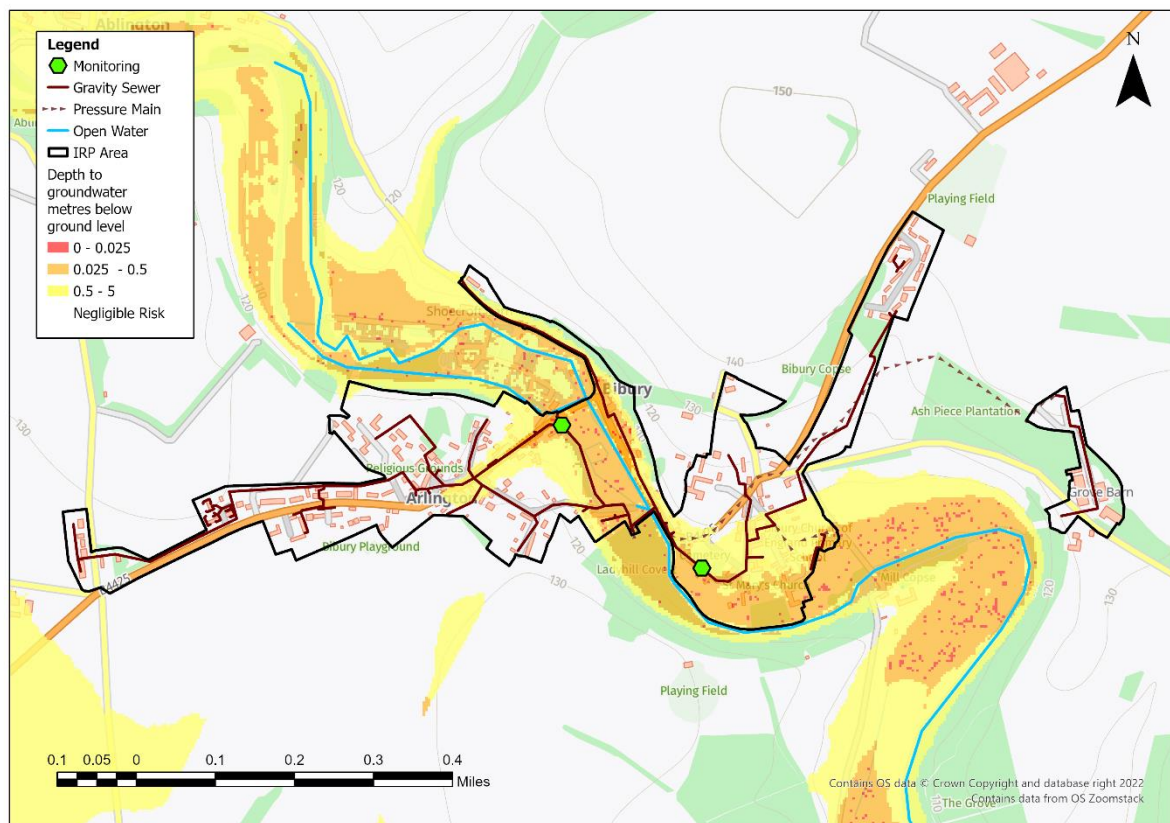
Figure 1 – Bibury Monitoring Plan

There are 2 GISMP depth monitors installed in the Bibury catchment. These will remain installed to allow the system and any changes within it to continue to be monitored.
