Groundwater Impacted System Management Plan

Bicester, Langford Brook

July 2021

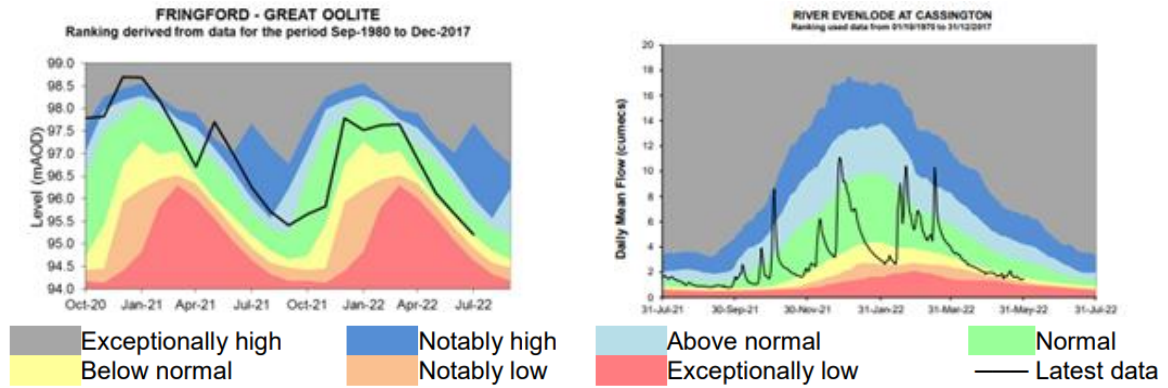
Figure 6 – Water Situation Report

In addition to these specific stations, the wider groundwater context is illustrated in the Water Situation Report for Cotswolds East and Thame . The nearest groundwater reference station is Fringford. This site shows lower overall groundwater than the previous year. This can be seen in the figure below alongside the river indicator Cassington on the River Evenlode.

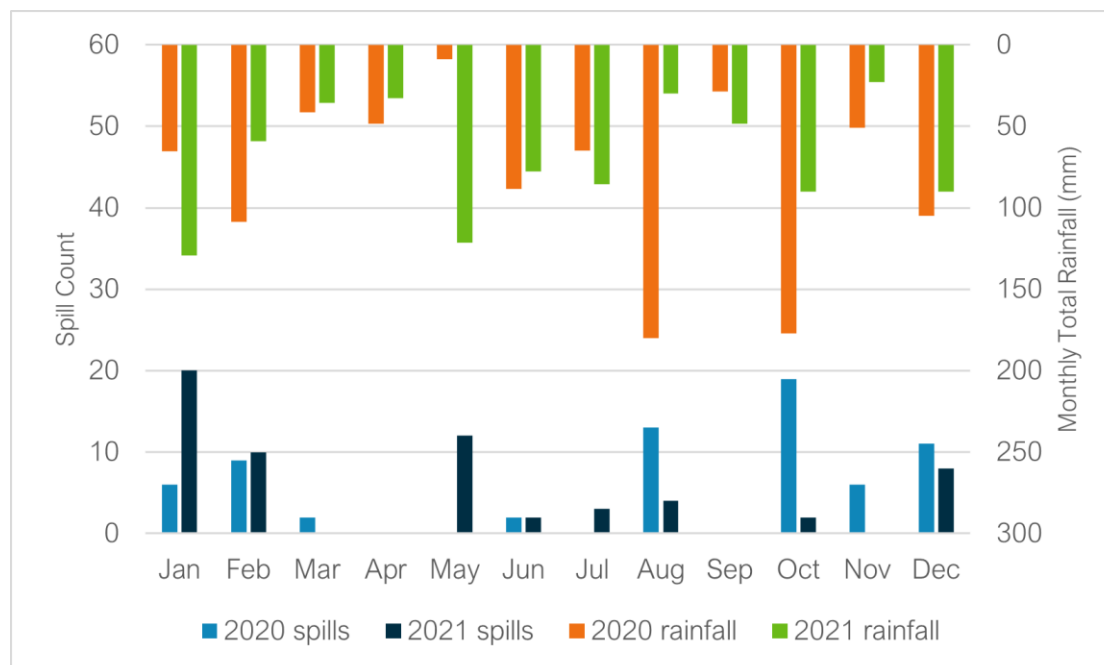
Figure 8 – EDM Monthly Performance

A critical part of the assessment of EDM performance and its relation to groundwater inundation is to review the month-on-month spill performance, against previous years and the monthly total rainfall values to give context to the performance. Note a spill frequency of 68 is stated for 2020, which is lower than the published spill count of 117. The data has been corrected and the revised spill count of 68 will be included in the re-submission to the EA. Similarly, a spill frequency of 61 is stated for 2021 which is slightly lower than the published spill count of 63. The revised spill count of 61 will be included in the re-submission to the EA. The EDM for Bicester was only operational 87% of the time in 2021, which may account for some variation in frequency numbers. Figure 8 below presents the EDM performance trend and rainfall for recent years.

The trend in spill performance across the two recorded years does show variation in spills, although these spills occur throughout all seasons in the 2020-2021 time period. Therefore, there will need to be a further review of the potential relationship between rainfall, elevated groundwater levels and spill frequency in the 2022/2023 hydrological year.

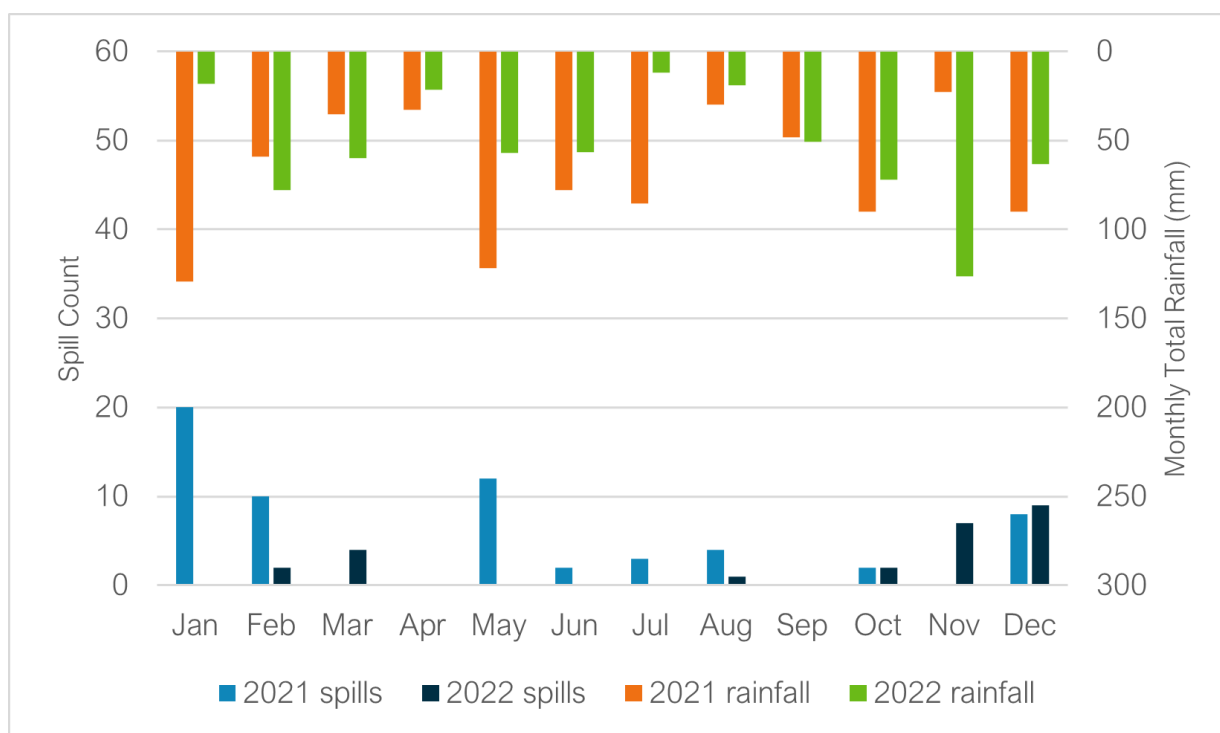
Figure 8 – EDM Monthly Performance

A critical part of the assessment of EDM performance and its relation to groundwater infiltration, is to review the month-on-month spill performance against previous years and the monthly total rainfall values to give context to the performance. Note, that the spill count of 61 reported for 2021 is slightly lower than the value of 63 contained in the Annual Return. The spill count has been revised/revalidated, and the value of 61 is the post-validation value. Note also, the EDM was only operational for 87% of the time in 2021, which may have impacted the recorded spill count. Figure 8 below presents the EDM performance trend and rainfall for recent years.

The data suggests a wider relationship between rainfall, elevated groundwater levels, and spill frequency. Despite a higher rainfall total in February 2022, significantly more spills were recorded at Bicester STW in February 2021. The indicator site data shown in Figure 5, suggests groundwater levels in the catchment were higher in February 2021. The occurrence of spills during the summer months, also suggests spills occurring at Bicester STW during prolonged or intense rainfall events, outside of periods of significantly elevated groundwater levels.

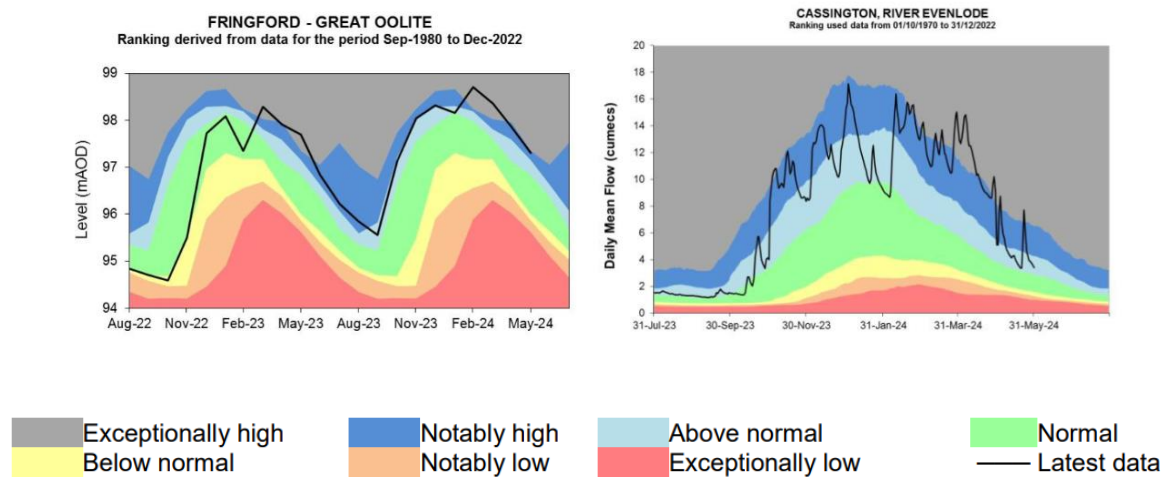
Figure 6 – Water Situation Report

In addition to these specific stations, the wider groundwater context is illustrated in the Water Situation Report for Cotswolds East and Thame. The nearest groundwater reference station is Fringford. This site shows groundwater levels have been observed at above normal and notably high levels for most of the current hydrological year, reaching exceptionally high levels in early spring 2024. This can be seen in Figure 6 alongside the river indicator located at Cassington on the River Evenlode.
