Groundwater Impacted System Management Plan

Bourton-on-the-Water, River Windrush

January 2021

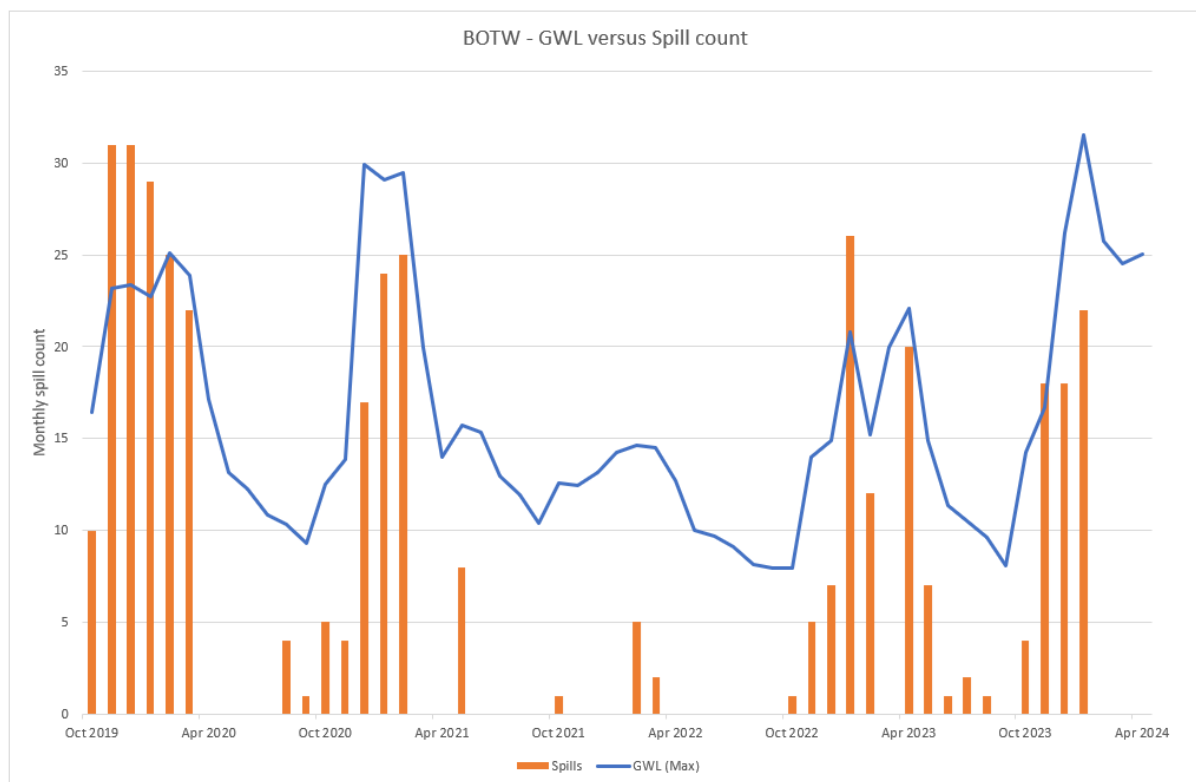
Figure 10 presents monthly spill frequency plotted against maximum groundwater level locally to the catchment. This shows that despite groundwater levels peaking in January 2024, the total number of spills recorded November 2023 – January 2024, was much lower than the number recorded November 2019 – January 2020, when groundwater levels reached lower levels. The EDM data for 2024, will provide improved insight into the performance of the network during a period when the indicator site data shown in Figures 5 and 6, suggests that groundwater levels in the catchment remained high for sustained periods.

Figure 11 – Groundwater levels and overflow spill counts for the Bourton-on-the-Water catchment from October 2019 – December 2023
