# Groundwater Impacted System Management Plan

Carterton, Shill Brook

July 2021

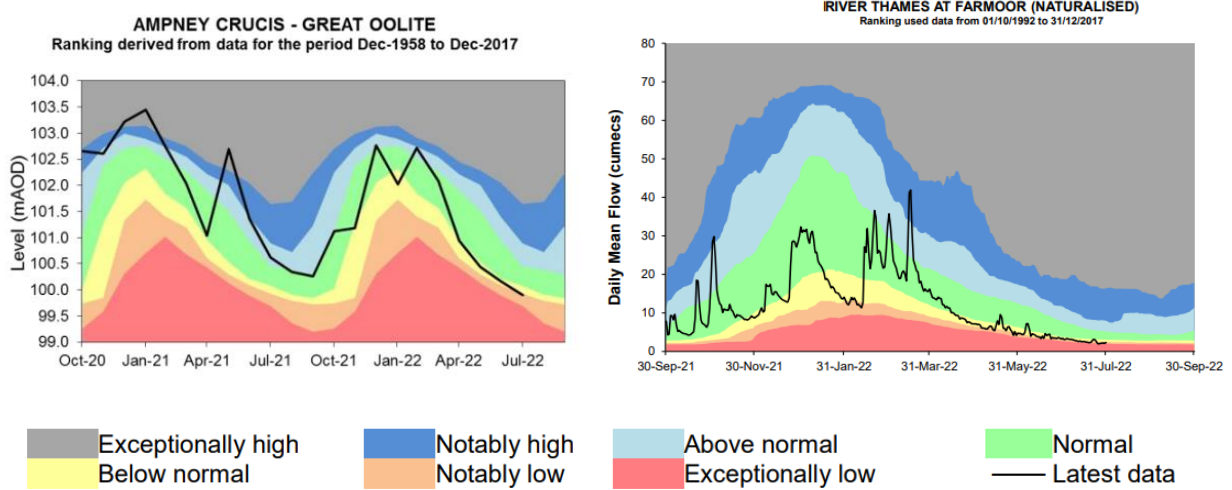
Figure 6 – Water Situation Report

In addition to this specific station, the wider groundwater context is illustrated in the Water Situation Report for Cotswolds West. The nearest groundwater reference station is Ampney Crucis. This site shows significantly lower overall groundwater than the previous year. This can be seen in the figure below alongside the river indicator location at Farmoor on the River Thames.

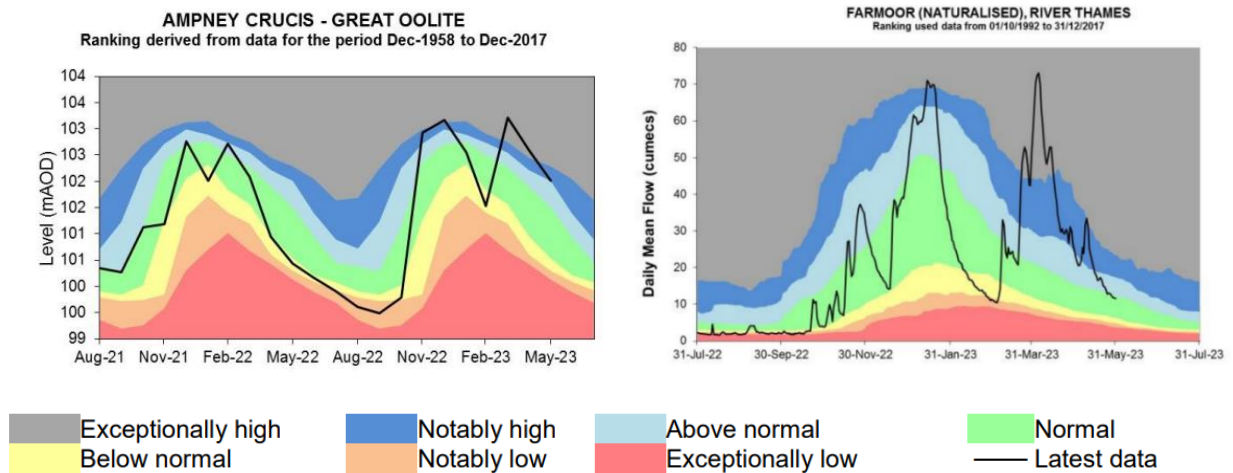
Figure 6 – Water Situation Report

In addition to these specific stations, the wider groundwater context is illustrated in the Water Situation Report for Cotswolds West. The nearest groundwater reference station is Ampney Crucis. This site shows groundwater levels generally at normal, below normal, and notably low levels in the 2021-2022 Hydrological Year, with brief periods of above normal groundwater levels. Conversely, from November to January 2022/23, and April to May 2023, notably high and exceptionally high groundwater levels were observed. This can be seen in the figure below alongside the river indicator location at Farmoor on the River Thames.
