Groundwater Impacted System Management Plan

Chinnor, Cuttle Brook (River Thame)

March 2021

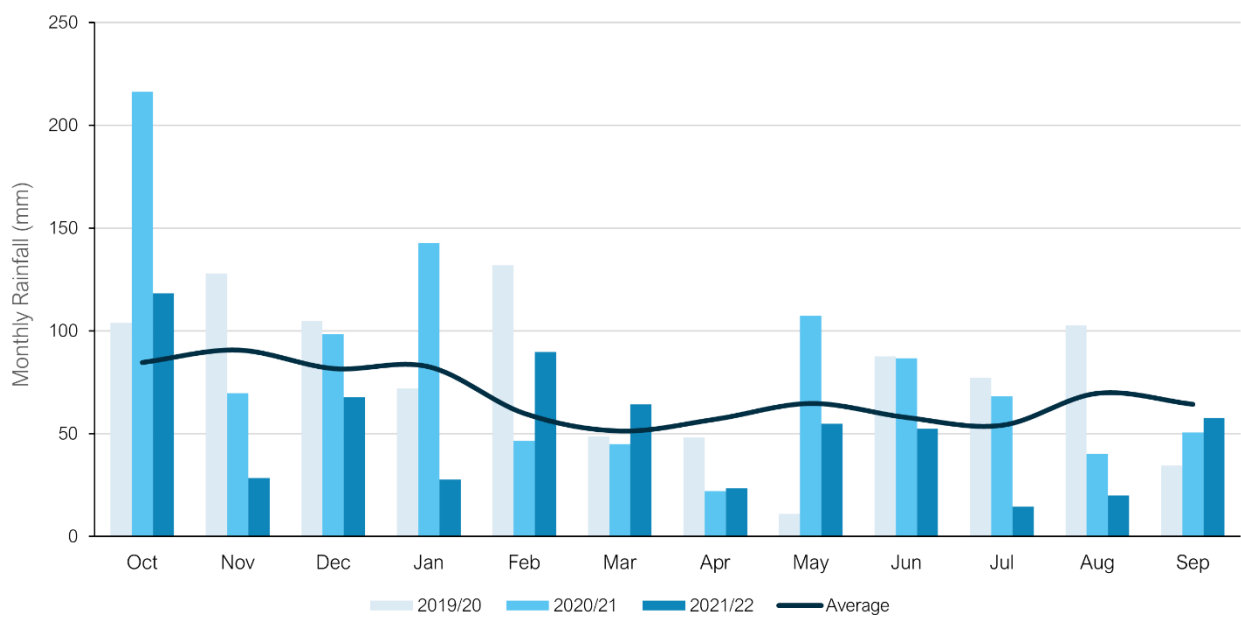
Figure 2 – Monthly Rainfall Performance

Representative Radar rainfall has been used to generate monthly data at catchment level for comparison with average data generated by local Met Office Weather Station Records. Figure 2 presents the comparison of this data for the last three hydrological years to support longer term trends within the local system.

Average Values taken from Met Office Weather Station at High Wycombe based on the period 1991-2020

The total rainfall for the 2021/22 hydrological year is 23% below the annual average total. Total rainfall values are presented in Table 3 below.

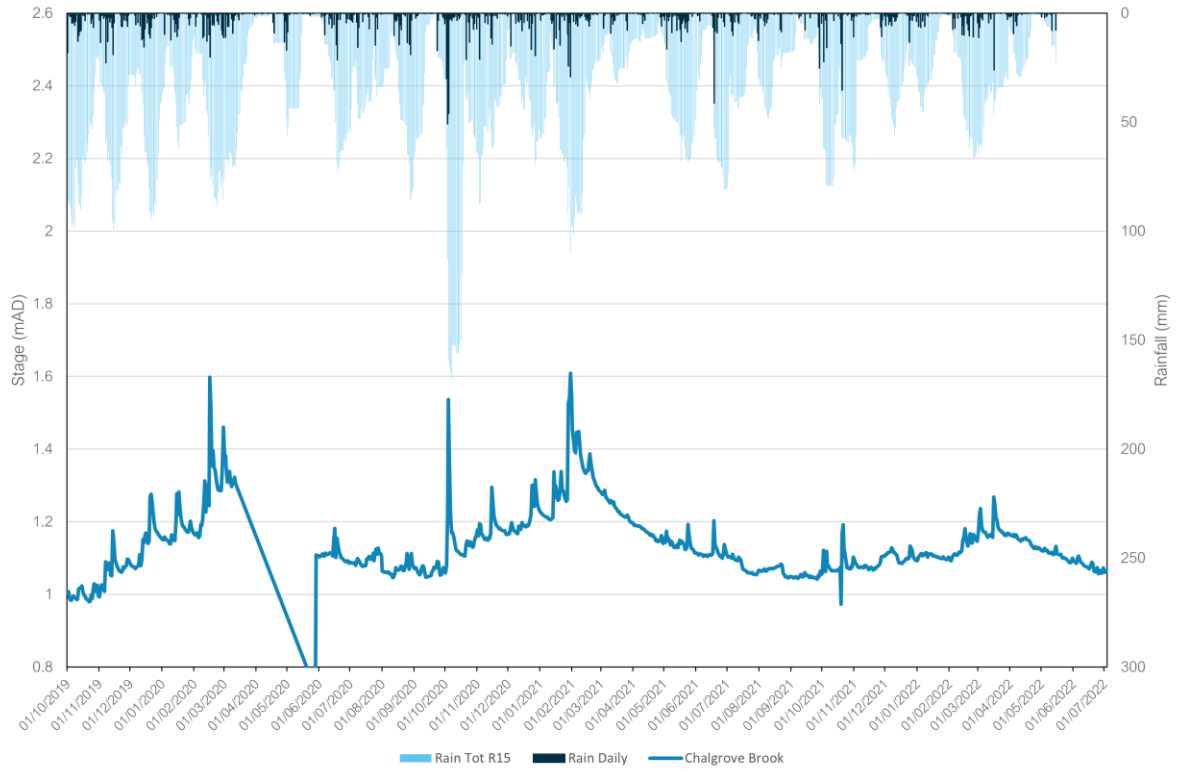
Figure 5A – Chalgrove Brook, Chalgrove

The following figures represent the last three hydrological years of level information at the indicator sites to build a picture of the relative conditions prevalent in the current year. It is presented against both the daily total rainfall values for the catchment and a rolling 15 day total rainfall.

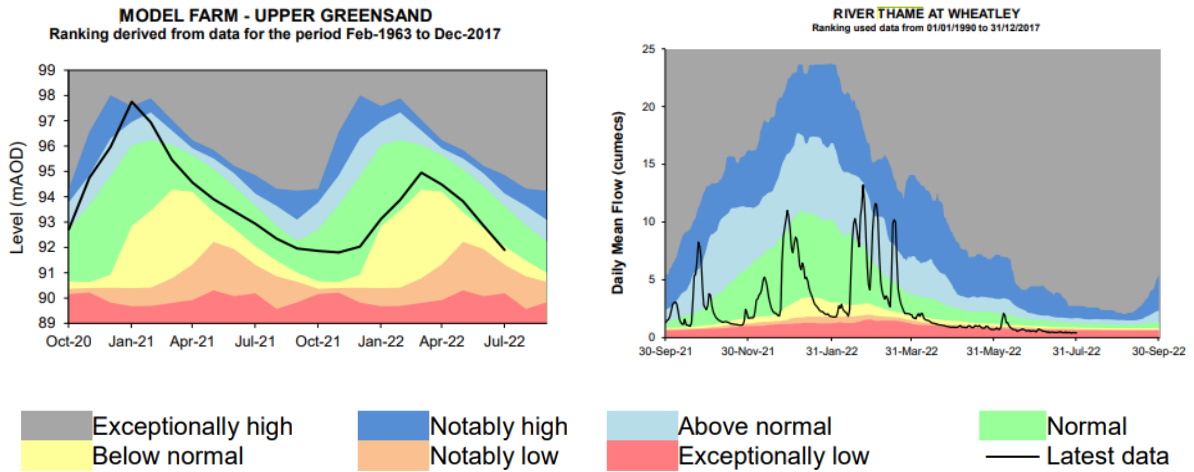
Figure 6 – Water Situation Report

In addition to this specific station, the wider groundwater context is illustrated in the Water Situation Report for the Thame. The nearest groundwater reference station is Model Farm. This site shows significantly lower overall groundwater than the previous year. This can be seen in the figure below alongside the river indicator location at Wheatley on the River Thame.

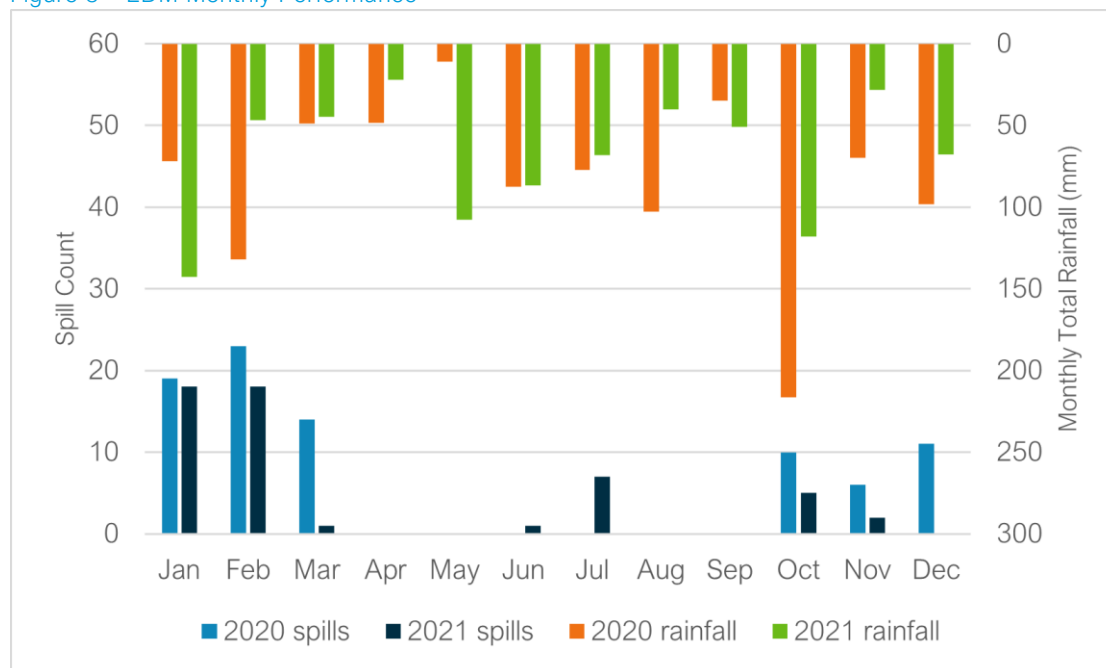
Figure 8 – EDM Monthly Performance

A critical part of the assessment of EDM performance and its relation to groundwater inundation is to review the month-on-month spill performance, against previous years and the monthly total rainfall values to give context to the performance. Figure 8 below presents the EDM performance trend and rainfall for recent years.

The trend in spill performance across the two recorded years does show variation in spills, with an overall focus on spills during the autumn and winter months. The data suggests a wider relationship between rainfall, elevated groundwater levels and spill frequency. A slower tail off in spills is evident within the first three months of 2020, when the indicator sites shown in Figure 5 suggest groundwater levels in the catchment were higher than in 2021. Despite broadly similar rainfall, no spills were recorded at Chinnor STW in December 2021, compared to 11 spills in December 2020. The indicator sites suggest groundwater levels in the catchment were higher in December 2020.

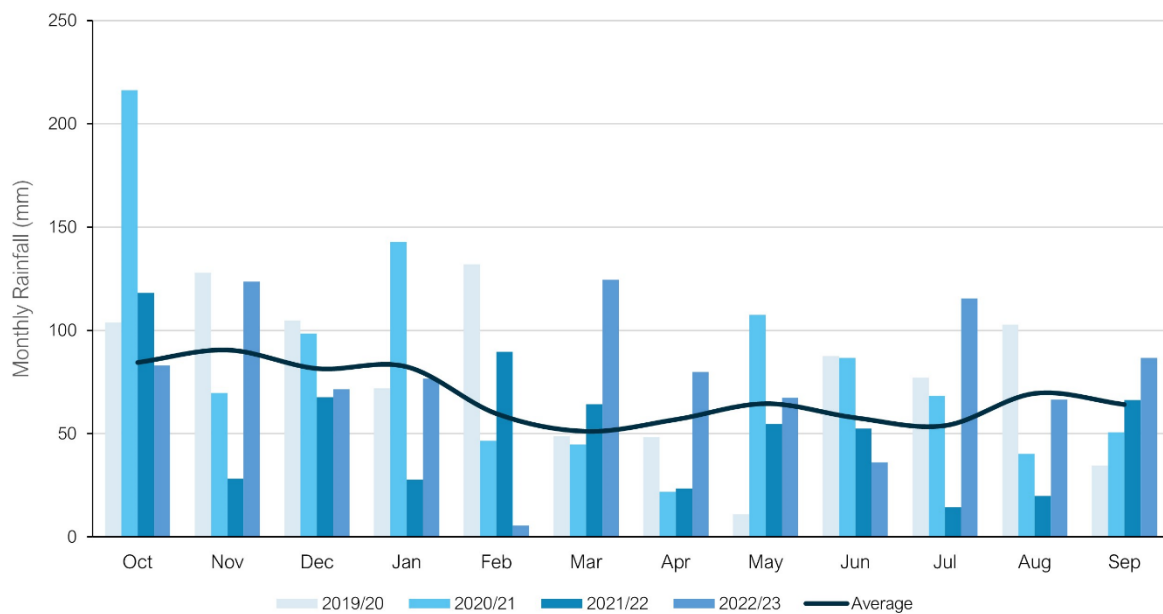
Figure 2 – Monthly Rainfall Performance

Representative Radar rainfall has been used to generate monthly data at catchment level for comparison with average data generated by local Met Office Weather Station Records. Figure 2 presents the comparison of this data for the last four hydrological years to support longer term trends within the local system.

Average Values taken from Met Office Weather Station at High Wycombe based on the period 1991-2020

The total rainfall for the 2022/23 hydrological year is 15% above the annual average total. Total rainfall values are presented in Table 3 below.

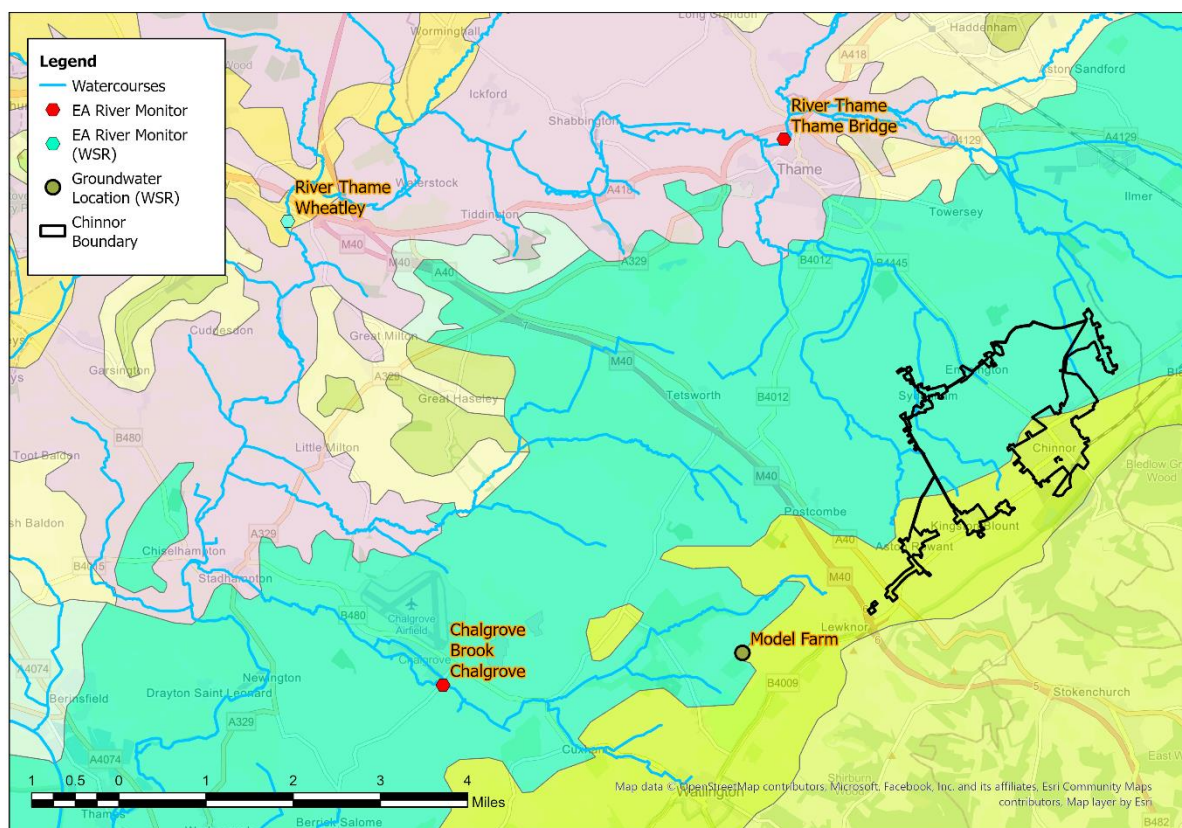
Figure 4 – Local Monitoring Stations

These sites are illustrated in the figure below, alongside the closest groundwater reference station and closest gauging station from the Water Situation Report.

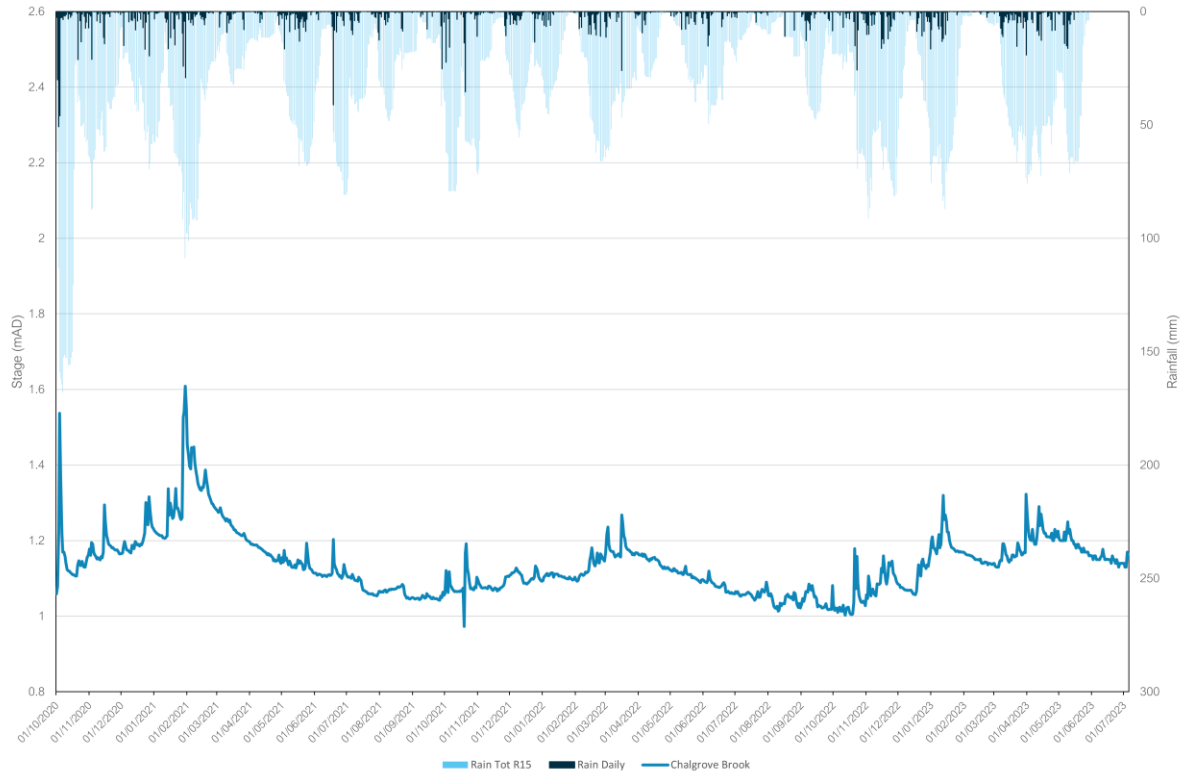
Figure 5A – Chalgrove Brook, Chalgrove

The following figures represent the last three hydrological years of level information at the indicator sites to build a picture of the relative conditions prevalent in the current year. It is presented against both the daily total rainfall values for the catchment and a rolling 15 day total rainfall.

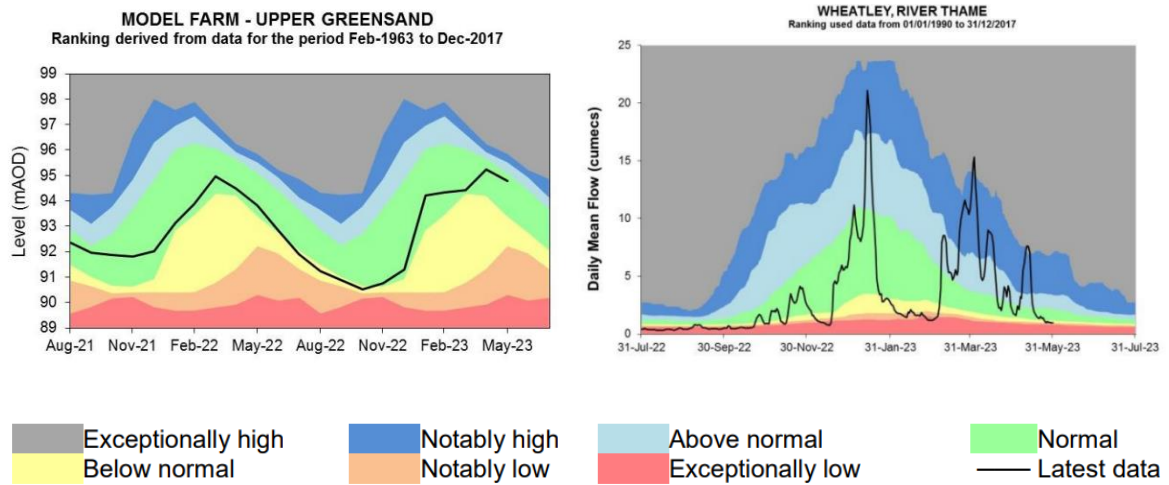
Figure 6 – Water Situation Report

In addition to these specific stations, the wider groundwater context is illustrated in the Water Situation Report for the Thame. This site shows normal or below normal groundwater levels during 2022, with groundwater levels observed to be at normal levels during 2023. This can be seen in the figure below alongside the river indicator location at Wheatley on the River Thame.

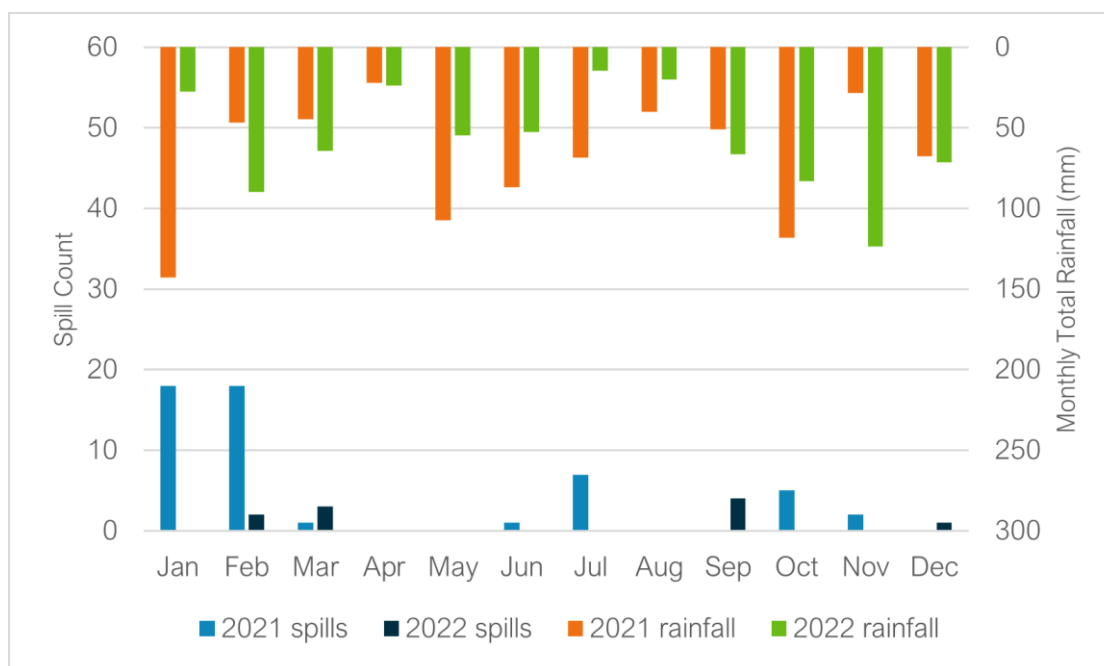
Figure 8 – EDM Monthly Performance

A critical part of the assessment of EDM performance and its relation to groundwater infiltration is to review the month-on-month spill performance, against previous years and the monthly total rainfall values to give context to the performance. Note that the spill frequency of ten stated for 2022, is one higher than the published figure of nine. The spill count has been revised/ revalidated, and ten is the post-validation value. Figure 8 below presents the EDM performance trend and rainfall for recent years.

The trend in spill performance across the two recorded years does show variation in spills, with an overall focus on spills during the autumn and winter months. The data suggests a wider relationship between rainfall, elevated groundwater levels and spill frequency. Despite a higher rainfall total in February 2022 compared to February 2021, significantly more spills were recorded at Chinnor STW in February 2021. The indicator sites shown in Figure 5, suggest groundwater levels in the catchment were higher in February 2021. The significant number of spills recorded in July 2021, is also indicative of spills occurring a result of intense rainfall events in the catchment, outside of periods of elevated groundwater levels.

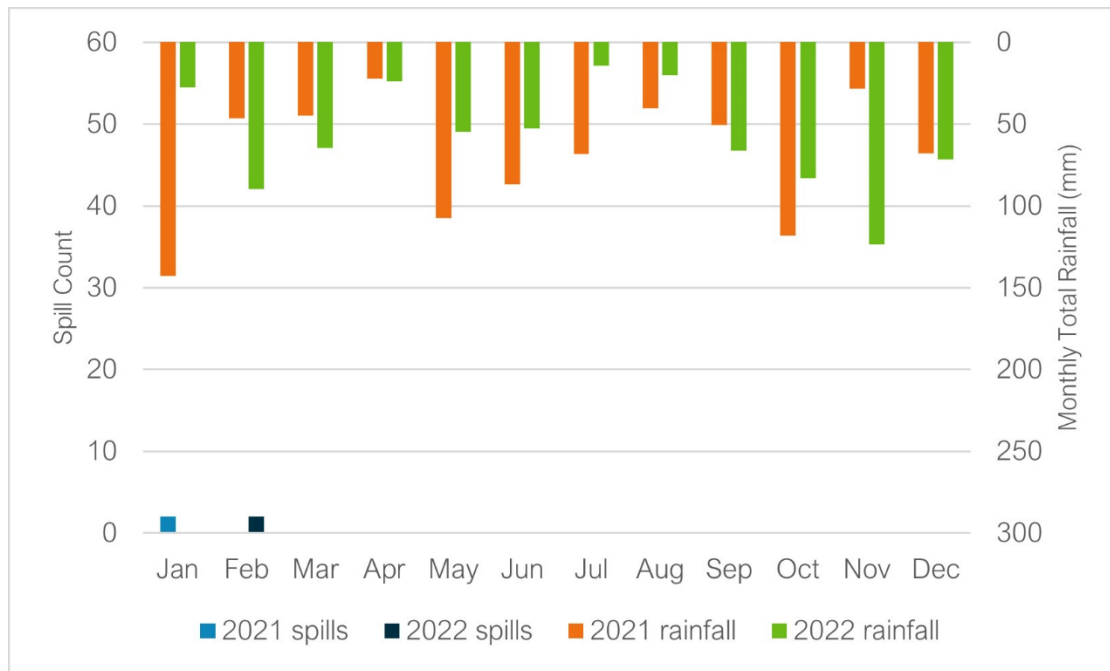
Figure 10 – EDM Monthly Performance

Figure 10 below presents the EDM performance trend and rainfall for 2022.

The data suggests a wider relationship between rainfall, elevated groundwater levels and spill frequency, as the only spills recorded across 2021/22 were in winter months, when the indicator site data shown in Figure 5 suggests groundwater levels in the catchment were elevated. However, spills were recorded at Manor Farm SPS in February 2022, but not in February 2021, despite the indicator site data shown in Figure 5 suggesting that groundwater levels in the catchment were higher in February 2021. This indicates that the total depth and intensity of individual rainfall events, occurring during periods of elevated groundwater levels, is also critical to determining overflow performance at Manor Farm SPS.

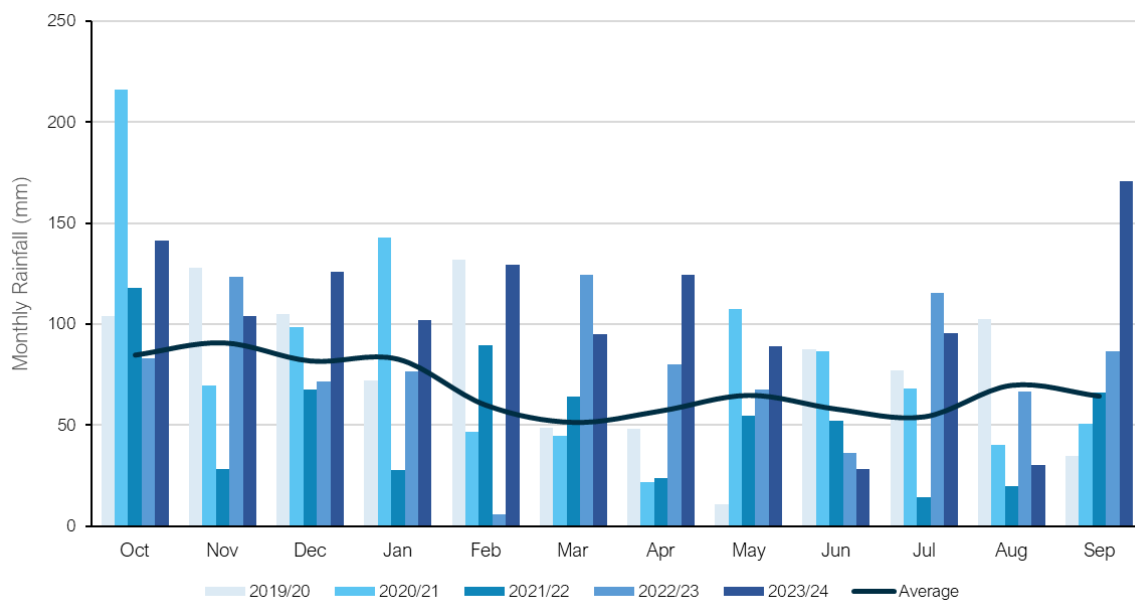
Figure 2 – Monthly Rainfall Data

Representative Radar rainfall has been used to generate monthly data at catchment level for comparison with average data generated by local Met Office Weather Station Records. Figure 2 presents the comparison of this data for the last five hydrological years to support longer term trends within the local system.

Average Values taken from Met Office Weather Station at High Wycombe based on the period 1991-2020

The total rainfall for the 2023/24 hydrological year is 51% above the annual average total. Total rainfall values are presented in Table 3 below.

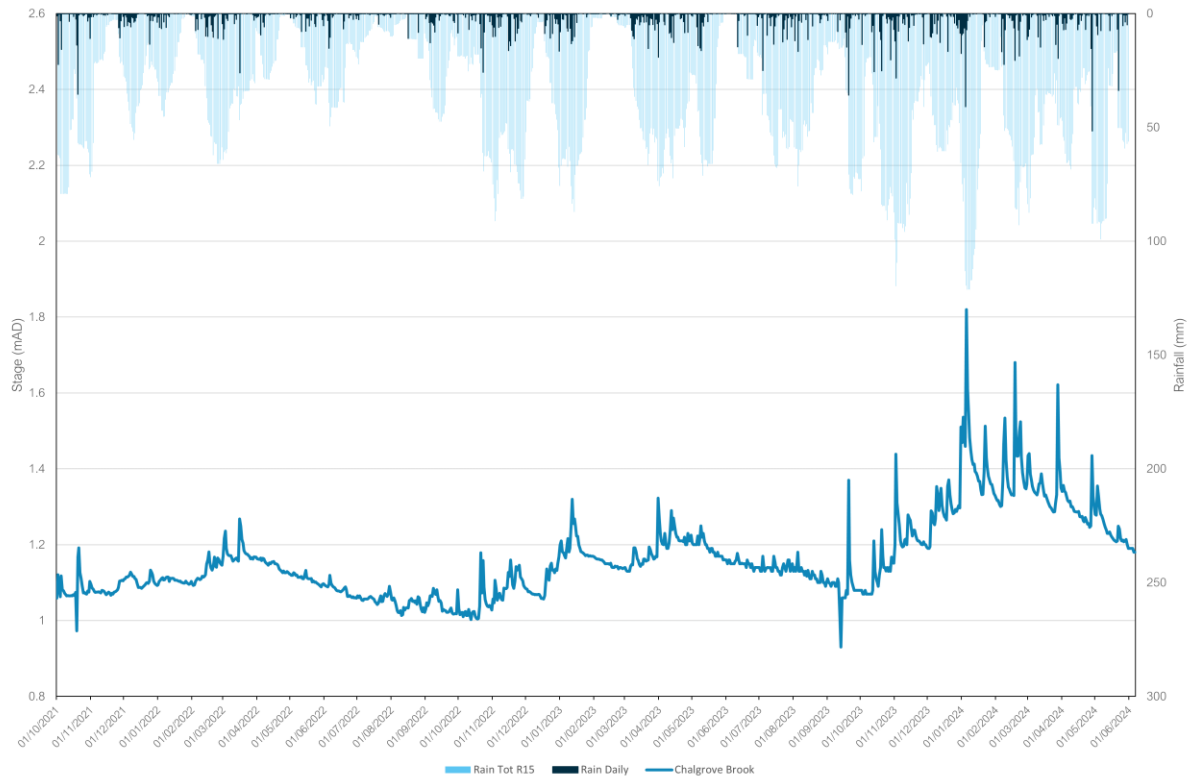
Figure 5A – Chalgrove Brook, Chalgrove

Figures 5A-5B represent the last three hydrological years of level information at the indicator sites to build a picture of the relative conditions prevalent in the current year. It is presented against both the daily total rainfall values for the catchment and a rolling 15 day total rainfall.

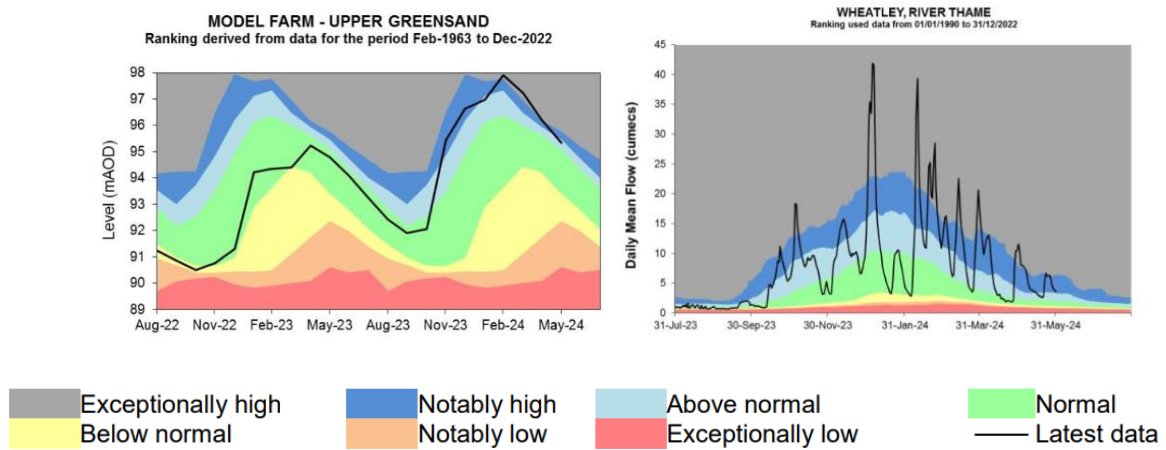
Figure 6 – Water Situation Report

In addition to these specific stations, the wider groundwater context is illustrated in the Water Situation Report for the Thames. The nearest groundwater reference station is Model Farm. This site shows groundwater levels generally at normal levels in 2023 before increasing towards the end of the year. November 2023 to February 2024 saw above normal/ notably high groundwater levels and exceptionally high groundwater levels were observed around March/April 2024. This can be seen in Figure 6 alongside the river indicator location at Wheatley on the River Thames.

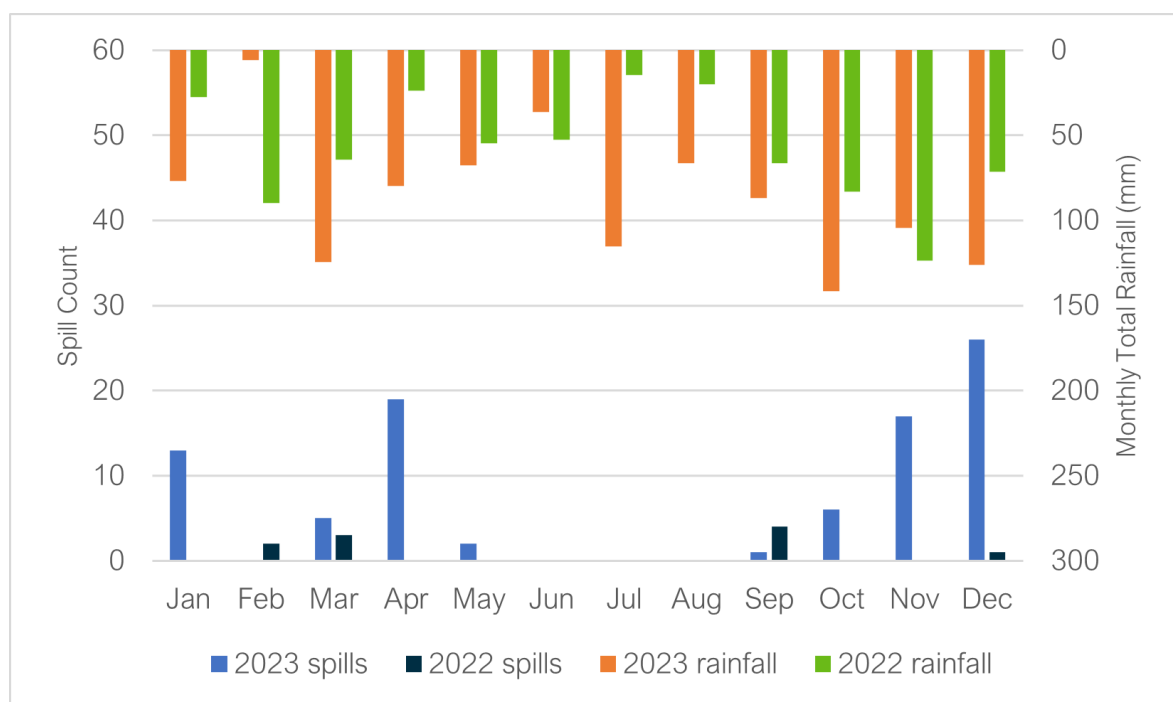
Figure 8 – EDM Monthly Performance at Chinnor STW

A critical part of the assessment of EDM performance and its relation to groundwater infiltration is to review the month-on-month spill performance, against previous years and the monthly total rainfall values to give context to the performance. Note that the spill frequency of ten stated for 2022, is one higher than the published figure of nine. The spill count was revised/ revalidated, and ten is the post-validation value. Figure 8 below presents the EDM performance trend and rainfall for recent years.

The EDM data for 2023 shows an overall focus on spills during the winter, spring and autumn months. The data suggests a wider relationship between rainfall, elevated groundwater levels and spill frequency. The indicator site data shown in Figure 6 suggests groundwater levels in the catchment became elevated October – December 2023, reaching notably high levels. A significant number of spills were recorded during this period, compared to the same period in 2022, when the indicator site data shown in Figures 5 and 6 suggest groundwater levels in the catchment were significantly lower. A high number of spills were also recorded in April 2023. The indicator site data shown in Figures 5 and 6 suggests groundwater levels in the catchment were relatively high during this period.

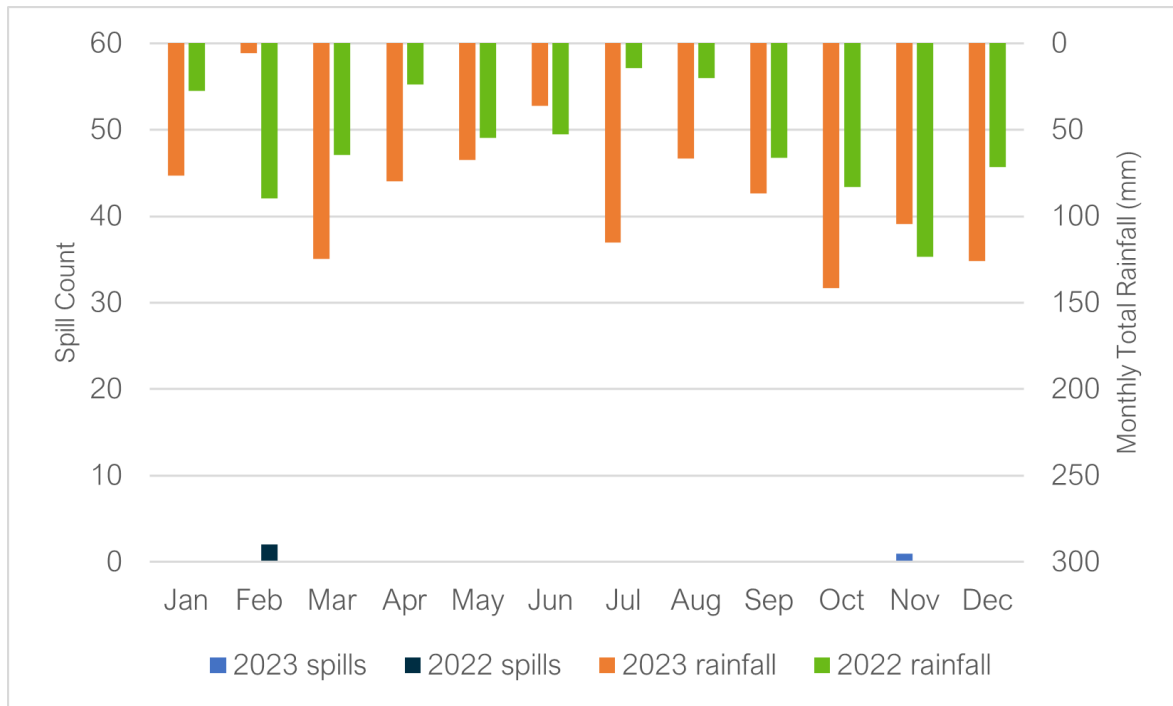
Figure 10 – EDM Monthly Performance at Manor Farm SPS

Figure 10 below presents the EDM performance trend and rainfall for 2022 and 2023.

The only spill recorded at Manor Farm in 2023 was in November, which does coincide with when the indicator site data suggests that groundwater levels in the catchment increased to notably high levels (see Figure 6). A limited number of spills at this site does make it difficult to identify a clear relationship between groundwater levels and spills at the overflow. As this overflow is located in the catchment rather than at the downstream STW, the data suggests the impact of groundwater infiltration on spills at the overflow to be more limited. Indicator site data suggests groundwater levels in the catchment have reached higher levels in 2024, therefore analysis of 2024 EDM data will provide an improved insight as to the potential impact of groundwater infiltration on spills at the overflow.
