Groundwater Impacted System Management Plan

Cirencester (including South Cerney)

River Churn

January 2021

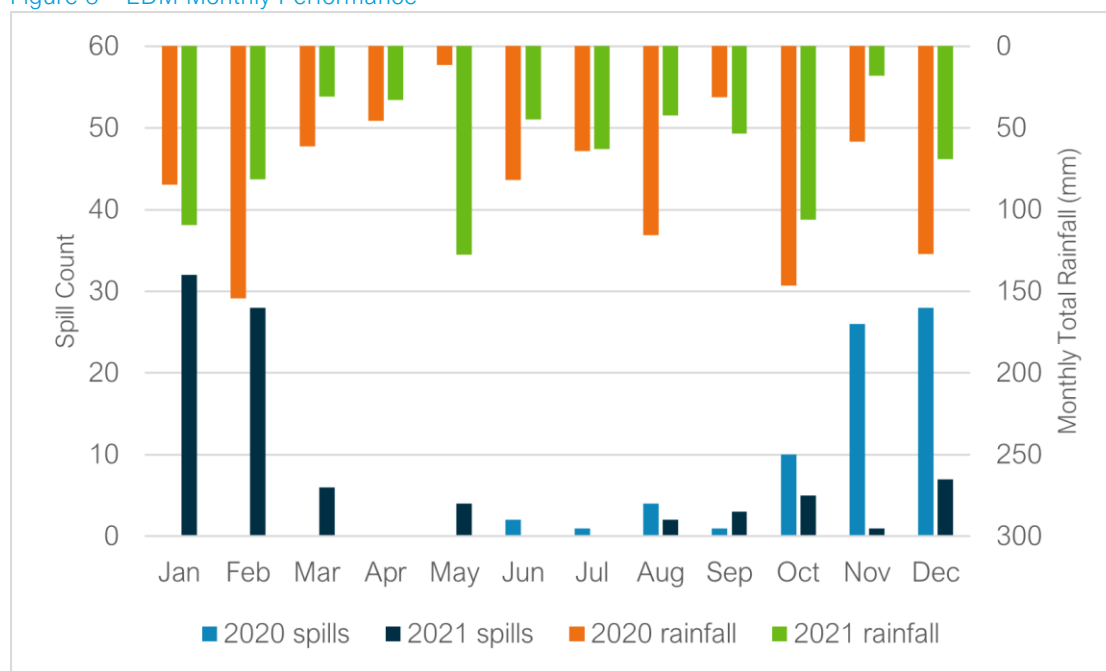
Figure 8 – EDM Monthly Performance

A critical part of the assessment of EDM performance and its relation to groundwater inundation is to review the month-on-month spill performance, against previous years and the monthly total rainfall values to give context to the performance. Figure 8 below presents the EDM performance trend and rainfall for recent years. Note that as the EDM monitor was installed in 2020, the 2020 spill count only includes spills from April 2020.

The trend in spill performance across the two recorded years does show variation in spills, with an overall focus on spills during the autumn and winter months. The data suggests a wider relationship between rainfall, elevated groundwater levels and spill frequency. The number of EDM spills recorded at Cirencester STW in November 2020 (26 spills) was similar to December 2020 (28 spills), despite December 2020 having a significantly greater total rainfall amount. As the indicator sites suggest groundwater levels in the catchment were similar across both months, the relatively high number of spills recorded in November 2020 is indicative of the role of groundwater infiltration.

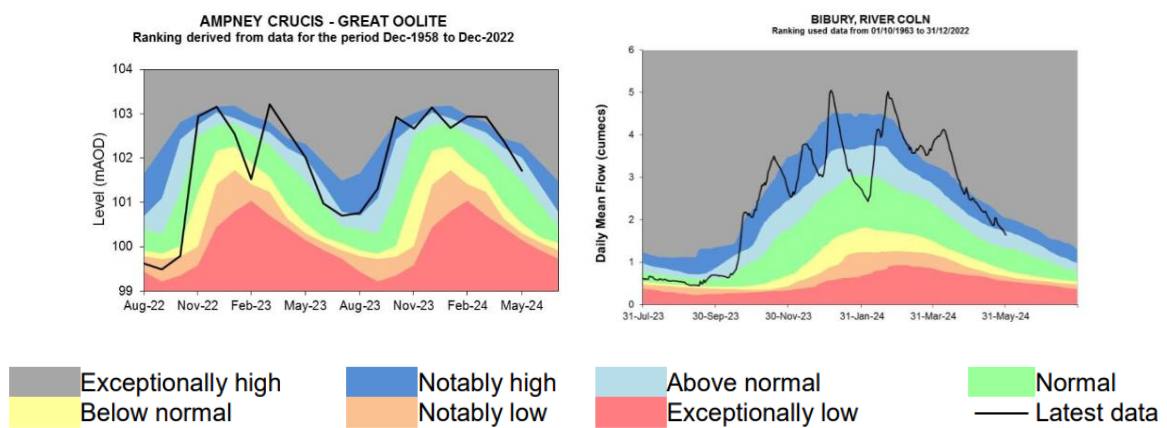
Figure 6 – Water Situation Report

In addition to these specific stations, the wider groundwater context is illustrated in the Water Situation Report for Cotswolds West. The nearest groundwater reference station is Ampney Crucis. This site shows groundwater levels from March through to the end of year in 2023 to be at above normal, notably high and exceptionally high levels. Groundwater levels in 2024 can be observed to sustain above normal / notably high levels throughout the January – May period. This can be seen in Figure 6 alongside the river indicator location at Bibury on the River Coln.
