Groundwater Impacted System Management Plan

Compton, River Pang

March 2021

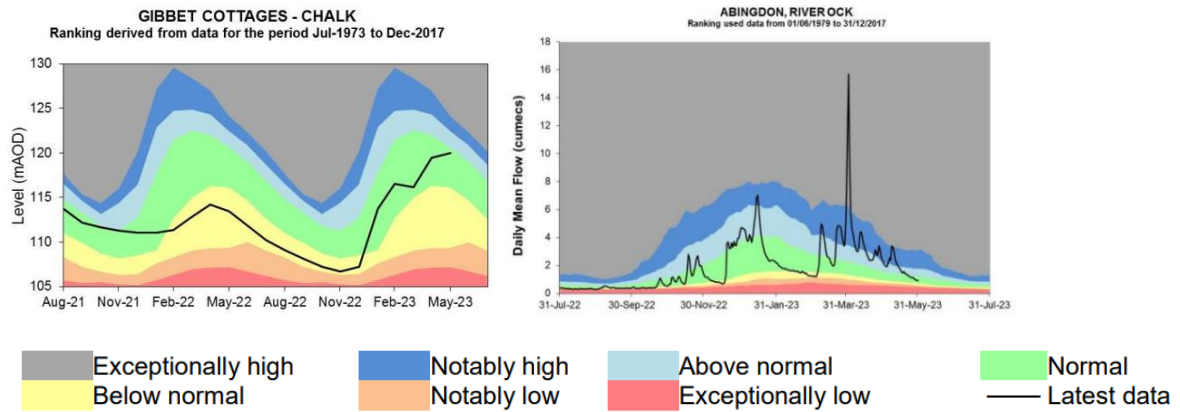
Figure 6 – Water Situation Report

In addition to these specific stations, the wider groundwater context is illustrated in the Water Situation Report for Berkshire Downs. The nearest groundwater reference station is Gibbet Cottages. This site shows groundwater levels were consistently below normal in 2022, before rising towards the end of the year. Groundwater levels have been within the normal range during 2023 and have generally been higher this hydrological year than within the previous hydrological year. This can be seen in the figure below alongside the river indicator Abingdon on the River Ock.

The trend in spill performance across the two recorded years does show variation in spills, with a focus on spills during the winter and early spring months. The data suggests a wider relationship between winter rainfall, elevated groundwater levels and spill frequency. Despite higher rainfall totals in February and March 2022 than in February and March 2021, no spills were recorded at Compton STW in 2022, however a significant number of spills were recorded February – April 2021. The indicator sites shown in Figure 5, suggest groundwater levels in the catchment were significantly higher February – April 2021, compared to the same period in 2022, with Figure 6 showing groundwater levels within the below normal range during 2022.

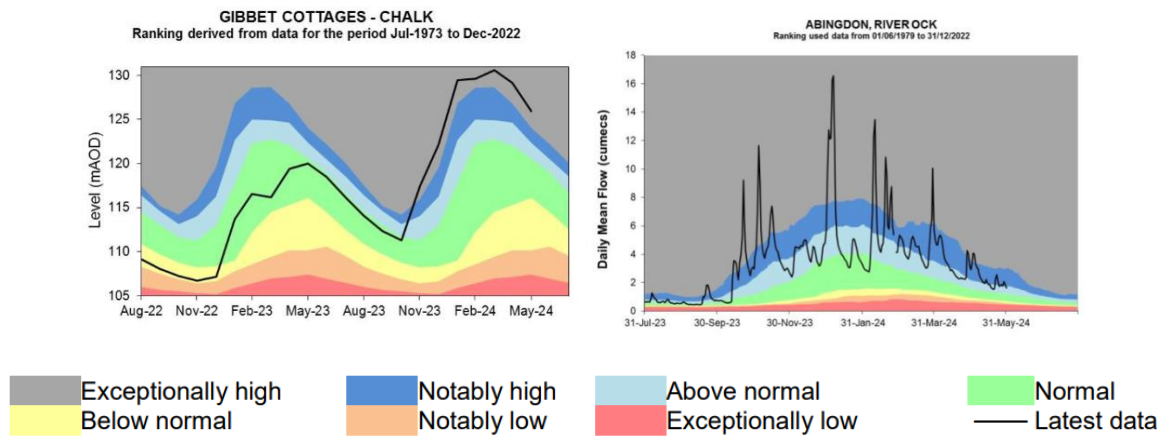
Figure 6 – Water Situation Report

In addition to these specific stations, the wider groundwater context is illustrated in the Water Situation Report for Berkshire Downs. The nearest groundwater reference station is Gibbet Cottages. This site shows groundwater levels generally at normal levels in 2023, before rising towards the end of the year to reach exceptionally high levels. Groundwater levels have remained exceptionally high in 2024. This can be seen in Figure 6 alongside the river indicator data at Abingdon on the River Ock.
