Groundwater Impacted System Management Plan

Crondall, River Hart

July 2021

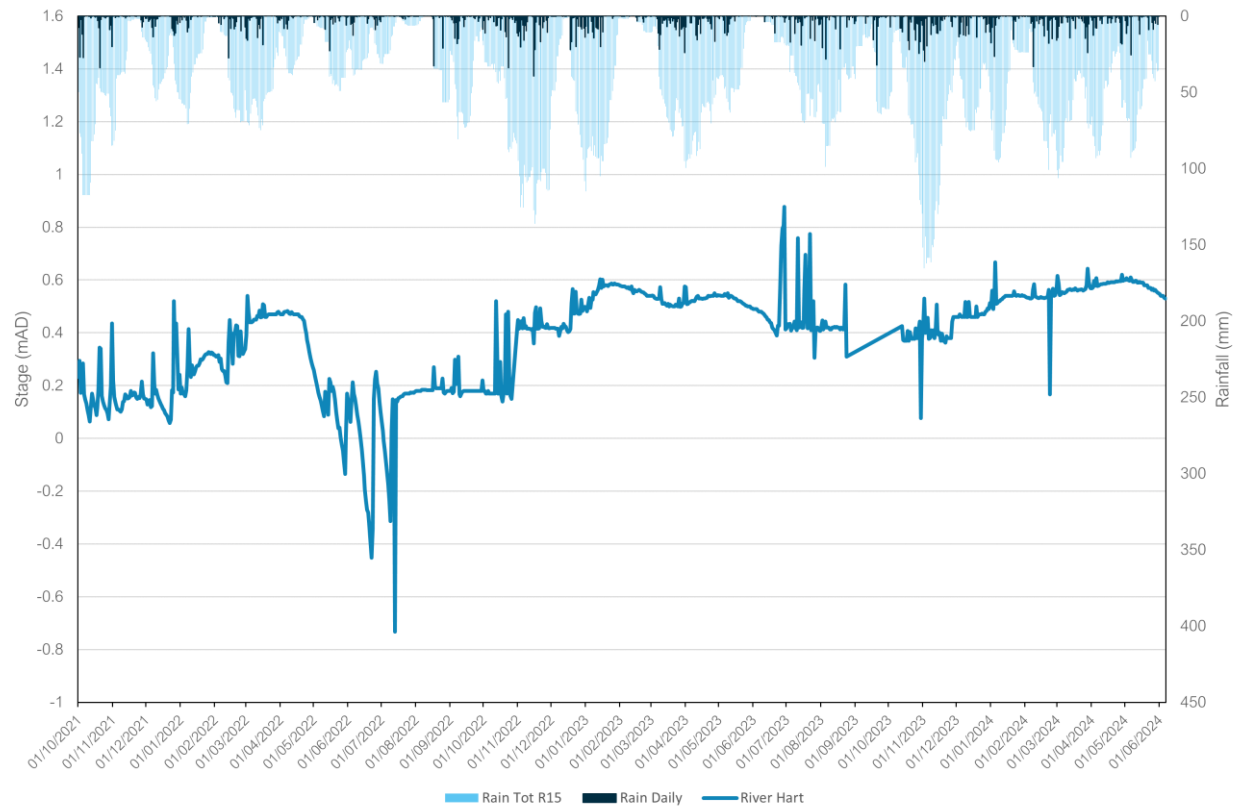
Figure 5A – River Hart, Crondall Pond

Figures 5A-5B represent the last three hydrological years of level information at the indicator sites to build a picture of the relative conditions prevalent in the current year. It is presented against both the daily total rainfall values for the catchment and a rolling 15 day total rainfall. Note that stage data for the River Hart at Redlands Lane site is only available to February 2024.

The data suggests a wider relationship between rainfall, elevated groundwater levels and spill frequency. The majority of spills recorded at Crondall STW occurred January – March 2023, when the indicator site data shown in Figures 5 and 6 suggests that groundwater levels in the catchment became elevated, reaching notably/ exceptionally high levels. In comparison, no spills were recorded at Crondall STW January – March 2022, with the indicator site data shown in Figure 5 suggesting groundwater levels in the catchment were generally lower. Similarly, an absence of spills across the summer months, despite some relatively high rainfall totals, is also
