Groundwater Impacted System Management Plan

East Shefford, River Lambourn

December 2020

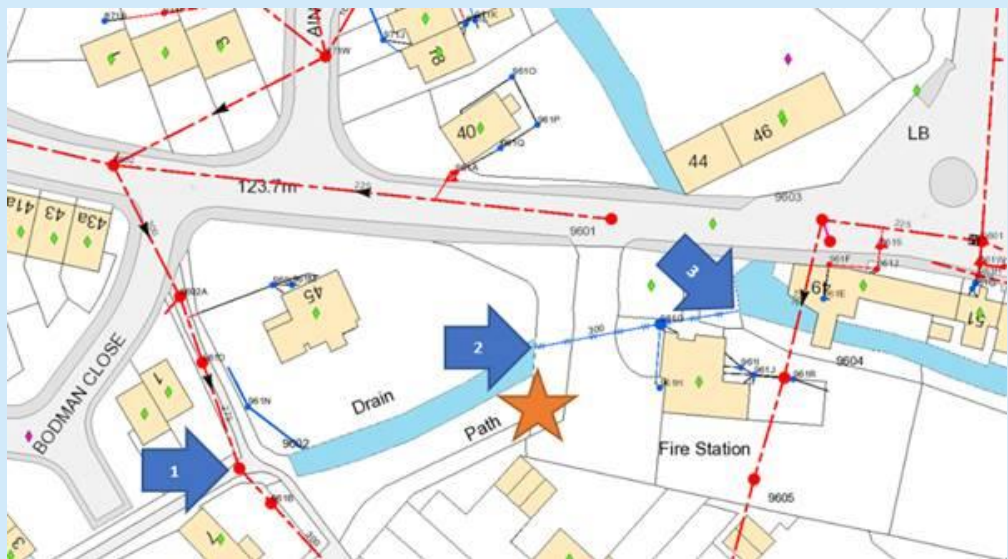
Location	Nr. Newbury Street, Lambourn (see star in Figure below). Flow will be drawn from the manhole located at point 1 and, after treatment (through an ATAC unit), discharged into the surface water culvert (point 2) which enters the main watercourse at point 3.
----------	--

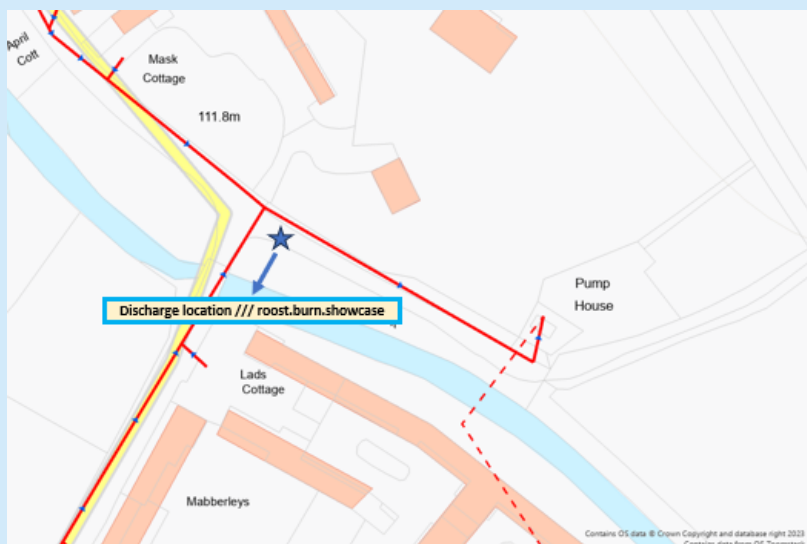
We will discharge into the River Lambourn from the bank. Flows will enter the watercourse, after treatment through an ATAC unit, at location W3W /// roost.burn.showcase (436692, 176475).

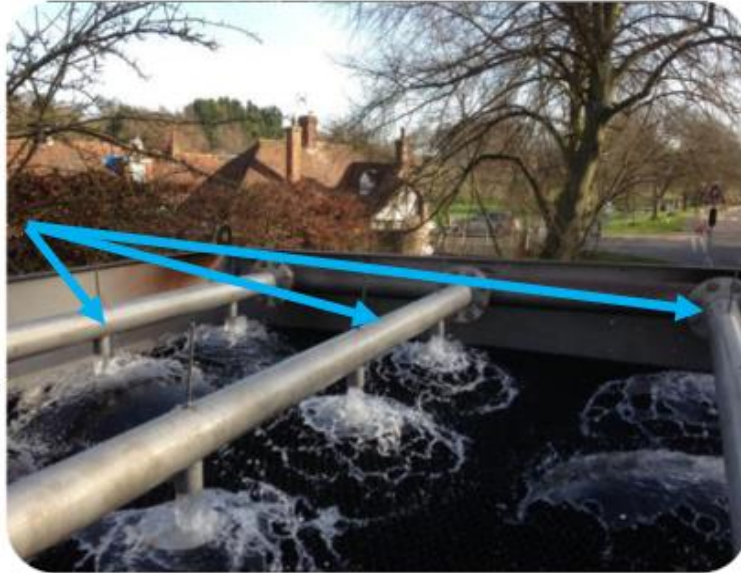
Inside view:

Dirty water being pumped into the unit and working its way through the filter system.

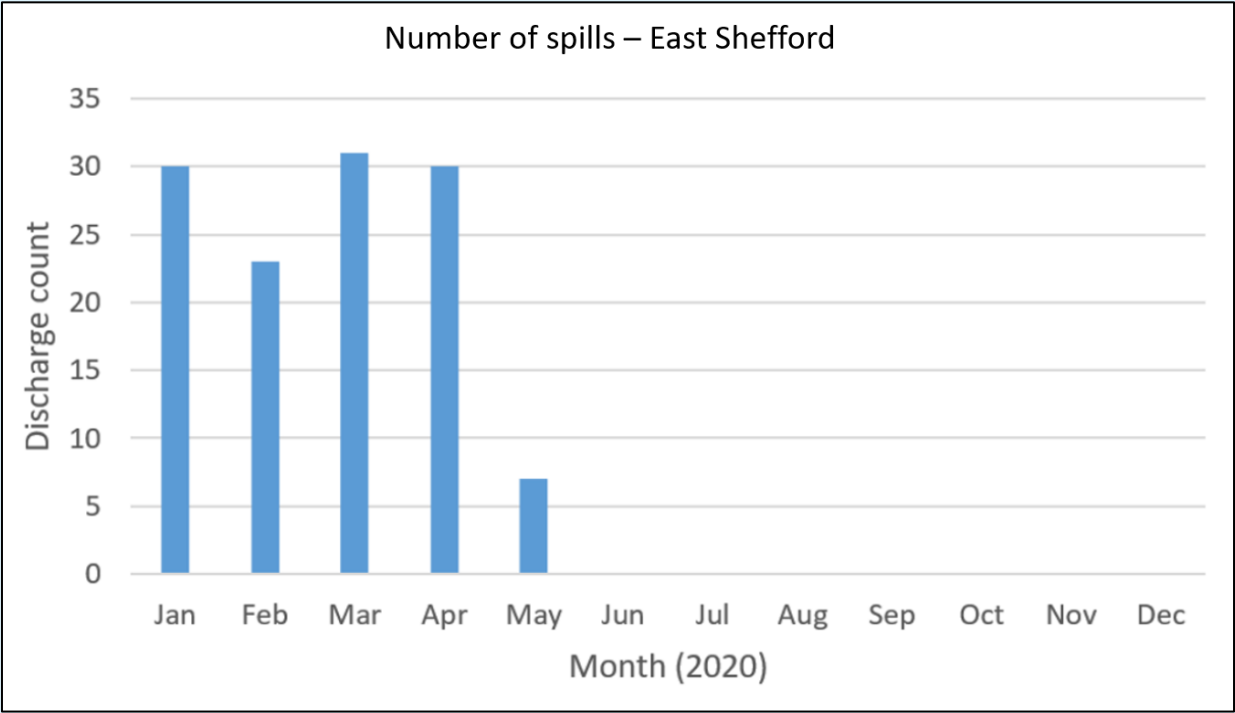
Figure 6 – Number of spills (discharge count) at East Shefford STW (taken from Event Duration Monitor (EDM) Data)*

Figure 6 shows that during the January to May 2020 period the Sewage Treatment Works (STW) experienced a number of discharges (spills). In the summer, no spills were recorded highlighting the influence of groundwater infiltration/winter flows on the system. This Combined Sewer Overflow location has met the trigger for the EA’s Storm Outfall Overflow Assessment Framework (SOAF) and is currently under further investigation with regards to root cause and impact. Tankering was carried out in the East Shefford system over the Winter period to minimise the risk of property flooding. Tankers were unable to keep up with the flows experienced therefore an ATAC bio-filter was deployed in order to protect properties as outlined in the original GISMP report.
