Groundwater Impacted System Management Plan

Fairford, River Coln

March 2021

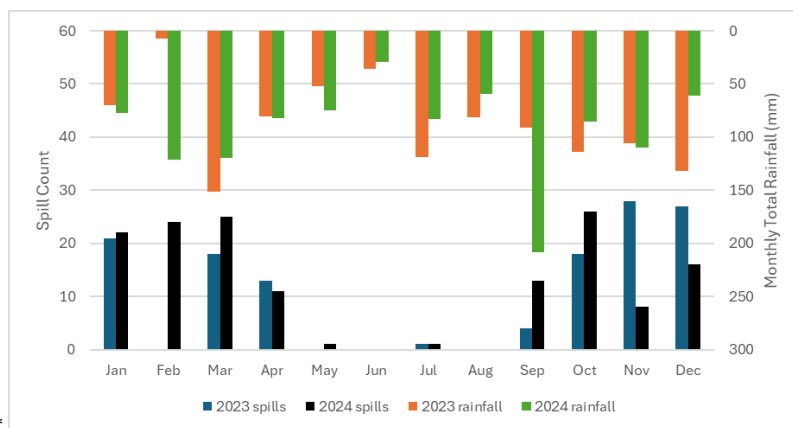
Figure 5: Monthly rainfall data versus monthly spill count for 2023 and 2024 – Ampney St Peter STW

Table 1 below details the last 2 years performance of overflows in the catchment. To assess EDM performance and its relation to groundwater infiltration, a review of the month-on-month spill performance in 2023 and 2024 against the monthly total rainfall values has been undertaken, as observed in Figure 5.

Figures 1 to 5 illustrate the relationship between rainfall and CSO spills. As shown in Figure 1, the decrease in rainfall from 2023/24 to 2024/25 correlates with a decrease in both the number and duration of CSO spills, as shown in Figure 5. However, Figure 2 shows an increase in the river levels, whereas Figure 3 indicates a decrease.

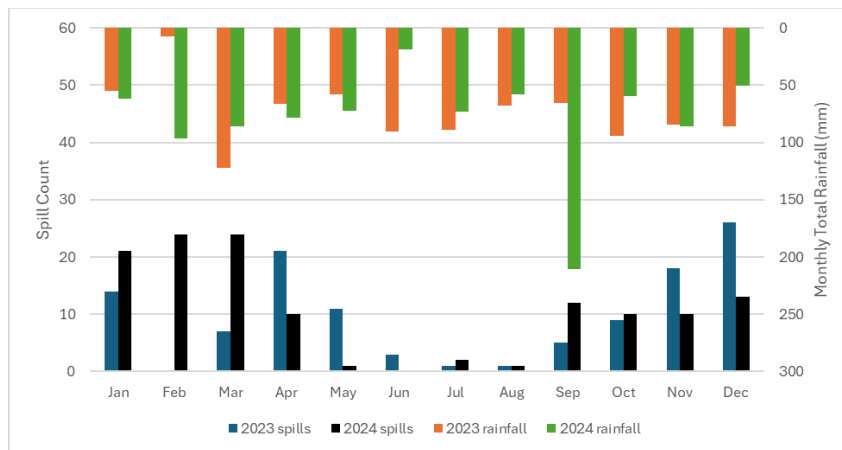
Figure 2: Monthly rainfall data versus monthly spill count for 2023 and 2024 – Drayton STW

Table 1 below details the last 2 years performance of overflows in the catchment. To assess EDM performance and its relation to groundwater infiltration, a review of the month-on-month spill performance in 2023 and 2024 against the monthly total rainfall values has been undertaken, as observed in Figure 2.

Figures 1 and 2 illustrate the relationship between rainfall and spills at CSOs. Figure 1 displays the reduced rainfall in 2024/25 compared to 2023/24, this corresponds to fewer and less duration or spills in 2025, compared to 2024. There is no data available for river or groundwater levels.

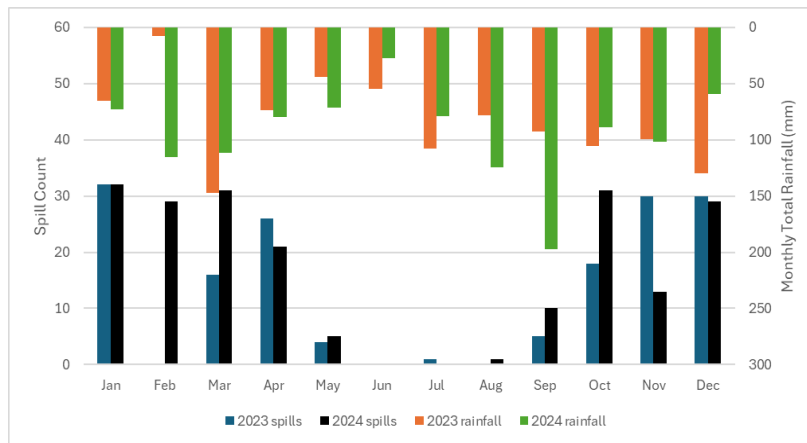
Figure 5: Monthly rainfall data versus monthly spill count for 2023 and 2024 – Fairford STW

Table 1 below details the last 2 years performance of overflows in the catchment. To assess EDM performance and its relation to groundwater infiltration, a review of the month-on-month spill performance in 2023 and 2024 against the monthly total rainfall values has been undertaken, as observed in Figure 5.

Figures 1 to 5 illustrate the relationship between rainfall and CSO spills. Figure 1 outlined the decrease in rainfall from 2023/24 to 2024/25, that correlates with reduced river levels displayed in Figures 2 and 3. There is also fewer and a shorter duration of CSO spills in 2025 compared to 2024 when observing Figure 5.
