Groundwater Impacted System Management Plan

Fairford, River Coln

March 2021

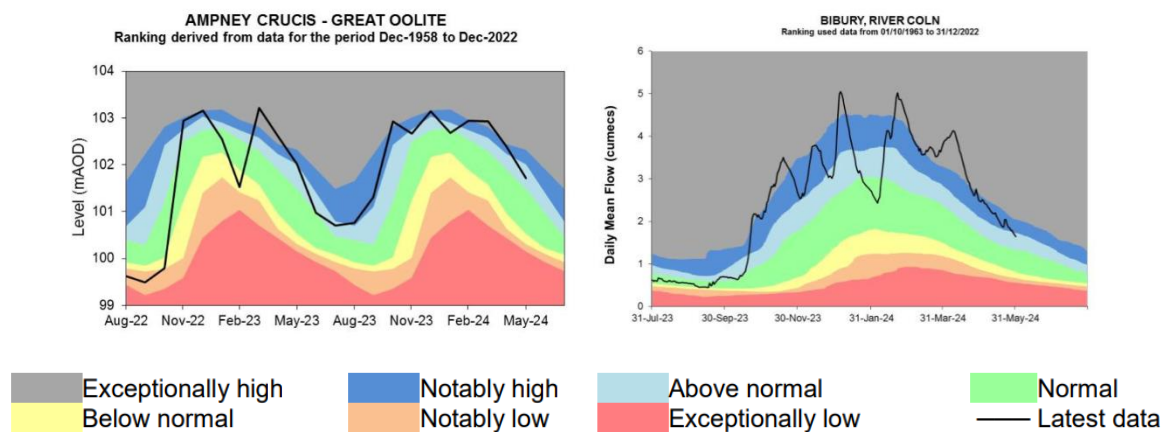
Figure 6 – Water Situation Report

In addition to these specific stations, the wider groundwater context is illustrated in the Water Situation Report for Cotswolds West. The nearest groundwater reference station is Ampney Crucis. This site shows groundwater levels from March through to the end of year in 2023 to be at above normal, notably high and exceptionally high levels. Groundwater levels in 2024 can be observed to sustain above normal / notably high levels throughout the January – May period. This can be seen in Figure 6 alongside the river indicator location at Bibury on the River Coln.
