# Groundwater Impacted System Management Plan

Maple Lodge (Misbourne Sub Catchment)

River Misbourne

July 2021

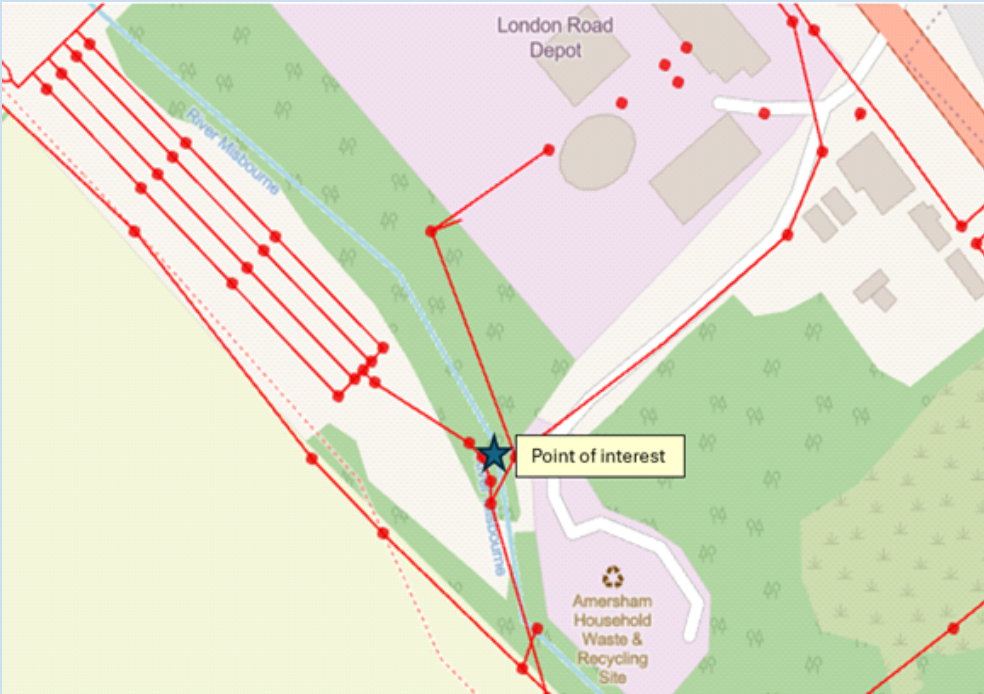
The Amersham ATAC will be deployed adjacent to the Amersham Household Waste and Recycling Centre and will discharge treated water into the River Misbourne at the point of interest marked below. There are a total of three units here with a singular discharge discharge point, additionally a mega unit is able to be deployed in the catchment with a higher treatment capacity than the ATAC units.

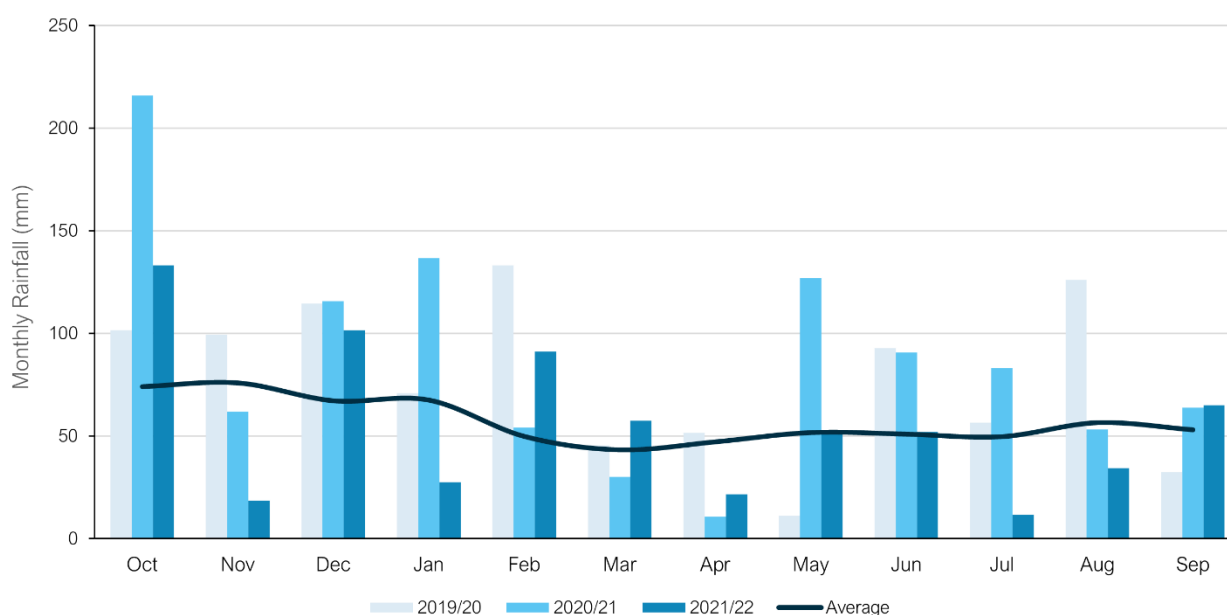
Figure 2 – Monthly Rainfall Performance

Representative Radar rainfall has been used to generate monthly data at catchment level for comparison with average data generated by local Met Office Weather Station Records. Figure 2 presents the comparison of this data for the last three hydrological years to support longer term trends within the local system.

Average Values taken from Met Office Weather Station at Northwood based on the period 1991-2020

The total rainfall for the 2021/22 hydrological year is 1.4% below the annual average total. Total rainfall values are presented in Table 3 below.

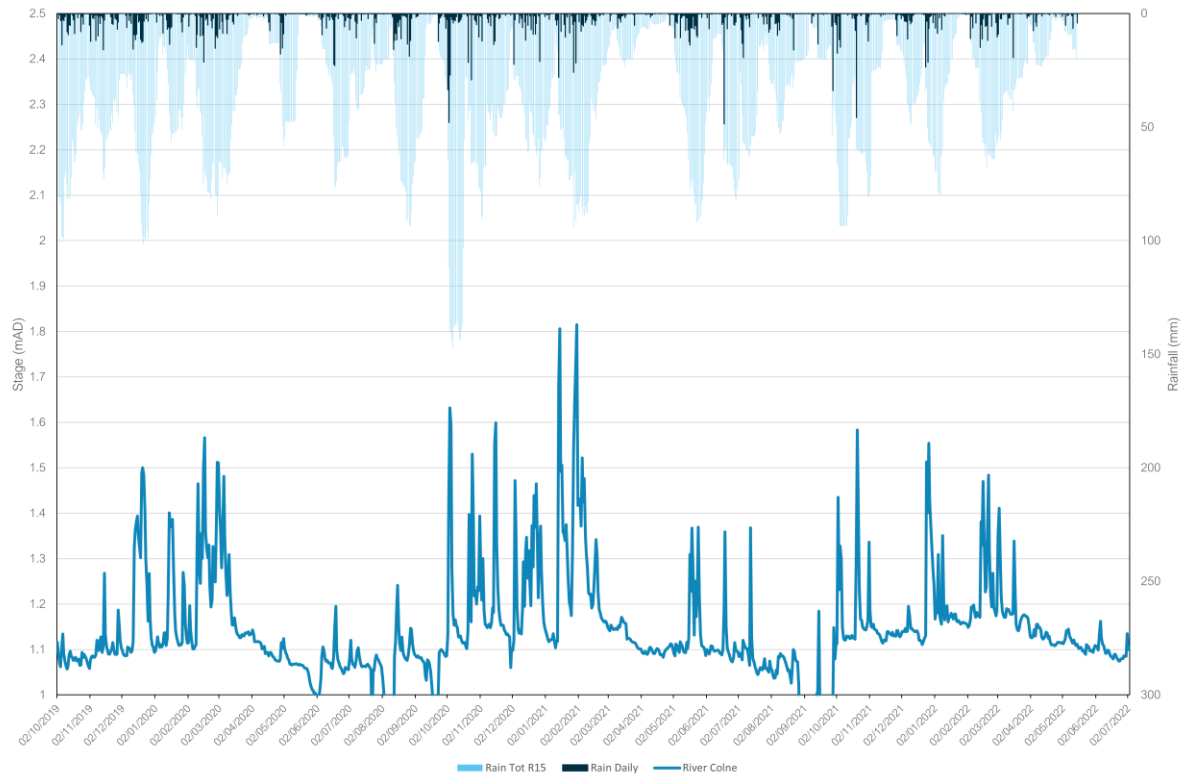
Figure 5A – River Colne, London Colney

The following figures represent the last three hydrological years of level information at the indicator sites to build a picture of the relative conditions prevalent in the current year. It is presented against both the daily total rainfall values for the catchment and a rolling 15 day total rainfall.

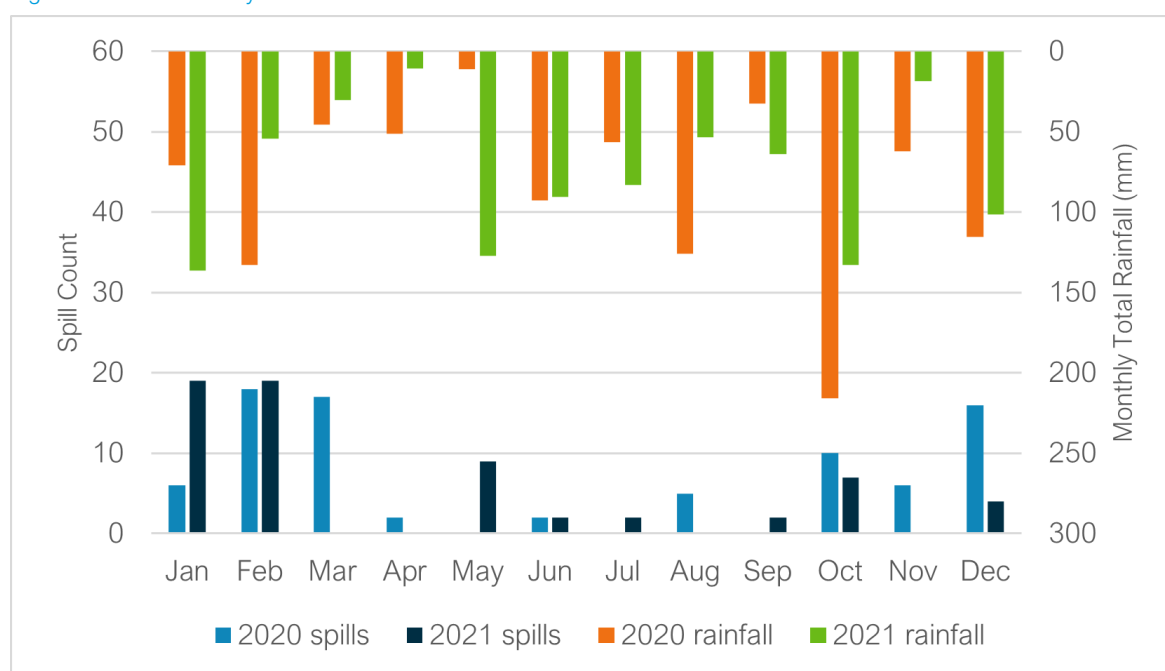
Figure 8 – EDM Monthly Performance

A critical part of the assessment of EDM performance and its relation to groundwater inundation is to review the month-on-month spill performance, against previous years and the monthly total rainfall values to give context to the performance. Figure 8 below presents the EDM performance trend and rainfall for recent years.

The trend in spill performance across the two recorded years does show variation in spills, with a focus on spills during the autumn and winter months. The data suggests a wider relationship between rainfall, elevated groundwater levels and spill frequency, particularly evident at the start of the hydrological years (Oct-Dec). Despite broadly similar rainfall amounts, significantly more EDM spills were recorded at Maple Lodge STW in December 2020, compared to December 2021. The indicator sites suggest groundwater levels in the catchment were lower in December 2021.

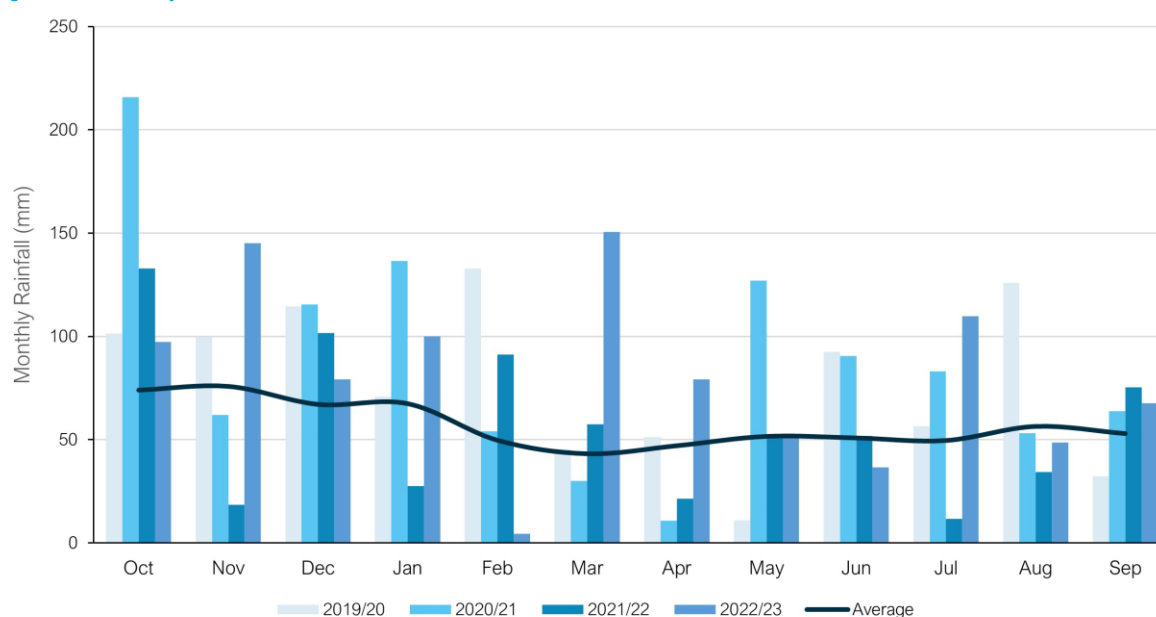
Figure 2 – Monthly Rainfall Performance

Representative Radar rainfall has been used to generate monthly data at catchment level for comparison with average data generated by local Met Office Weather Station Records. Figure 2 presents the comparison of this data for the last four hydrological years to support longer term trends within the local system.

Average Values taken from Met Office Weather Station at Northwood based on the period 1991-2020

The total rainfall for the 2022/23 hydrological year is 41% above the annual average total. Total rainfall values are presented in Table 3 below.

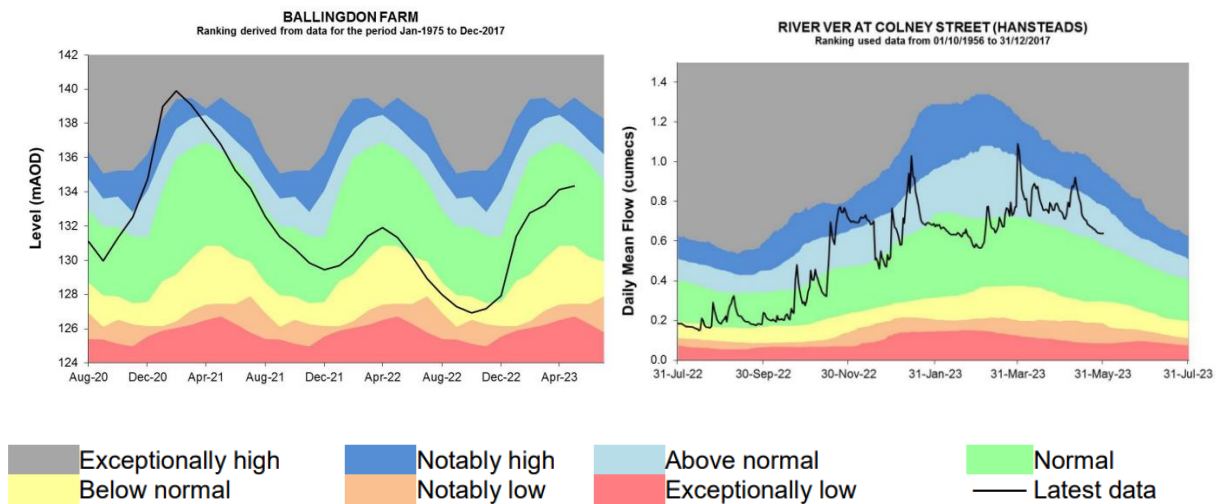
Figure 6 – Water Situation Report

In addition to these specific stations, the wider groundwater context is illustrated in the Water Situation Report for Chilterns East - Colne. The nearest groundwater reference station is Ballingdon Farm. This site shows groundwater levels at normal or below normal levels in 2022. Groundwater levels are observed to rise towards the end of the year and have been observed at normal levels in 2023, and at higher levels than equivalent periods in 2022. This can be seen in the figure below alongside the river indicator location at Colney Street on the River Ver.

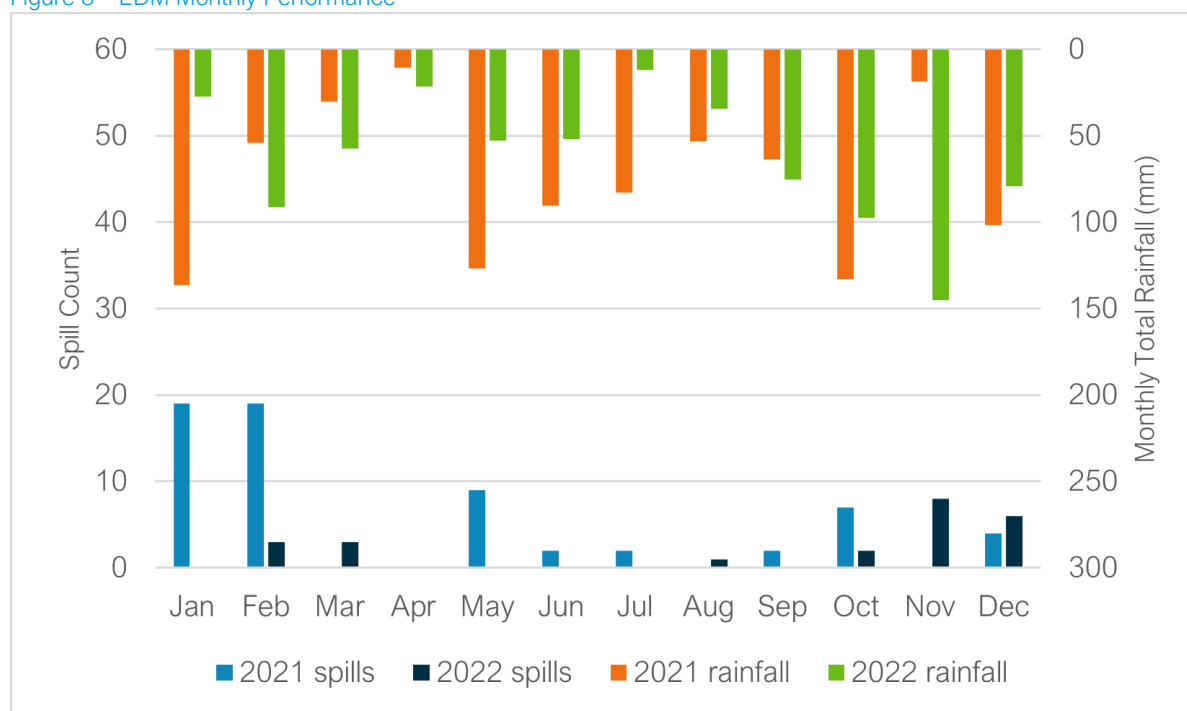
Figure 8 – EDM Monthly Performance

A critical part of the assessment of EDM performance and its relation to groundwater infiltration, is to review the month-on-month spill performance against previous years and the monthly total rainfall values to give context to the performance. Figure 8 below presents the EDM performance trend and rainfall for recent years.

The trend in spill performance across the two recorded years does show variation in spills, with a focus on spills during the autumn and winter months. The data suggests a wider relationship between rainfall, elevated groundwater levels and spill frequency. Significantly more EDM spills were recorded at Maple Lodge STW in January and February 2021, compared to the same period in 2022. The indicator site data shown in Figure 5, suggests groundwater levels in the catchment were significantly higher in January and February 2021, with Figure 6 suggesting they were notably/ exceptionally high over the period, compared to the normal levels observed January – February 2022.

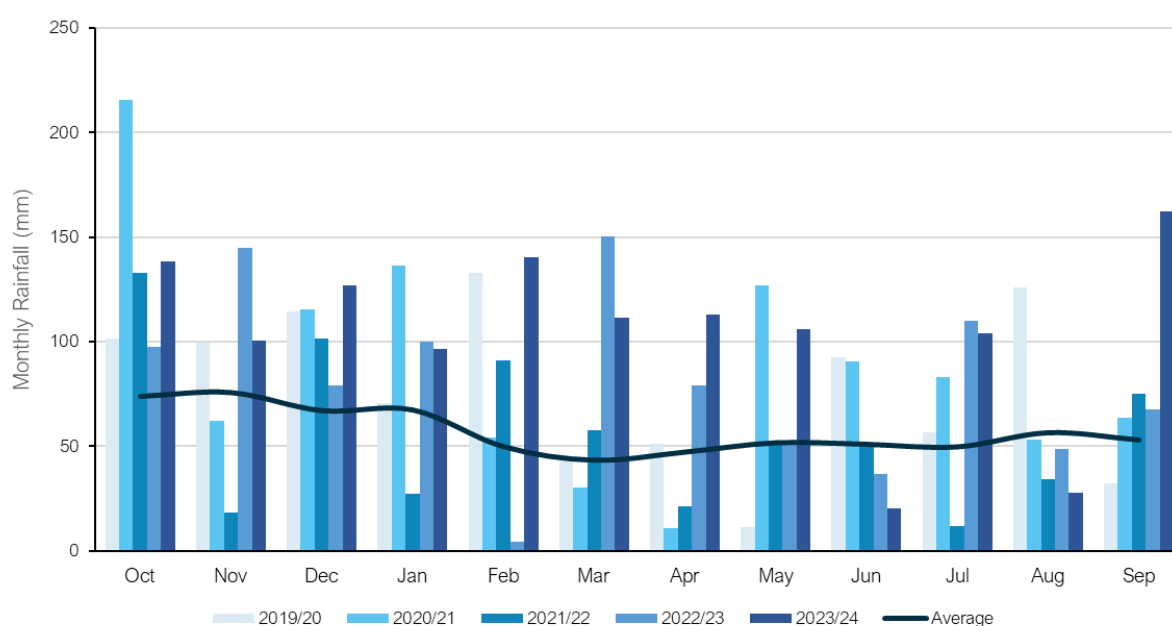
Figure 2 – Monthly Rainfall Data

Representative Radar rainfall has been used to generate monthly data at catchment level for comparison with average data generated by local Met Office Weather Station Records. Figure 2 presents the comparison of this data for the last five hydrological years to support longer term trends within the local system.

Average Values taken from Met Office Weather Station at Northwood based on the period 1991-2020

The total rainfall for the 2023/24 hydrological year is 82% above the annual average total. Total rainfall values are presented in Table 3 below.

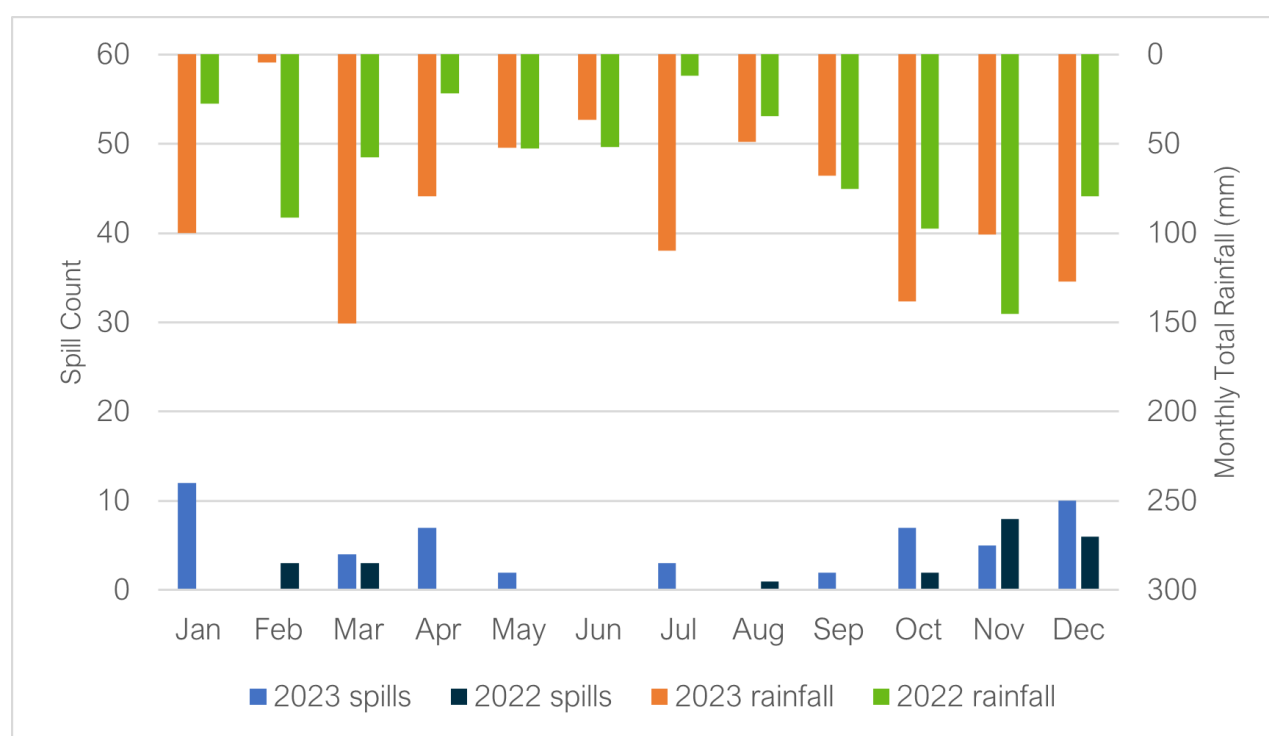
Figure 8 – EDM Monthly Performance ‘Maple Lodge STW’

A critical part of the assessment of EDM performance and its relation to groundwater infiltration, is to review the month-on-month spill performance against previous years and the monthly total rainfall values to give context to the performance. Figure 8 below presents the EDM performance trend and rainfall for recent years.

The trend in spill performance across the two recorded years does show variation in spills, with a focus on spills during the autumn and winter months. The data suggests a wider relationship between rainfall, elevated groundwater levels and spill frequency. For example, despite a significantly higher rainfall total in March 2023 compared to March 2022, a similar number of spills were recorded. The indicator site data shown in Figure 5, suggests that groundwater levels in the catchment were similar in March 2022 and March 2023. The occurrence of spills in the summer months, is also indicative of spills occurring in the catchment during prolonged or intense rainfall events, outside of periods of significantly elevated groundwater levels.
