Groundwater Impacted System Management Plan

Marlborough, River Kennet

January 2021

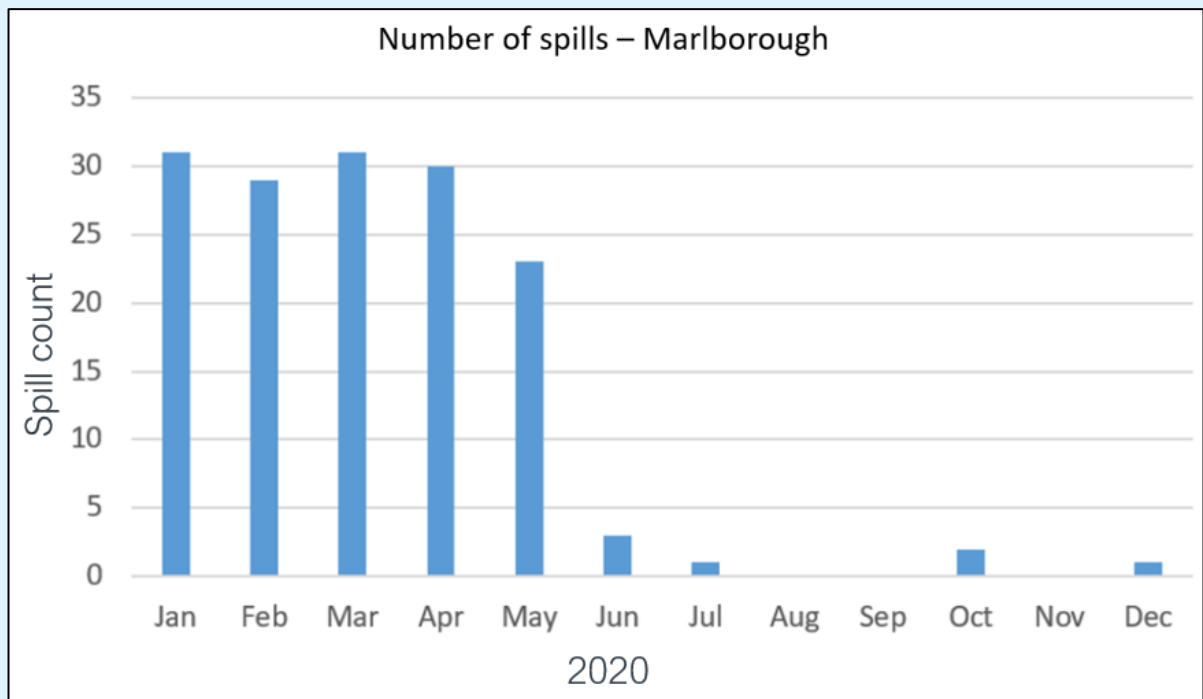
Figure 8 – Number of spills (discharge count) at Marlborough STW (taken from Event Duration Monitor (EDM) Data).*

Figure 8 shows the number of spills per month from Marlborough Sewage Treatment Works (STW). January to May 2020 saw the greatest number of discharges. In the summer period the number of spills were much lower, highlighting the influence of groundwater infiltration/winter flows on the system. This Combined Sewer Overflow location has met the trigger for the EA's Storm Outfall Overflow Assessment Framework (SOAF) and is currently under further investigation with regards to root cause and impact.

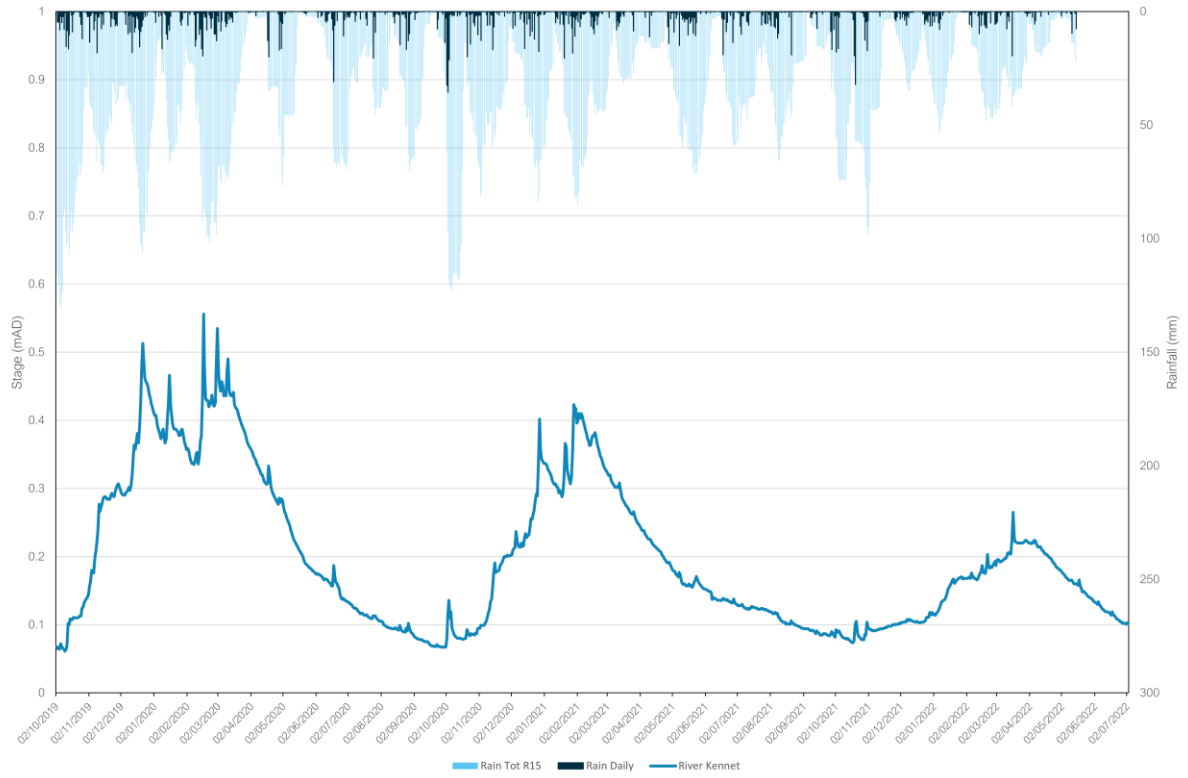
Figure 5A – River Kennet at Marlborough

The following figures represent the last three hydrological years of level information at the indicator sites to build a picture of the relative conditions prevalent in the current year. It is presented against both the daily total rainfall values for the catchment and a rolling 15 day total rainfall.

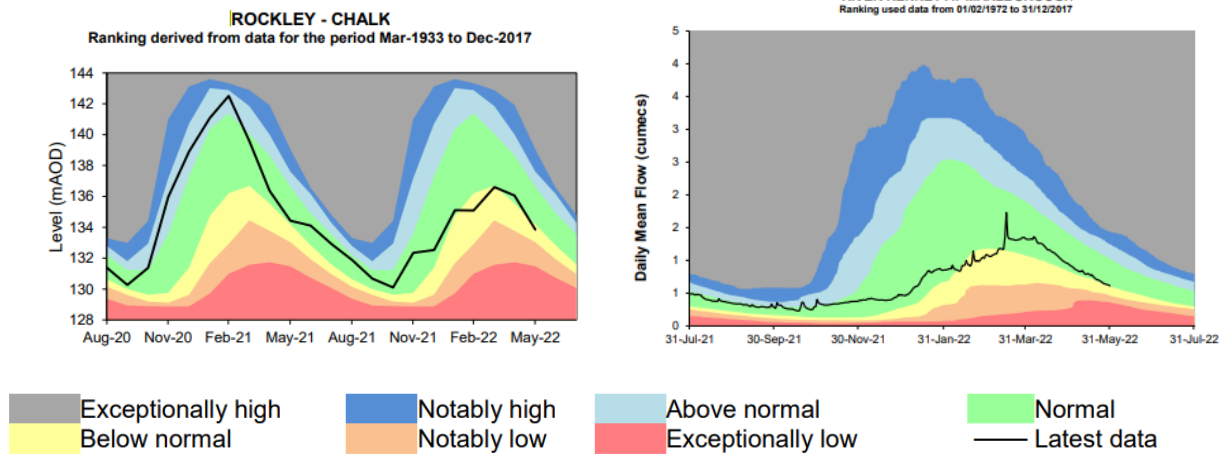
Figure 6 – Water Situation Report

In addition to these specific stations, the wider groundwater context is illustrated in the Water Situation Report for the Berkshire Downs. The nearest groundwater reference station is Rockley OBH. This site shows significantly lower overall groundwater than the previous year. This can be seen in the figure below alongside the river indicator location at Marlborough on the River Kennet.

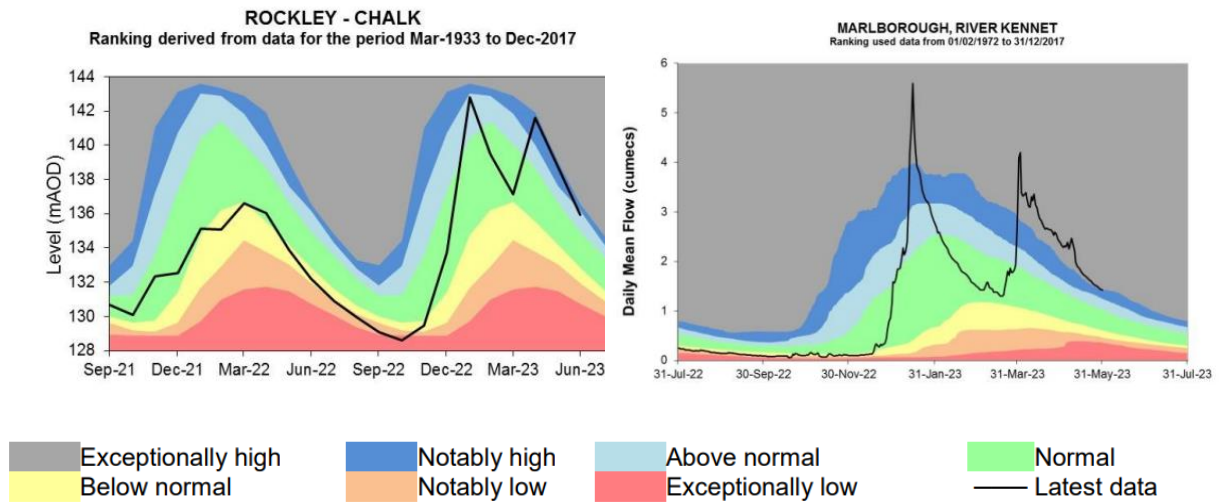
Figure 6 – Water Situation Report

In addition to these specific stations, the wider groundwater context is illustrated in the Water Situation Report for the Berkshire Downs. The nearest groundwater reference station is Rockley OBH. This site shows groundwater levels generally at below normal or notably low levels in 2022. Groundwater levels rise towards the end of the year and are observed at above normal levels in December 2022. Groundwater levels in 2023 have remained higher than the equivalent periods in 2022. This can be seen in the figure below alongside the river indicator location at Marlborough on the River Kennet.
