Groundwater Impacted System Management Plan

Milton-under-Wychwood, River Evenlode

April 2021

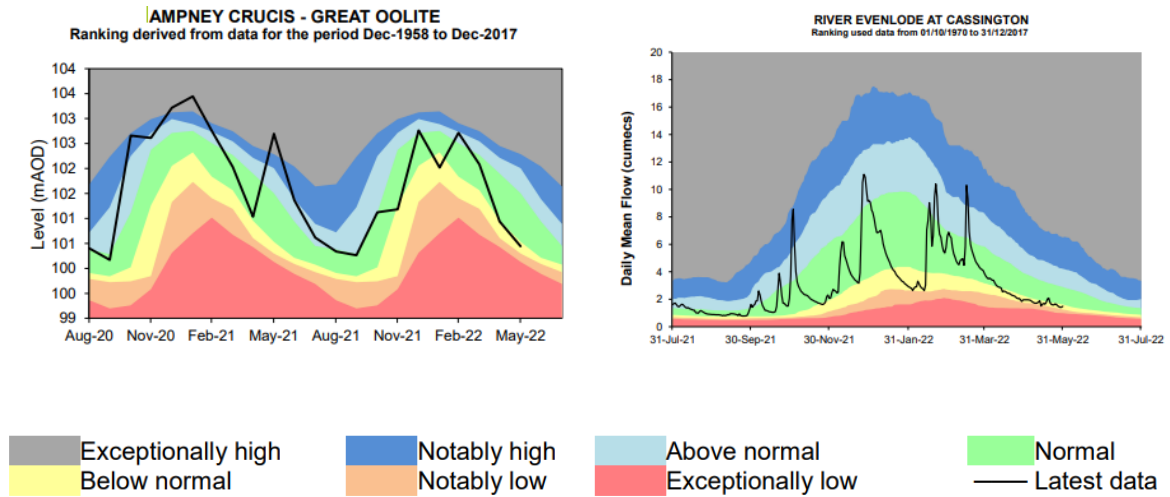
Figure 6 – Water Situation Report

In addition to these specific stations, the wider groundwater context is illustrated in the Water Situation Report for Cotswold East. The nearest groundwater reference station is Ampney Crucis. This site shows generally lower overall groundwater than the previous year, particularly evident during the winter months. This can be seen in the figure below alongside the river indicator location at Cassington on the River Evenlode.

Extract from - [Water Situation Report \(publishing.service.gov.uk\)](https://publishing.service.gov.uk)

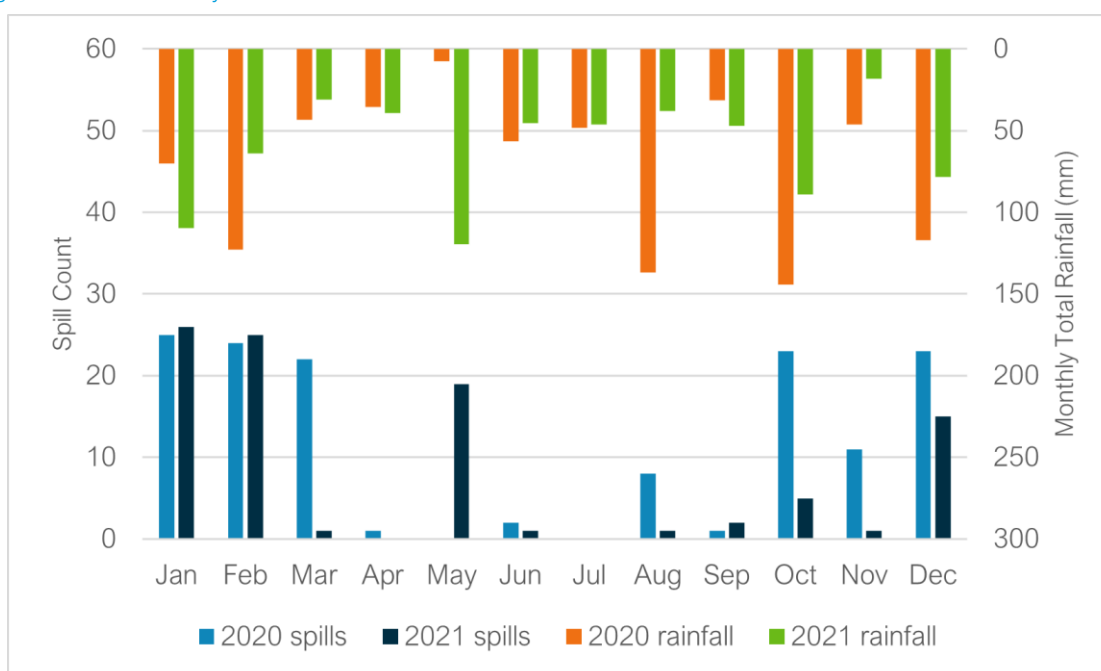
Figure 8 – EDM Monthly Performance

A critical part of the assessment of EDM performance and its relation to groundwater inundation is to review the month-on-month spill performance, against previous years and the monthly total rainfall values to give context to the performance. Figure 8 below presents the EDM performance trend and rainfall for recent years.

The trend in spill performance across the two recorded years does show variation in spills, with a focus on spills during the autumn and winter months. The data suggests a wider relationship between rainfall, elevated groundwater levels and spill frequency. A slower tail off in spills is evident within the first half of 2020, when the indicator sites suggest groundwater levels in the catchment were higher than within the first half of 2021.

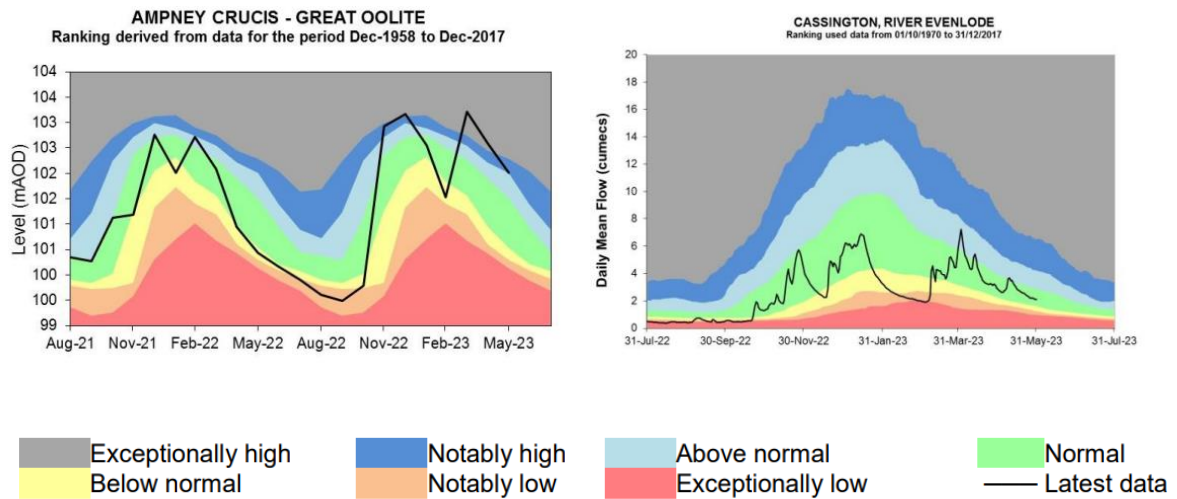
Figure 6 – Water Situation Report

In addition to this specific station, the wider groundwater context is illustrated in the Water Situation Report for Cotswold East. The nearest groundwater reference station is Ampney Crucis. This site shows groundwater levels were generally at normal, below normal, or notably low levels in 2022. Groundwater levels have generally been higher in 2023, reaching above normal, notably high, and exceptionally high levels. This can be seen in the figure below alongside the river indicator location at Cassington on the River Evenlode.

Extract from - [Water Situation Report \(publishing.service.gov.uk\)](https://publishing.service.gov.uk)

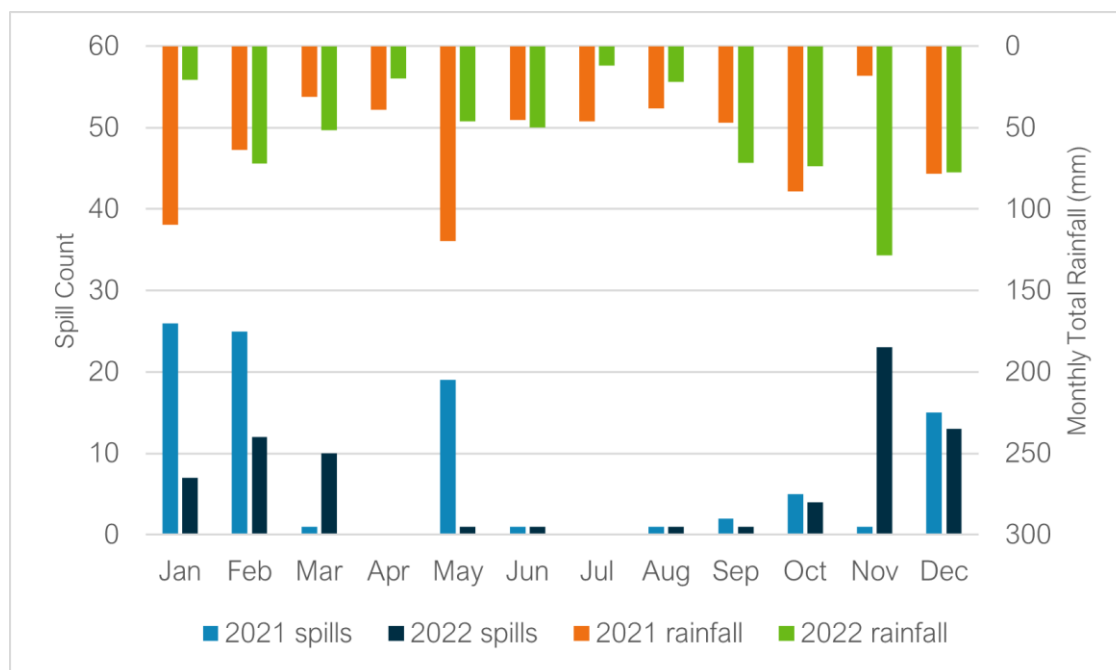
Figure 8 – EDM Monthly Performance

A critical part of the assessment of EDM performance and its relation to groundwater infiltration is to review the month-on-month spill performance, against previous years and the monthly total rainfall values to give context to the performance. Figure 8 below presents the EDM performance trend and rainfall for recent years.

The trend in spill performance across the two recorded years does show variation in spills, with a focus on spills during the autumn and winter months. The data suggests a wider relationship between rainfall, elevated groundwater levels and spill frequency. Despite broadly similar rainfall totals, significantly more spills were recorded at Milton-under-Wychwood STW in February 2021 compared to February 2022. The indicator site data shown in Figure 5, suggests groundwater levels in the catchment were higher in February 2021. In November 2022, a significantly higher number of spills were recorded in comparison to November 2021, with Figure 6 suggesting groundwater levels in the catchment reached notably high levels during the period.

EDM data for the Milton-under-Wychwood catchment is indicative of the role of groundwater infiltration on overflow spills in the catchment. This hydrological year (October 2022 – September 2023), indicator site data suggests groundwater levels in the catchment have generally been higher than the previous hydrological year, and EDM data for 2023 will be analysed once available to continue to examine the relationship between groundwater levels and overflow spills in the catchment.
