Groundwater Impacted System Management Plan

Ramsbury, River Kennet

December 2020

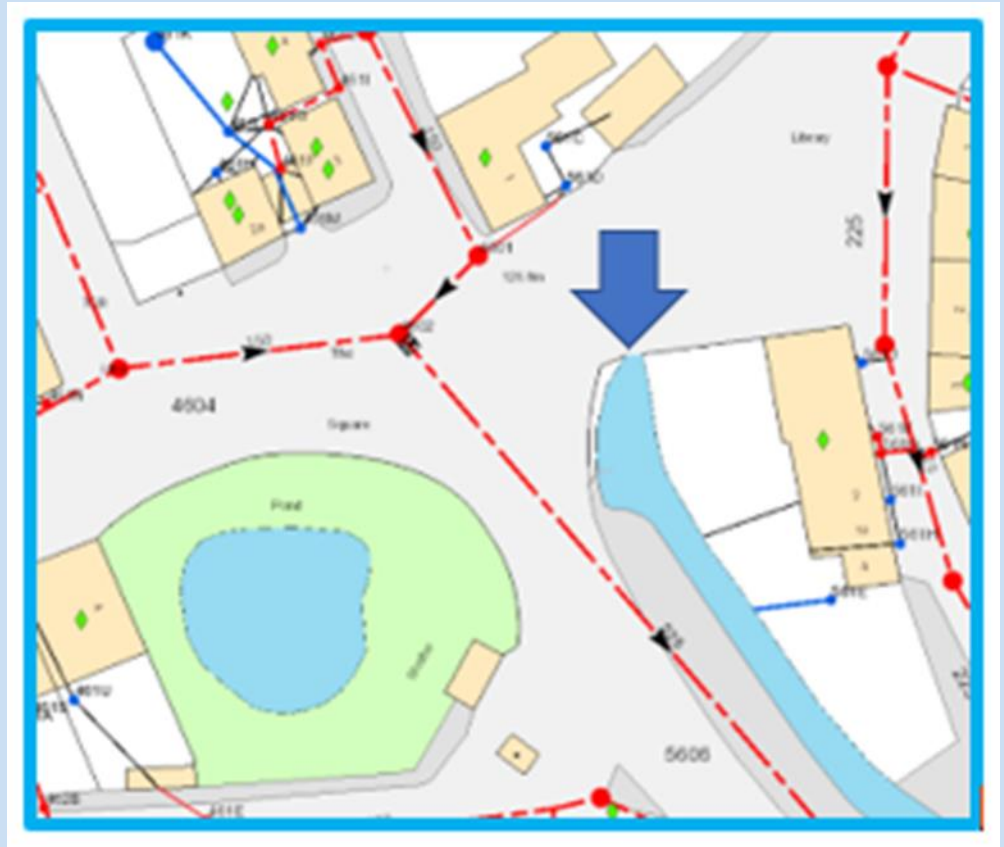
Lottage Road, Aldbourne. The ATAC would be deployed to the carpark to the front of the library, this would then draw flows from the Lottage Road area via MH 5607. Following filtration, it would then pass flow forward via an unmapped culvert MH. Flows from the culvert MH would be discharged to 51°28'45.4"N 1°37'10.8"W (51.479269, -1.619665)

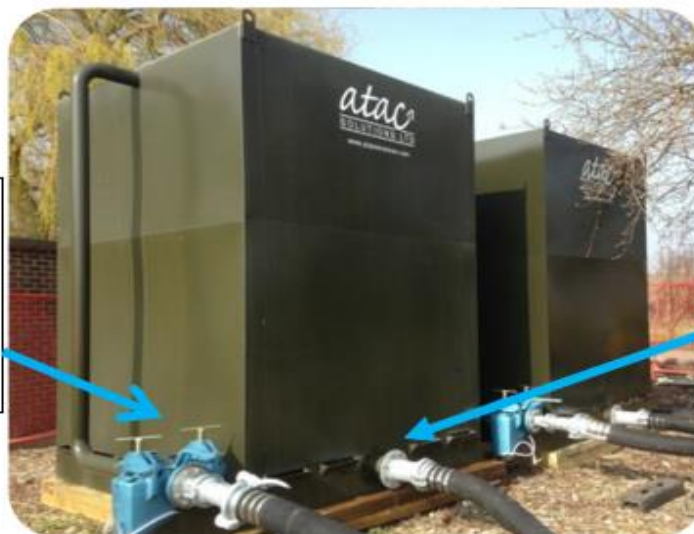
Outside view:

Dirty water entering the filter unit to be treated and then pumped to the top of the unit

Treated water leaving the unit and returning to the environment

<p>In order to minimise the impact on the watercourse the discharges will be treated via an ATAC Biofilter which removes solids and biological loading from wastewater influents, whilst also adding dissolved oxygen into the effluent flow.</p>
Mitigation	<p>Should flows stay within the sewer, and not reach the volume to discharge from the sewer, no discharge to the river will take place.</p>
Monitoring	<p>During periods of discharge daily samples of water quality will be taken upstream and downstream to assess impact on the river amenity, use and quality.</p> <p>The following parameters at a minimum will be tested:</p> <ul style="list-style-type: none">• Biological Oxygen Demand• ammonia• solids• phosphorus• and bacterial quality including E. Coli
Contact	<p>If discharges occur the Environment Agency will be informed (by logging through the Agency's National Incident Communication Service). For any other reporting please use the Environment Agency pollution reporting number 0800 807060. In addition, local community representatives will be informed.</p> <p>If the ATACs are deployed signage will be placed in the locality and local letter drops carried out to inform residents. An example of the type of signage and information displayed is shown in the appendix of this document.</p>

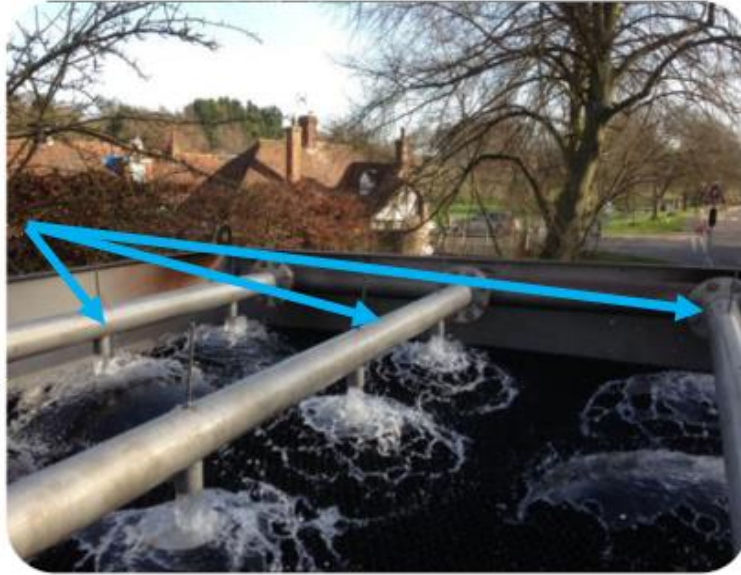
Inside view:

Dirty water being pumped into the unit and working its way through the filter system.

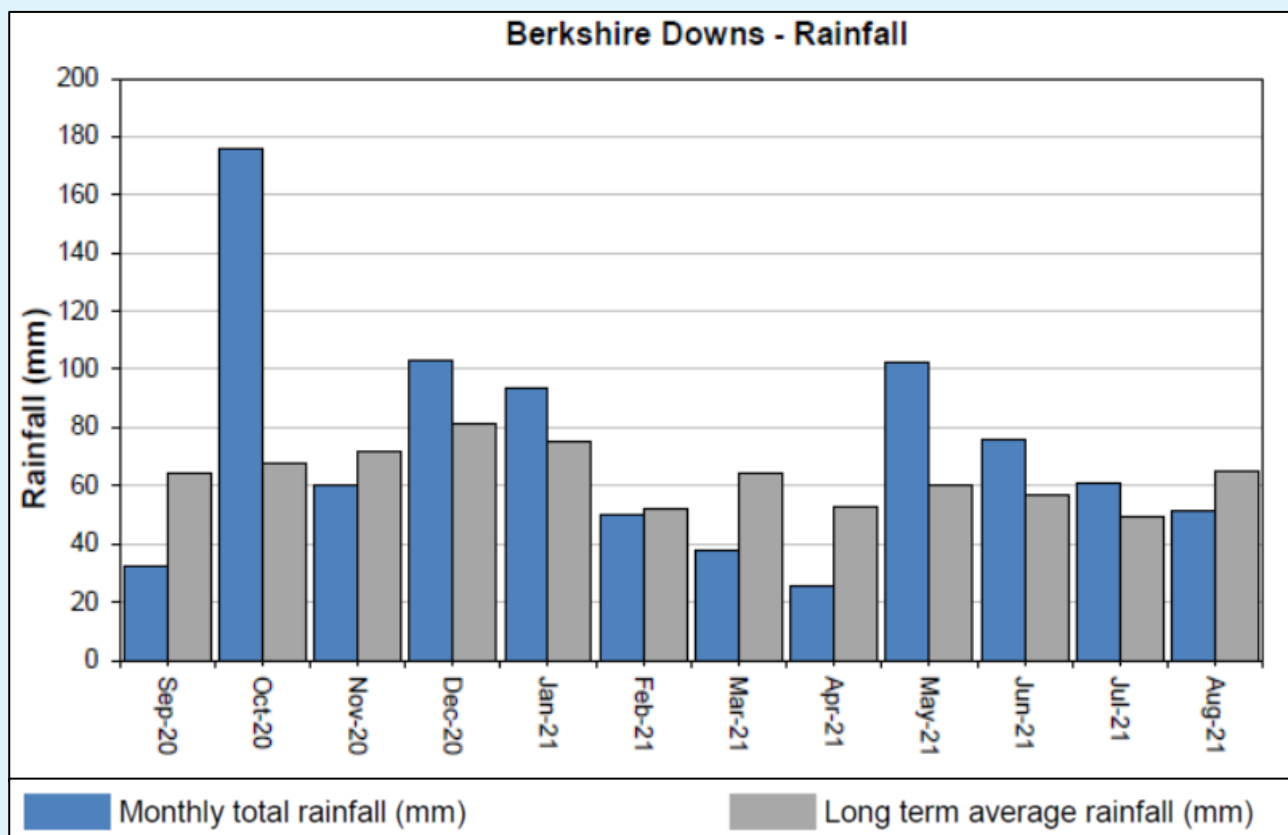
Figure 2 – Monthly rainfall depths local to the system

Ramsbury is situated in the Berkshire Downs water resources area. Figure 2 shows the monthly rainfall total depths against the long-term average rainfall in the location of Ramsbury over the period taken from the *Environment Agency Water Situation Report August 2021*.⁸

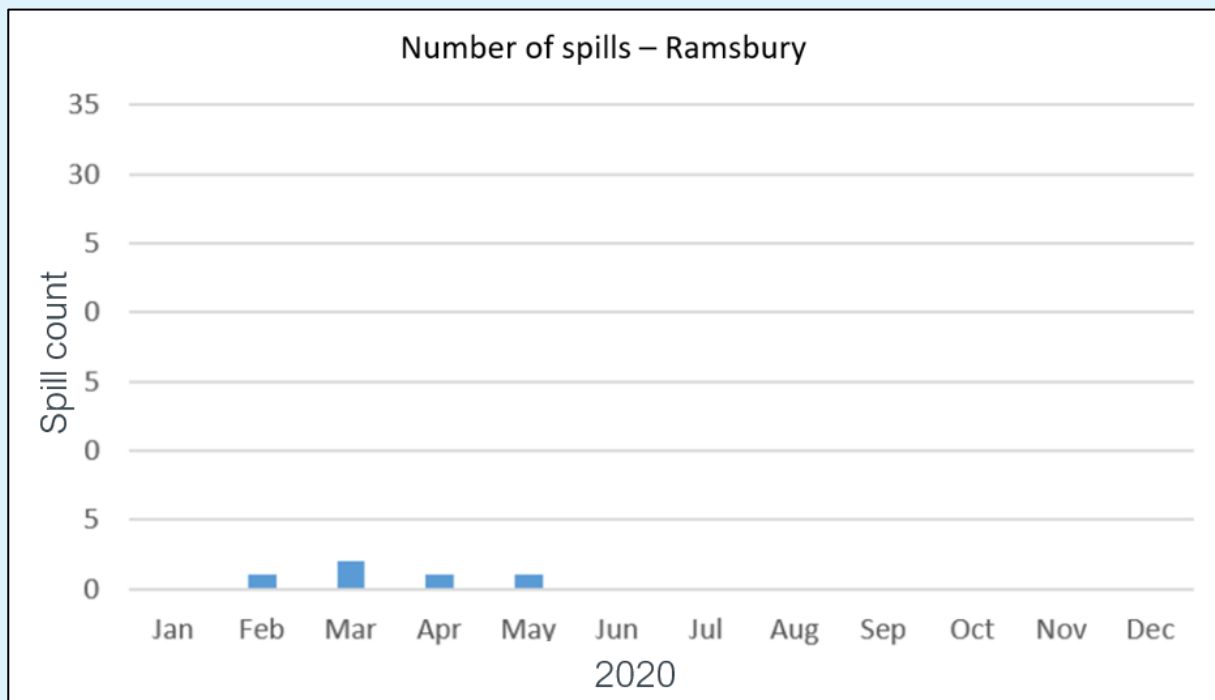
Figure 6 – Number of spills (discharge count) at Ramsbury STW (taken from Event Duration Monitor (EDM) Data).*

Figure 6 shows the number of spills per month from Ramsbury Sewage Treatment Works. The number of spills at this location indicates that the impact of groundwater infiltration at the STW is minimal. Tankering was carried out in the Ramsbury system over the Winter period to minimise the risk of property flooding. Tankers were unable to keep up with the levels of flows experienced, therefore an ATAC bio-filter was deployed to protect properties from flooding as outlined in the original GISMP report.

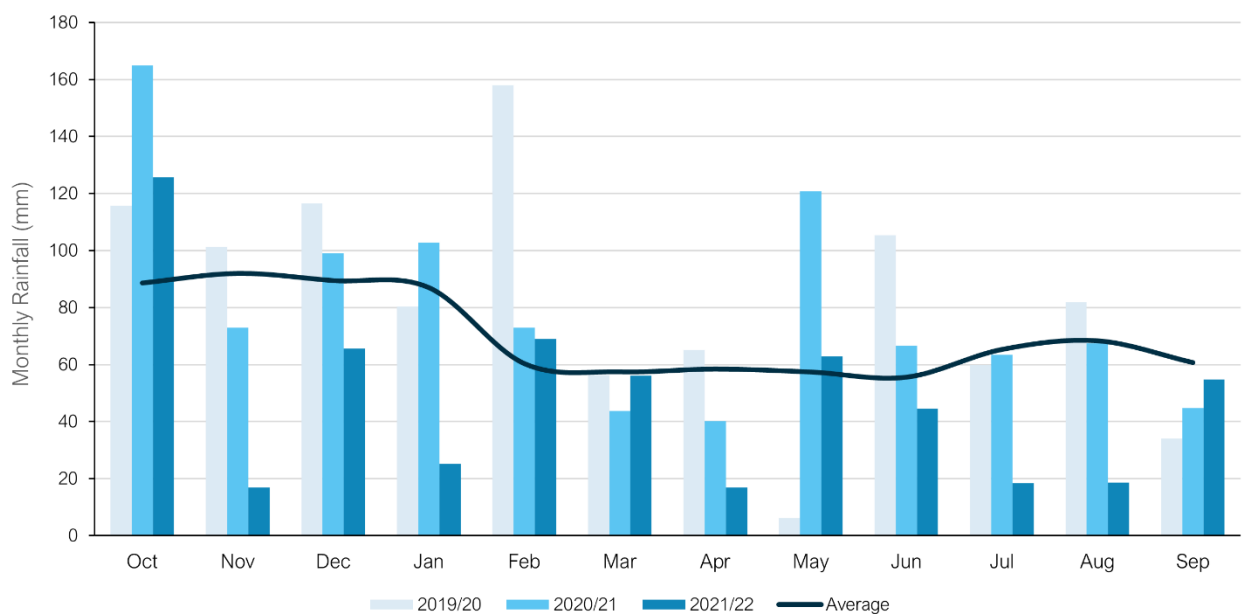
Figure 2 – Monthly Rainfall Performance

Representative Radar rainfall has been used to generate monthly data at catchment level for comparison with average data generated by local Met Office Weather Station Records. Figure 2 presents the comparison of this data for the last three hydrological years to support longer term trends within the local system.

Average Values taken from Met Office Weather Station at Marlborough based on the period 1991-2020

The total rainfall for the 2021/22 hydrological year is 31% below the annual average total. Total rainfall values are presented in Table 3 below.

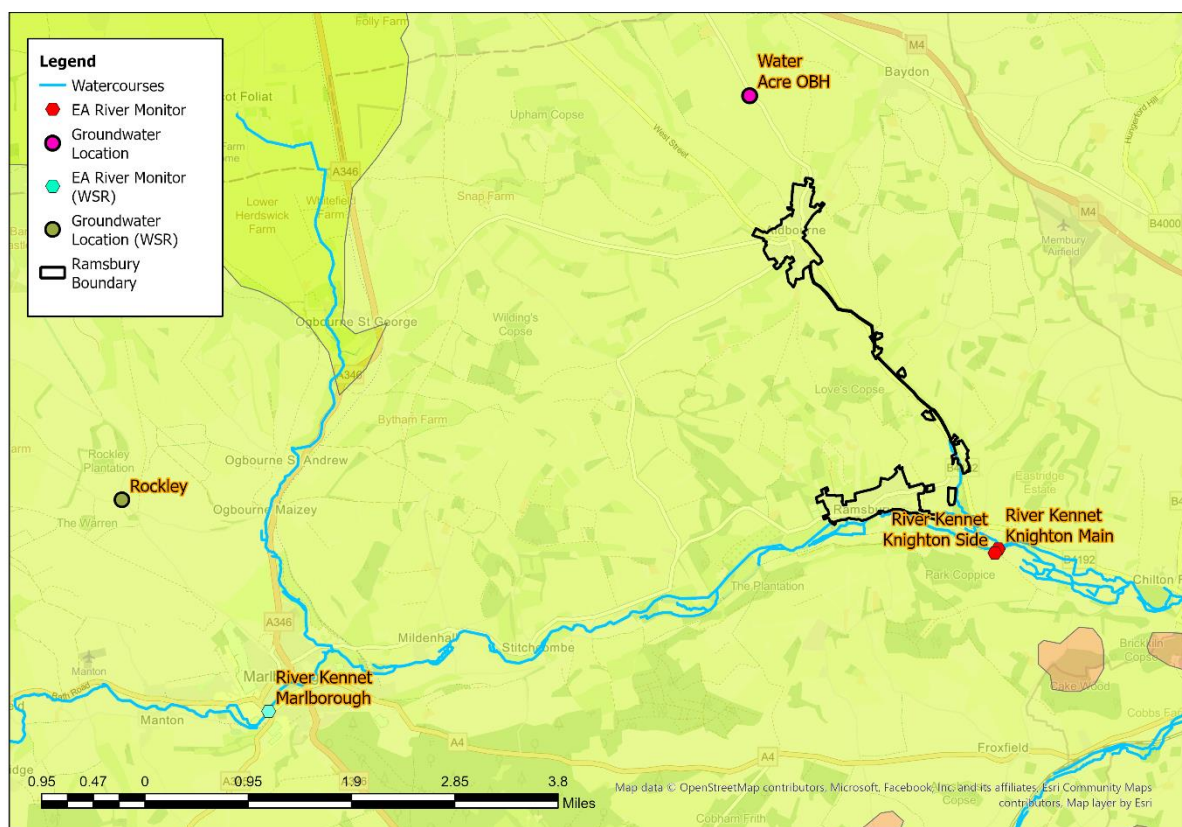
Figure 4 – Local Monitoring Stations

These sites are illustrated in the figure below, alongside the closest groundwater reference station and closest gauging station from the Water Situation Report.

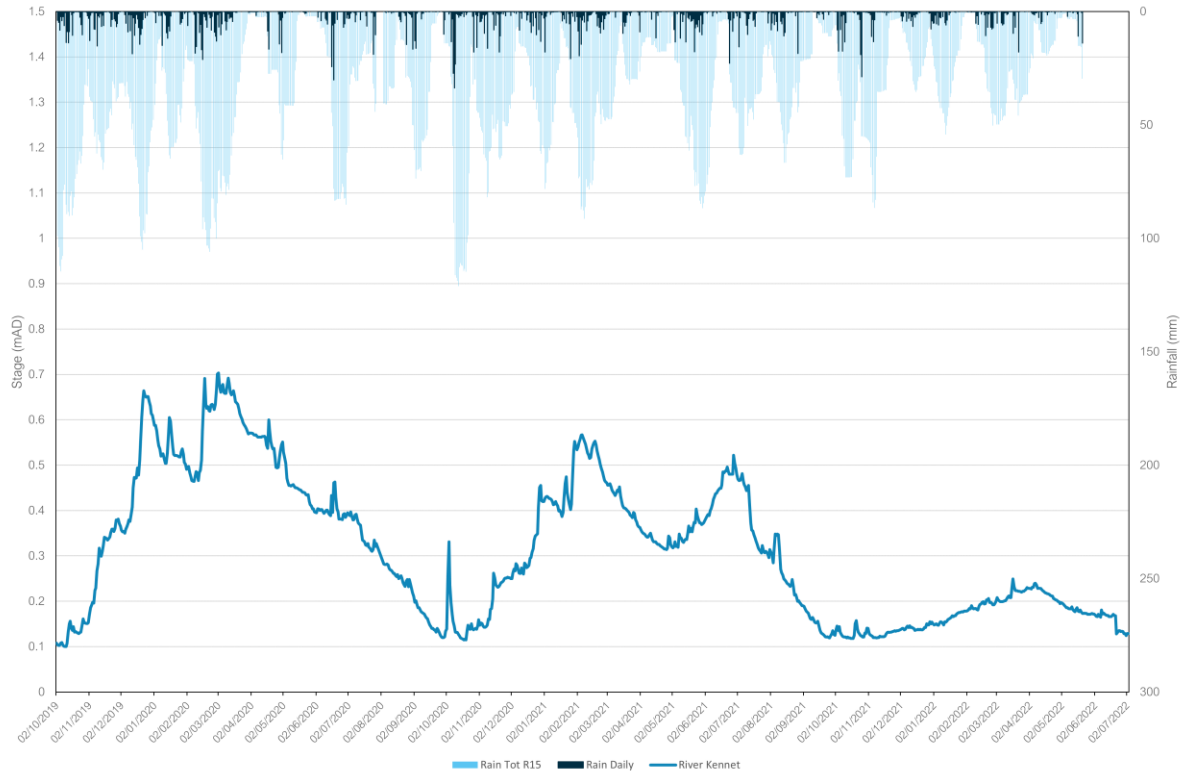
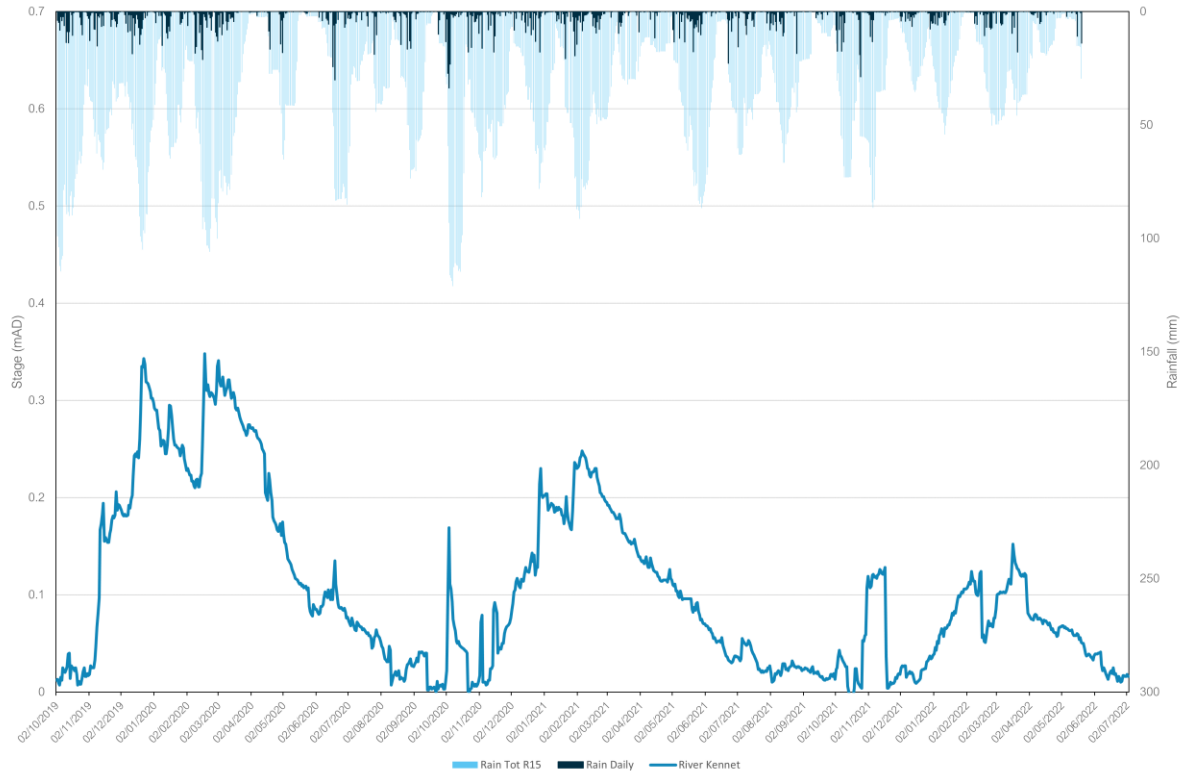
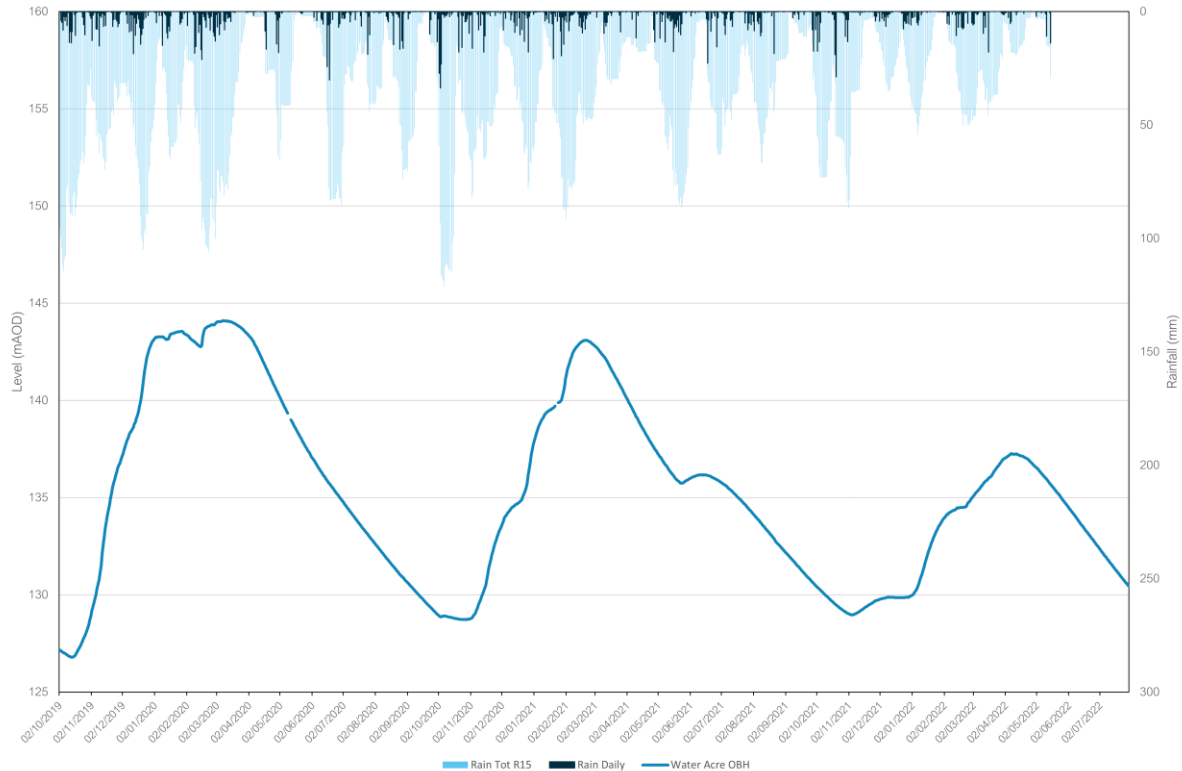
The following figures represent the last three hydrological years of level information at the indicator sites to build a picture of the relative conditions prevalent in the current year. It is presented against both the daily total rainfall values for the catchment and a rolling 15 day total rainfall.

Figure 5A – Kennet, Knighton Main

Figure 5B – Kennet, Knighton Side

Figure 5C – Water Acre OBH

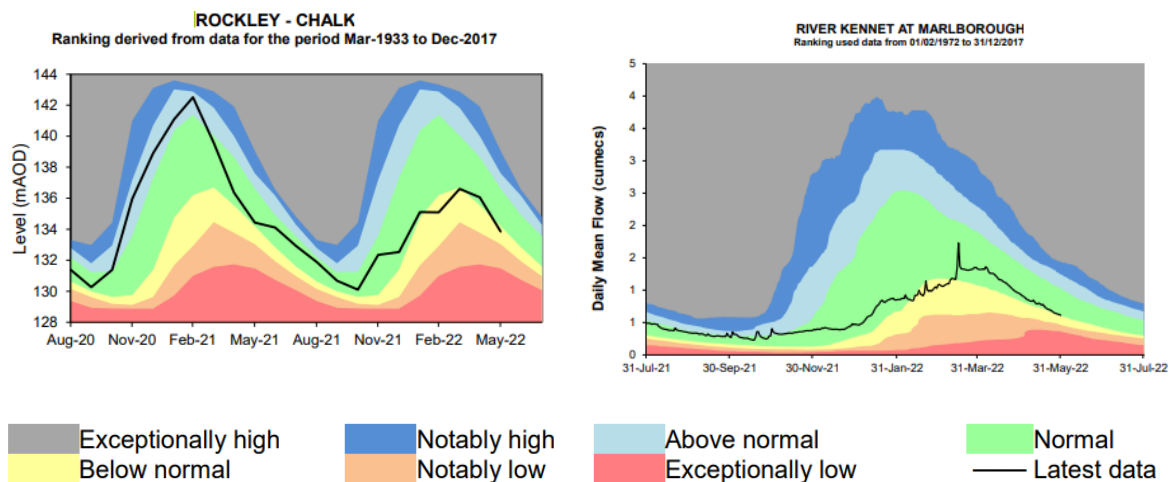
Figure 6 – Water Situation Report

In addition to these specific stations, the wider groundwater context is illustrated in the Water Situation Report for the Berkshire Downs. The nearest groundwater reference station is Rockley. This site shows significantly lower overall groundwater than the previous year. This can be seen in the figure below alongside the river indicator location at Marlborough on the River Kennet.

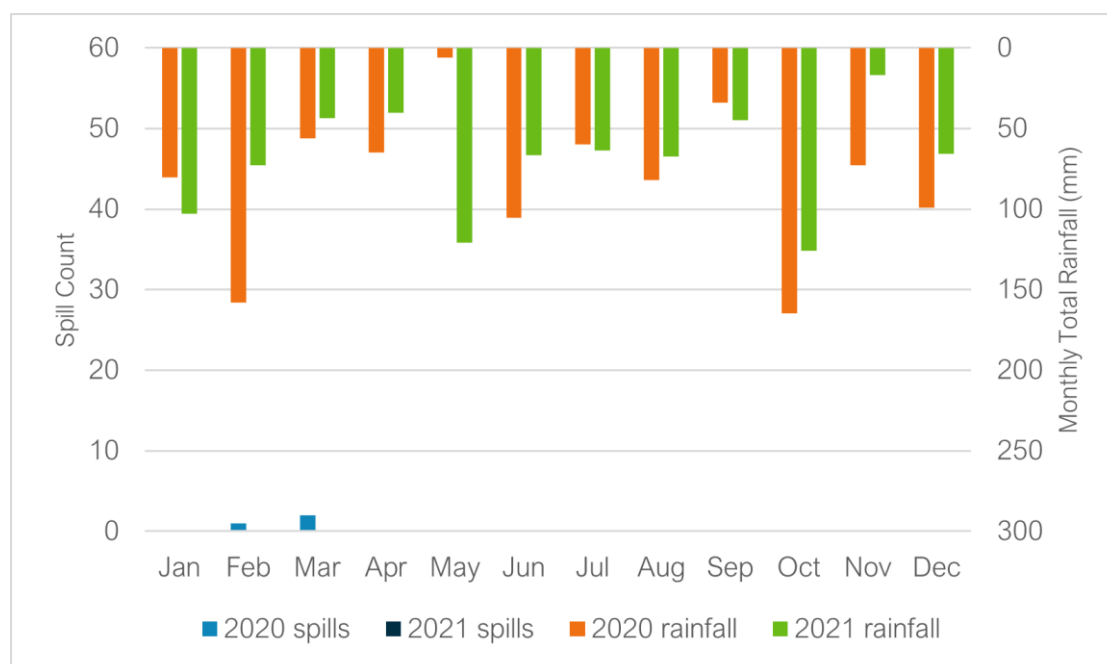
Figure 8 – EDM Monthly Performance

A critical part of the assessment of EDM performance and its relation to groundwater inundation is to review the month-on-month spill performance, against previous years and the monthly total rainfall values to give context to the performance. Figure 8 below presents the EDM performance trend and rainfall for recent years.

The data suggests a wider relationship between rainfall, elevated groundwater levels and spill frequency, as the only spills recorded over the two-year period were in February and March 2020, when the indicator sites suggest groundwater levels in the catchment were particularly elevated.

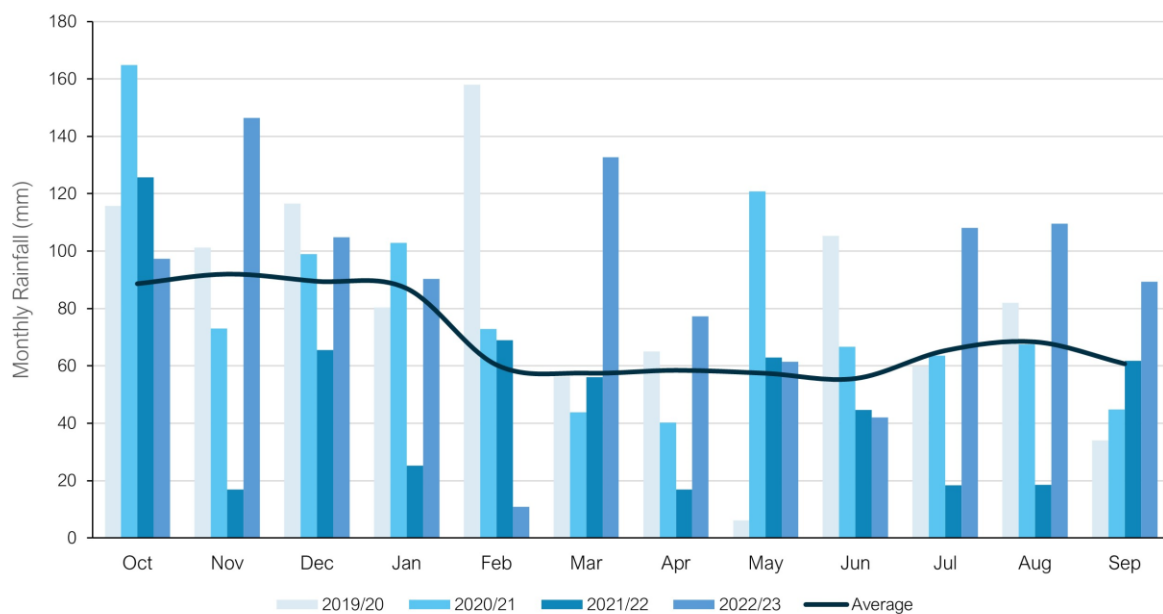
Figure 2 – Monthly Rainfall Performance

Representative Radar rainfall has been used to generate monthly data at catchment level for comparison with average data generated by local Met Office Weather Station Records. Figure 2 presents the comparison of this data for the last four hydrological years to support longer term trends within the local system.

Average Values taken from Met Office Weather Station at Marlborough based on the period 1991-2020

The total rainfall for the 2022/23 hydrological year is 27% above the annual average total. Total rainfall values are presented in Table 3 below.

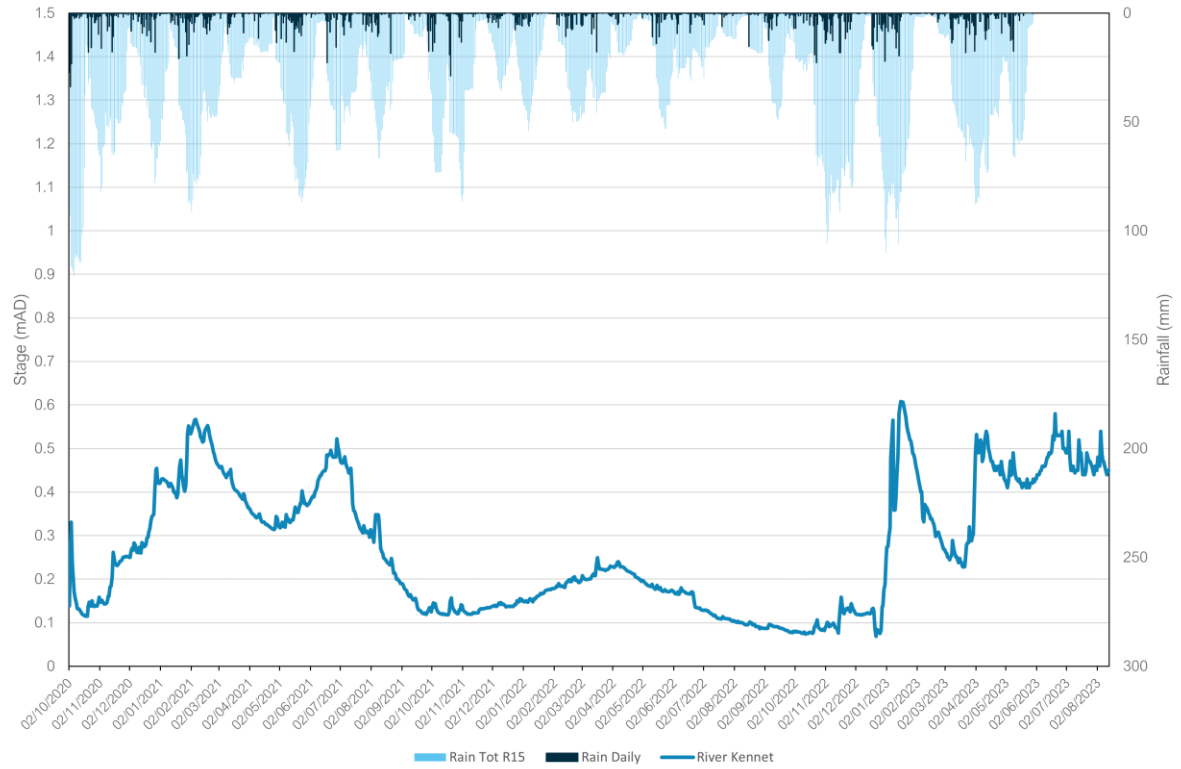
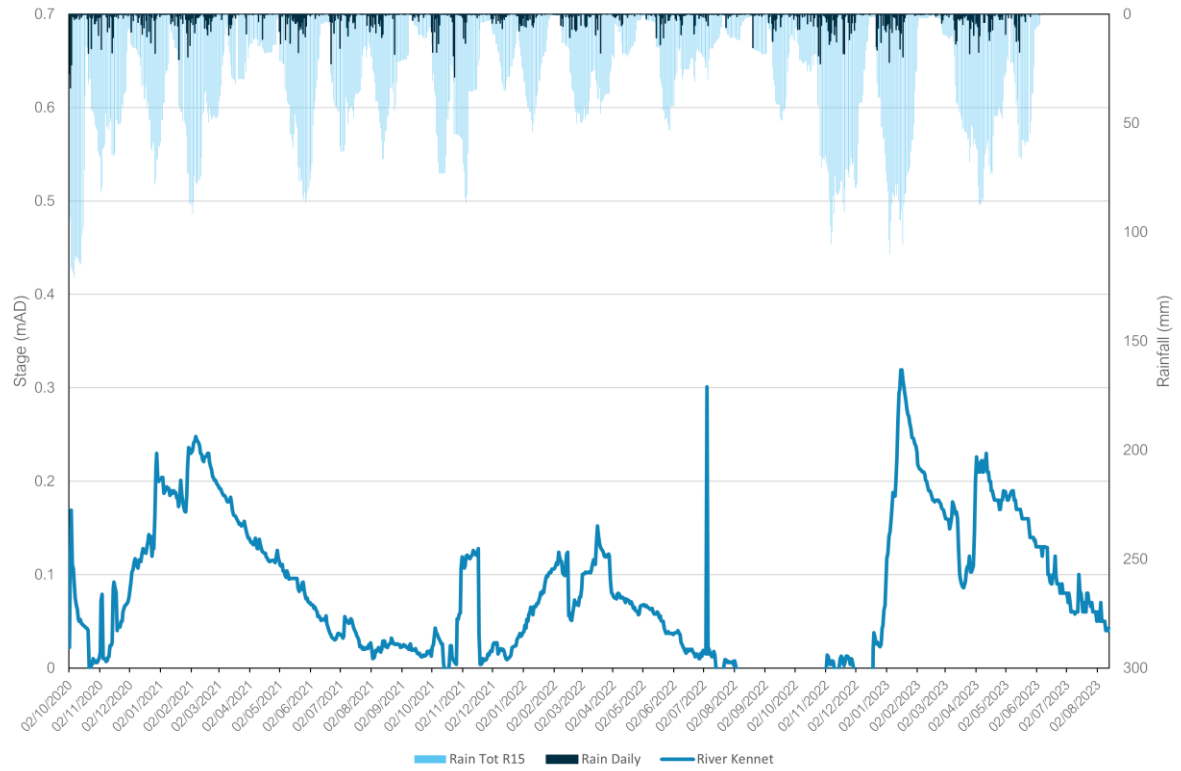
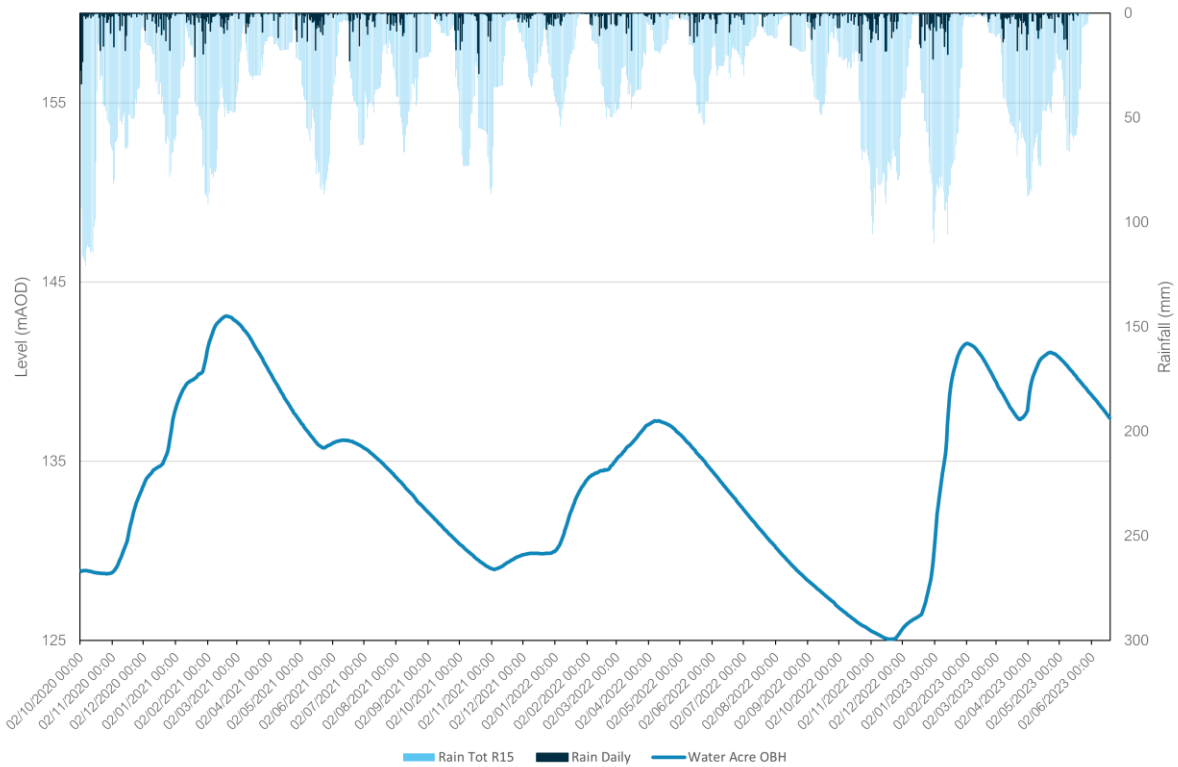
The following figures represent the last three hydrological years of level information at the indicator sites to build a picture of the relative conditions prevalent in the current year. It is presented against both the daily total rainfall values for the catchment and a rolling 15 day total rainfall.

Figure 5A – Kennet, Knighton Main

Figure 5B – Kennet, Knighton Side

Figure 5C – Water Acre OBH

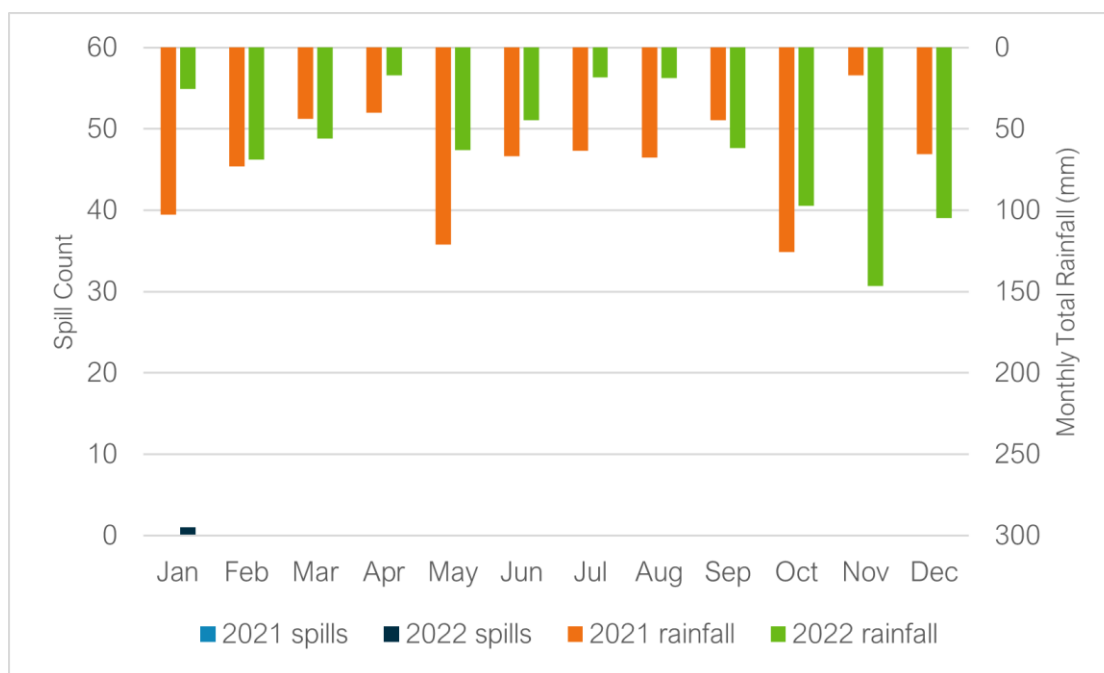
Figure 8 – EDM Monthly Performance

A critical part of the assessment of EDM performance and its relation to groundwater infiltration is to review the month-on-month spill performance, against previous years and the monthly total rainfall values to give context to the performance. Figure 8 below presents the EDM performance trend and rainfall for recent years.

The utility of the last two years of EDM data to suggest a wider relationship between rainfall, elevated groundwater levels and spill frequency is limited, as only one spill was recorded at Ramsbury STW across 2021 and 2022.

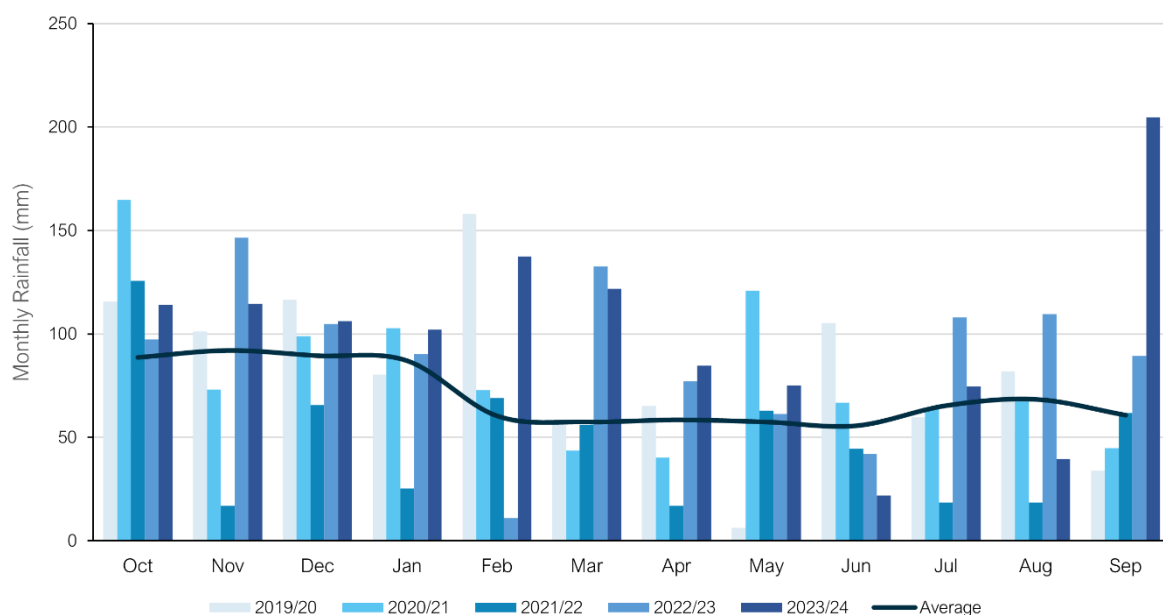
Figure 2 – Monthly Rainfall Data

Representative Radar rainfall has been used to generate monthly data at catchment level for comparison with average data generated by local Met Office Weather Station Records. Figure 2 presents the comparison of this data for the last five hydrological years to support longer term trends within the local system.

Average Values taken from Met Office Weather Station at Marlborough based on the period 1991-2020

The total rainfall for the 2023/24 hydrological year is 42% above the annual average total. Total rainfall values are presented in Table 3 below.

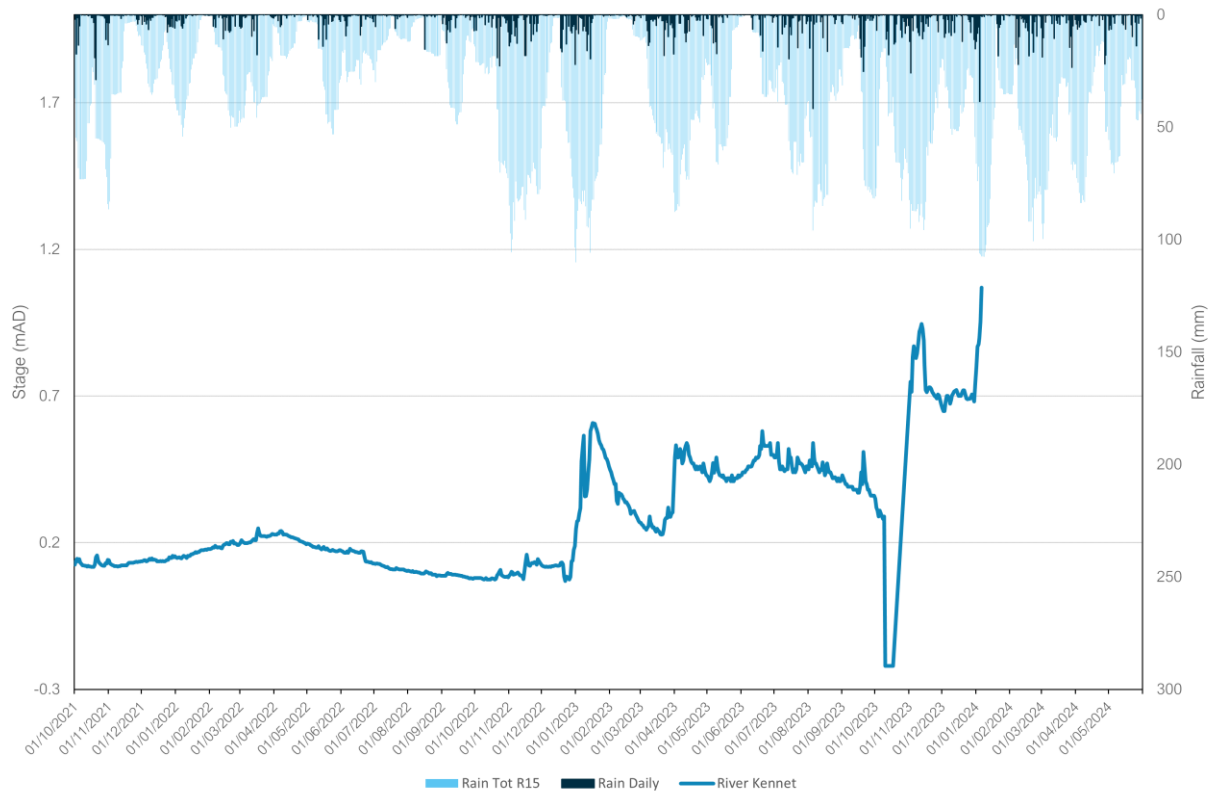
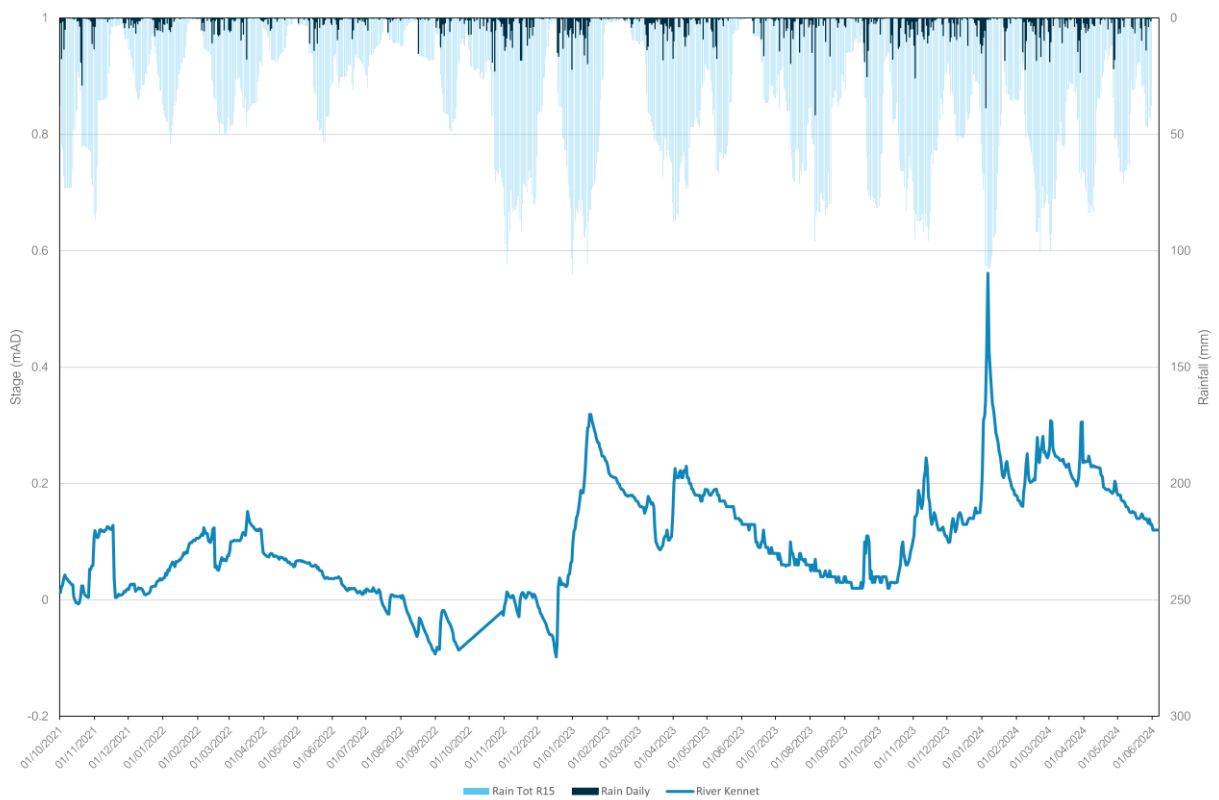
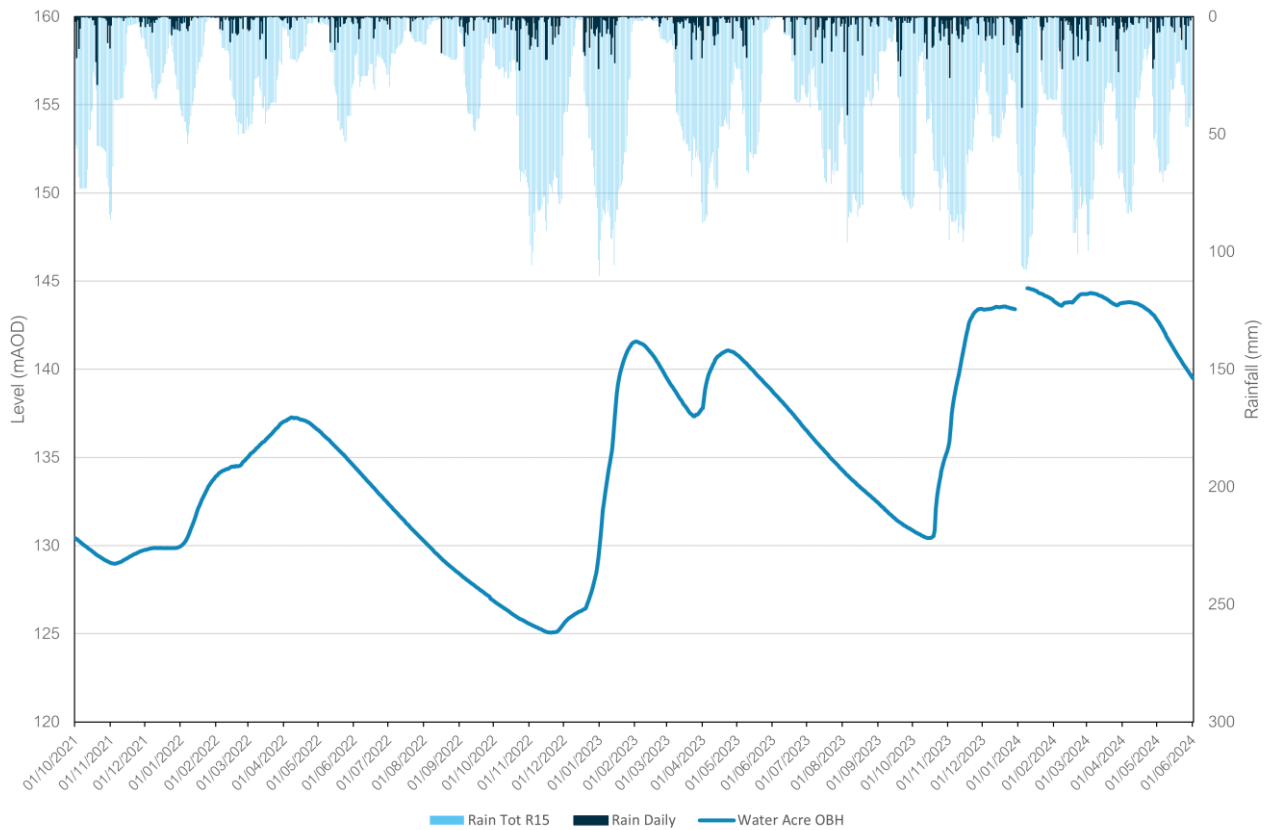
Figures 5A-5C represent the last three hydrological years of level information at the indicator sites to build a picture of the relative conditions prevalent in the current year. It is presented against both the daily total rainfall values for the catchment and a rolling 15 day total rainfall. Note that no stage data is available for the River Kennet at Knighton Main site post February 2024.

Figure 5A – Kennet, Knighton Main

Figure 5B – Kennet, Knighton Side

Figure 5C – Water Acre OBH

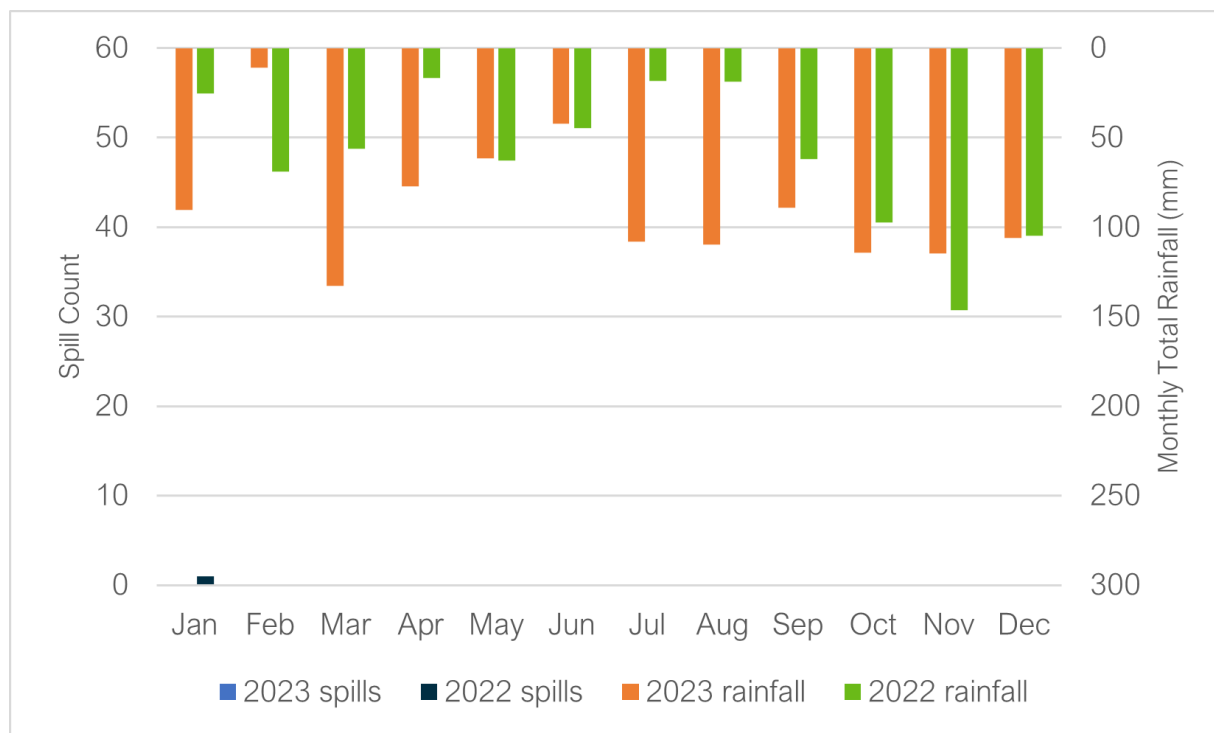
Figure 8 – EDM Monthly Performance

A critical part of the assessment of EDM performance and its relation to groundwater infiltration is to review the month-on-month spill performance, against previous years and the monthly total rainfall values to give context to the performance. Figure 8 below presents the EDM performance trend and rainfall for recent years.

The utility of the last two years of EDM data to suggest a wider relationship between rainfall, elevated groundwater levels and spill frequency is limited, as only one spill was recorded at Ramsbury STW across 2022 and 2023.

Please see the 2022 Addendum Report (included in this PDF document), for discussion regarding trends evident in the EDM data for 2020, indicative of the role of groundwater infiltration on spills in the catchment. The EDM data for 2024 will also be analysed once available, to continue to examine the potential relationship between groundwater levels and overflow spills in the catchment. The indicator site data shown in Figures 5 and 6, suggests that groundwater levels in the catchment reached higher levels in 2024 than those observed in 2022 and 2023.
