Groundwater Impacted System Management Plan

Marlborough, River Kennet

January 2021

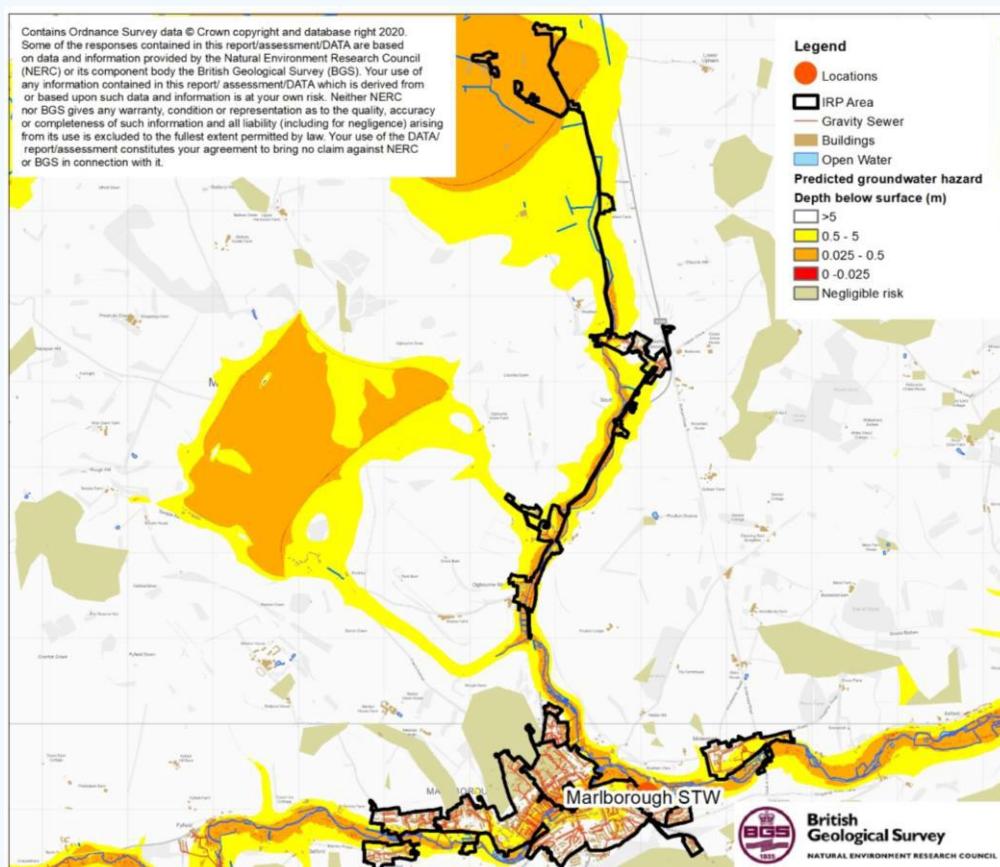
Figure 1.0 – East Shefford catchment

Marlborough is located on the River Kennet in Wiltshire, England, 10 miles South of Swindon. Marlborough serves a population equivalent³ of 9,930 with a predominantly separate sewerage network totalling some 64 km in length excluding private drains and sewers. The extent of the catchment is shown in Figure 1.0 above.

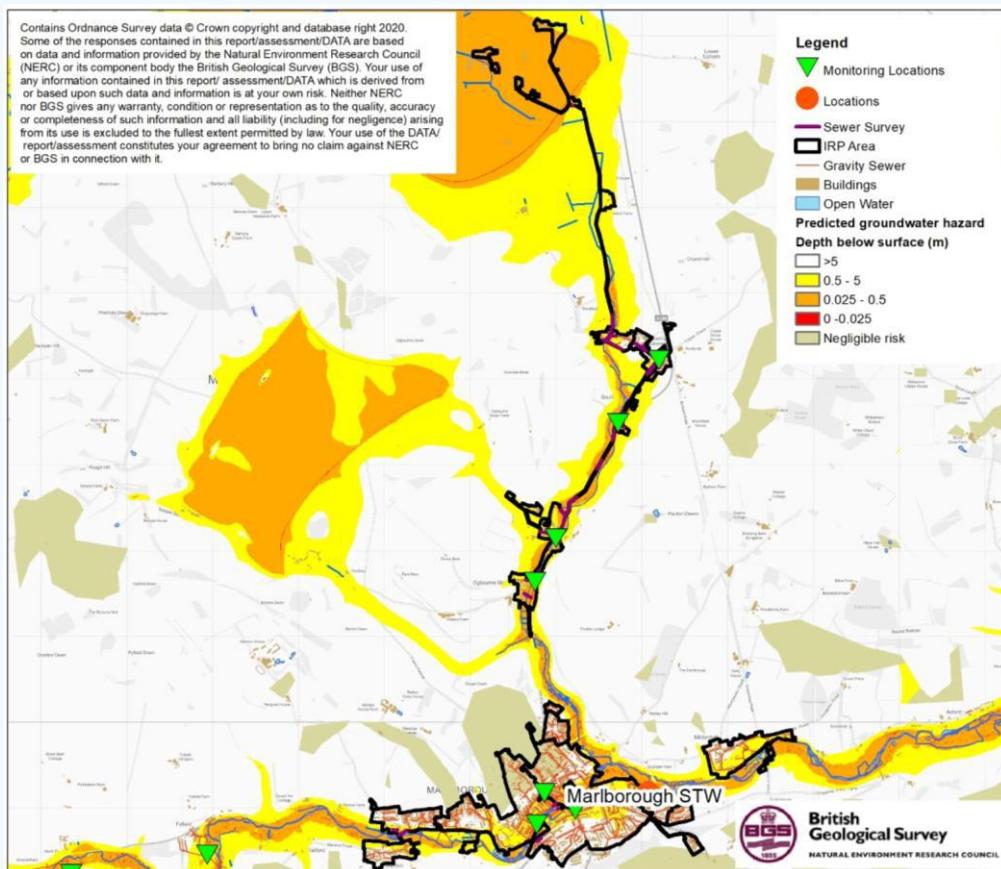
Figure 2.0 – Marlborough monitoring and infiltration zones

Key to bringing the impact of groundwater infiltration under control will be an enhanced monitoring regime. We have identified and have installed several telemetered depth monitor locations around the Marlborough system – see Figure 2.0.

We engaged with JBA Consulting to develop plans for Marlborough that identify zones of groundwater risk, see Figure 2.0. These zones are modelled areas where the groundwater has been determined to be above the sewer and hence pose a potential risk for groundwater ingress.

Sewer Depth Monitors have been installed in the catchment in 2020(see Figure 2.0). These devices are telemetered and provide real time data on the level of flow in the sewer.

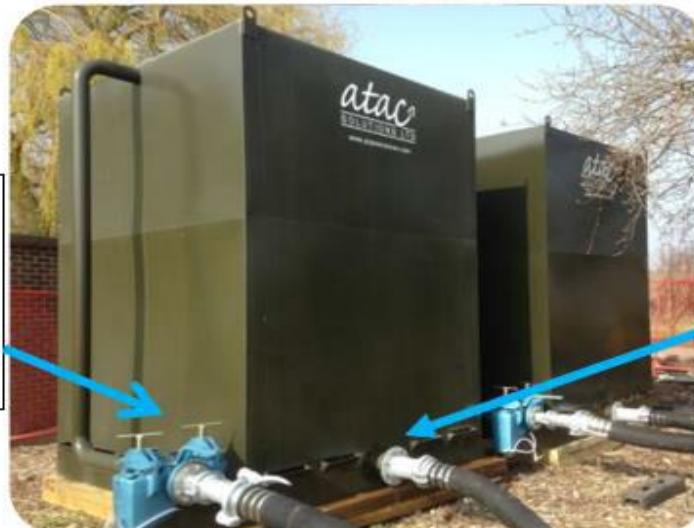
Outside view:

Dirty water entering the filter unit to be treated and then pumped to the top of the unit

Treated water leaving the unit and returning to the environment

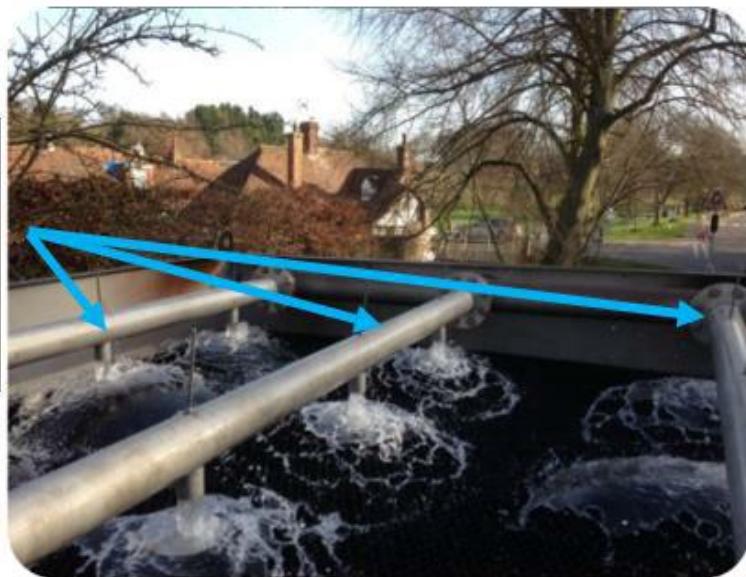
Inside view:

Dirty water
being
pumped into
the unit and
working its
way through
the filter
system.

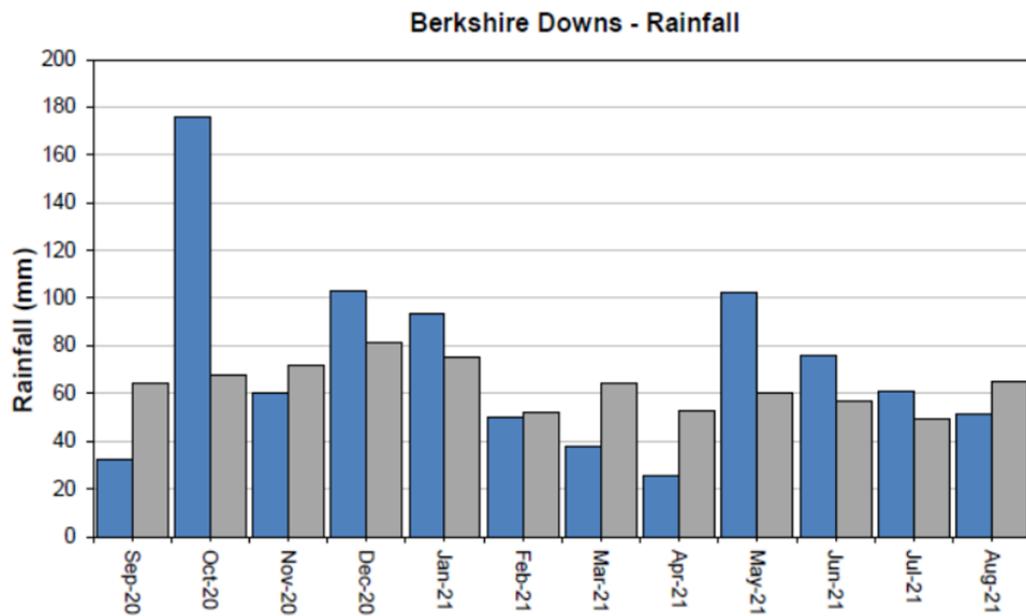
Figure 2 – Monthly rainfall depths local to the system

Marlborough is situated in the Berkshire Downs water resources area. Figure 2 shows the monthly rainfall total depths against the long-term average rainfall in the location of Marlborough over the period taken from the *Environment Agency Water Situation Report August 2021*.¹

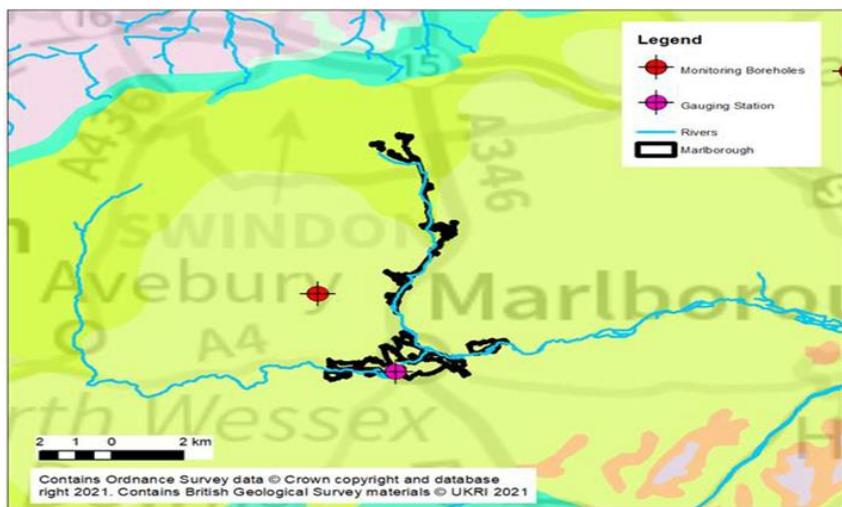
Figure 3 – Location of Rockley Park Monitoring Borehole Relative to Marlborough

Figure 3 shows the location of the British Geological Survey (BGS) monitoring borehole at Rockley which has been monitoring since 1932. Figures 4 and 5 show river levels in the River Kennet at Marlborough which are a good indication of local groundwater levels over time. Figure 6 and 7 show the last two and ten years of groundwater level data overlain on expected ranges. This shows how recent groundwater levels have compared against the expected range, they show that generally over the last two winters groundwater levels have been notably high in 2019 and above normal in 2020.

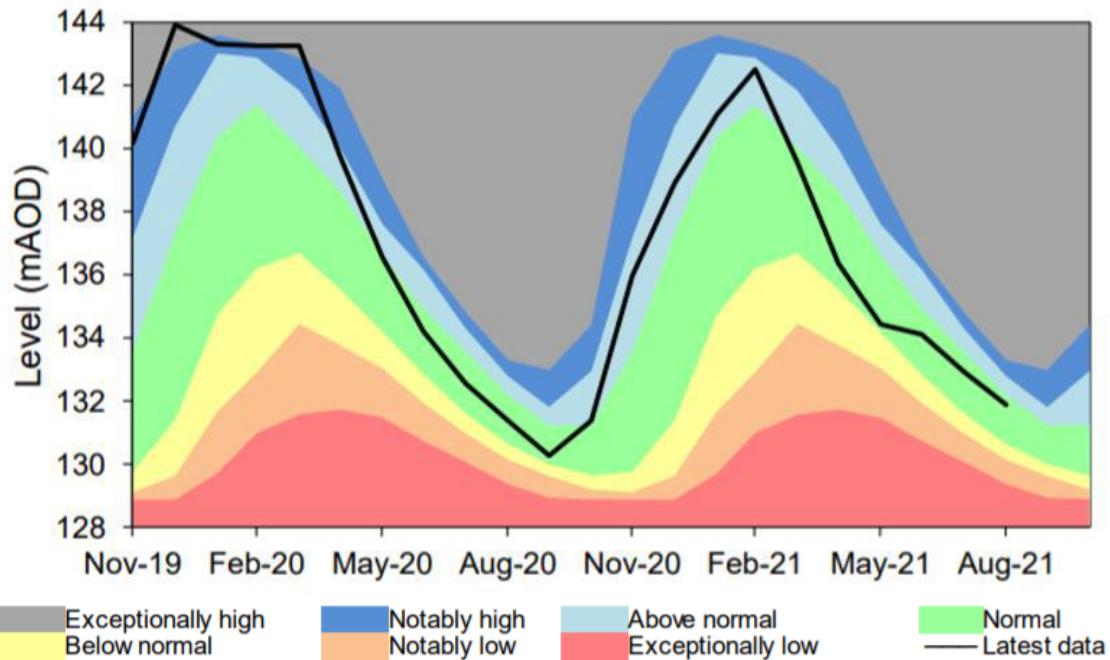
Figure 6 – 2019-2021 Groundwater levels at Rockley. (Environment Agency Water Situation Report August 2021)

ROCKLEY - CHALK
Ranking derived from data for the period Mar-1933 to Dec-2017

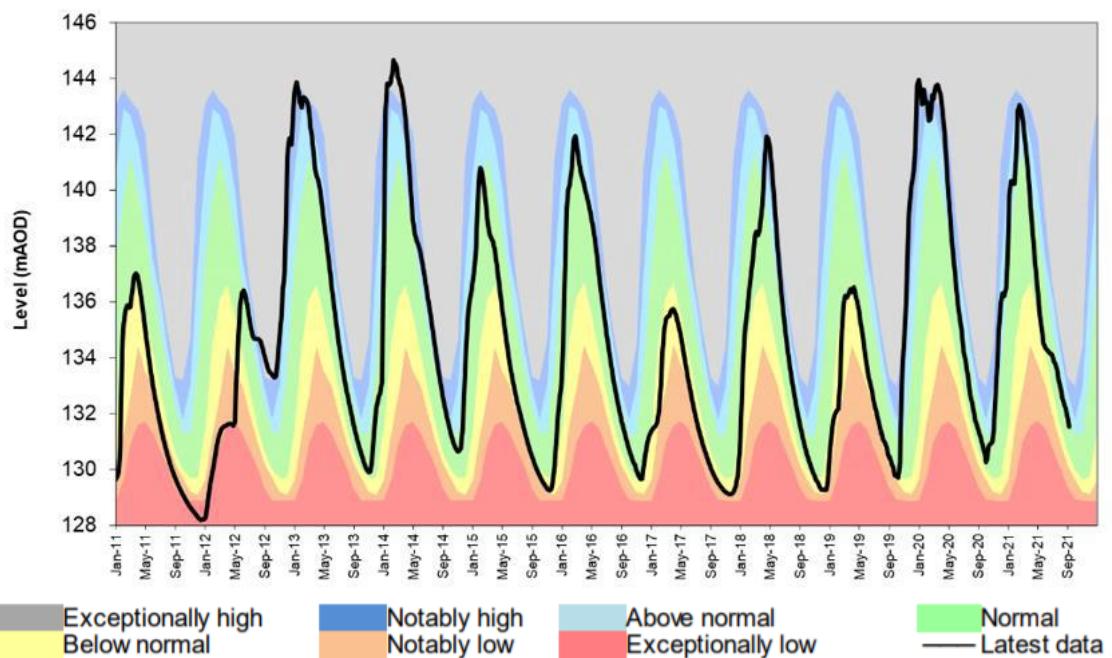
Figure 7 – 2011-2021 Groundwater levels at Rockley. (Environment Agency Water Situation Report August 2021)

MARLBOROUGH DOWNS - ROCKLEY - CHALK
Ranking derived from data for the period Mar 1933 to Dec 2017

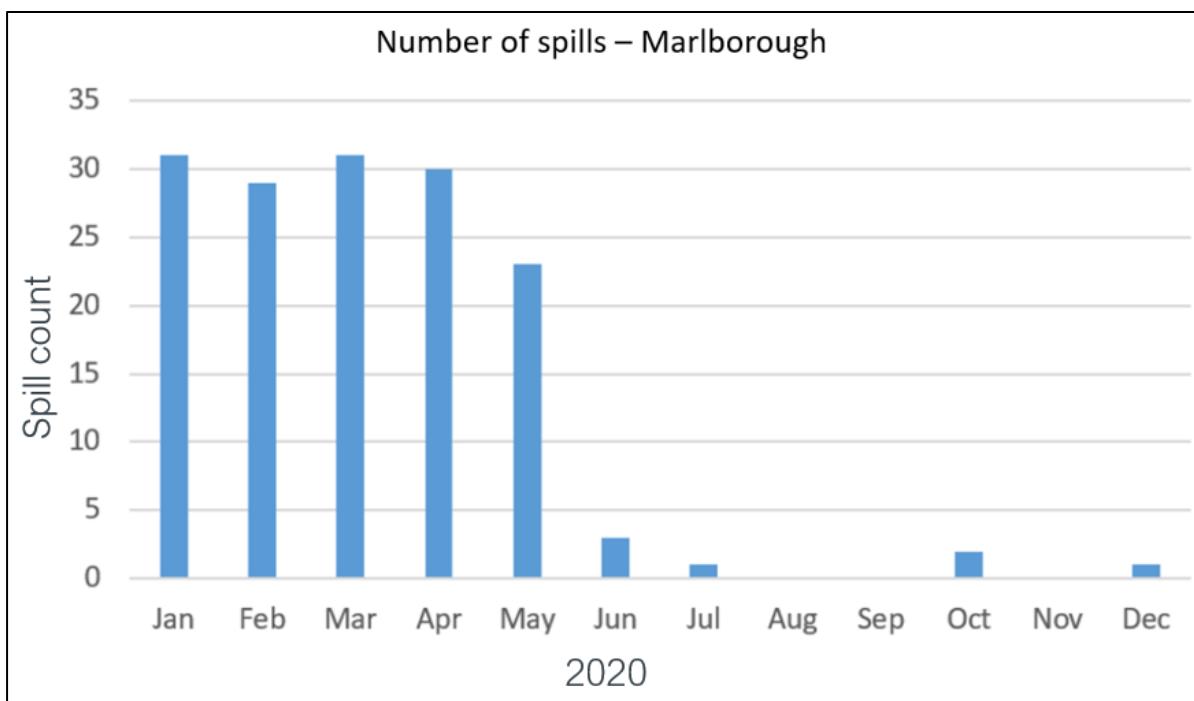
Figure 8 – Number of spills (discharge count) at Marlborough STW (taken from Event Duration Monitor (EDM) Data).*

Figure 8 shows the number of spills per month from Marlborough Sewage Treatment Works (STW). January to May 2020 saw the greatest number of discharges. In the summer period the number of spills were much lower, highlighting the influence of groundwater infiltration/winter flows on the system. This Combined Sewer Overflow location has met the trigger for the EA's Storm Outfall Overflow Assessment Framework (SOAF) and is currently under further investigation with regards to root cause and impact.

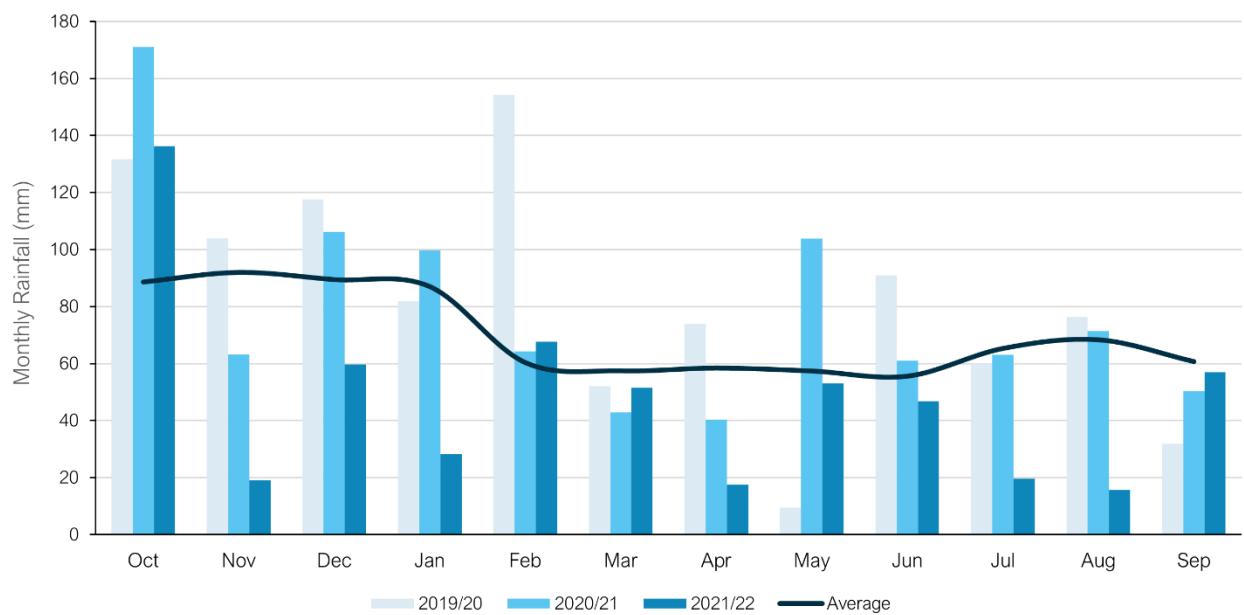
Figure 2: Monthly Rainfall Performance

Representative Radar rainfall has been used to generate monthly data at catchment level for comparison with average data generated by local Met Office Weather Station Records. Figure 2 presents the comparison of this data for the last three hydrological years to support longer term trends within the local system.

(Average Values taken from Met Office Weather Station at High Wycombe based on the period 1991-2020)

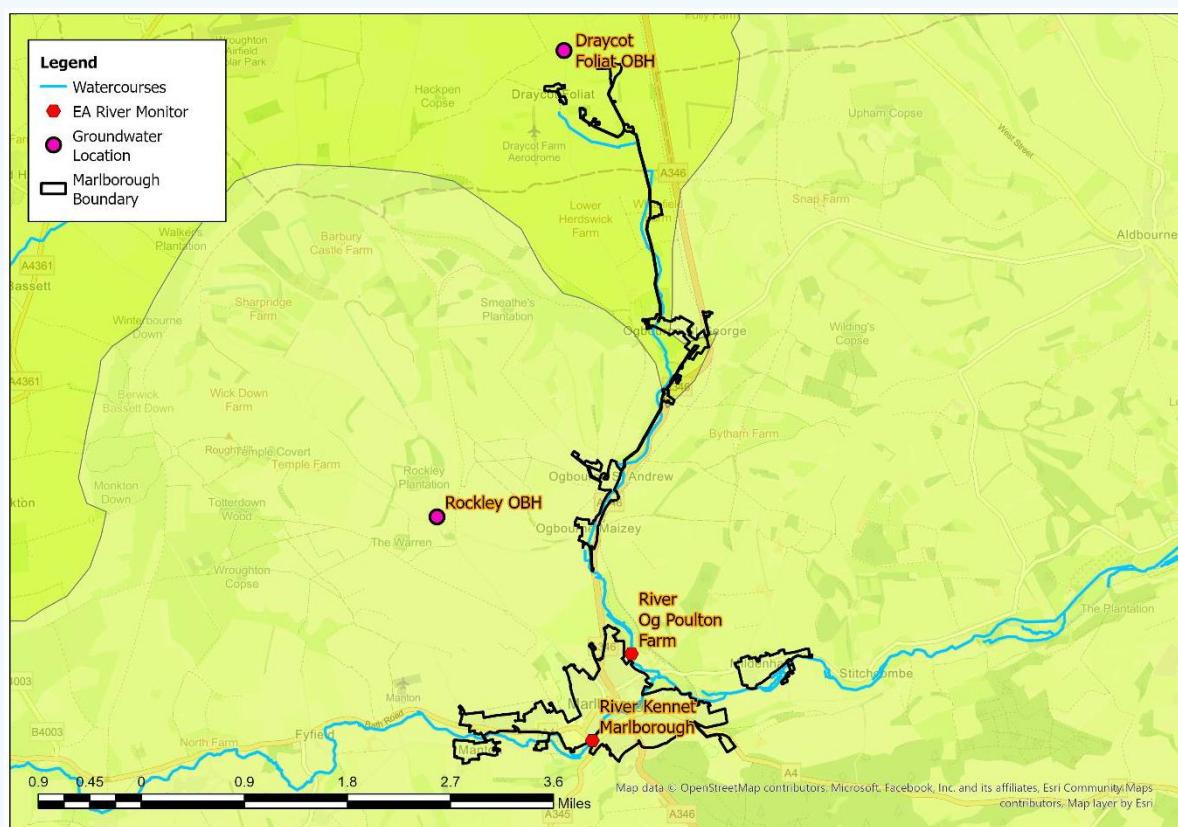
Figure 4: Local Monitoring Stations

- River Kennet, Marlborough
- River Og, Poulton Farm
- Rockley OBH
- Draycot Foliat OBH

These sites are illustrated in the figure below, alongside the closest groundwater reference station and closest gauging station from the Water Situation Report. The closest groundwater reference station from the WSR is also Rockley OBH and the closest gauging station from the WSR is also at Marlborough on the River Kennet.

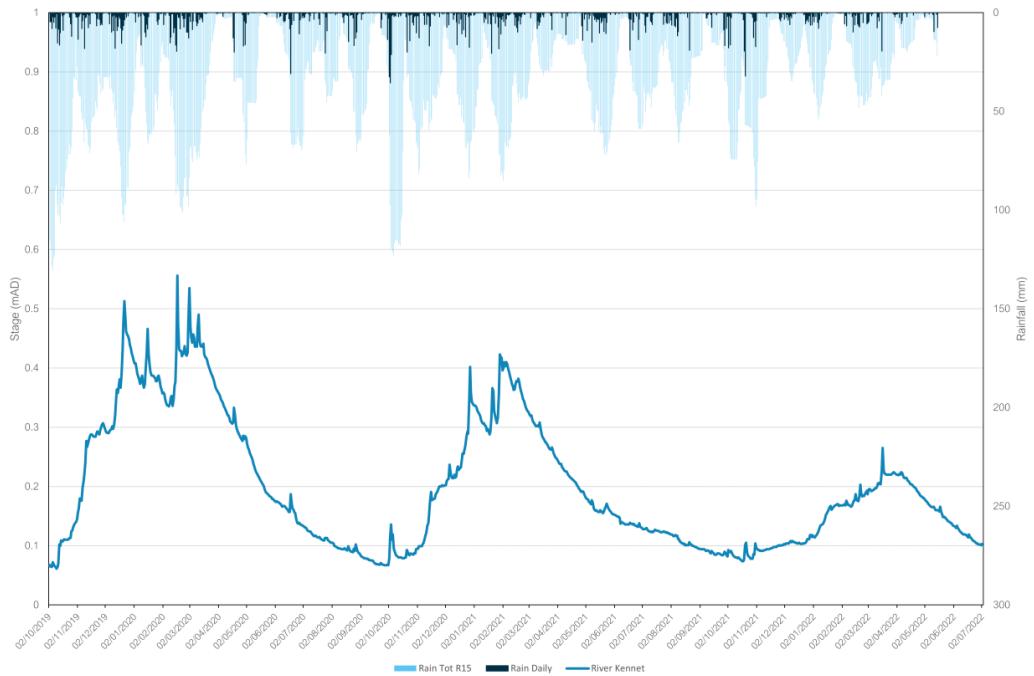
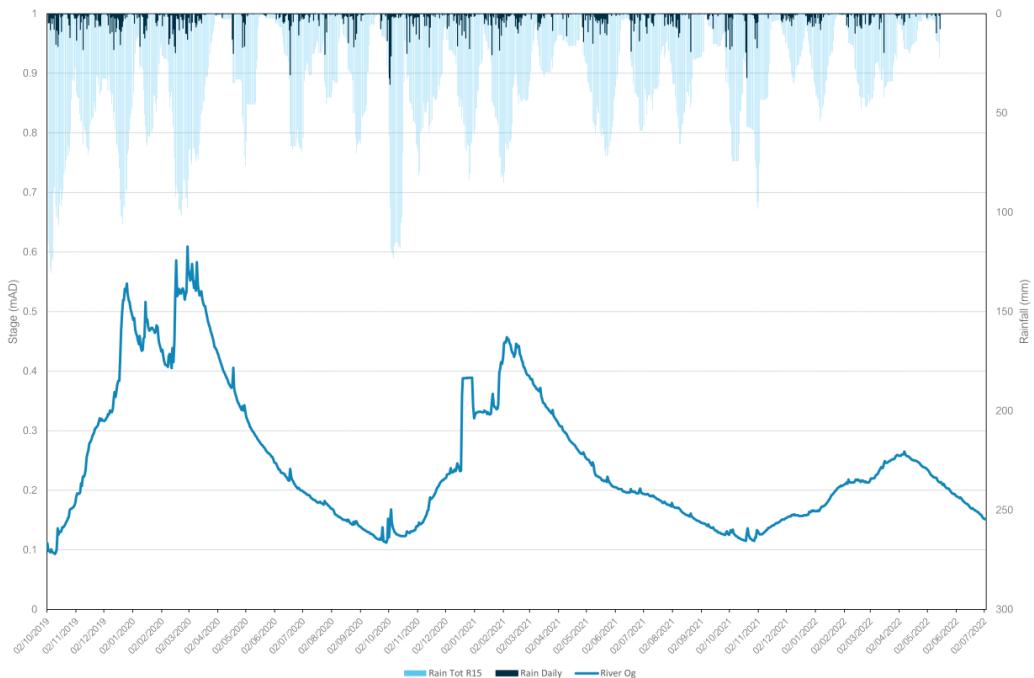
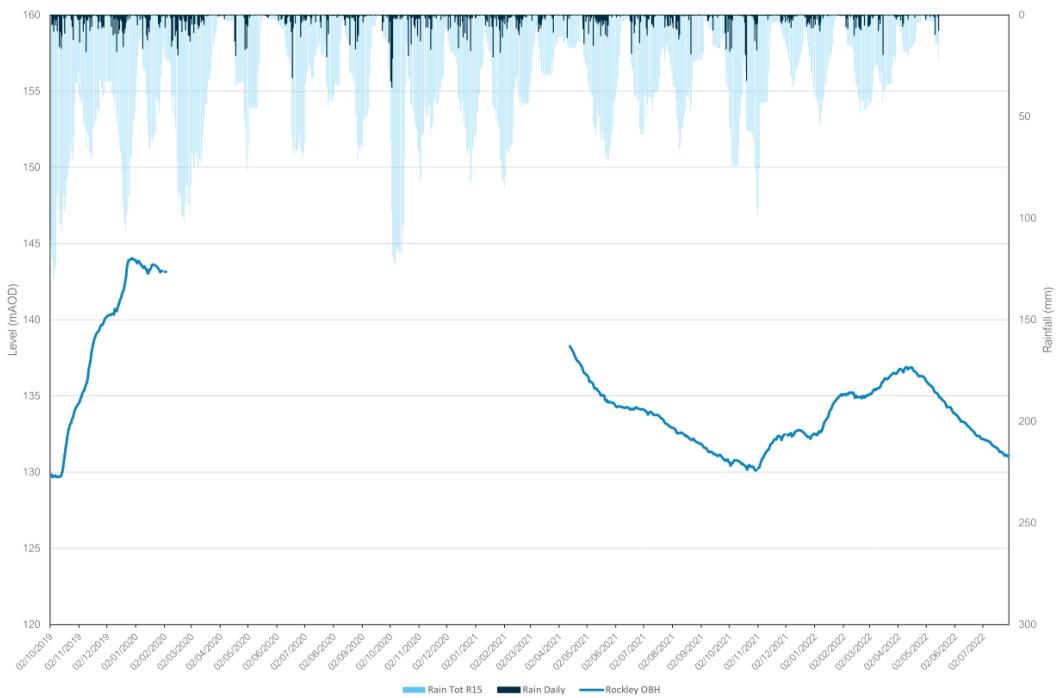
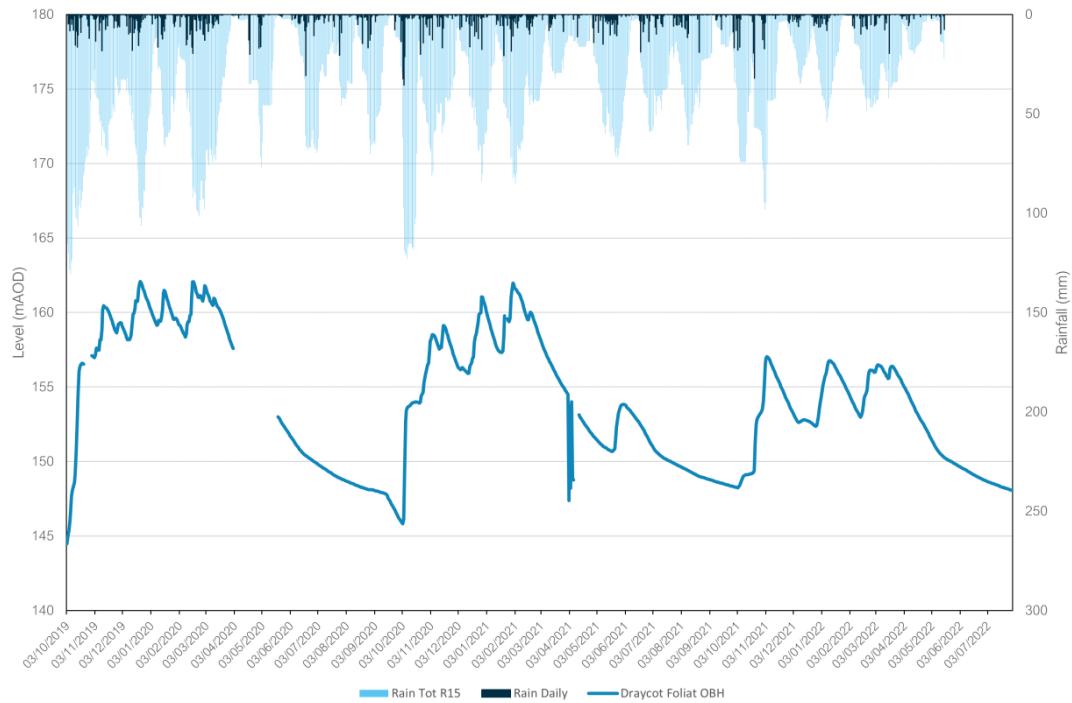
The following figures represent the last three hydrological years of level information at the indicator sites to build a picture of the relative conditions prevalent in the current year. It is presented against both the daily total rainfall values for the catchment and a rolling 15-day total rainfall.

Figure 5A – River Kennet at Marlborough

Figure 5B – River Og at Poulton Farm

Figure 5C – Rockley OBH

Figure 5D – Draycot Foliat OBH

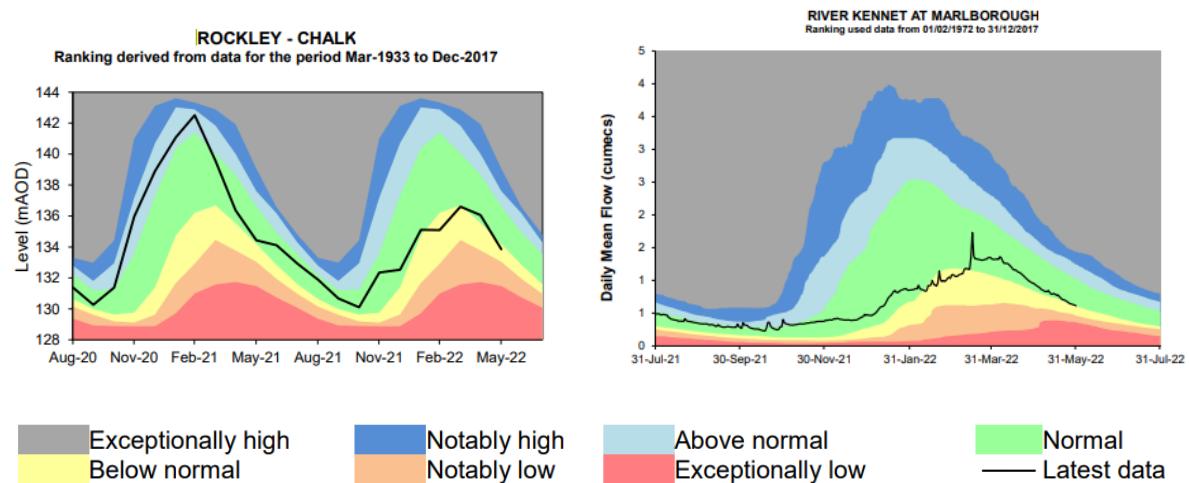
Figure 6 – Water Situation Report

In addition to these specific stations, the wider groundwater context is illustrated in the Water Situation Report for the Berkshire Downs. The nearest groundwater reference station is Rockley OBH. This site shows significantly lower overall groundwater than the previous year. This can be seen in the figure below alongside the river indicator location at Marlborough on the River Kennet.

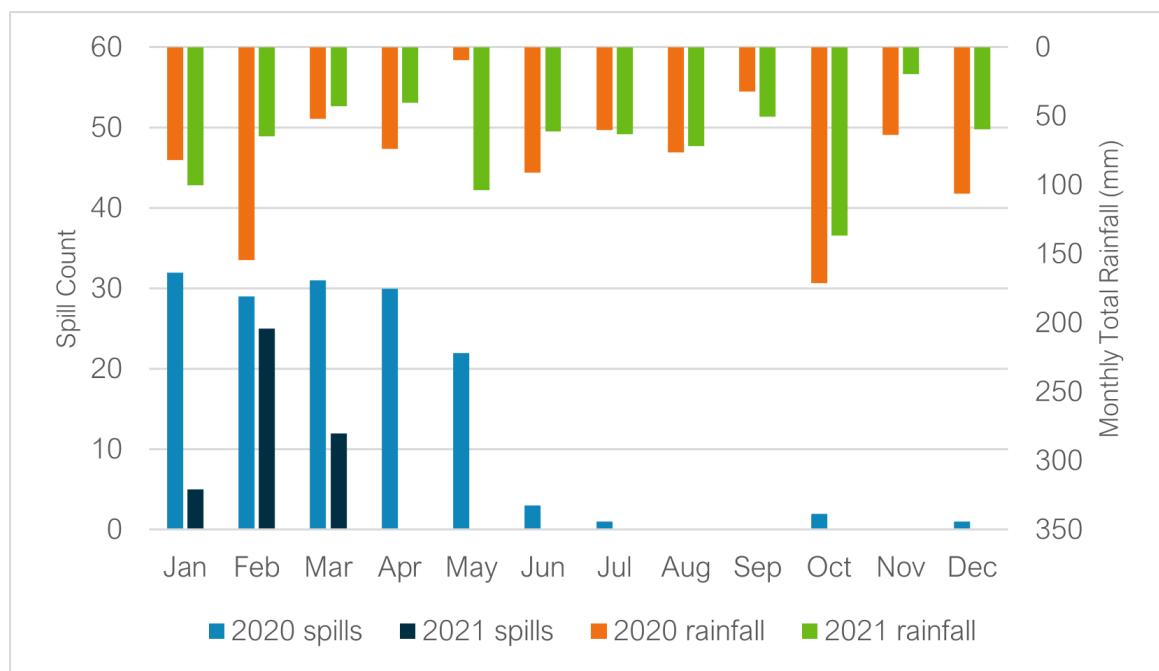
Figure 8 – EDM Monthly Performance

A critical part of the assessment of EDM performance and its relation to groundwater inundation is to review the month-on-month spill performance, against previous years and the monthly total rainfall values to give context to the performance. Figure 8 below presents the EDM performance trend and rainfall for recent years.

The trend in spill performance across the two recorded years does show variation in spills, with a focus on spills during the winter and spring months. The data suggests a wider relationship between rainfall, elevated groundwater levels and spill frequency. A slower tail off in spills is evident within the first half of 2020, when the indicator sites suggest groundwater levels in the catchment were higher than within the first half of 2021.

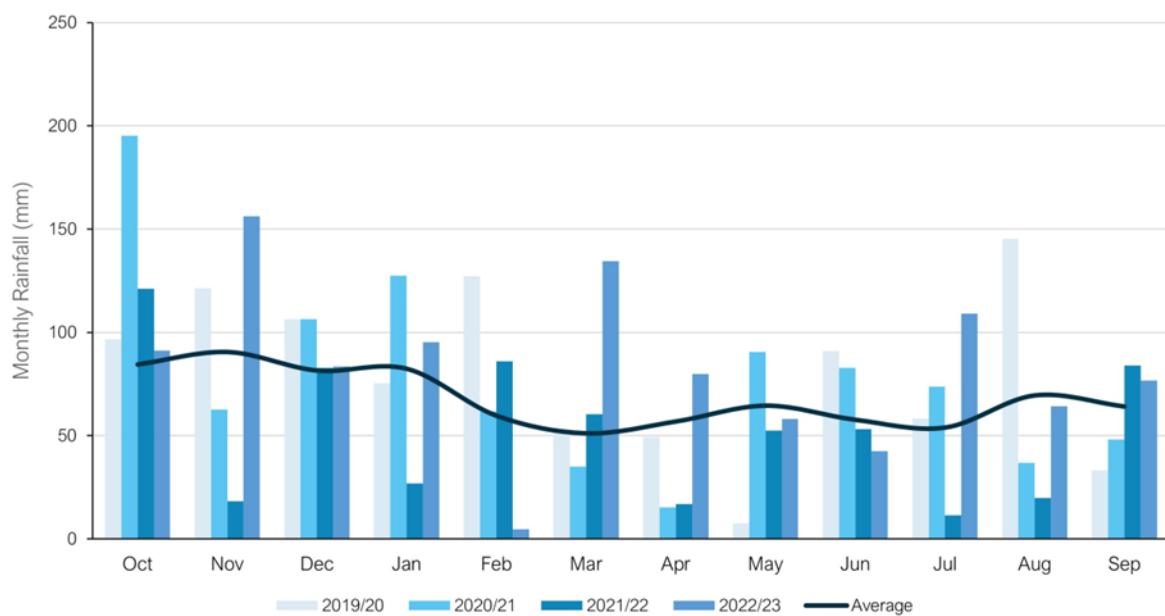
Figure 2: Monthly Rainfall Performance

Representative Radar rainfall has been used to generate monthly data at catchment level for comparison with average data generated by local Met Office Weather Station Records. Figure 2 presents the comparison of this data for the last four hydrological years to support longer term trends within the local system.

(Average Values taken from Met Office Weather Station at High Wycombe based on the period 1991-2020)

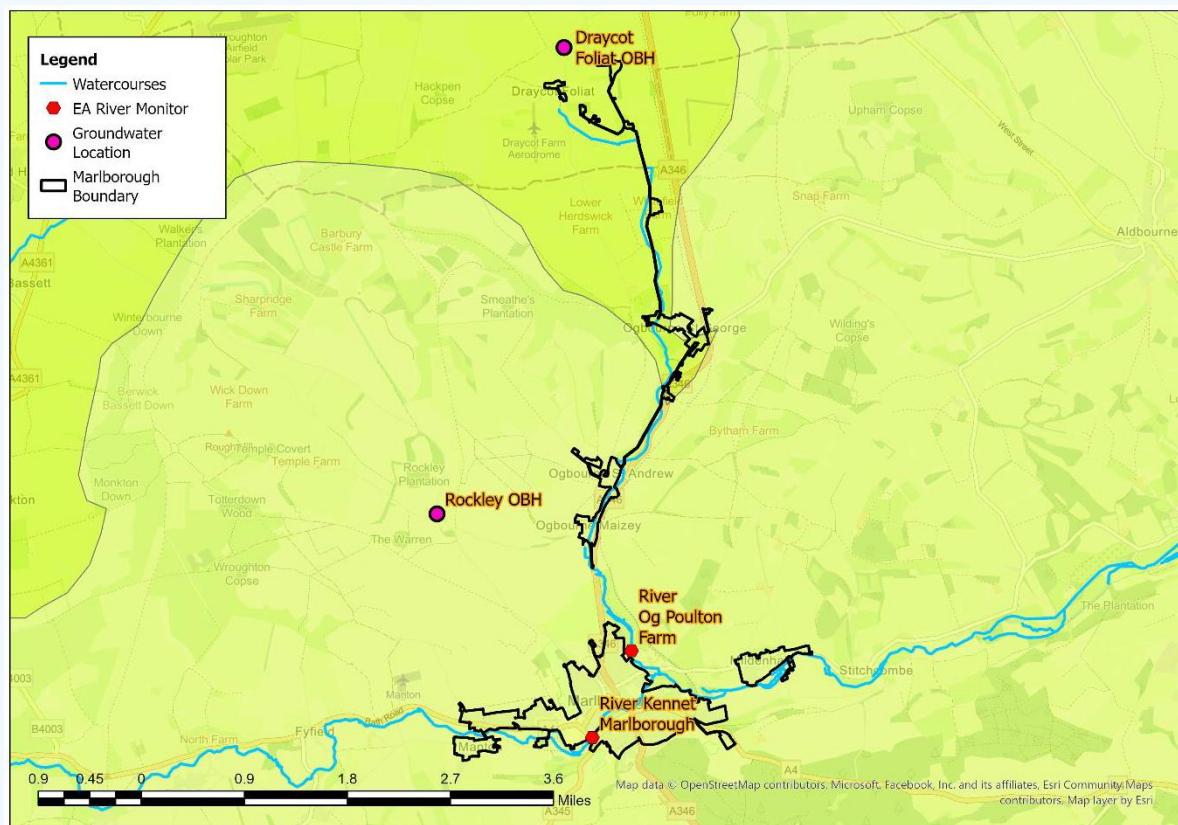
Figure 4: Local Monitoring Stations

- River Kennet, Marlborough
- River Og, Poulton Farm
- Rockley OBH
- Draycot Foliat OBH

These sites are illustrated in the figure below, alongside the closest groundwater reference station and closest gauging station from the Water Situation Report. The closest groundwater reference station from the WSR is also Rockley OBH and the closest gauging station from the WSR is also at Marlborough on the River Kennet.

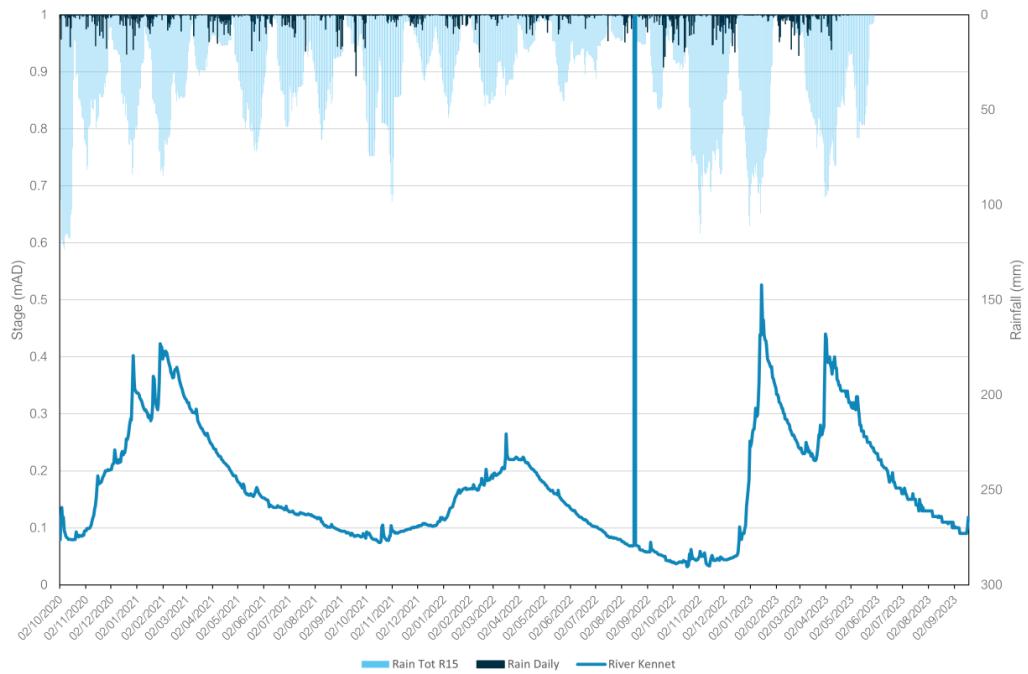
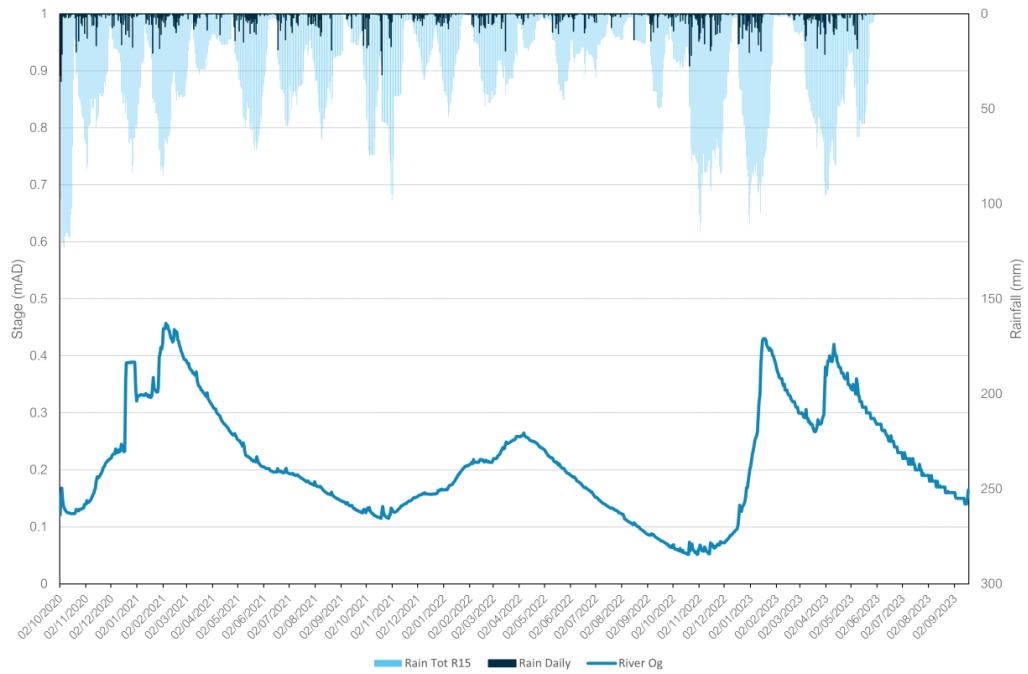
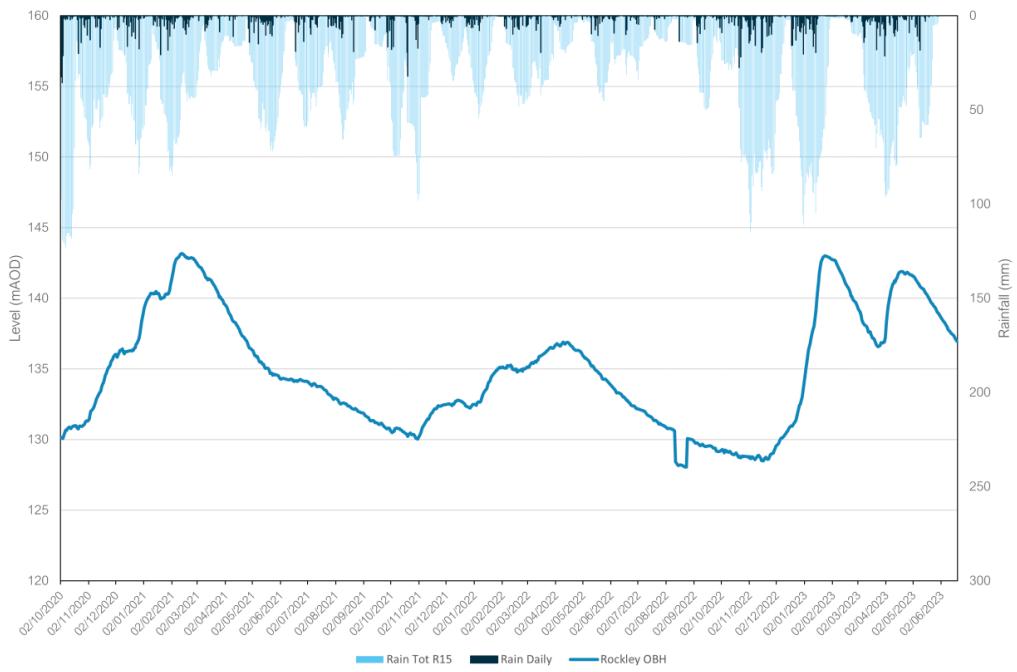
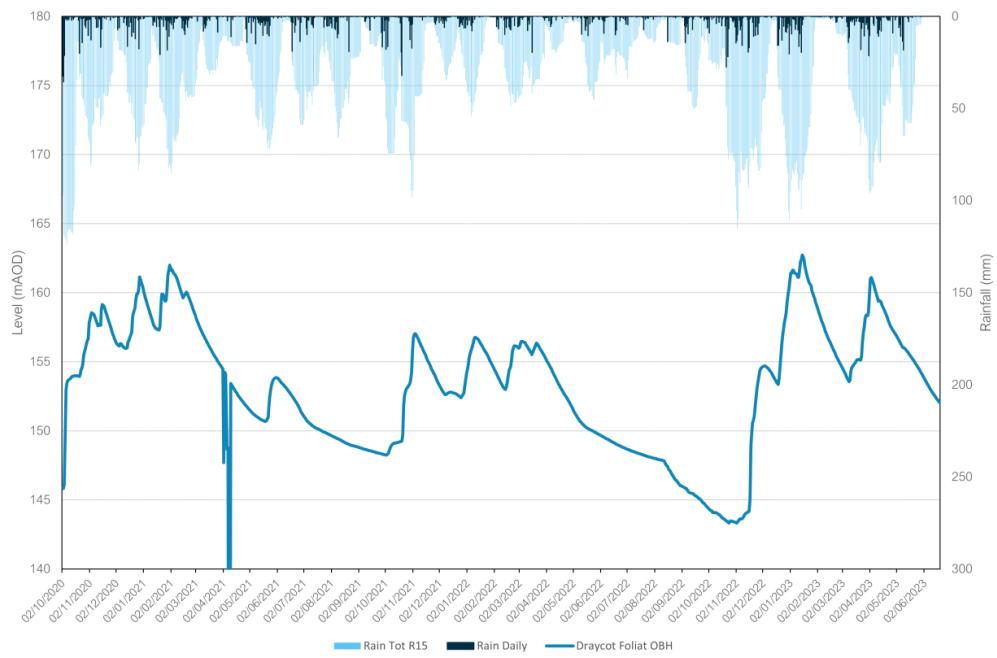
The following figures represent the last three hydrological years of level information at the indicator sites to build a picture of the relative conditions prevalent in the current year. It is presented against both the daily total rainfall values for the catchment and a rolling 15-day total rainfall.

Figure 5A – River Kennet at Marlborough

Figure 5B – River Og at Poulton Farm

Figure 5C – Rockley OBH

Figure 5D – Draycot Foliat OBH

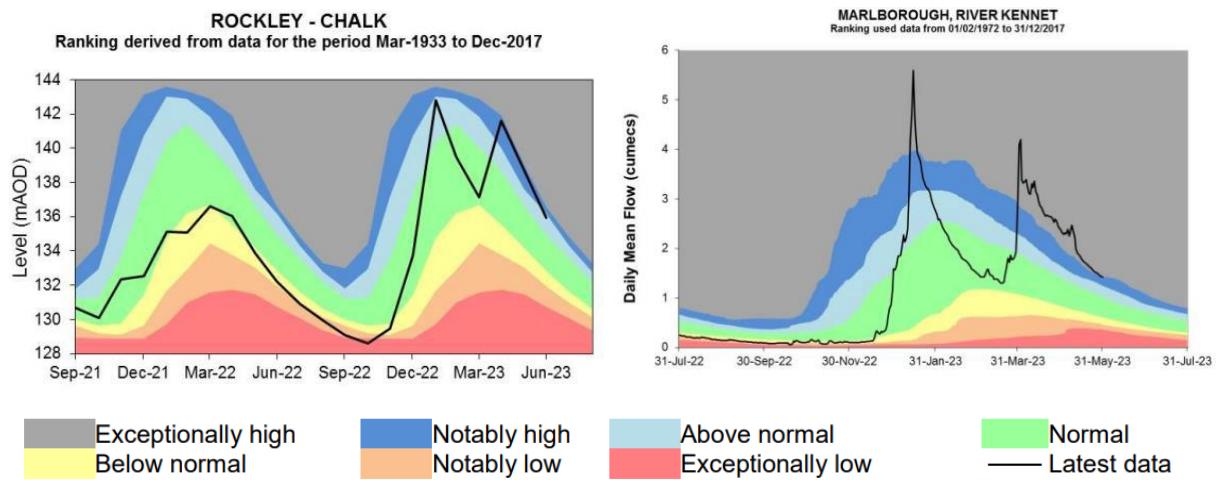
Figure 6 – Water Situation Report

In addition to these specific stations, the wider groundwater context is illustrated in the Water Situation Report for the Berkshire Downs. The nearest groundwater reference station is Rockley OBH. This site shows groundwater levels generally at below normal or notably low levels in 2022. Groundwater levels rise towards the end of the year and are observed at above normal levels in December 2022. Groundwater levels in 2023 have remained higher than the equivalent periods in 2022. This can be seen in the figure below alongside the river indicator location at Marlborough on the River Kennet.

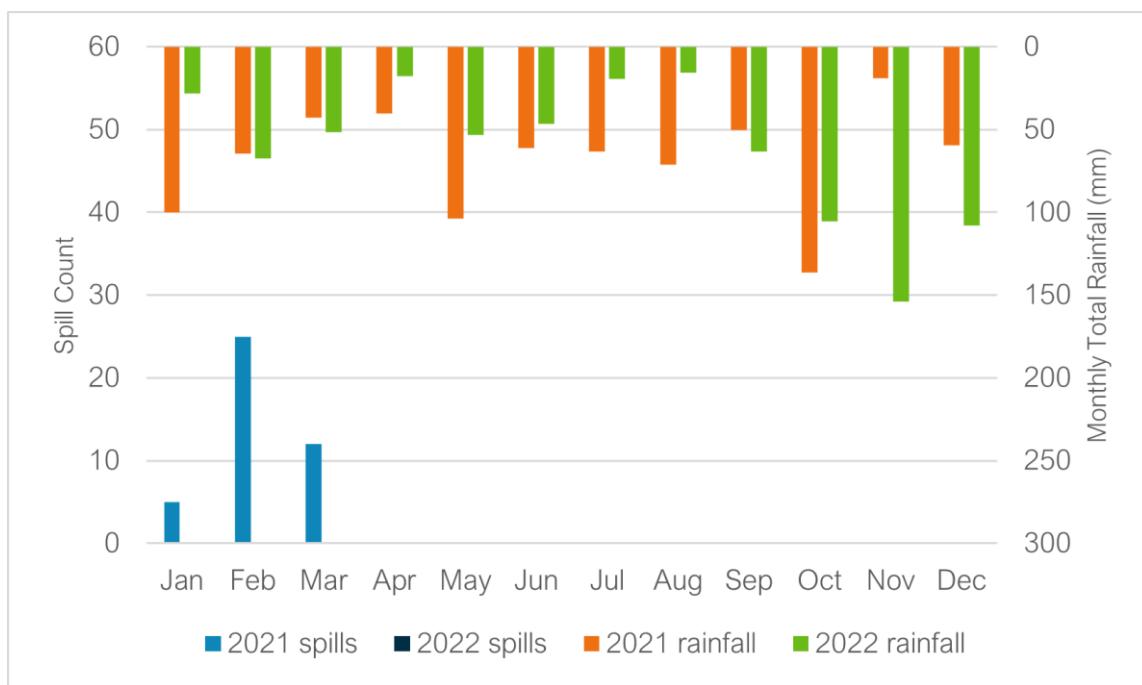
Figure 8 – EDM Monthly Performance

A critical part of the assessment of EDM performance and its relation to groundwater inundation is to review the month-on-month spill performance, against previous years and the monthly total rainfall values to give context to the performance. Figure 8 below presents the EDM performance trend and rainfall for recent years.

The data suggests a wider relationship between rainfall, elevated groundwater levels and overflow spill frequency. Despite broadly similar rainfall totals, no spills were recorded at Marlborough STW February – March 2022, however a significant number of spills were recorded February – March 2021. The indicator site data shown in Figure 5, suggests groundwater levels in the catchment were significantly more elevated over the period in 2021.

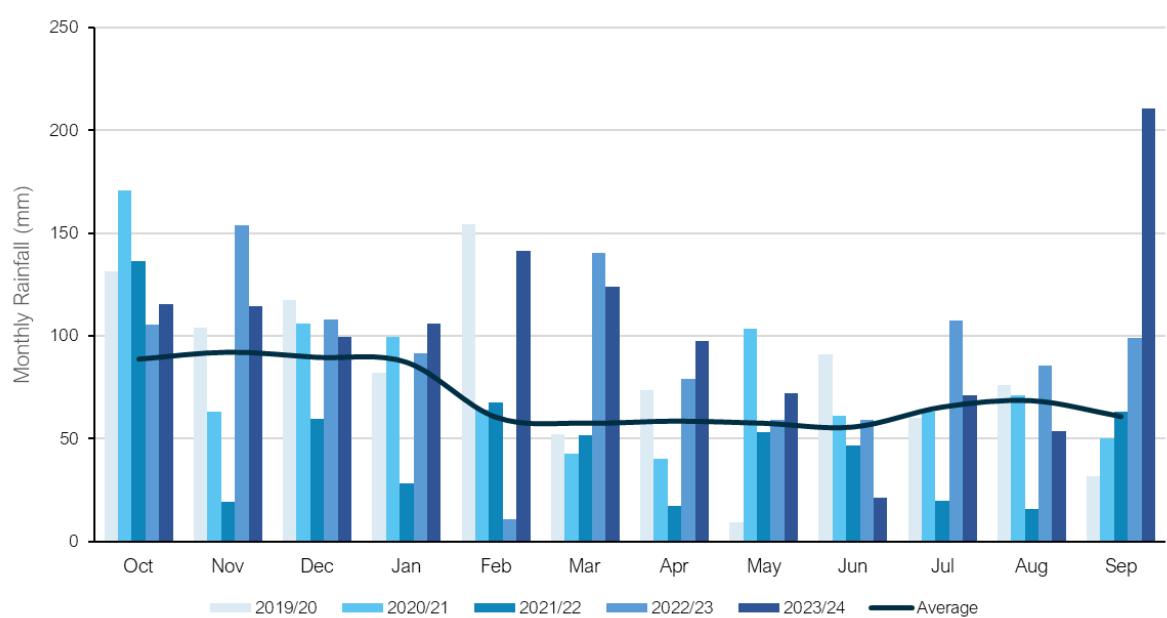
Figure 2: Monthly Rainfall Performance

Representative Radar rainfall has been used to generate monthly data at catchment level for comparison with average data generated by local Met Office Weather Station Records. Figure 2 presents the comparison of this data for the last four hydrological years to support longer term trends within the local system.

(Average Values taken from Met Office Weather Station at High Wycombe based on the period 1991-2020)

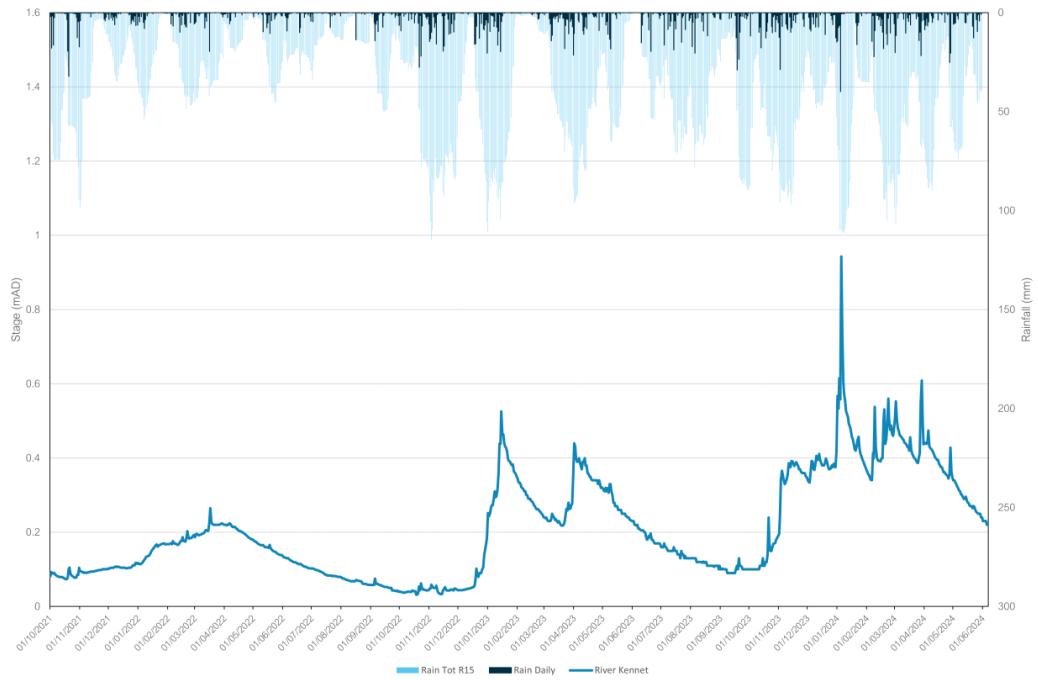
Figure 5A – River Kennet at Marlborough

The following figures represent the last three hydrological years of level information at the indicator sites to build a picture of the relative conditions prevalent in the current year. It is presented against both the daily total rainfall values for the catchment and a rolling 15-day total rainfall.

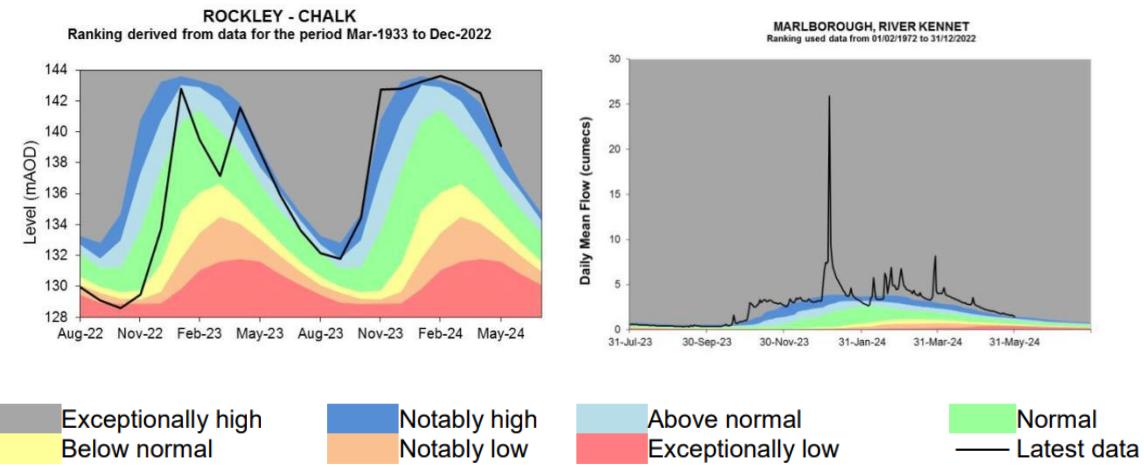
Figure 6 – Water Situation Report

In addition to these specific stations, the wider groundwater context is illustrated in the Water Situation Report for the Berkshire Downs. The nearest groundwater reference station is Rockley OBH. This site shows groundwater levels peaked at above normal/ notably high levels in 2023. Groundwater levels have been higher during the first half of 2024 compared to the equivalent

period in 2023, consistently at notably high/ exceptionally high levels. This can be seen in Figure 6 alongside the river indicator location at Marlborough on the River Kennet.
