Groundwater Impacted System Management Plan

Marlborough, River Kennet

January 2021

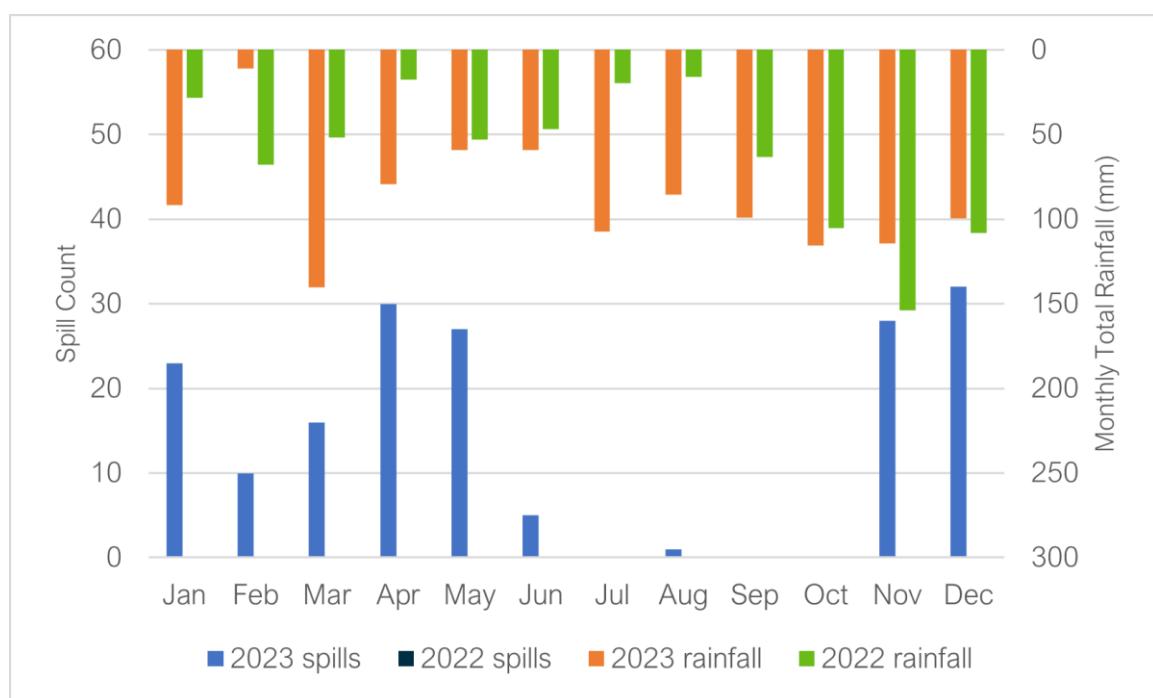
Figure 8 – EDM Monthly Performance

A critical part of the assessment of EDM performance and its relation to groundwater inundation is to review the month-on-month spill performance, against previous years and the monthly total rainfall values to give context to the performance. Figure 8 below presents the EDM performance trend and rainfall for recent years.

The data suggests a wider relationship between rainfall, elevated groundwater levels and overflow spill frequency. No spills were recorded at Marlborough STW in 2022, however 172 spills were recorded in 2023. The indicator site data shown in Figure 5, suggests that groundwater levels in the catchment were generally more elevated throughout 2023, reaching higher levels than those observed in 2022. The high threshold level for groundwater infiltration into the network, which is when significant levels of groundwater infiltration begin to occur, has been assigned as 0.3 mAD at the River Kennet at Marlborough indicator site. As can be seen in Figure 5A, this level was not reached in 2022 when no spills at Marlborough STW were recorded, however was exceeded for significant periods in 2023. These periods coincide with

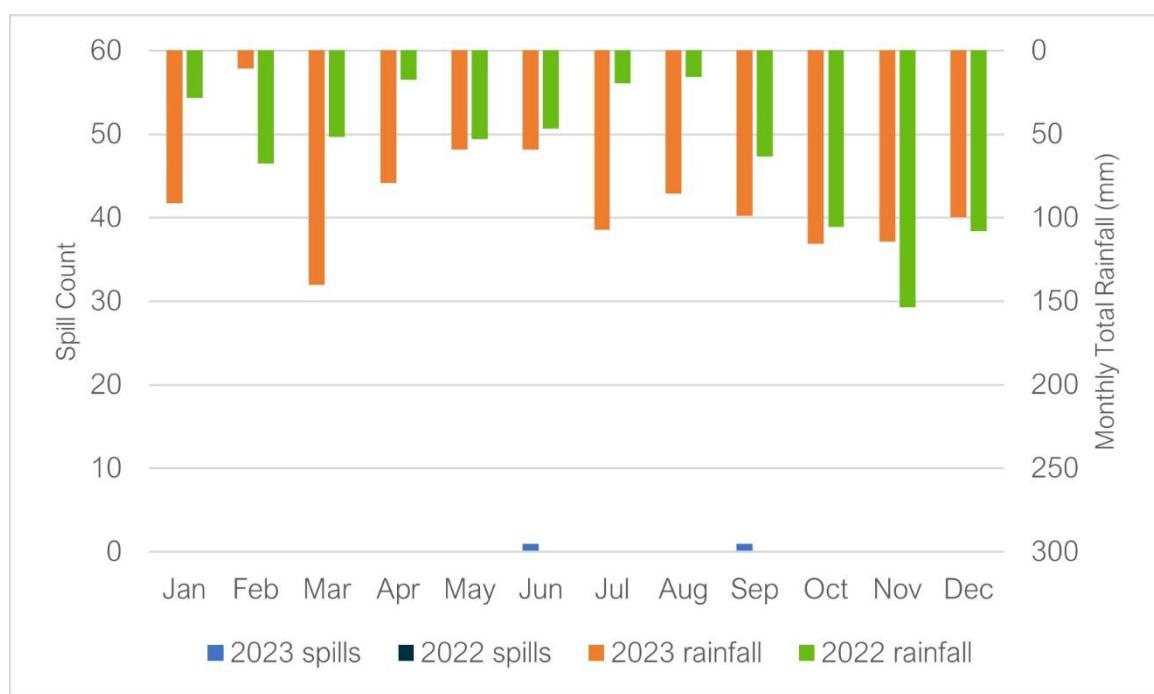
Figure 10 – EDM Monthly Performance

A critical part of the assessment of EDM performance and its relation to groundwater inundation is to review the month-on-month spill performance, against previous years and the monthly total rainfall values to give context to the performance. Figure 10 below presents the EDM performance trend and rainfall for recent years.

The data for London Road SPS is not indicative of a wider relationship between rainfall, elevated groundwater levels and spill frequency at the overflow. No spills were recorded in 2022, and only two spills were recorded in 2023, which occurred outside of periods of elevated groundwater levels. Note however, tankering was required upstream of the pumping station at the end of the year, to manage flows during this period of high groundwater levels, which may have reduced the spill frequency here. The EDM data for 2024 will be analysed once available, to continue to understand if there is a relationship between groundwater levels and spills at the overflow. The indicator site data shown in Figures 5 and 6, suggests that groundwater levels in the catchment reached higher levels in 2024 than in 2023.

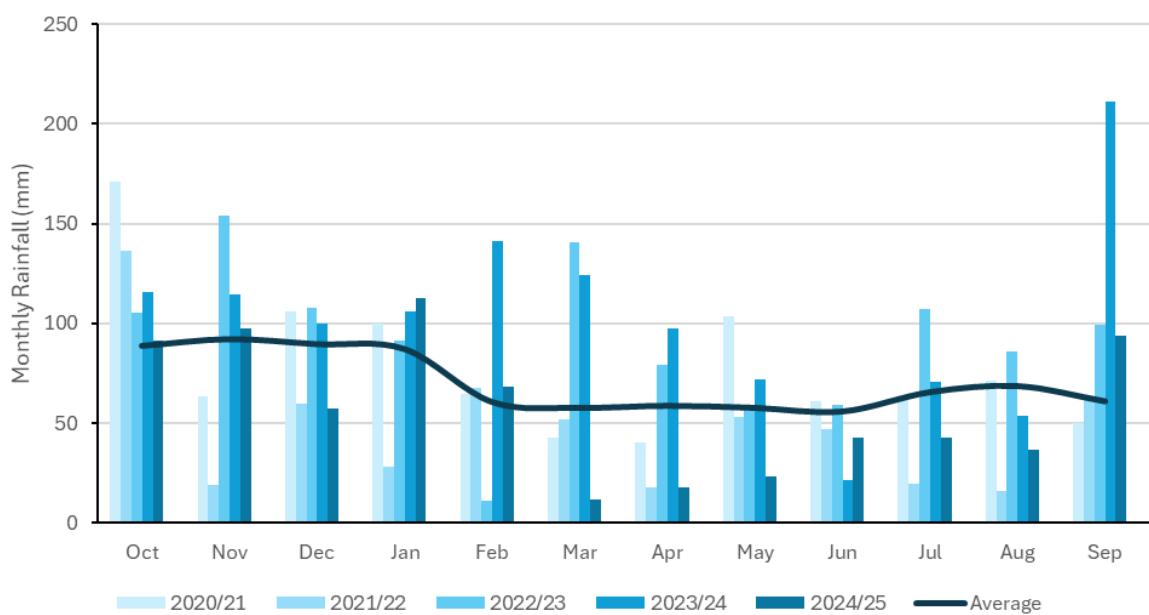
Figure 2: Monthly Rainfall Performance

Representative Radar rainfall has been used to generate monthly data at catchment level for comparison with average data generated by local Met Office Weather Station Records. Figure 2 presents the comparison of this data for the last four hydrological years to support longer term trends within the local system.

(Average Values taken from Met Office Weather Station at High Wycombe based on the period 1991-2020)

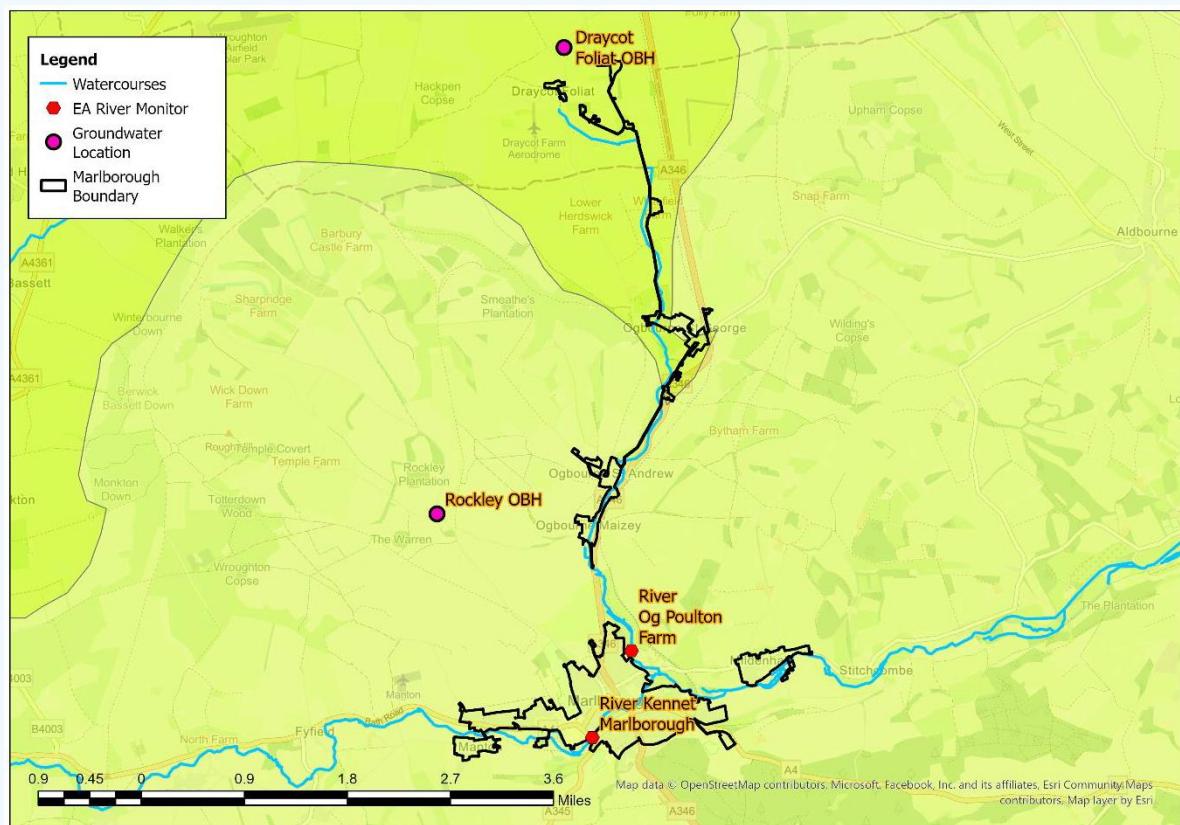
Figure 4: Local Monitoring Stations

- River Kennet, Marlborough
- River Og, Poulton Farm
- Rockley OBH
- Draycot Foliat OBH

These sites are illustrated in the figure below, alongside the closest groundwater reference station and closest gauging station from the Water Situation Report. The closest groundwater reference station from the WSR is also Rockley OBH and the closest gauging station from the WSR is also at Marlborough on the River Kennet.

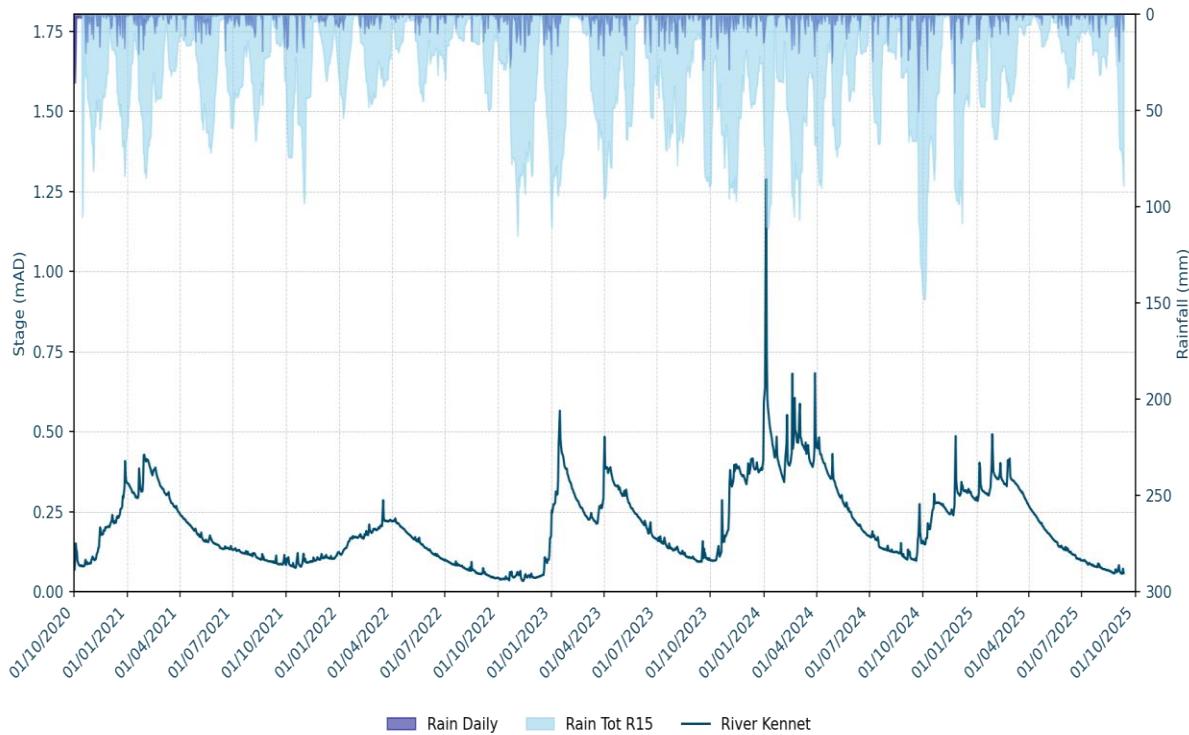
Figure 5A – River Level for River Kennet at Marlborough

The following figures represent the last three hydrological years of level information at the indicator sites to build a picture of the relative conditions prevalent in the current year. It is presented against both the daily total rainfall values for the catchment and a rolling 15-day total rainfall.

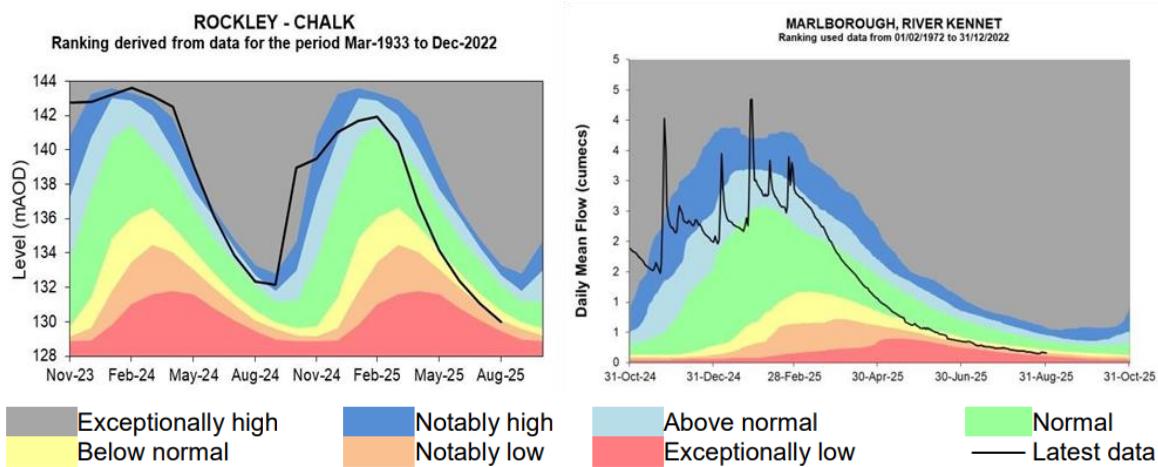
Figure 6 – Ground Water Situation Report

In addition to these specific stations, the wider groundwater context is illustrated in the Water Situation Report for the Berkshire Downs. The nearest groundwater reference station is Rockley OBH. This site shows groundwater levels at this site remained exceptionally high throughout 2024, with a slight decline observed between May and August, though levels still stayed notably high during that period. In 2025, groundwater levels continued to be notably high until mid-year, after which a gradual decline was observed. This can be seen in Figure 6 alongside the river indicator location at Marlborough on the River Kennet.

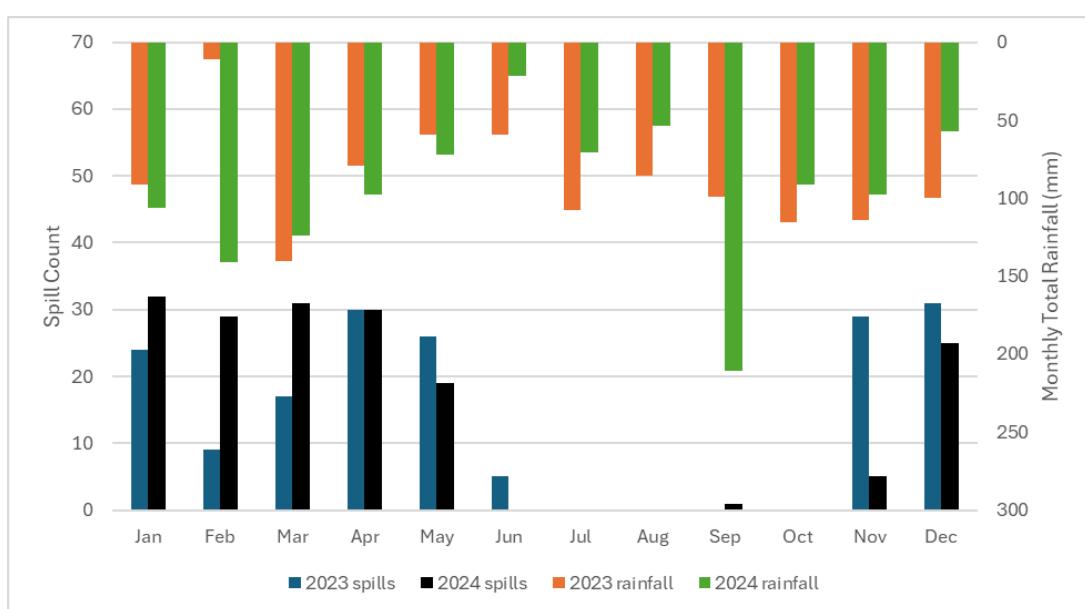
A critical part of the assessment of EDM performance and its relation to groundwater inundation is to review the month-on-month spill performance, against previous years and the monthly total rainfall values to give context to the performance. Figure 8 below presents the EDM performance trend and rainfall for recent years.

Figure 8 – Monthly rainfall data versus monthly spill count for 2023 and 2024 – Marlborough STW

The data suggests a wider relationship between rainfall, elevated groundwater levels and overflow spill frequency. A total of 172 spills were recorded at Marlborough STW in 2024 which is the same number of spills recorded in the previous year, however, in 2024, spill duration increased. The high threshold level for groundwater infiltration occurred during the winter period, which is when significant levels of groundwater infiltration begin to occur. As can be seen in Table 7, the higher number of spills occurred during the winter period, correlating with the levels of groundwater and river levels being higher during this period (see Figure 5A-D and 6). This indicates the wider relationship between groundwater levels and spills at the overflow.

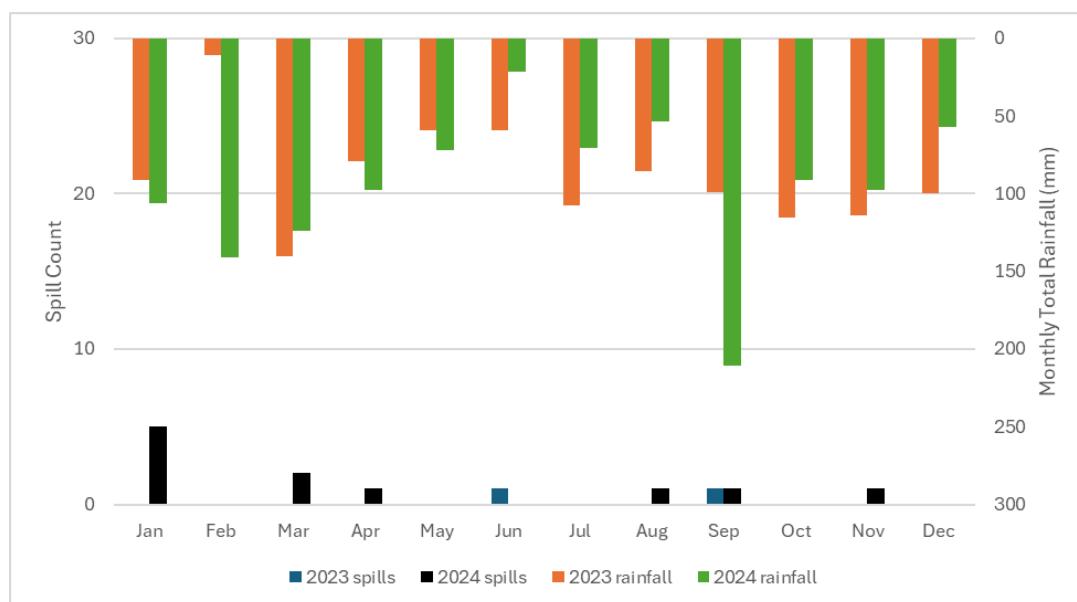
A critical part of the assessment of EDM performance and its relation to groundwater inundation is to review the month-on-month spill performance, against previous years and the monthly total rainfall values to give context to the performance. Figure 10 below presents the EDM performance trend and rainfall for recent years.

Figure 10 – Monthly rainfall data versus monthly spill count for 2023 and 2024 – London Road SPS

The data suggests a wider relationship between rainfall, elevated groundwater levels and overflow spills. A higher number of spills were recorded at London Road SPS in 2024, with Figure 10 suggesting average rainfall for 2024 increased during the 2023/24 period compared to the previous year, and the river level data shown in Figure 5A-D suggesting they were significantly higher than in 2022/23. However, it is important to note the potential impact of asset availability on spills in 2025.
