Groundwater Impacted System Management Plan

Chesham, River Chess

January 2021

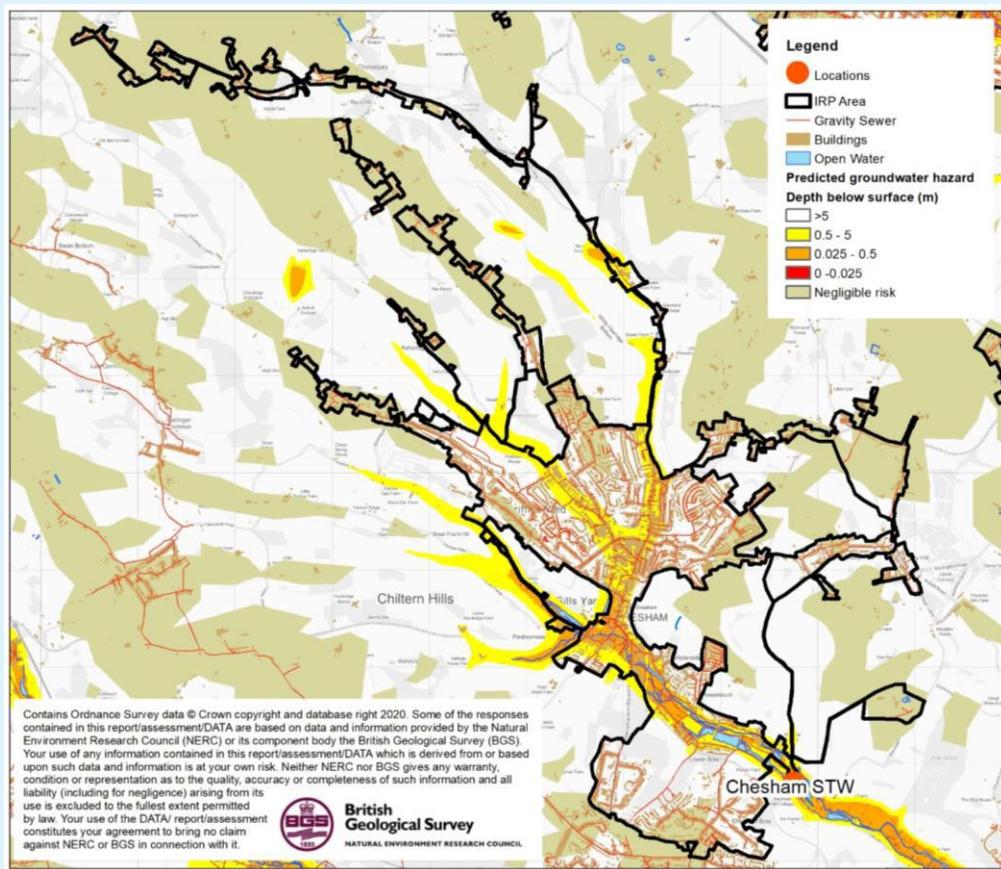
Figure 1.0 – Chesham STW catchment

Chesham is located in the Chiltern Hills, Buckinghamshire, England, 11 miles South East of the County town of Aylesbury. Chesham serves a population equivalent³ of 37,250 with a predominantly separate sewerage network totalling some 139 km in length excluding private drains and sewers. The extent of the catchment is shown in Figure 1.0 above.

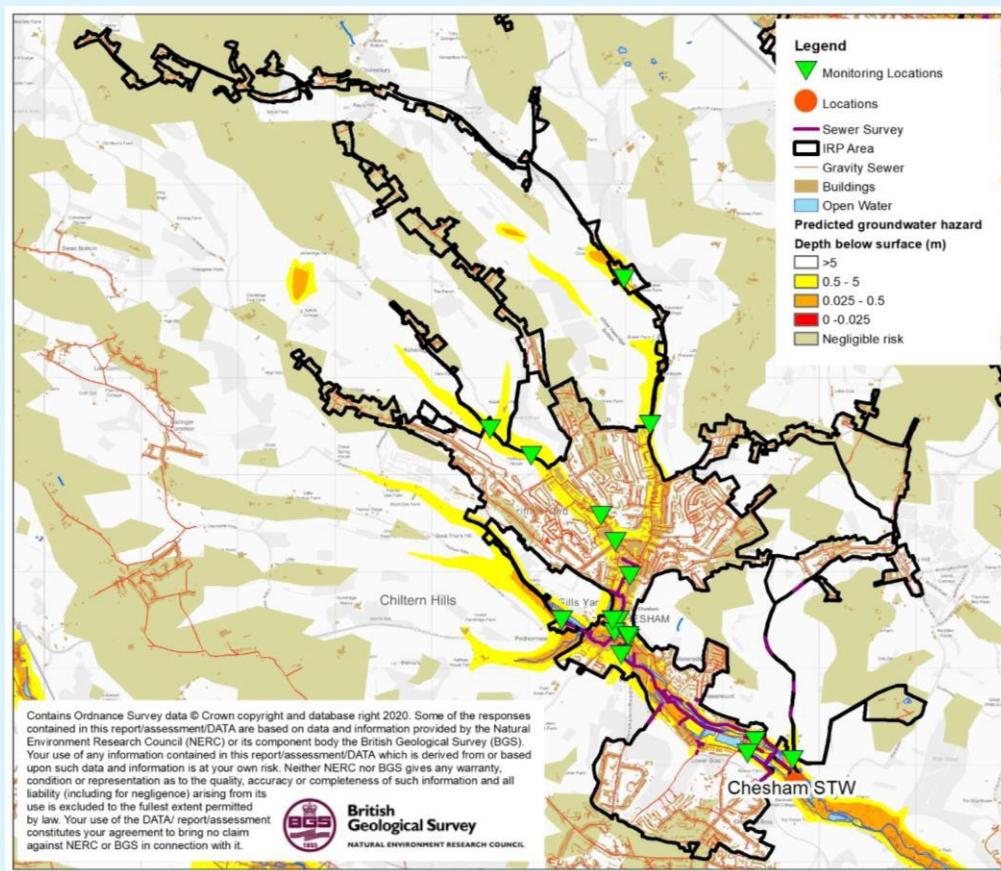
Figure 2.0 – Chesham monitoring and infiltration zones

Key to bringing the impact of groundwater infiltration under control will be an enhanced monitoring regime. We have identified and have installed several telemetered depth monitor locations around the Chesham system – see Figure 2.0.

We engaged with JBA Consulting to develop plans for Chesham that identify zones of groundwater risk, see Figure 2.0. These zones are modelled areas where the groundwater has been determined to be above the sewer and hence pose a potential risk for groundwater ingress.

Sewer Depth Monitors have been installed in the catchment during 2020 (see Figure 2.0). These devices are telemetered and provide real-time data on the level of flow in the sewer.

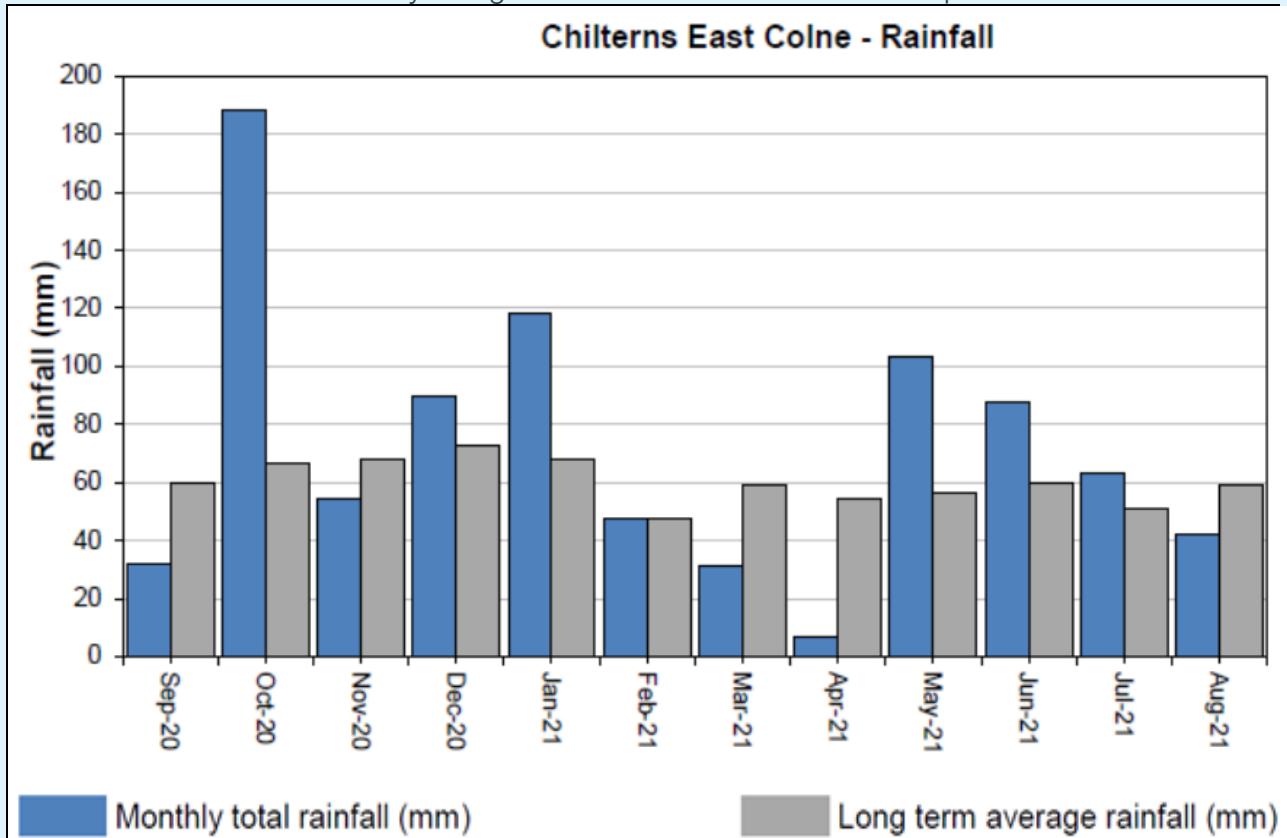
Figure 2 – Monthly rainfall depths local to the system

Chesham is situated in the Chilterns East Colne water resources area. Figure 2 shows the monthly total rainfall depths against the long-term average rainfall in the in the location of Chesham over the period taken from the ¹*Environment Agency Water Situation Report August 2021*¹. The graph indicates that monthly rainfall at times in the last year has significantly exceeded long-term averages, this was especially notable in the winter period.

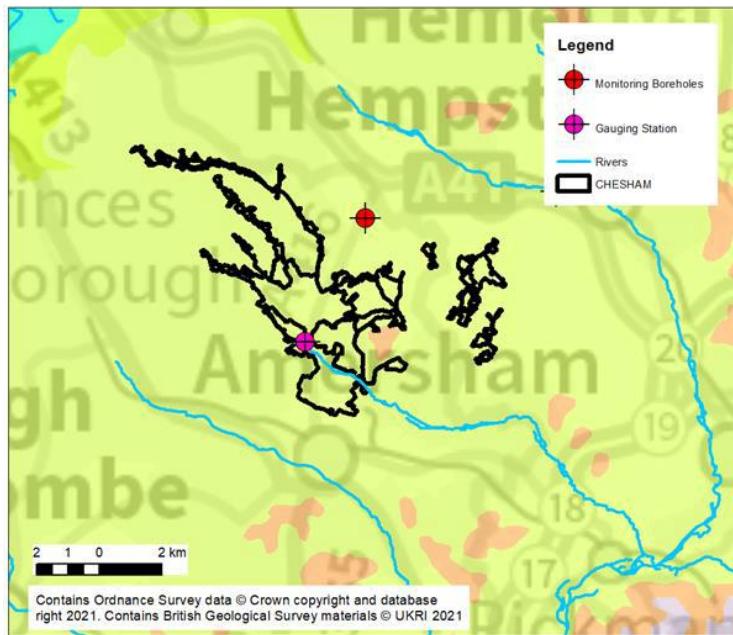
Figure 3 – Location of Ashley Green Monitoring Borehole Relative to Chesham

Figure 3 shows the location of the British Geological Survey (BGS) monitoring borehole at Ashley Green which has been monitoring the same Chalk aquifer than lies beneath Chesham since 1961. Figures 4 and 5 show river levels in the River Chess at Chesham which are a good indication of local groundwater levels over time Figure 6 and 7 show the last two and ten years of groundwater level data overlain on expected ranges. This shows how recent groundwater levels have compared against the expected range.

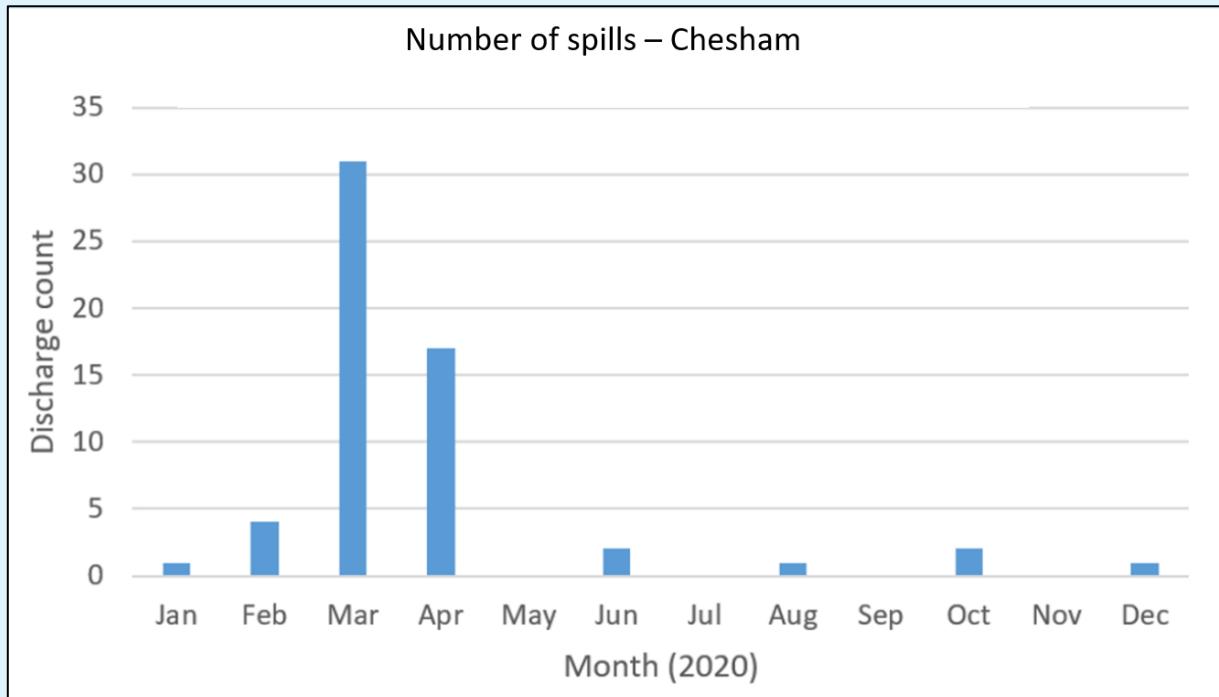
Figure 8 – Number of spills (discharge count) at Chesham Sewage treatment Works (STW) (taken from Event Duration monitor (EDM) Data).*

Figure 8 shows the number of spills per month from Chesham Sewage Treatment Works (STW). The greatest number of spills occurred in March and April which correlates with periods of high river levels in the River Chess. Levels in the River Chess are representative of local groundwater levels.

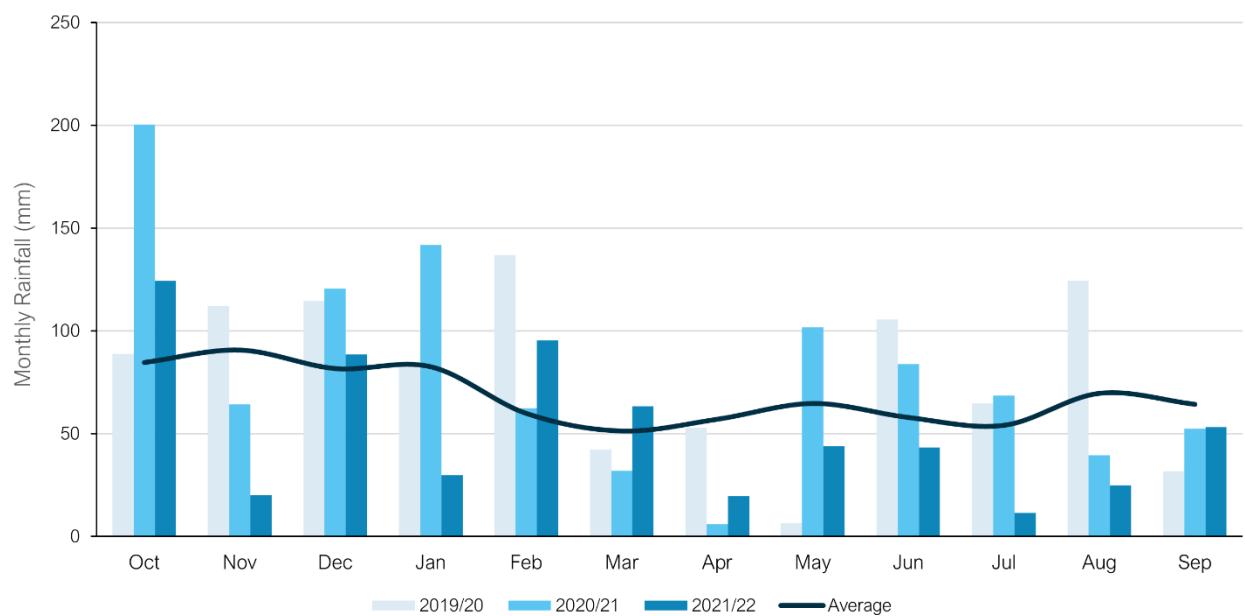
Figure 2 – Monthly Rainfall Performance

Representative Radar rainfall has been used to generate monthly data at catchment level for comparison with average data generated by local Met Office Weather Station Records. Figure 2 presents the comparison of this data for the last three hydrological years to support longer term trends within the local system.

Average Values taken from Met Office Weather Station at High Wycombe based on the period 1991-2020

The total rainfall for the 2021/22 hydrological year is 23% below the annual average total. Total rainfall values are presented in Table 3 below.

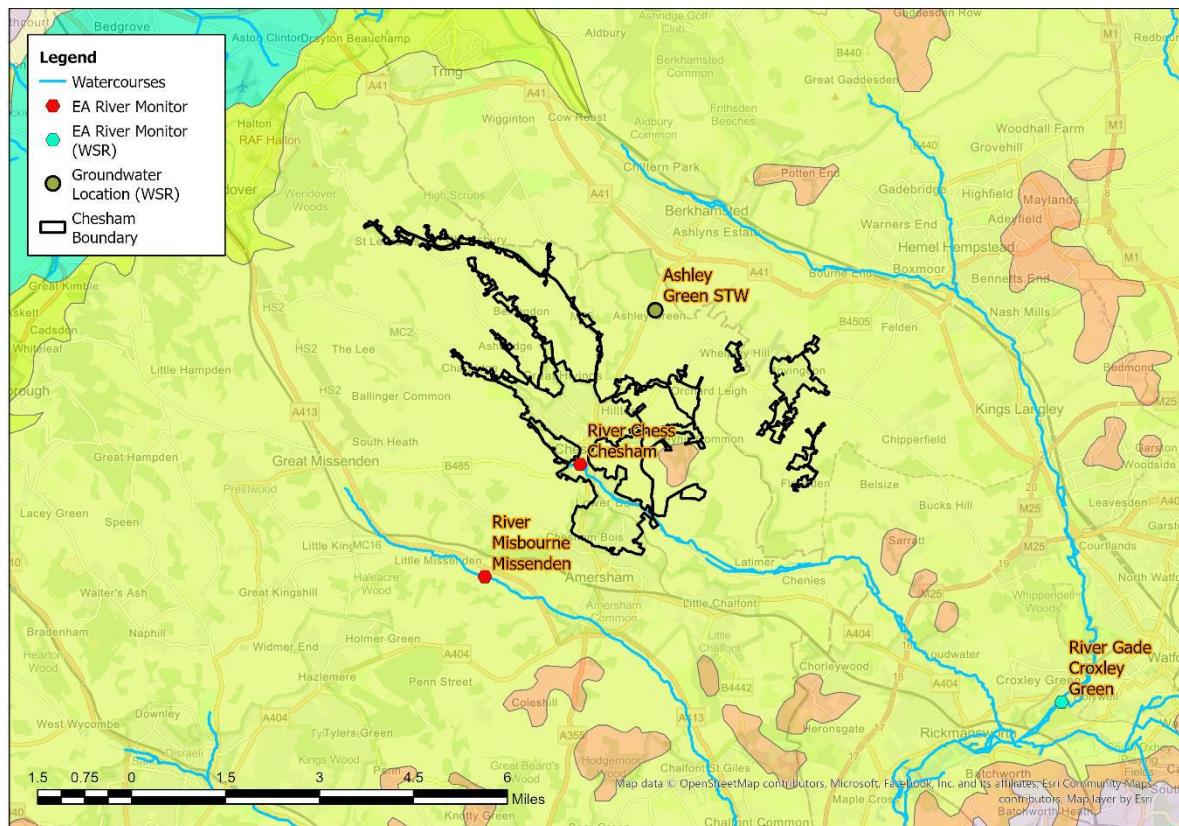
Figure 4 – Local Monitoring Stations

These sites are illustrated in the figure below, alongside the closest groundwater reference station and closest gauging station from the Water Situation Report.

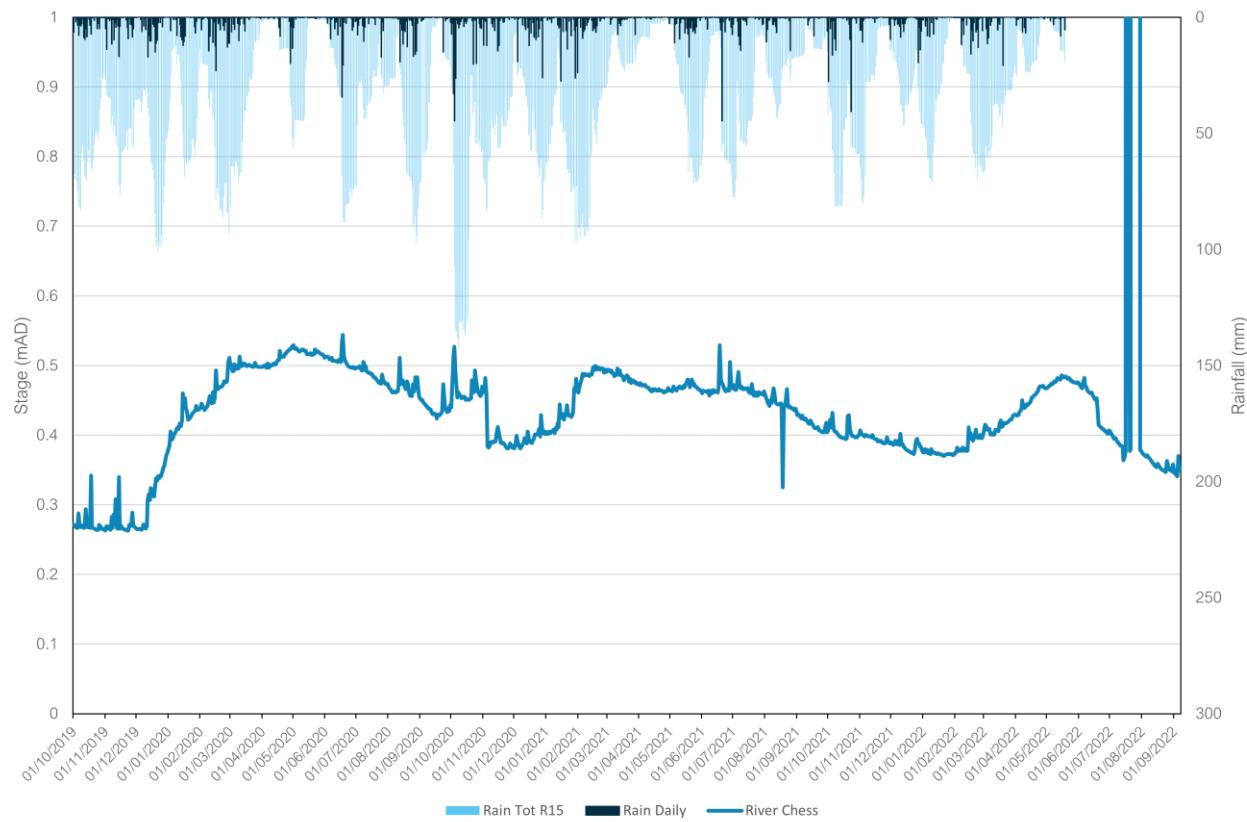
Figure 5A – River Chess, Chesham

The following figures represent the last three hydrological years of level information at the indicator sites to build a picture of the relative conditions prevalent in the current year. It is presented against both the daily total rainfall values for the catchment and a rolling 15-day total rainfall.

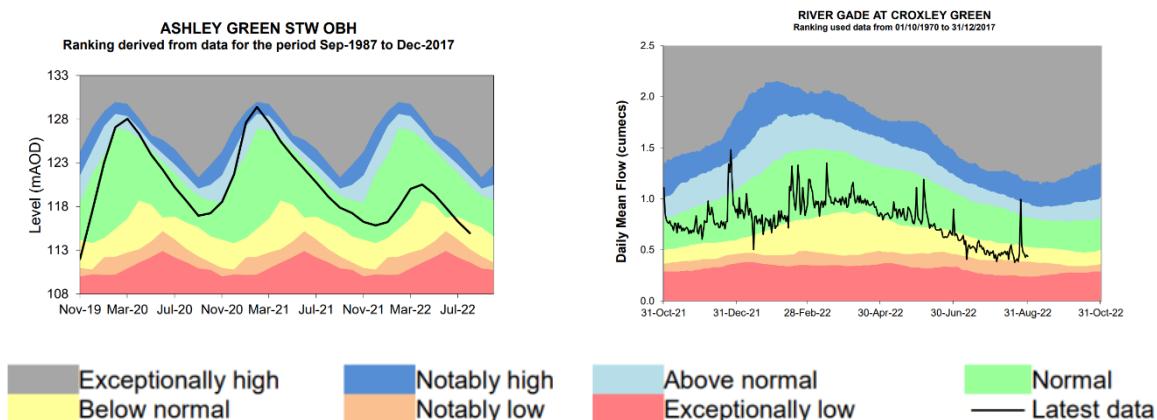
Figure 6 – Water Situation Report

Situation Report for Chilterns - East – Colne. The nearest groundwater reference station is Ashley Green STW. This site shows significantly lower overall groundwater than the previous year. This can be seen in the figure below alongside the river indicator Croxley Green on the River Gade.

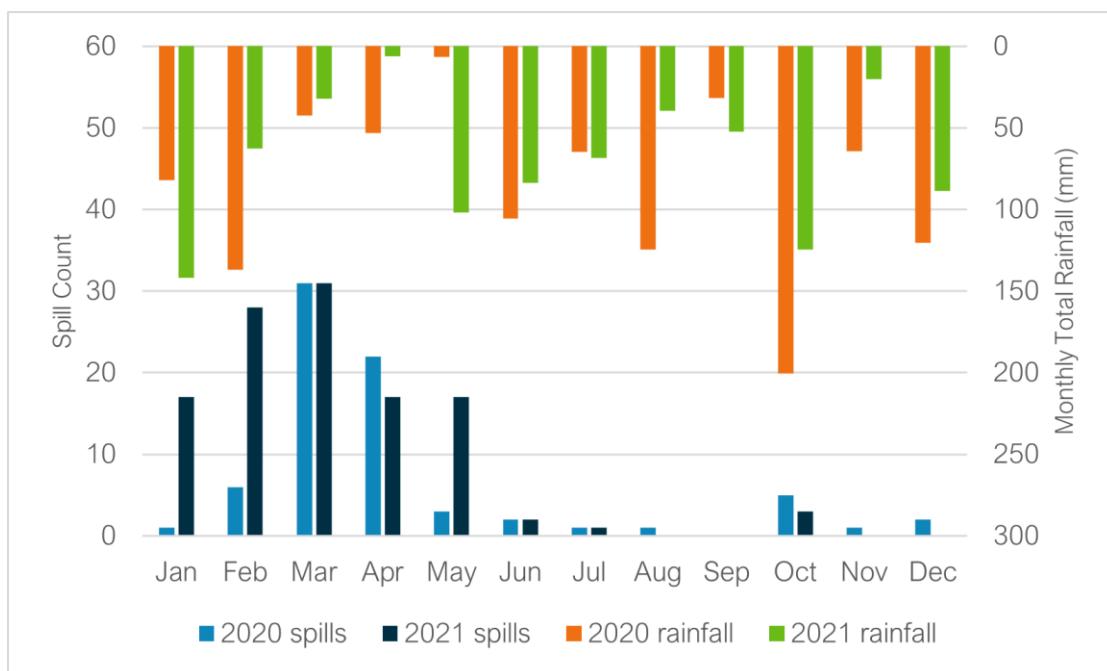
Figure 8 – EDM Monthly Performance

A critical part of the assessment of EDM performance and its relation to groundwater inundation is to review the month-on-month spill performance, against previous years and the monthly total rainfall values to give context to the performance. Note a spill frequency of 75 is stated for 2020, which is higher than the published spill count of 59. The data has been revalidated/ corrected and the revised spill count of 75 will be included in the re-submission to the EA. Figure 8 below presents the EDM performance trend and rainfall for recent years.

The trend in spill performance across the two recorded years does show variation in spills, with an overall focus on spills during the winter and spring months. The data suggests a wider relationship between rainfall, elevated groundwater levels and spill frequency.

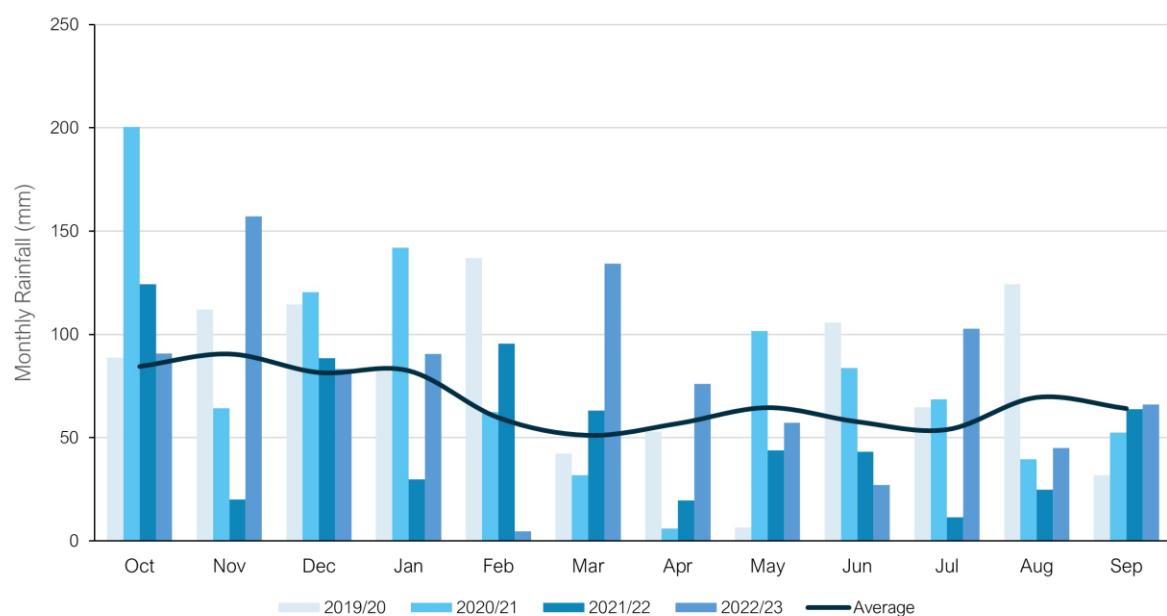
Figure 2 – Monthly Rainfall Performance

Representative Radar rainfall has been used to generate monthly data at catchment level for comparison with average data generated by local Met Office Weather Station Records. Figure 2 presents the comparison of this data for the last four hydrological years to support longer-term trends within the local system.

Average Values taken from Met Office Weather Station at High Wycombe based on the period 1991-2020

The total rainfall for the 2022/23 hydrological year is 14% above the annual average total. Total rainfall values are presented in Table 3 below.

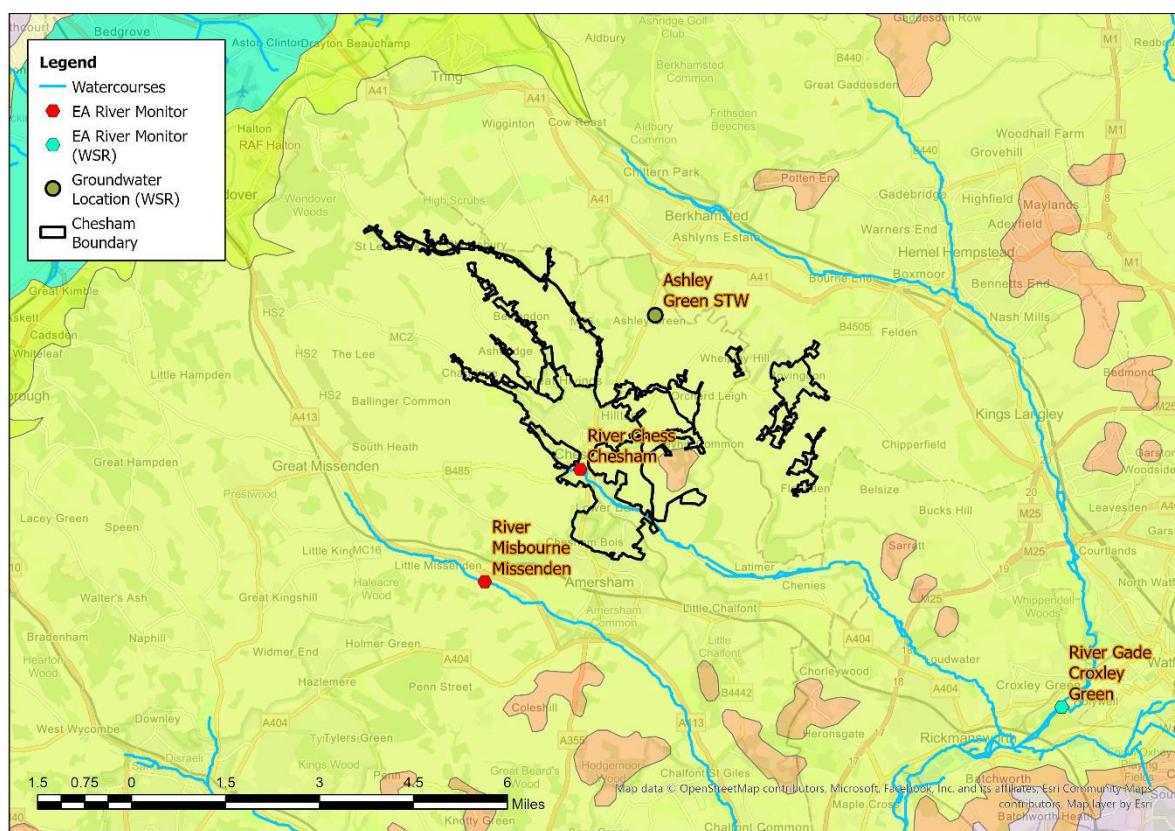
Figure 4 – Local Monitoring Stations

These sites are illustrated in the figure below, alongside the closest groundwater reference station and closest gauging station from the Water Situation Report.

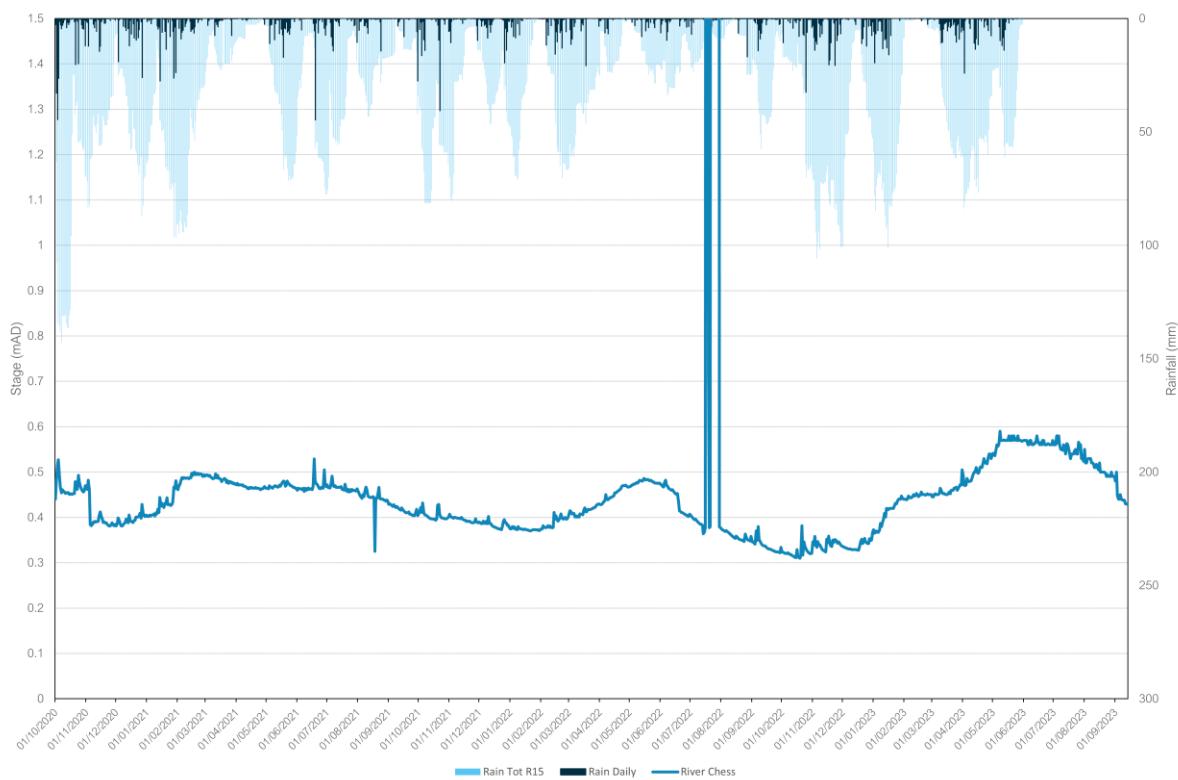
Figure 5A – River Chess, Chesham

The following figures represent the last three hydrological years of level information at the indicator sites to build a picture of the relative conditions prevalent in the current year. It is presented against both the daily total rainfall values for the catchment and a rolling 15-day total rainfall.

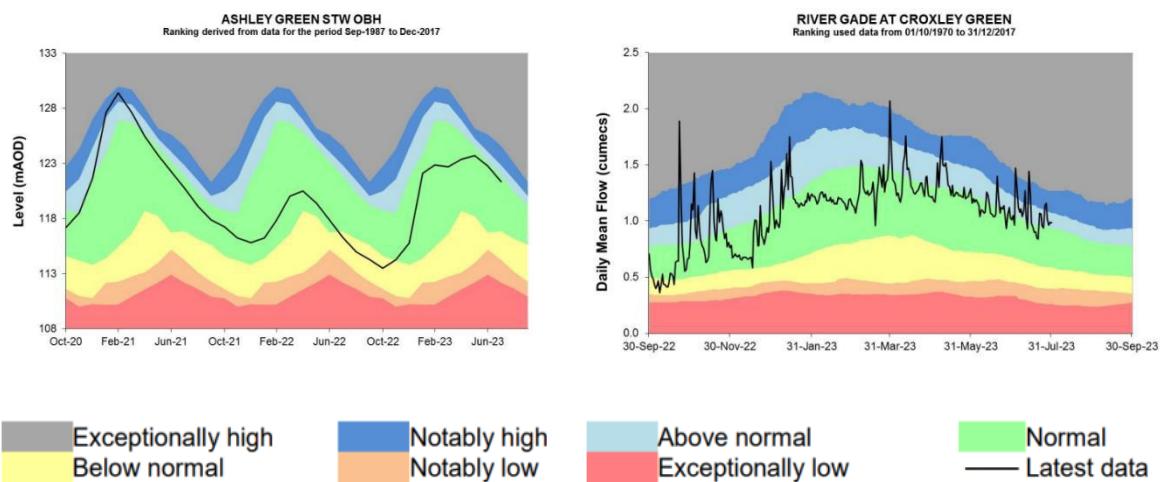
Figure 6 – Water Situation Report

In addition to these specific stations, the wider groundwater context is illustrated in the Water Situation Report for Chilterns - East – Colne. The nearest groundwater reference station is Ashley Green STW. This site shows groundwater levels at normal or below normal in 2022. Groundwater levels have been observed at normal levels in 2023, however have reached higher levels than in 2022. This can be seen in the figure below alongside the river indicator located at Croxley Green on the River Gade.

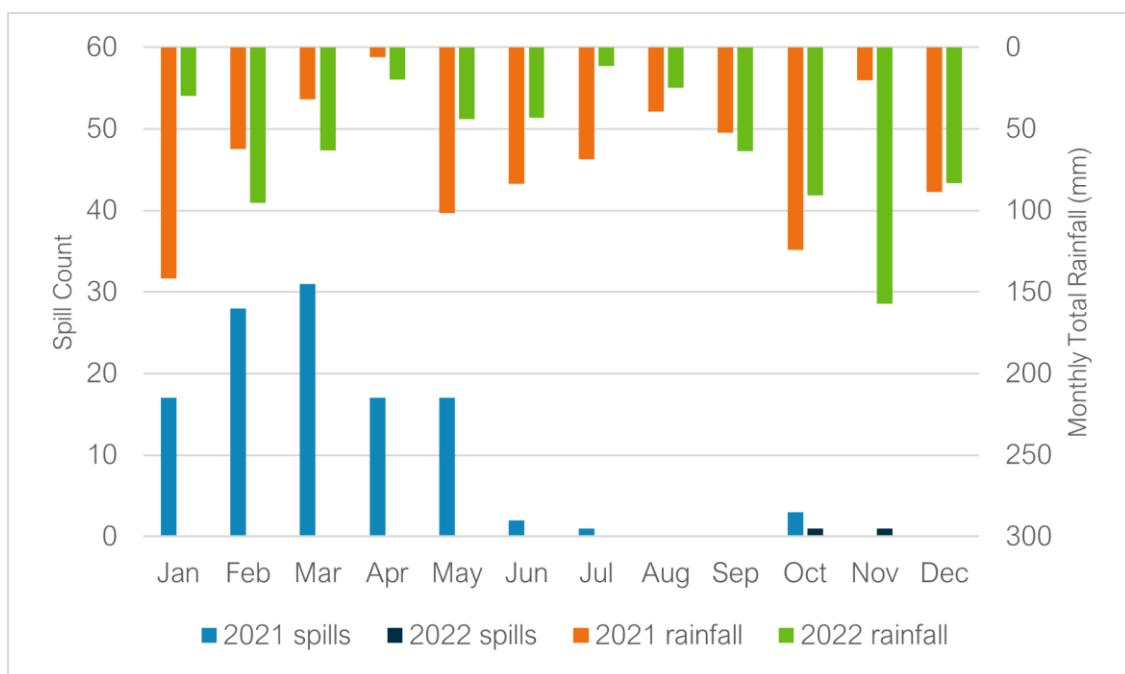
Figure 8 – EDM Monthly Performance

A critical part of the assessment of EDM performance and its relation to groundwater infiltration, is to review the month-on-month spill performance against previous years and the monthly total rainfall values to give context to the performance. Figure 8 below presents the EDM performance trend and rainfall for recent years.

The data suggests a wider relationship between rainfall, elevated groundwater levels and spill frequency. An elevated groundwater level observed in the first half of 2021 (see Figures 5 and 6), coincides with a significant number of spills recorded January – May. For 2022, Figure 6 suggests groundwater levels in the catchment remained at a normal level in the first half of the year and were significantly lower than the same period in 2021. This corresponds with an absence of any recorded spills during the first half of 2022, despite a higher rainfall total in February, March and April 2022.

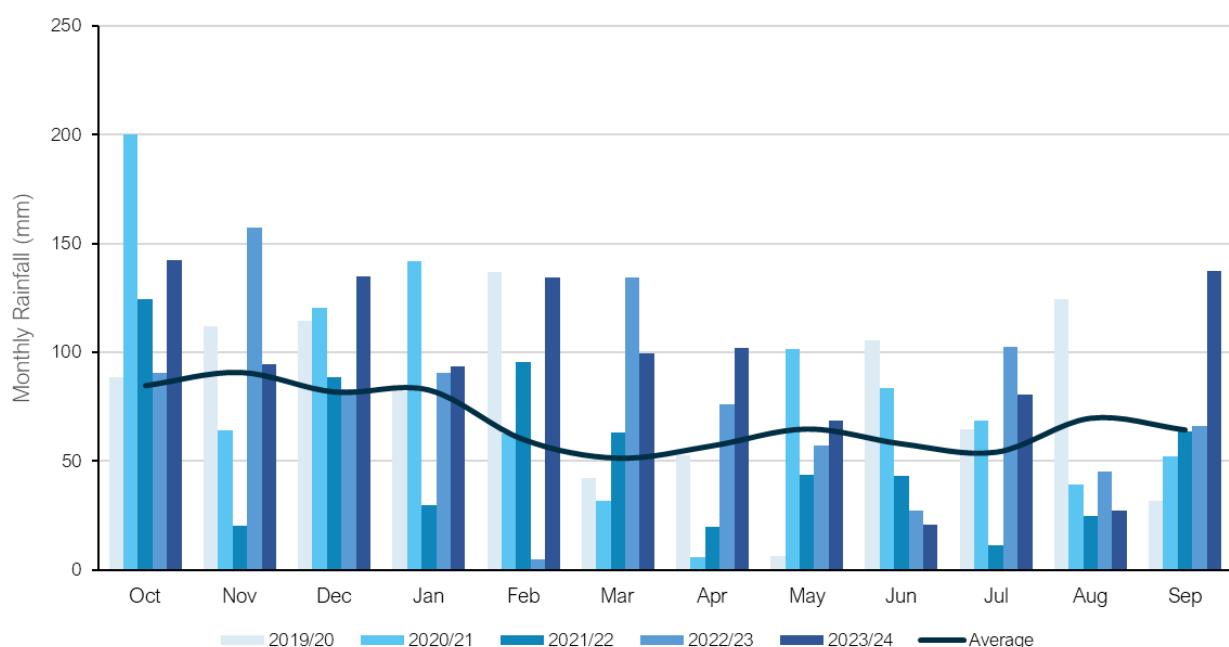
Figure 2 – Monthly Rainfall Data

Representative Radar rainfall has been used to generate monthly data at catchment level for comparison with average data generated by local Met Office Weather Station Records. Figure 2 presents the comparison of this data for the last five hydrological years to support longer term trends within the local system.

Average Values taken from Met Office Weather Station at High Wycombe based on the period 1991-2020

The total rainfall for the 2023/24 hydrological year is 39% above the annual average total. Total rainfall values are presented in Table 3 below.

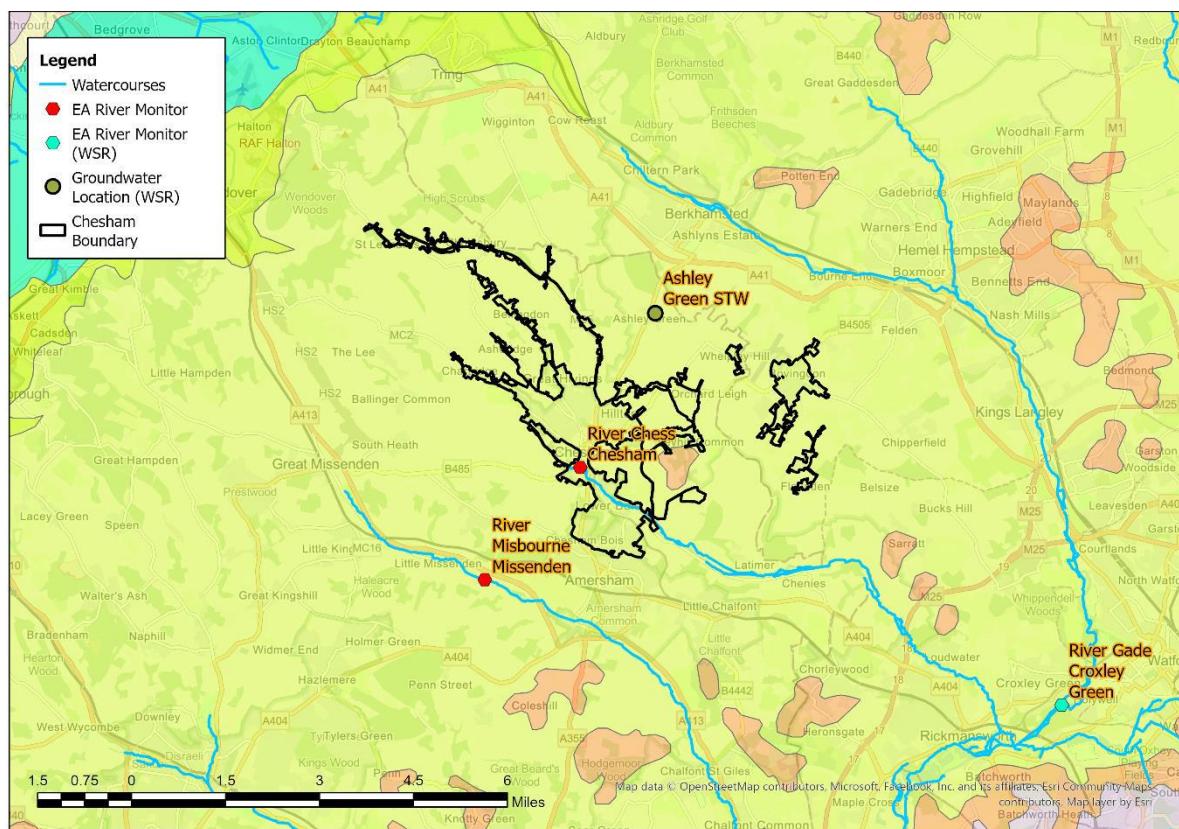
Figure 4 – Local Monitoring Stations

These sites are illustrated in Figure 4, alongside the closest groundwater reference station and closest gauging station from the Water Situation Report.

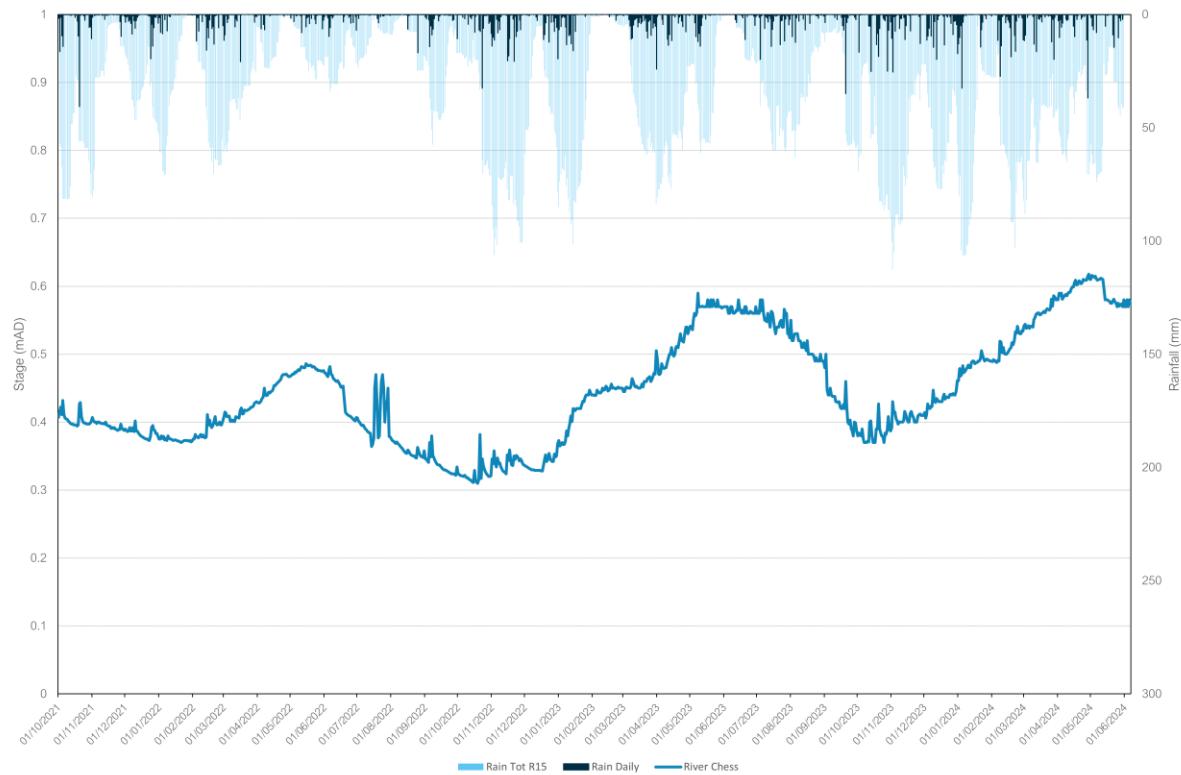
Figure 5A – River Chess, Chesham

Figures 5A-5B represent the last three hydrological years of level information at the indicator sites to build a picture of the relative conditions prevalent in the current year. It is presented against both the daily total rainfall values for the catchment and a rolling 15-day total rainfall.

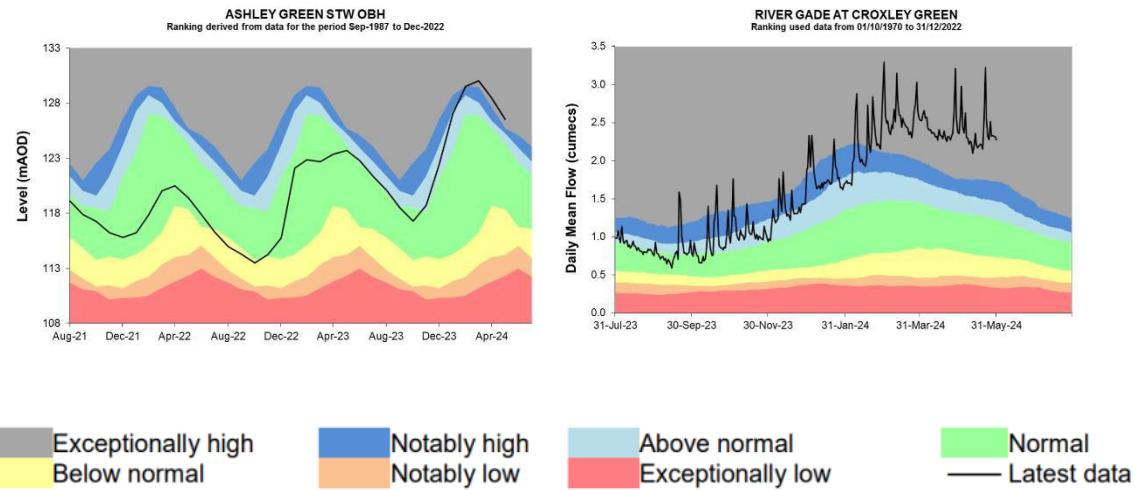
Figure 6 – Water Situation Report

In addition to these specific stations, the wider groundwater context is illustrated in the Water Situation Report for Chilterns - East – Colne. The nearest groundwater reference station is Ashley Green STW OBH. This site shows groundwater levels to be at normal levels throughout 2023, whereas groundwater levels in 2024 are seen to rise to notably high / exceptionally high levels. This can be seen in Figure 6 alongside the river indicator located at Croxley Green on the River Gade.

The EDM data for 2024 will be analysed once available to continue to understand the impact of the works completed on spills at the STW, as the indicator site data shown in Figure 6 suggests that groundwater levels in the catchment reached exceptionally high levels in 2024.

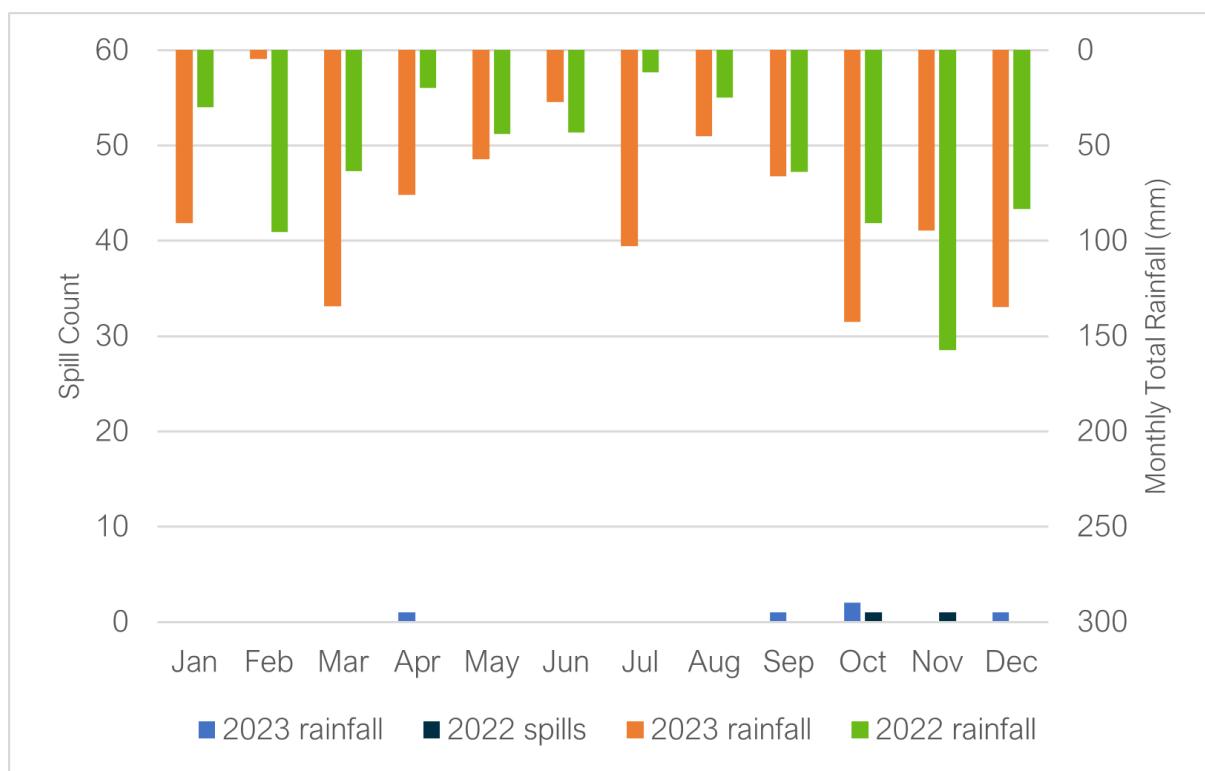
Figure 8 – EDM Monthly Performance

A critical part of the assessment of EDM performance and its relation to groundwater infiltration, is to review the month-on-month spill performance against previous years and the monthly total rainfall values to give context to the performance. Figure 8 below presents the EDM performance trend and rainfall for recent years.

A low number of spills were recorded at Chesham STW across 2022 and 2023, this compares to a long-term average spill count of 35. The indicator site data shown in Figures 5 and 6, suggests that groundwater levels in the catchment remained relatively low in 2022, however rose significantly in 2023. The high threshold level for groundwater infiltration in the catchment, which is when significant levels of groundwater infiltration in the network begin to occur, has been assigned as 0.48 mAD at the River Chess at Chesham indicator site. As can be seen in Figure 5A, this level was significantly exceeded for a sustained period in 2023, however this is not reflected in recorded spills at the STW. A major treatment capacity upgrade was completed at Chesham STW in early 2023. The low number of spills that occurred at the site in 2023, when

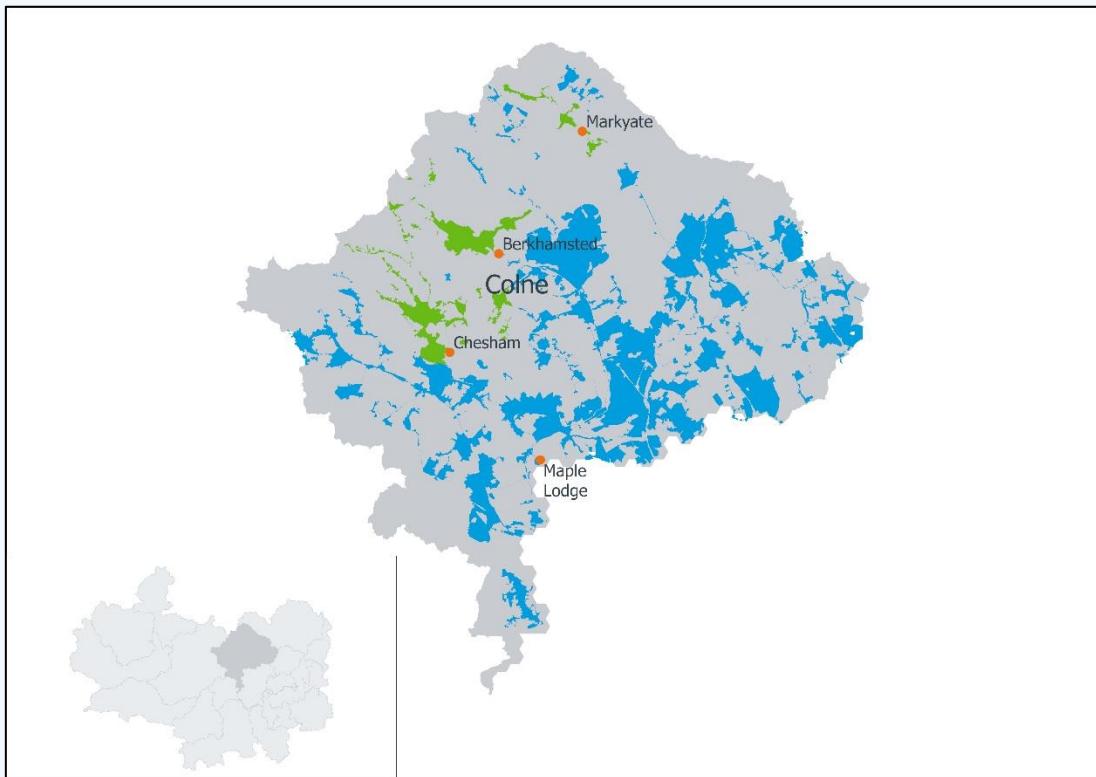
Figure 1: Relationship of the Sewer Systems to Associated Rivers

Sewer System	Associated River / Stream	Relationship to the River Thames
Berkhamsted STW	River Bulbourne	Indirect tributary of the River Thames via River Colne
Chesham STW	River Chess	Indirect tributary of the River Thames via River Colne
Maple Lodge STW	River Colne	Direct tributary of the River Thames
Markyate STW	River Ver	Indirect tributary of the River Thames via River Colne

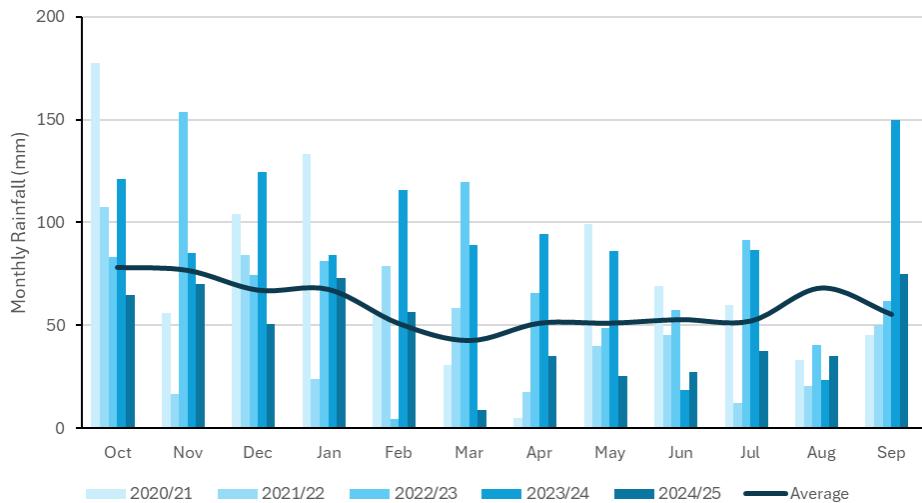
Figure 1: Monthly rainfall data 2020/21 to 2024/25

Figures 1 to 5 illustrate the relationship between rainfall and spills at CSOs. As shown in Figure 1, the decrease in rainfall from 2023/24 to 2024/25 correlates with reduced river levels (Figures 2 and 3), as well as a decline in the number and duration of CSO spills shown in Figure 5.

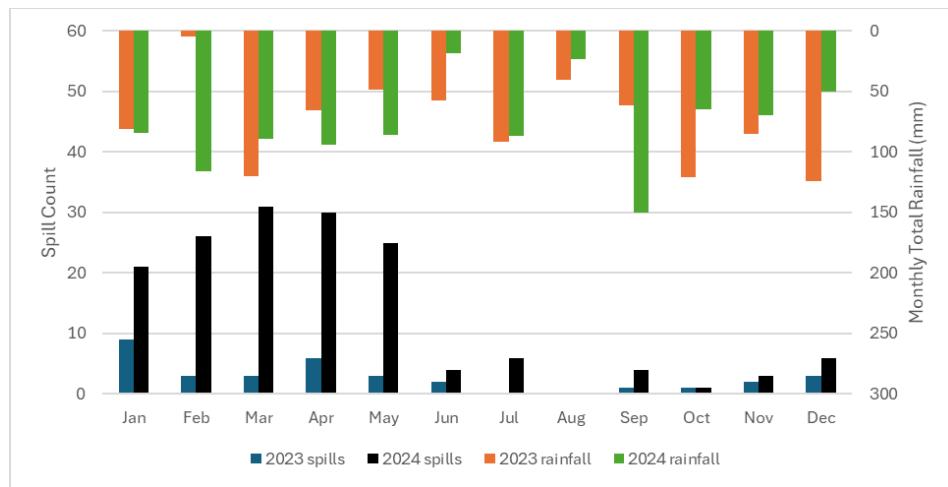
Figure 5: Monthly rainfall data versus monthly spill count for 2023 and 2024 – Berkhamsted STW

Table 1 below details the last 2 years performance of overflows in the catchment. To assess EDM performance and its relation to groundwater infiltration, a review of the month-on-month spill performance in 2023 and 2024 against the monthly total rainfall values has been undertaken, as observed in Figure 5.

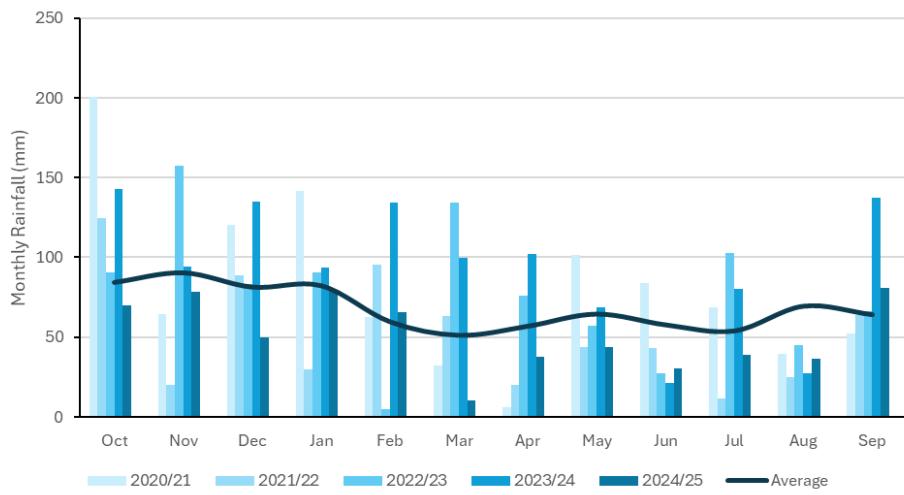
Figure 1: Monthly rainfall data 2020/21 to 2024/25

Figures 1 to 5 illustrate the relationship between rainfall and spills at CSOs. As shown in Figure 1, there is decrease in rainfall from 2023/24 to 2024/25. However, river levels follow a similar pattern as previous year (Figures 2 and 3), along with a decline in both the number and duration of CSO spills shown in Figure 5.

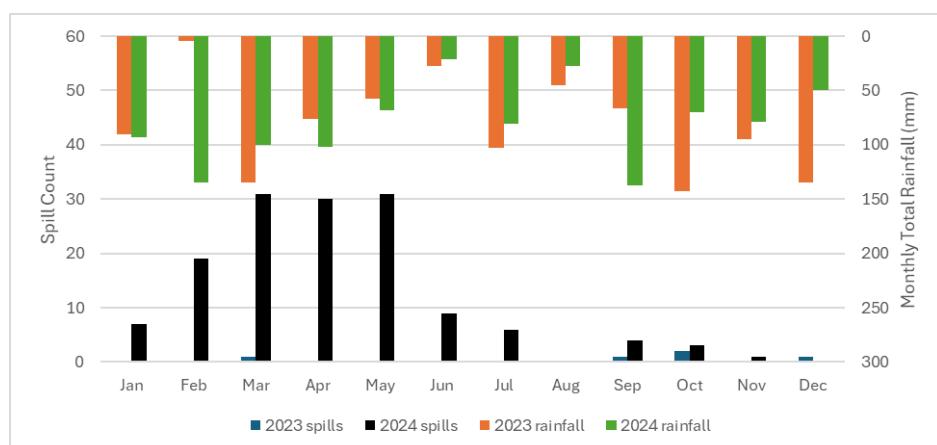
Figure 5: Monthly rainfall data versus monthly spill count for 2023 and 2024 – Chesham STW

Table 1 below details the last 2 years performance of overflows in the catchment. To assess EDM performance and its relation to groundwater infiltration, a review of the month-on-month spill performance in 2023 and 2024 against the monthly total rainfall values has been undertaken, as observed in Figure 5.

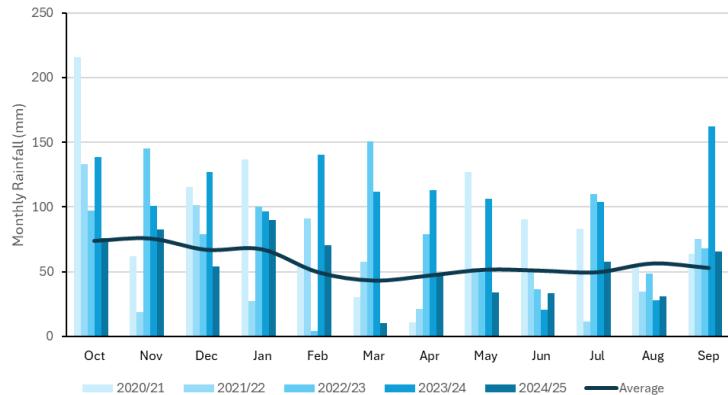
Figure 1: Monthly rainfall data 2020/21 to 2024/25

Figures 1 to 7 illustrate the relationship between rainfall and CSO spills. As shown in Figure 1, the reduction in rainfall from 2023/24 to 2024/25. However, river levels follow a similar pattern as previous year (Figures 2 to 5), along with a decline in both the number and duration of CSO spills shown in Figure 7.
