Groundwater Impacted System Management Plan

Chesham, River Chess

January 2021

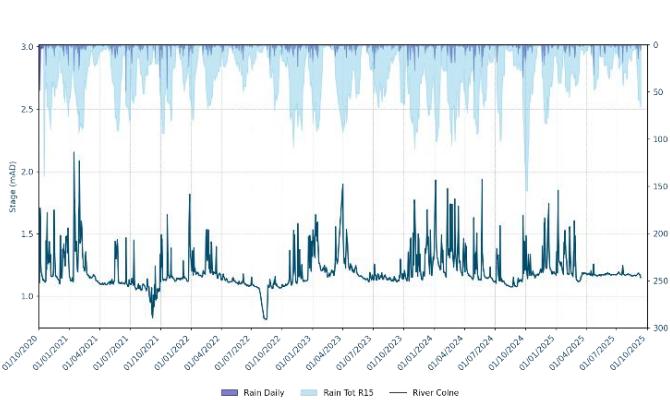
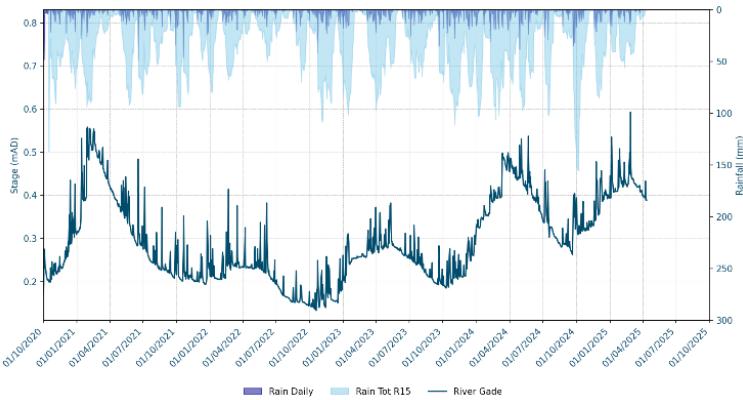
Figure 2: River Level data for River Colne, London Colney / Figure 3: River Level data for River Gade, Hemel Hempstead, Bury Mill

Figures 1 to 7 illustrate the relationship between rainfall and CSO spills. As shown in Figure 1, the reduction in rainfall from 2023/24 to 2024/25. However, river levels follow a similar pattern as previous year (Figures 2 to 5), along with a decline in both the number and duration of CSO spills shown in Figure 7.

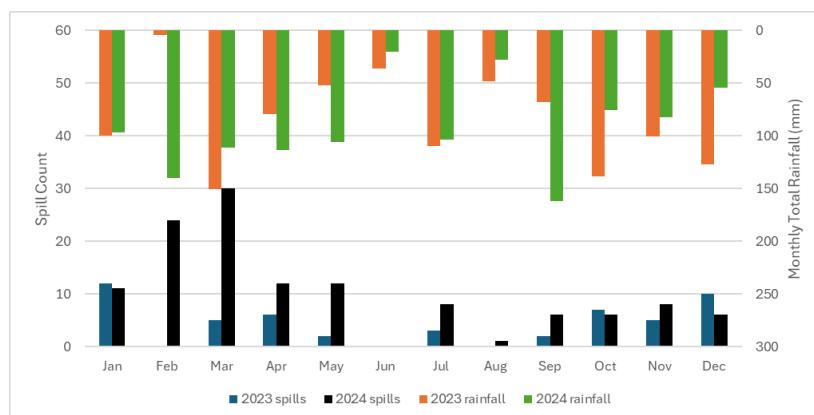
Figure 7: Monthly rainfall data versus monthly spill count for 2023 and 2024 – Maple Lodge STW

Table 1 below details the last 2 years performance of overflows in the catchment. To assess EDM performance and its relation to groundwater infiltration, a review of the month-on-month spill performance in 2023 and 2024 against the monthly total rainfall values has been undertaken, as observed in Figure 7.

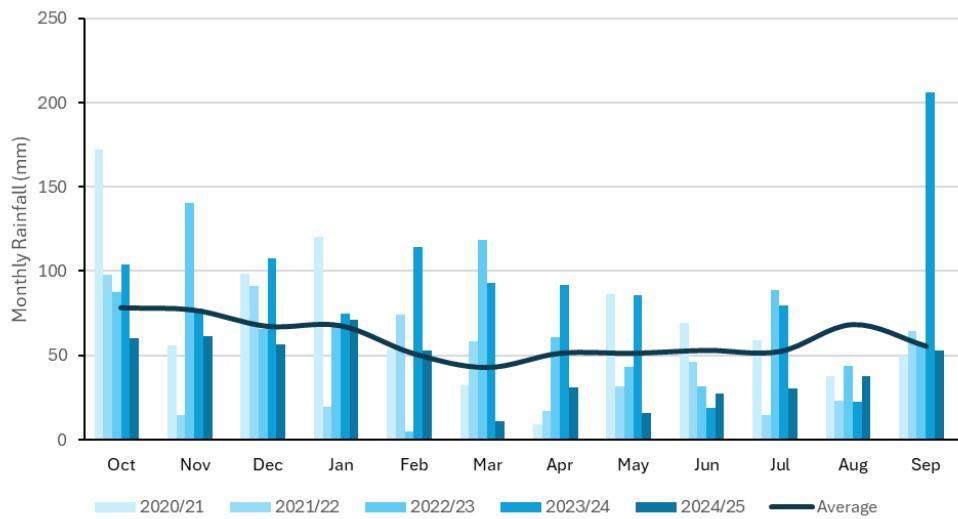
Figure 1: Monthly rainfall data 2020/21 to 2024/25

Figures 1 to 5 illustrate the relationship between rainfall and CSO spills. As shown in Figure 1, the decrease in rainfall from 2023/24 to 2024/25. However, River levels follow a similar pattern as previous year (Figures 2), along with a decline in both the number and duration of CSO spills shown in Figure 5.

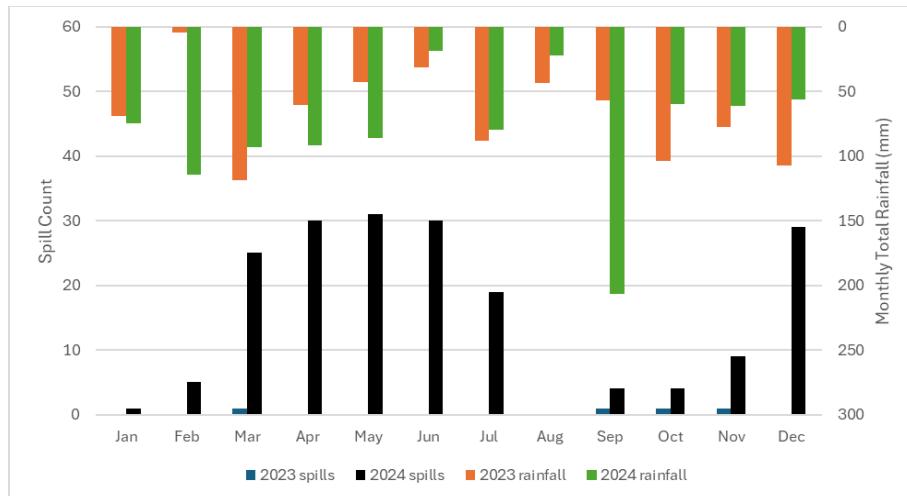
Figure 5: Monthly rainfall data versus monthly spill count for 2023 and 2024– Markyate STW

Table 1 below details the last 2 years performance of overflows in the catchment. To assess EDM performance and its relation to groundwater infiltration, a review of the month-on-month spill performance in 2023 and 2024 against the monthly total rainfall values has been undertaken, as observed in Figure 5.

However, months March to July 2024 (Figure 5) show no strong correlation between rainfall and number of spills as spill count stays at an average of 30 spills throughout that period, while rainfall decreases significantly in some months. We can deduce that river levels have a correlation with the number of spillages, as the highest number of spillages happened during a period of high river levels (see Figure 2 & 3). Tankering has been undertaken at the STW during 2024 due to high groundwater levels.
