# Groundwater Impacted System Management Plan

East Shefford, River Lambourn

December 2020

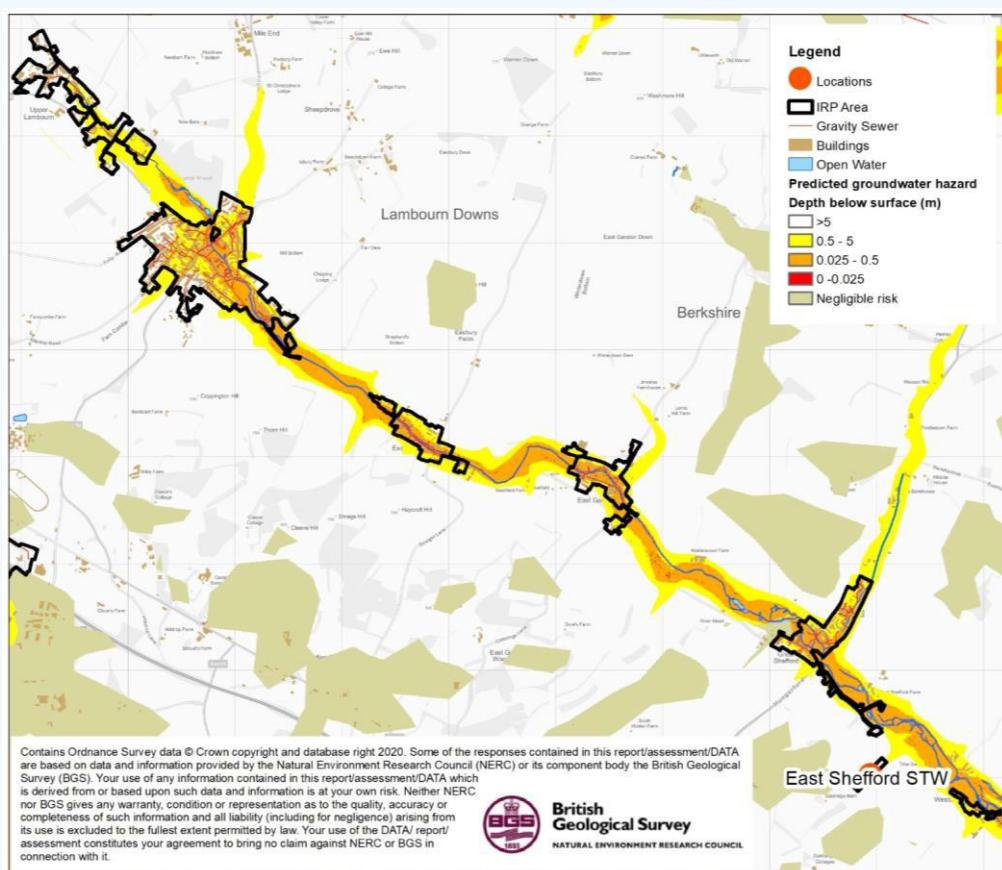
Figure 1.0 – East Shefford catchment

East Shefford is located in Berkshire. The East Shefford sewer network serves a population equivalent<sup>3</sup> of 6,020 within the settlements of Lambourn, Great Shefford, East Shefford, Eastbury and East Garston with a predominantly separate sewerage network totalling some 30km in length excluding private drains and sewers. The extent of the catchment is shown in Figure 1.0 above.

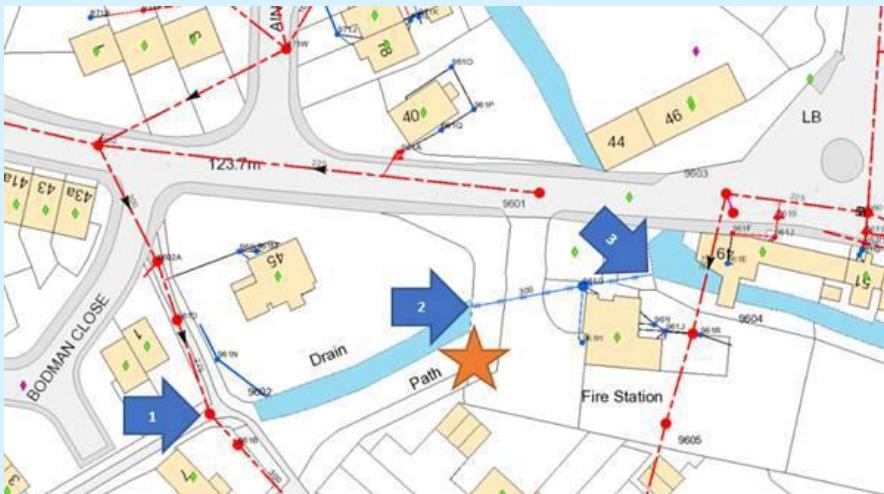
Location	<p>Nr. Newbury Street, Lambourn (see star in Figure below). Flow will be drawn from the manhole located at point 1 and, after treatment (through an ATAC unit), discharged into the surface water culvert (point 2) which enters the main watercourse at point 3.</p>

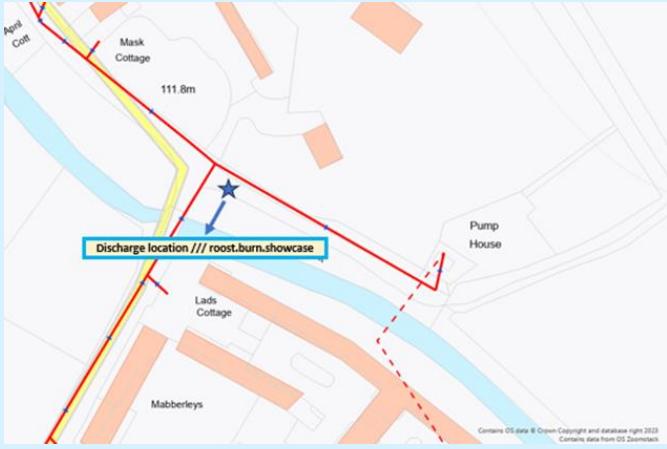
Location	<p>We will discharge into the River Lambourn from the bank. Flows will enter the watercourse, after treatment through an ATAC unit, at location W3W///roost.burn.showcase (436692, 176475).</p>

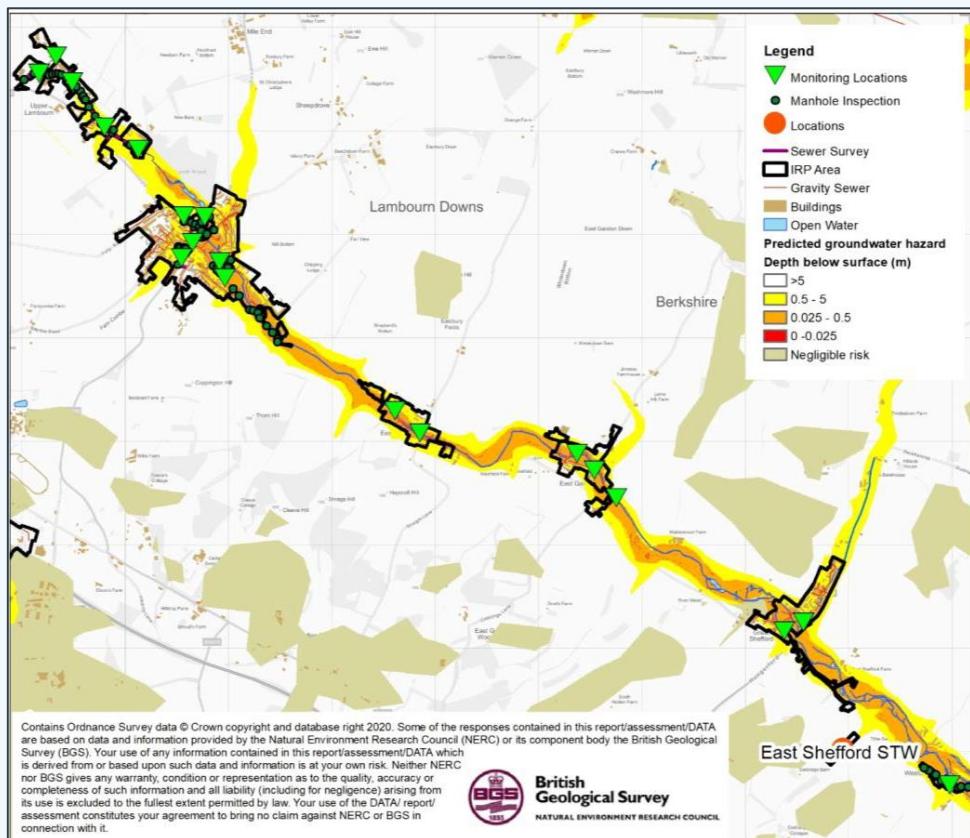
Figure 2.0 – East Shefford monitoring and infiltration zones

Key to bringing the impact of groundwater infiltration under control will be an enhanced monitoring regime. We have identified and have installed several telemetered depth monitor locations around the East Shefford system – see Figure 2.0.

We engaged with JBA Consulting to develop plans for East Shefford that identify zones of groundwater risk, see Figure 2.0. These zones are modelled areas where the groundwater has been determined to be above the sewer and hence pose a potential risk for groundwater ingress.

Sewer Depth Monitors have now been installed in the catchment (see Figure 2.0). These devices are telemetered and provide real time data on the level of flow in the sewer.

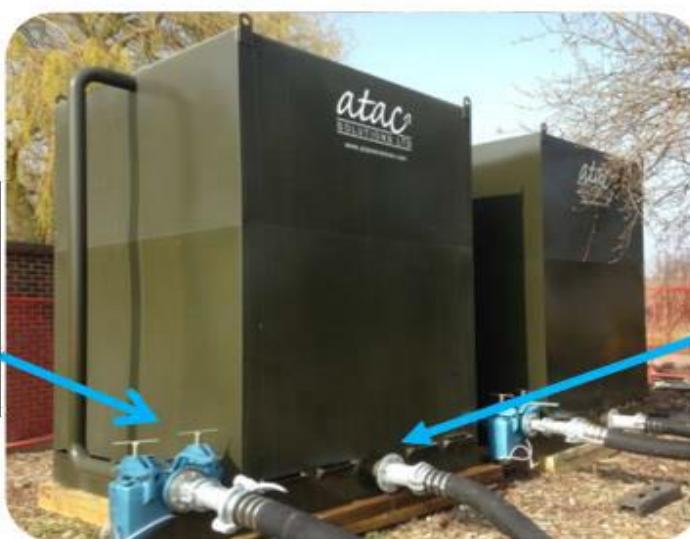
Outside view:

Dirty water entering the filter unit to be treated and then pumped to the top of the unit

Treated water leaving the unit and returning to the environment

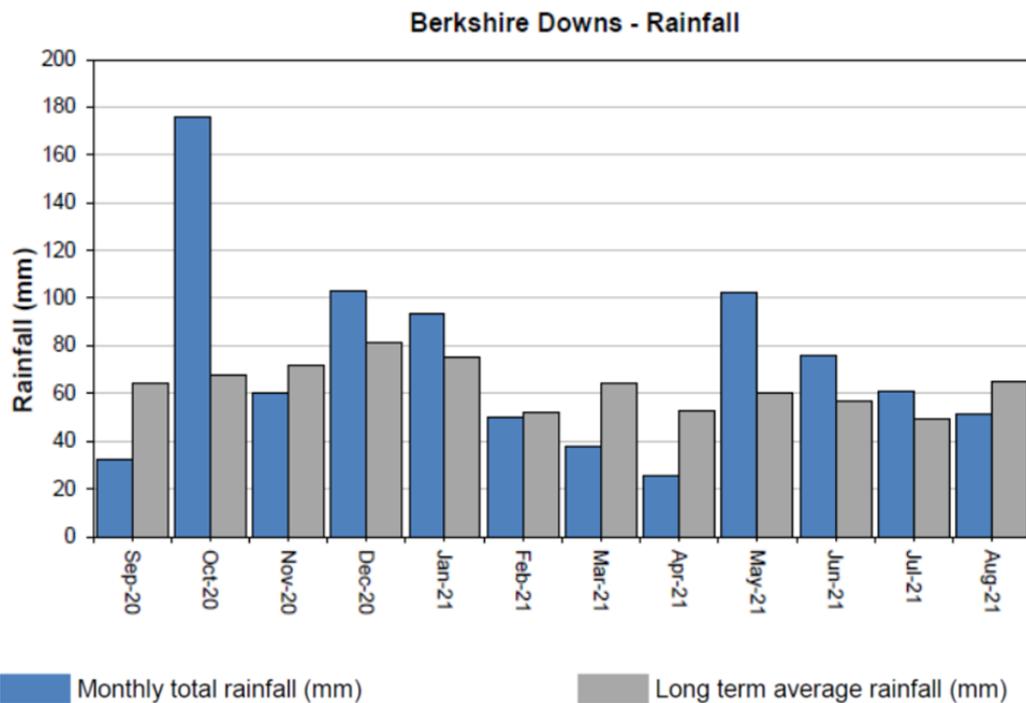
Figure 2 – Monthly rainfall depths local to the system

East Shefford is situated in the Berkshire Downs water resources area. Figure 2 shows the monthly rainfall depths against the Long-term average rainfall in the location of East Shefford over the period taken from the *Environment Agency Water Situation Report August 2021*<sup>1</sup>. The graph indicates that monthly rainfall at times in the last year has marginally exceeded long-term averages, with notable exceedance in October 2020 as a result of Storm Alex.

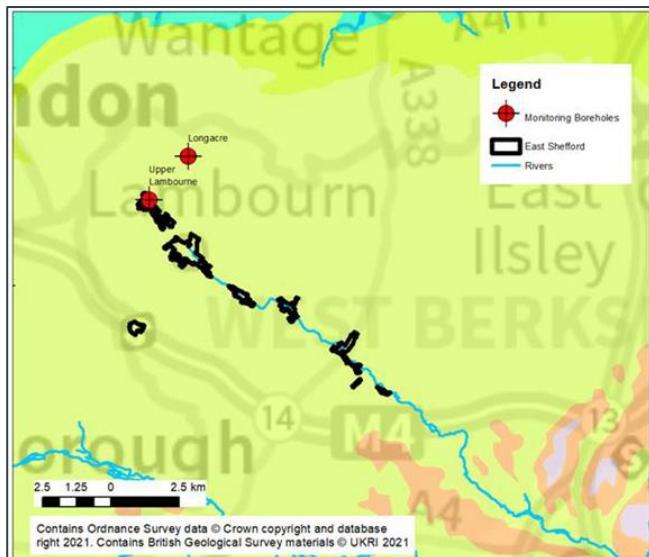
Figure 3 – Location of Upper Lambourne and Longacre Monitoring Boreholes Relative to East Shefford

The Environment Agency has several observation boreholes measuring groundwater levels in the chalk in the area. From previous investigations we have identified that the Upper Lambourn and Longacre boreholes are good indicators of groundwater levels within the catchment. Figure 3 shows the location of the British Geological Survey (BGS) monitoring boreholes at Upper Lambourn and Longacre. Figure 4 and 5 present the last year and last ten years groundwater level. They show that last winter's groundwater level has been notably high, with the groundwater maximum close to or matching historic levels recorded in the winters of 2012/13 and 2013/14.

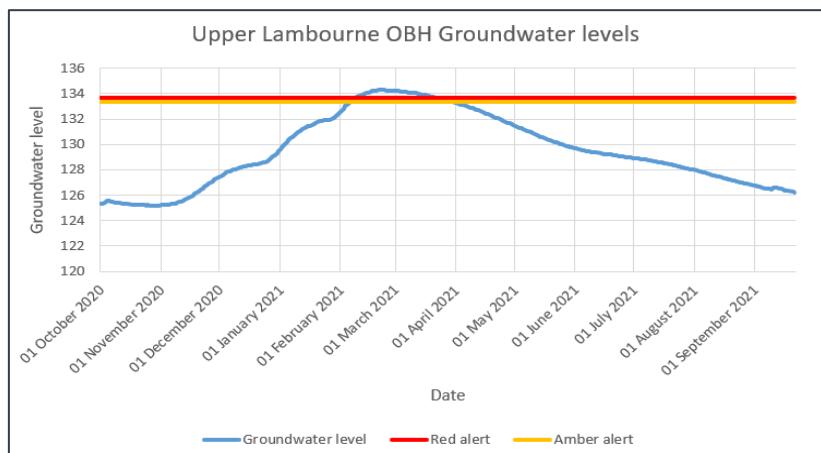
Figure 4 – 2020/21 Groundwater Levels at Upper Lambourne Observation Borehole (OBH)

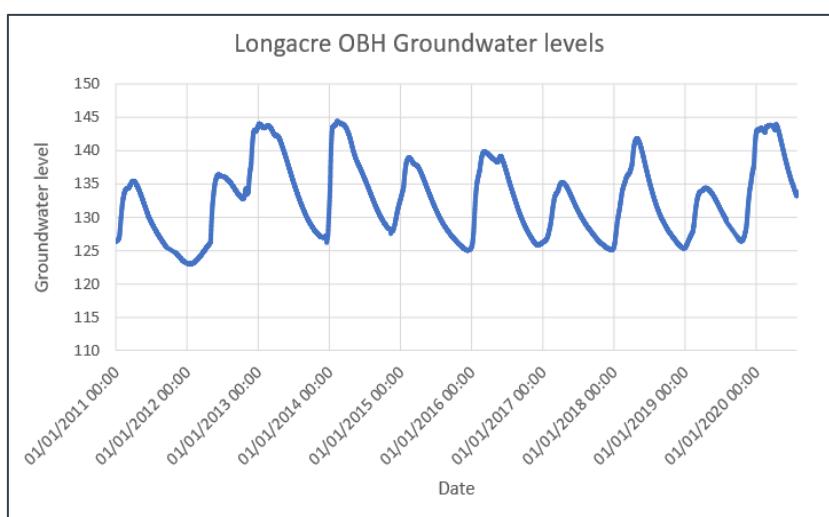
Figure 5 – 2011-2021 Groundwater Levels at Longacre Observation Borehole (OBH) (more complete data for this time period than Upper Lambourne OBH).

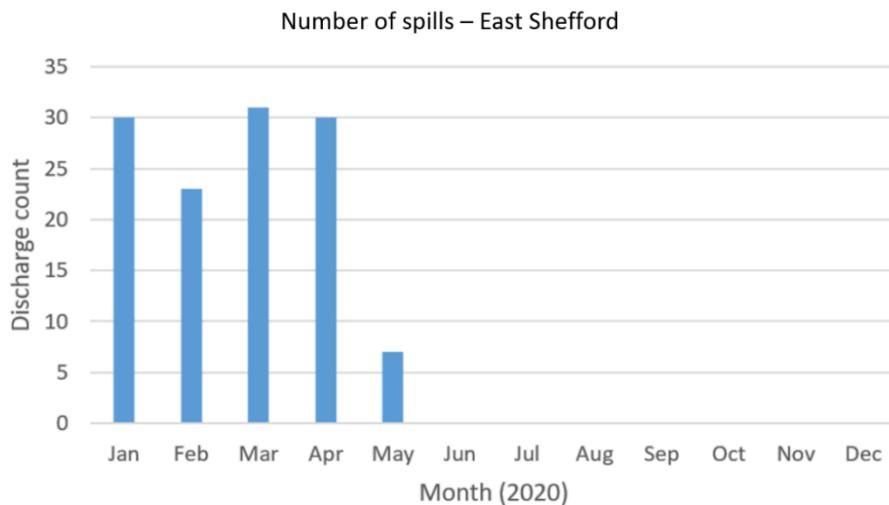
Figure 6 – Number of spills (discharge count) at East Shefford STW (taken from Event Duration Monitor (EDM) Data).\*

Figure 6 shows that during the January to May 2020 period the Sewage Treatment Works (STW) experienced a number of discharges (spills). In the summer, no spills were recorded highlighting the influence of groundwater infiltration/winter flows on the system. This Combined Sewer Overflow location has met the trigger for the EA's Storm Outfall Overflow Assessment Framework (SOAF) and is currently under further investigation with regards to root cause and impact. Tankering was carried out in the East Shefford system over the Winter period to minimise the risk of property flooding. Tankers were unable to keep up with the flows experienced therefore an ATAC bio-filter was deployed in order to protect properties as outlined in the original GISMP report.

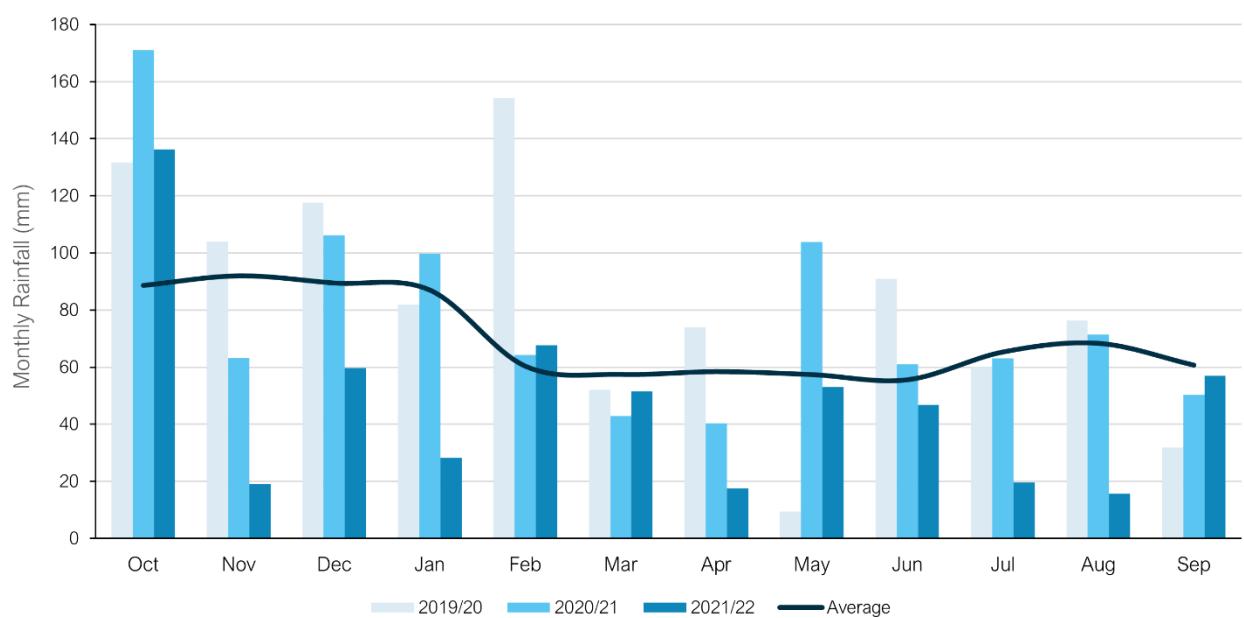
Figure 2: Monthly Rainfall Performance

Representative Radar rainfall has been used to generate monthly data at catchment level for comparison with average data generated by local Met Office Weather Station Records. Figure 2 presents the comparison of this data for the last three hydrological years to support longer term trends within the local system.

(Average Values taken from Met Office Weather Station at Marlborough based on the period 1991-2020)

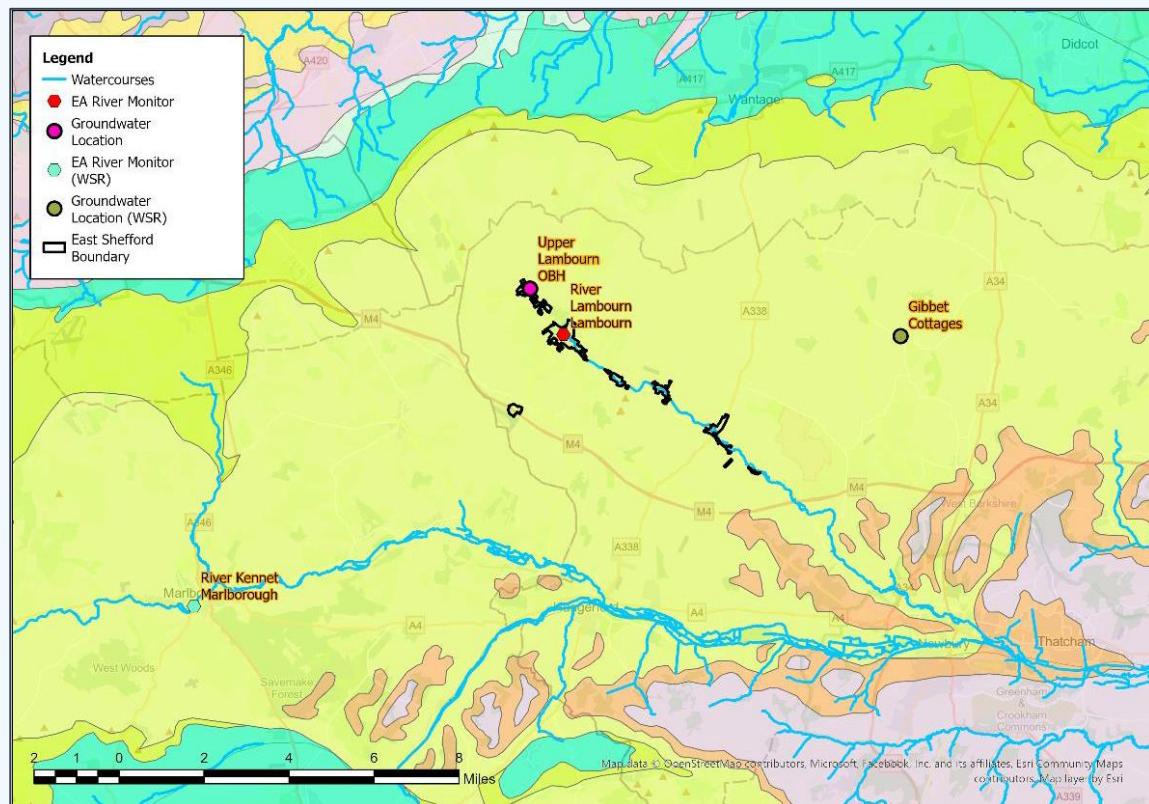
Figure 4: Local Monitoring Stations

- River Lambourn, Lambourn.
- Upper Lambourn OBH.

These sites are illustrated in Figure 4 below, alongside the closest groundwater reference station and closest gauging station from the Water Situation Report.

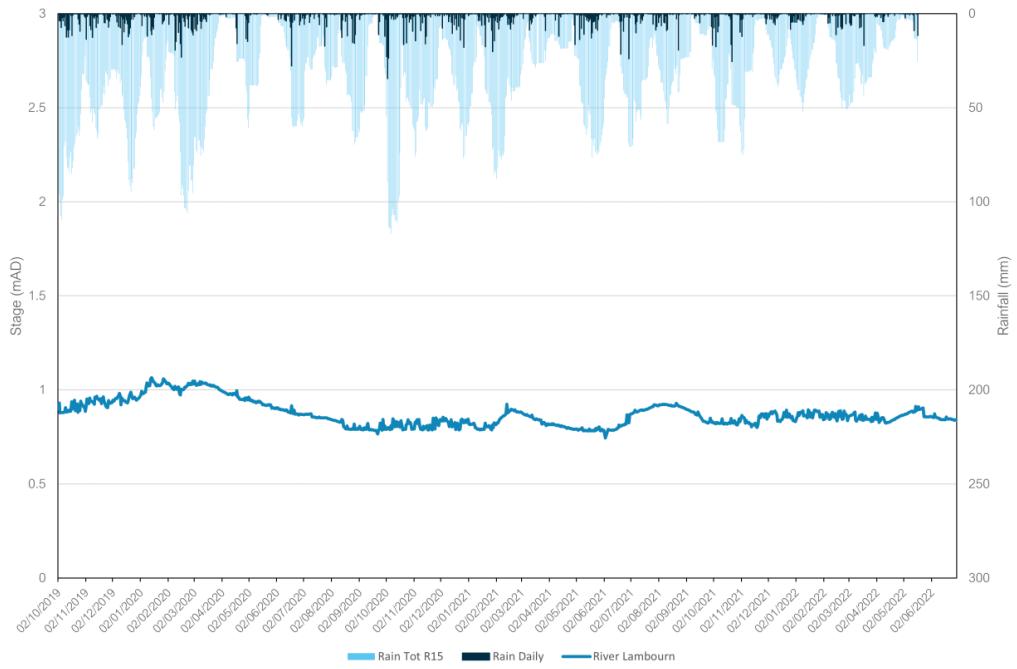
Figure 5A – River Lambourn at Lambourn

The following figure represents the last three hydrological years of level information at the indicator site to build a picture of the relative conditions prevalent in the current year. It is presented against both the daily total rainfall values for the catchment and a rolling 15 day total rainfall.

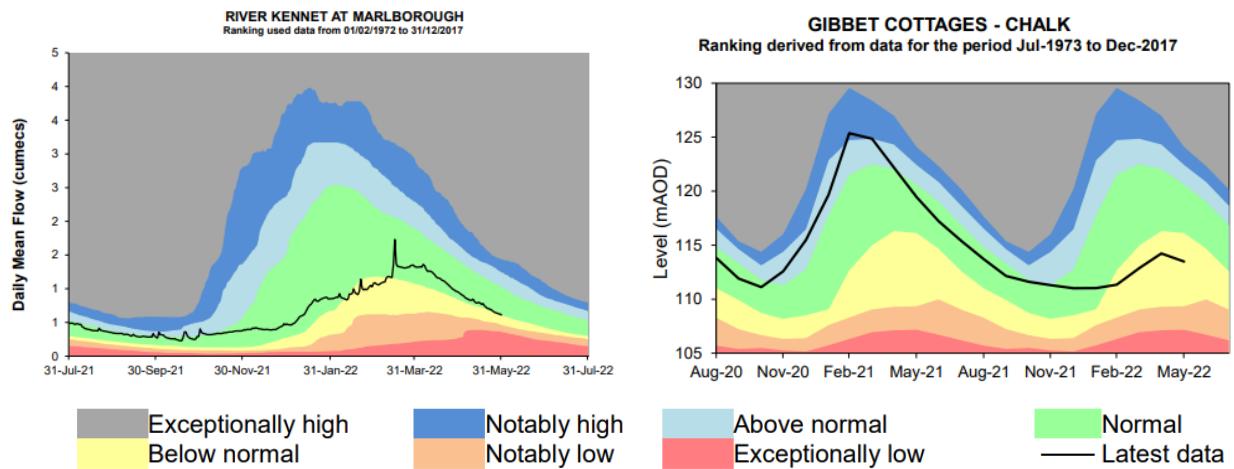
Figure 6 – Water Situation Report

In addition to these specific stations, the wider groundwater context is illustrated in the Water Situation Report for the Berkshire Downs water resources area. The closest groundwater reference station is Gibbet Cottages. This site shows significantly lower overall groundwater than the previous year. This can be seen in the figure below alongside the river indicator location at Marlborough on the River Kennet.

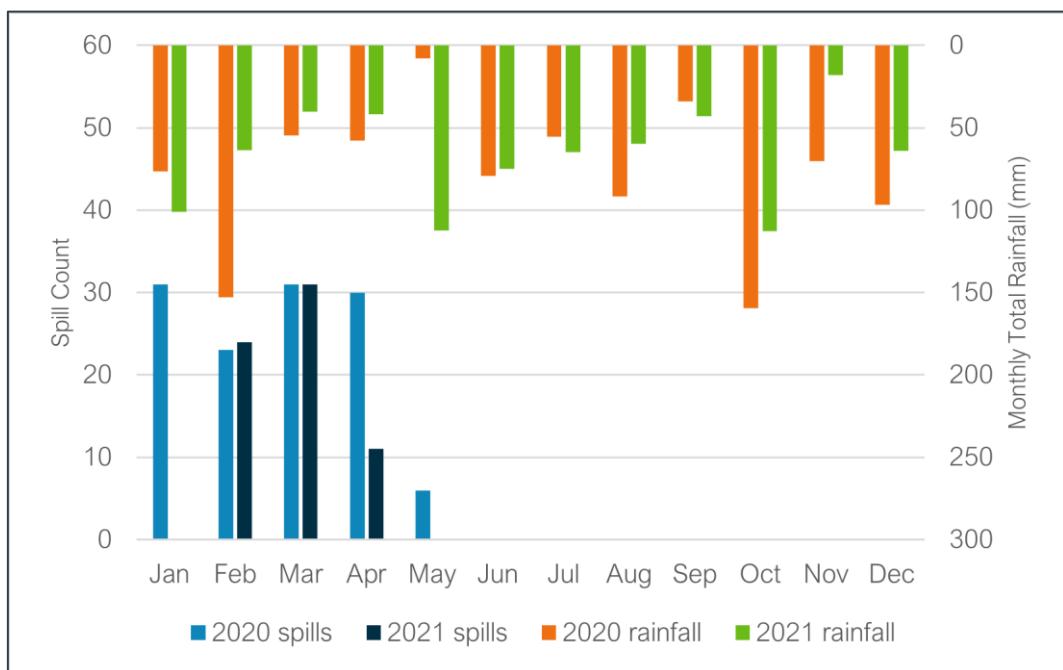
Figure 8 – EDM Monthly Performance

A critical part of the assessment of EDM performance and its relation to groundwater inundation is to review the month-on-month spill performance, against previous years and the monthly total rainfall values to give context to the performance. Figure 8 below presents the EDM performance trend and rainfall for recent years.

The trend in spill performance suggests a winter focus to spill occurrence at the overflow. The groundwater trend at the Lambourn OBH illustrates the variation in level between 2020 and 2021, which led to more significant spills in 2020 with broadly similar rainfall.

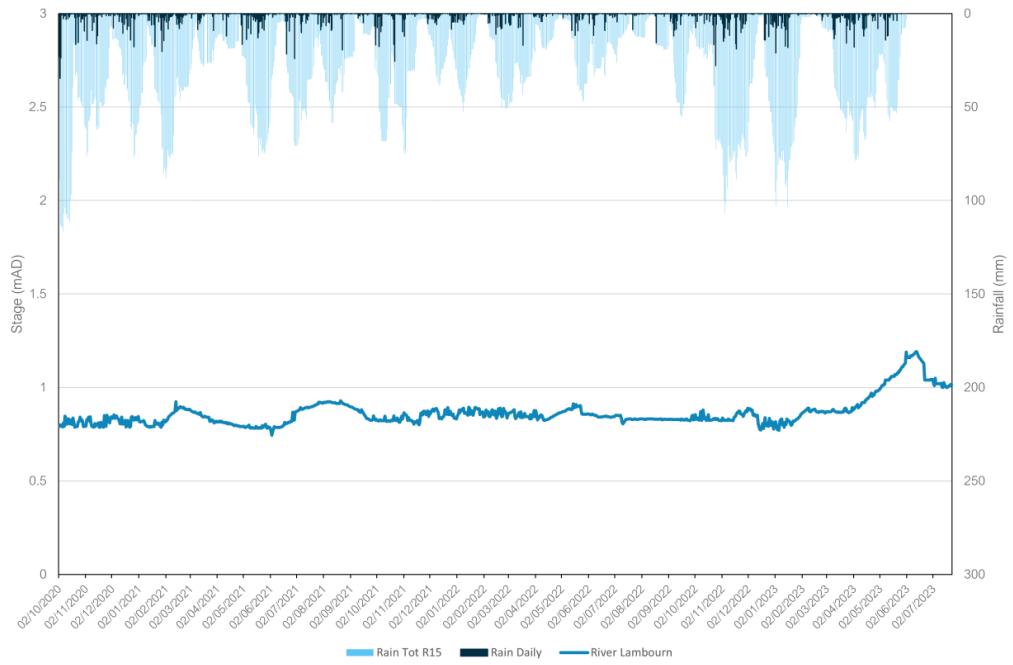
Figure 5A – River Lambourn at Lambourn

The following figures represent the last three hydrological years of level information at the indicator sites to build a picture of the relative conditions prevalent in the current year. It is presented against both the daily total rainfall values for the catchment and a rolling 15-day total rainfall.

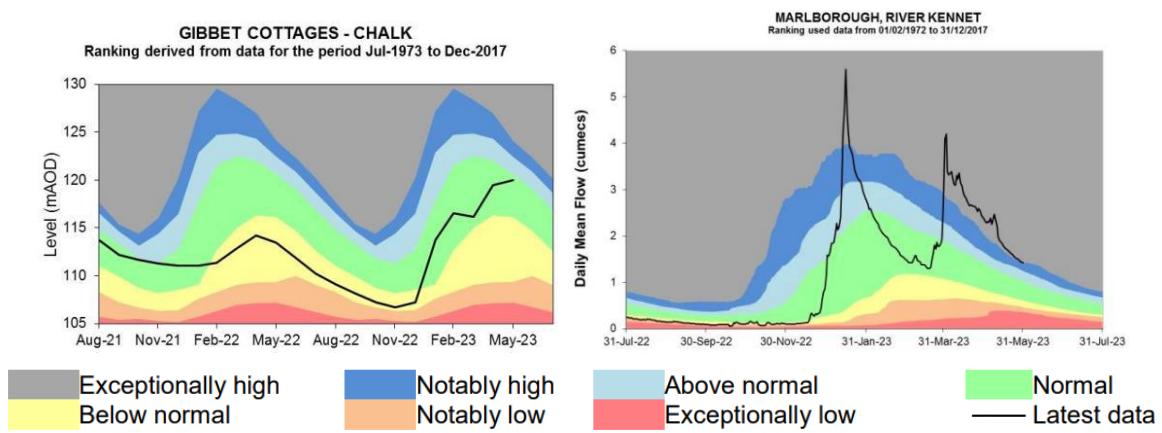
Figure 6 – Water Situation Report

In addition to these specific stations, the wider groundwater context is illustrated in the Water Situation Report for the Berkshire Downs water resources area. The closest groundwater reference station is Gibbet Cottages. This site shows groundwater levels consistently below normal in 2022. Groundwater levels rise towards the end of 2022 and are observed at normal levels in 2023. This can be seen in the figure below alongside the river indicator location at Marlborough on the River Kennet.

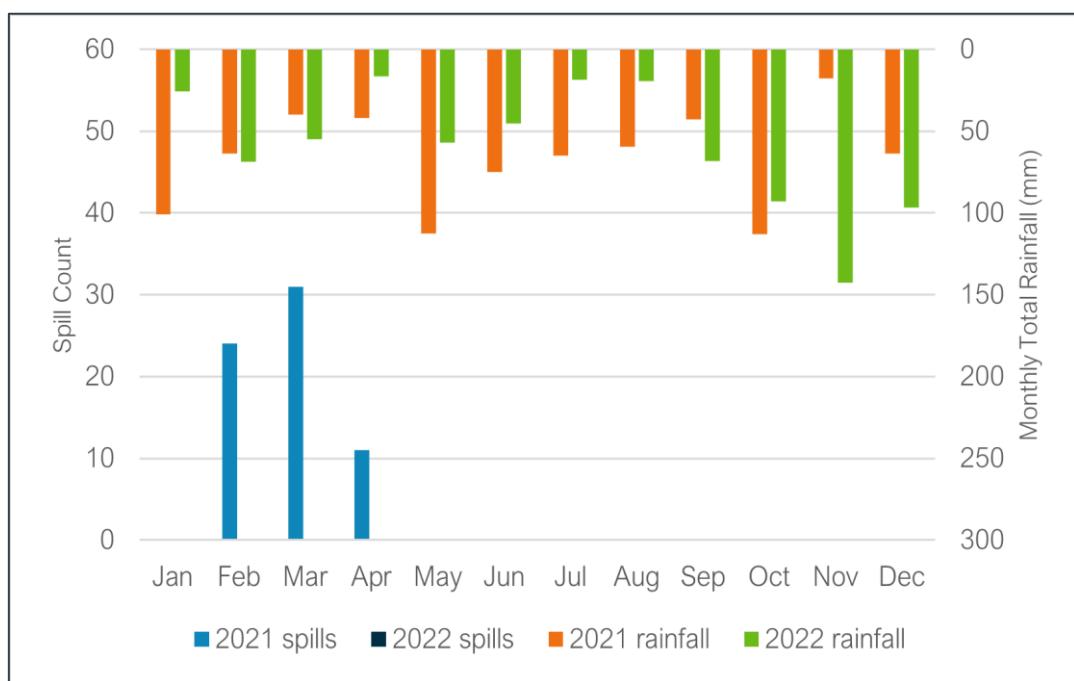
Figure 8 – EDM Monthly Performance

A critical part of the assessment of EDM performance and its relation to groundwater infiltration is to review the month-on-month spill performance, against previous years and the monthly total rainfall values to give context to the performance. Figure 8 below presents the EDM performance trend and rainfall for recent years.

The data suggests a wider relationship between rainfall totals, elevated groundwater levels and spill frequency. No spills were recorded at East Shefford STW in 2022, compared to 66 spills in 2021, all of which occurred during the February – April period. The Upper Lambourn OBH indicator site shown in Figure 5, suggests groundwater levels in the catchment were particularly elevated during this period, and significantly higher than the same period in 2022, when Figure 6 suggests groundwater levels in the catchment were below normal.

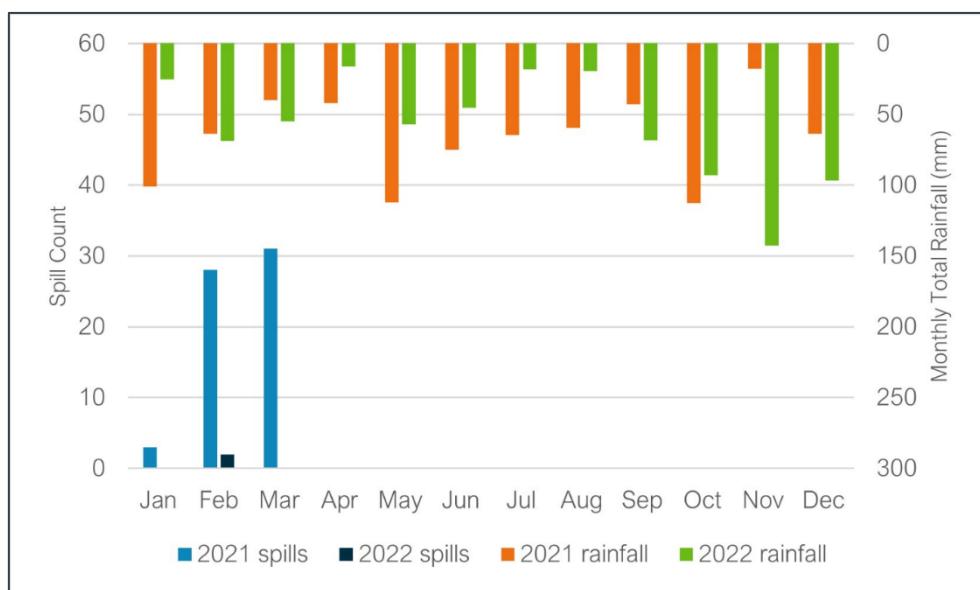
Figure 10 – EDM Monthly Performance

As with East Shefford STW, the EDM data for East Garston SPS, suggests a wider relationship between rainfall totals, elevated groundwater levels and spill frequency. Only two spills were recorded at the overflow in 2022, with Figure 6 suggesting groundwater levels were consistently below normal level in the catchment during this period. This compares to 68 spills recorded January – March 2021. The indicator site data shown in Figure 5, suggests groundwater levels in the catchment were significantly higher than within the same period in 2022. However, note that tankering has been undertaken at the SPS, which could potentially mask some of the groundwater impact on spills at the overflow.

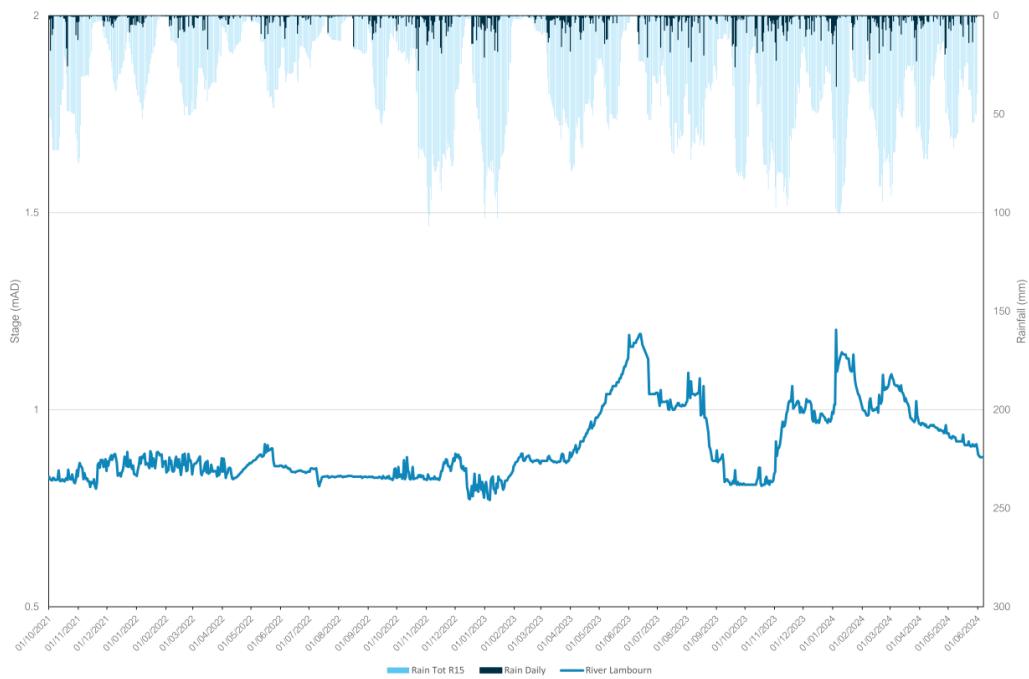
Figure 5A – River Lambourn at Lambourn

Figures 5A-5B represent the last three hydrological years of level information at the indicator sites to build a picture of the relative conditions prevalent in the current year. It is presented against both the daily total rainfall values for the catchment and a rolling 15-day total rainfall.

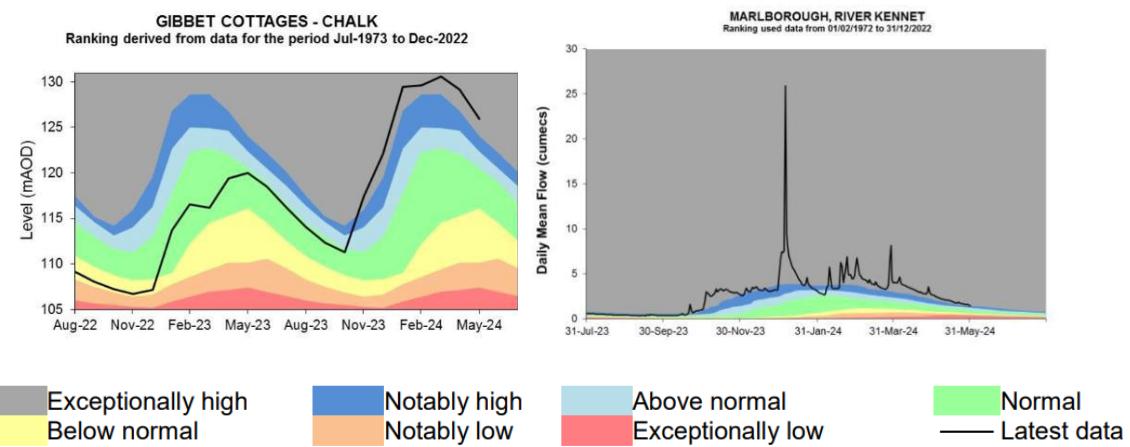
Figure 6 – Water Situation Report

In addition to these specific stations, the wider groundwater context is illustrated in the Water Situation Report for the Berkshire Downs water resources area. The closest groundwater reference station is Gibbet Cottages. This site shows groundwater levels generally at normal levels throughout 2023, before rising to exceptionally high levels towards the end of the year. Groundwater levels have remained exceptionally high in 2024. This can be seen in Figure 6 alongside the river indicator location at Marlborough on the River Kennet.

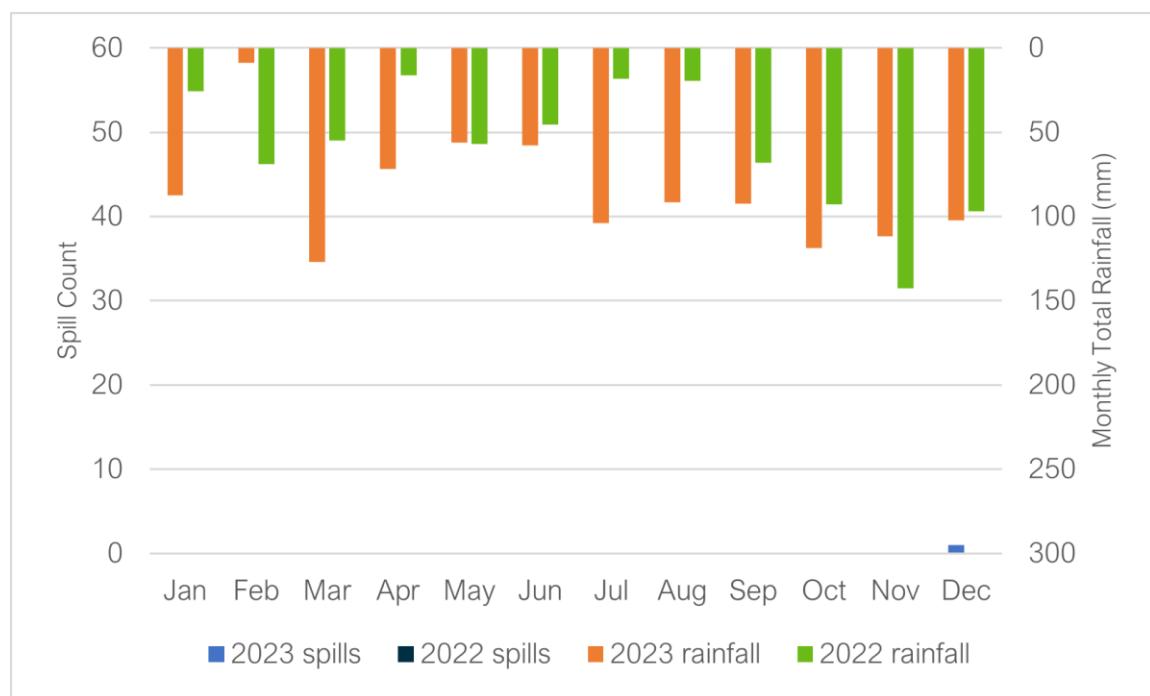
Figure 8 – EDM Monthly Performance at East Shefford STW

A critical part of the assessment of EDM performance and its relation to groundwater infiltration is to review the month-on-month spill performance, against previous years and the monthly total rainfall values to give context to the performance. Figure 8 below presents the EDM performance trend and rainfall for recent years.

No spills were recorded at East Shefford STW in 2022 and only one spill was recorded in 2023. Whilst groundwater levels in the catchment were relatively low in 2022 (see Figure 5B), they were significantly higher in 2023, exceeding the high threshold level for groundwater infiltration into the sewer network in East Garston (assigned as 130.10 mAOD at the Upper Lambourn OBH indicator site) and Lambourn (assigned as 131.00 mAOD at the Upper Lambourn indicator site). Upgrades to East Shefford STW are ongoing, improving the ability of the site to treat the volumes of incoming sewage. The low spill frequency at East Shefford STW in 2023, indicates that the upgrades completed to date at the site, have successfully reduced the spill frequency here. The EDM data for 2024, when indicator site data suggests groundwater levels in the catchment were exceptionally high (see Figure 6), will be analysed once available to continue to understand the impact of the treatment works upgrades completed.

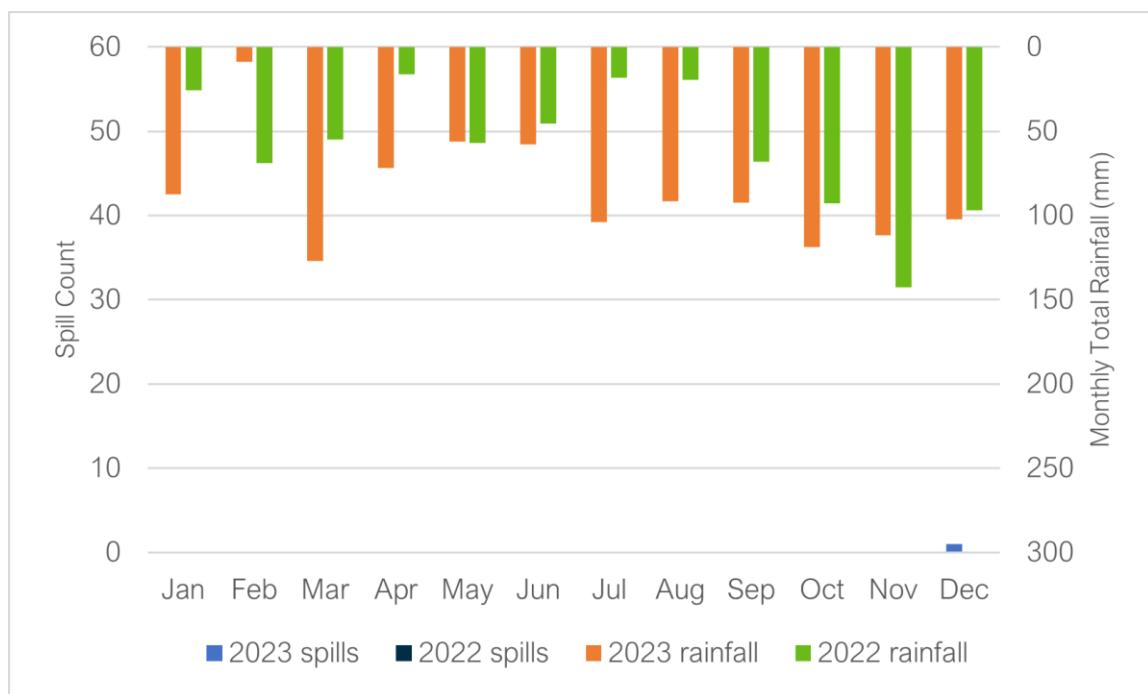
Figure 10 – EDM Monthly Performance at East Garston STW

Figure 10 below presents the EDM performance trend and rainfall for 2022 and 2023.

A low number of spills were recorded at East Garston SPS in 2022 and 2023. It is therefore difficult to determine a wider relationship between rainfall, elevated groundwater levels and spill frequency at the overflow using the data for 2022 and 2023. However, the majority of spills in 2023 were recorded in April, when Figure 6 suggests groundwater levels in the catchment were at exceptionally high levels. For further discussion regarding the relationship between groundwater levels and spills in the catchment, see the 2023 Addendum Report included in this PDF document.

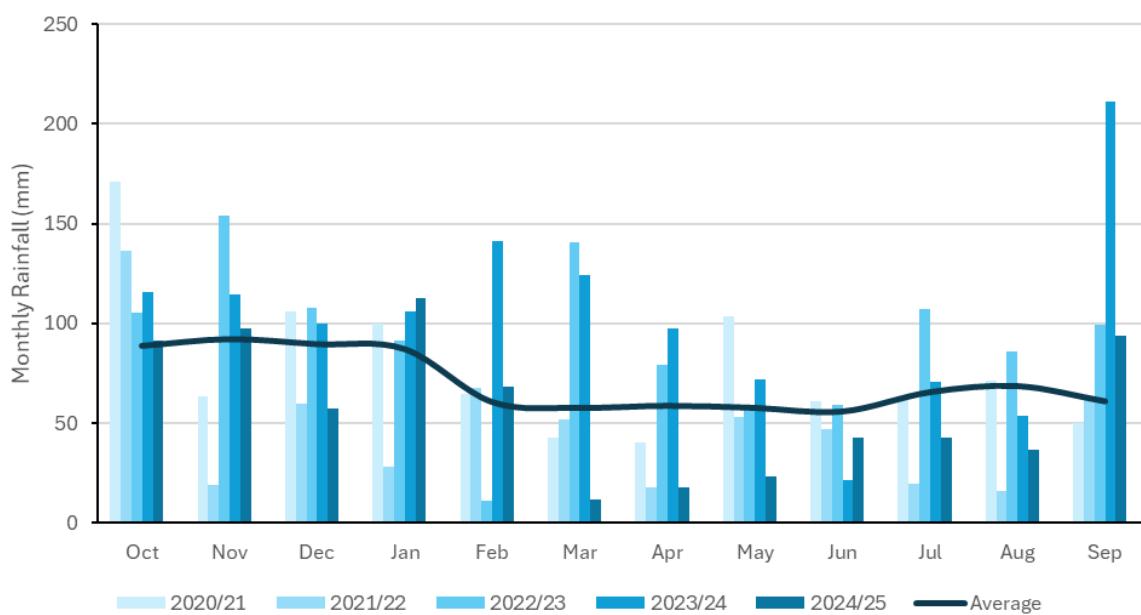
Figure 2: Monthly Rainfall Performance

Representative Radar rainfall has been used to generate monthly data at catchment level for comparison with average data generated by local Met Office Weather Station Records. Figure 2 presents the comparison of this data for the last four hydrological years to support longer term trends within the local system.

(Average Values taken from Met Office Weather Station at Marlborough based on the period 1991-2020)

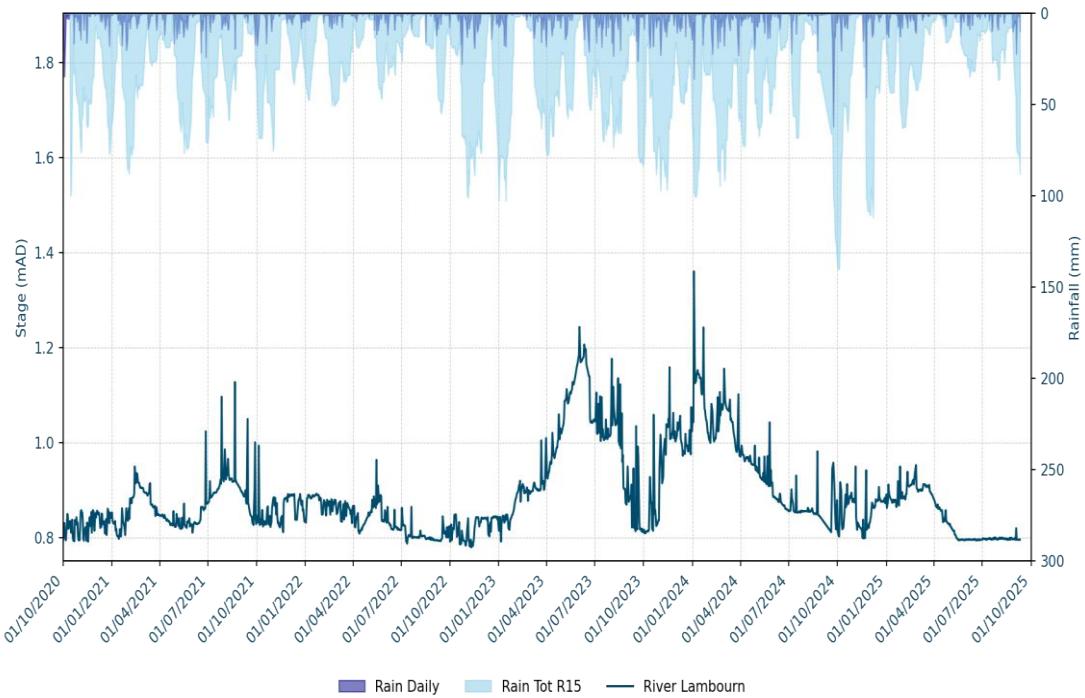
Figure 5A – River Level data for River Lambourn at Lambourn

Figures 5A-5B represent the last five hydrological years of level information at the indicator sites to build a picture of the relative conditions prevalent in the current year. It is presented against both the daily total rainfall values for catchment and a rolling 15-day total rainfall.

A total of one spill was recorded at East Shefford STW in 2023 and 35 spills were recorded in 2024. However, during months January to April, river levels were at the highest for the year (see Figure 5A & B) which could have led to groundwater ingress leading to the high number of spills during this period (see Table 7). Moreover, groundwater levels in the catchment were significantly high in 2024, it decreased slightly for 2025 (see Figure 6), therefore not exceeding the high threshold level for groundwater infiltration, however the effect of this decrease will be analysed when 2025 spill data is published.

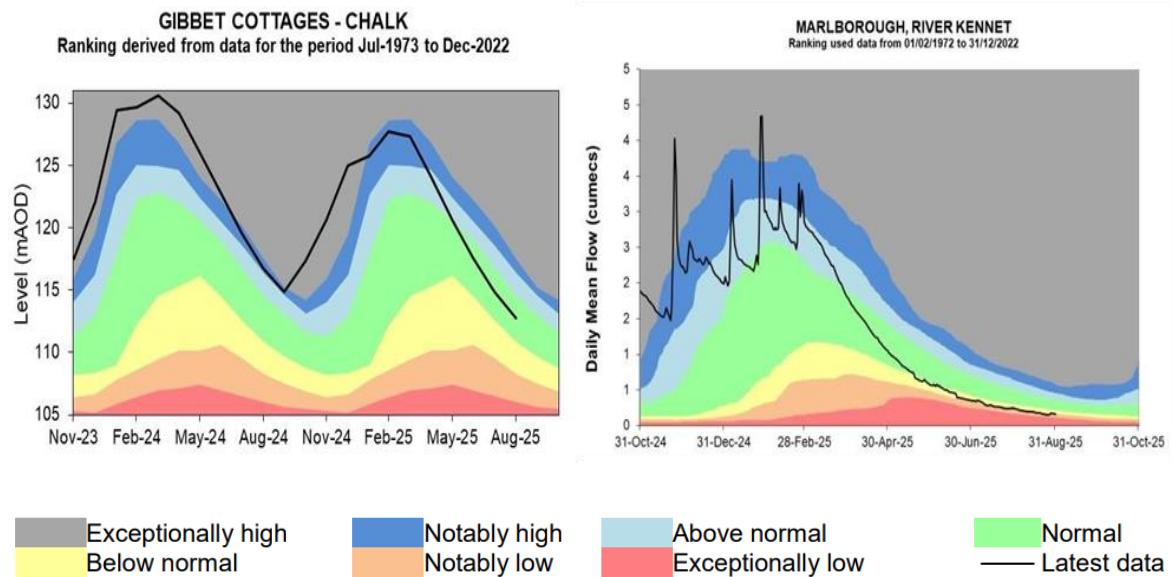
Figure 6 – Ground Water Situation Report

In addition to these specific stations, the wider groundwater context is illustrated in the Water Situation Report for the Berkshire Downs water resources area. The closest groundwater reference station is Gibbet Cottages. This site shows groundwater levels exceptionally high throughout 2024, with a slight decline around May to August but remaining at notably high levels. Groundwater levels remained notably high till mid-2025 and have gradually declined since then. This can be seen in Figure 6 alongside the river indicator location at Marlborough on the River Kennet.

A total of four spills were recorded at East Garston SPS in 2023, and no spills were recorded in 2024. It is therefore difficult to determine a wider relationship between rainfall, elevated groundwater levels and spill frequency at the overflow using the data for 2023 and 2024. Moreover, Figure 6 suggests groundwater levels in the catchment were lower in 2025 compared to the previous year, by levels reaching above normal/notably high instead of exceptionally high, the effect of this decrease will be analysed when 2025 spill data is published. For further discussion regarding the relationship between groundwater levels and spills in the catchment, see the 2025 Addendum Report included in this PDF document.

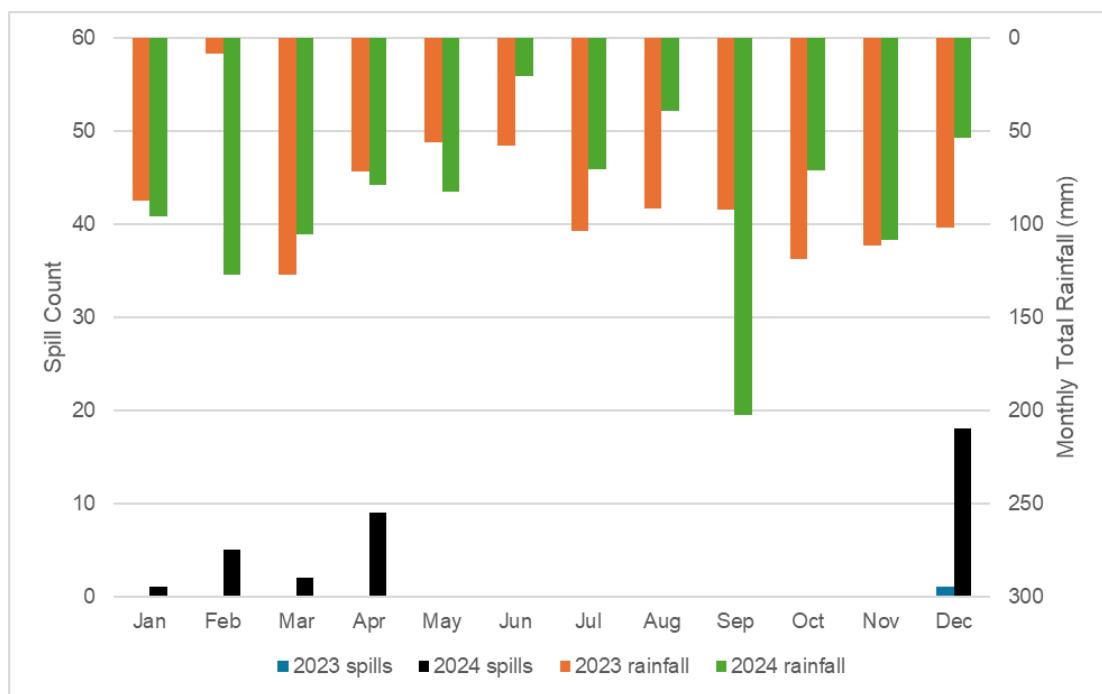
A critical part of the assessment of EDM performance and its relation to groundwater inundation is to review the month-on-month spill performance, against previous years and the monthly total rainfall values to give context to the performance. Figure 8 below presents the EDM performance trend and rainfall for recent years.

Figure 8 – Monthly rainfall data versus monthly spill count for 2023 and 2024 at East Shefford STW

A review of river level data over 2023/24 has increased compared to previous years. For East Shefford STW the number and duration of spills have increased in 2024 compared to 2023. The higher number of annual spills and river levels could be a result of the increased rainfall in 2024 (seen in Figure 8). During months January to April 2024, river levels were at the highest for the year (see Figure 5B) which could have led to groundwater ingress leading to the high number of spills during this period.

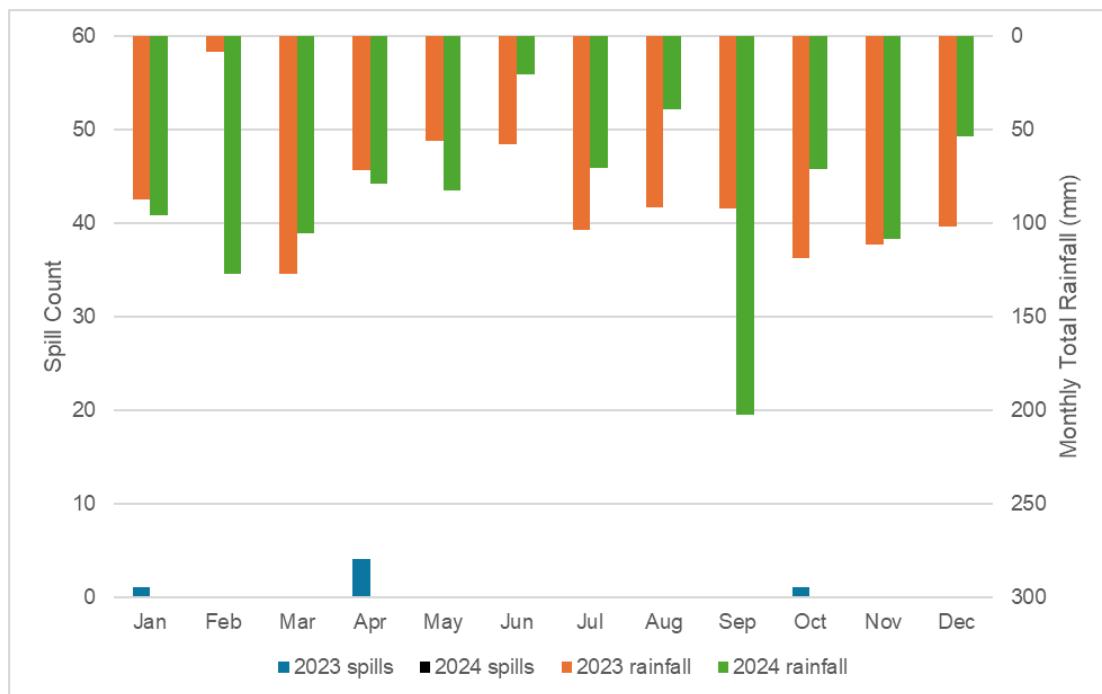
Figure 10 – Monthly rainfall data versus monthly spill count for 2023 and 2024 at East Garston STW
