# Groundwater Impacted System Management Plan Berkhamsted,

River Bulbourne

January 2021

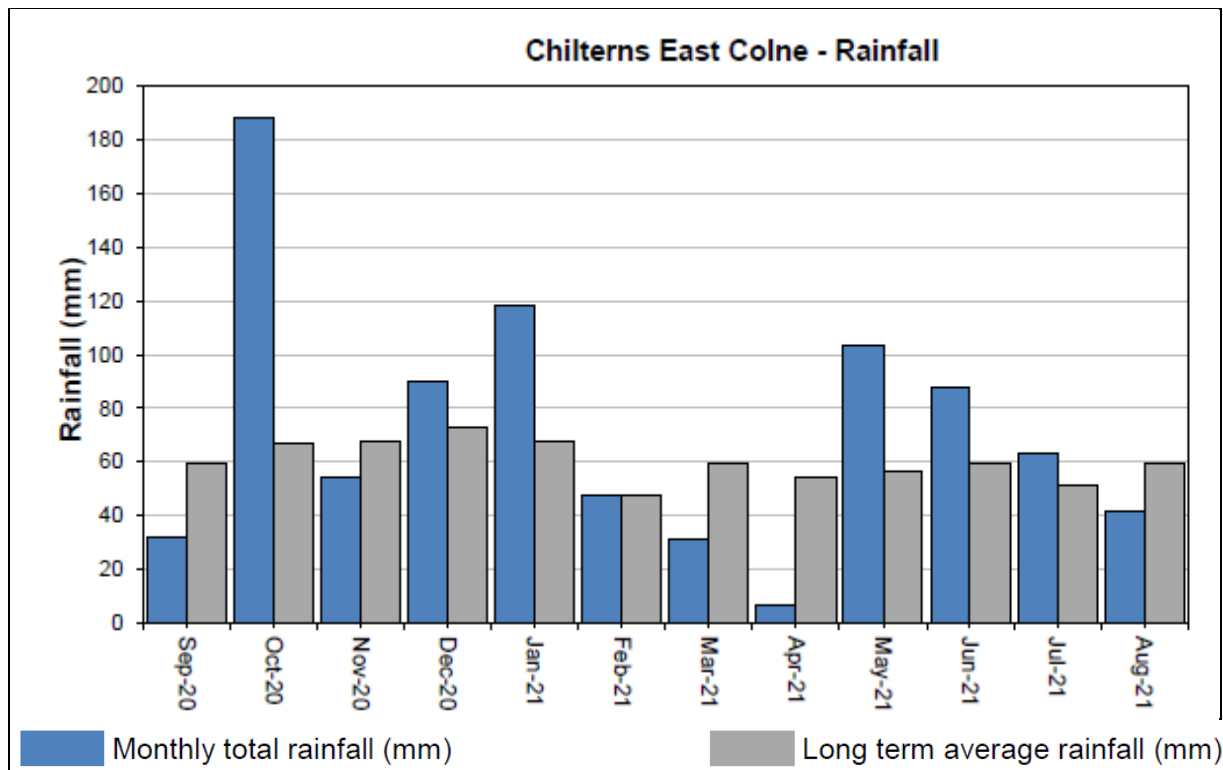
Figure 2 – Monthly rainfall depths local to the system

Berkhamsted is situated in the Chilterns East Colne water resources area. Figure 2 shows the monthly rainfall total depths against the long-term average rainfall in the location of Berkhamsted over the period taken from the *Environment Agency Water Situation Report August 2021*<sup>1</sup>

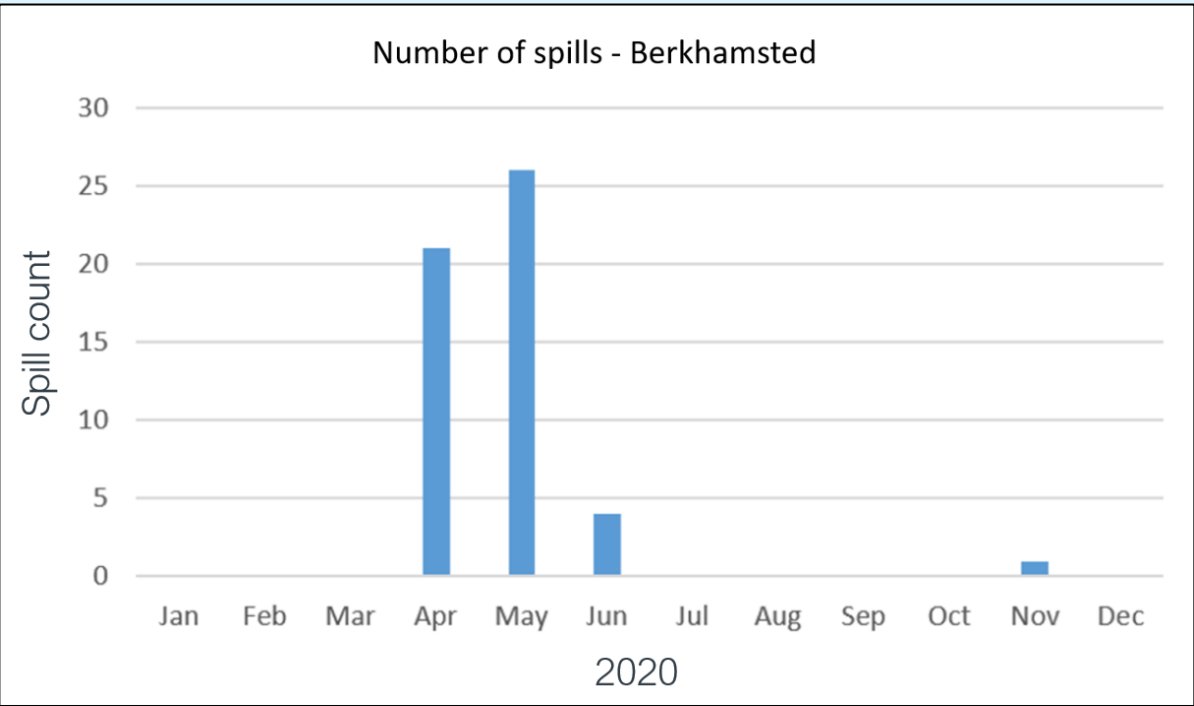
Figure 7 – Number of spills (discharge count) at Berkhamsted STW (taken from Event Duration Monitor (EDM) Data\*).

Figure 7 shows the number spills per month from Berkhamsted Sewage Treatment Works (STW). April and May experienced the greatest number of spills. There is a lag between high rainfall and high flows in the Berkhamsted system that arrive at the STW. We are still investigating this lag between groundwater level and spills; it may be indicative of a combination of surface water and groundwater combining to trigger problems as opposed to one of the other mechanisms being more dominant.

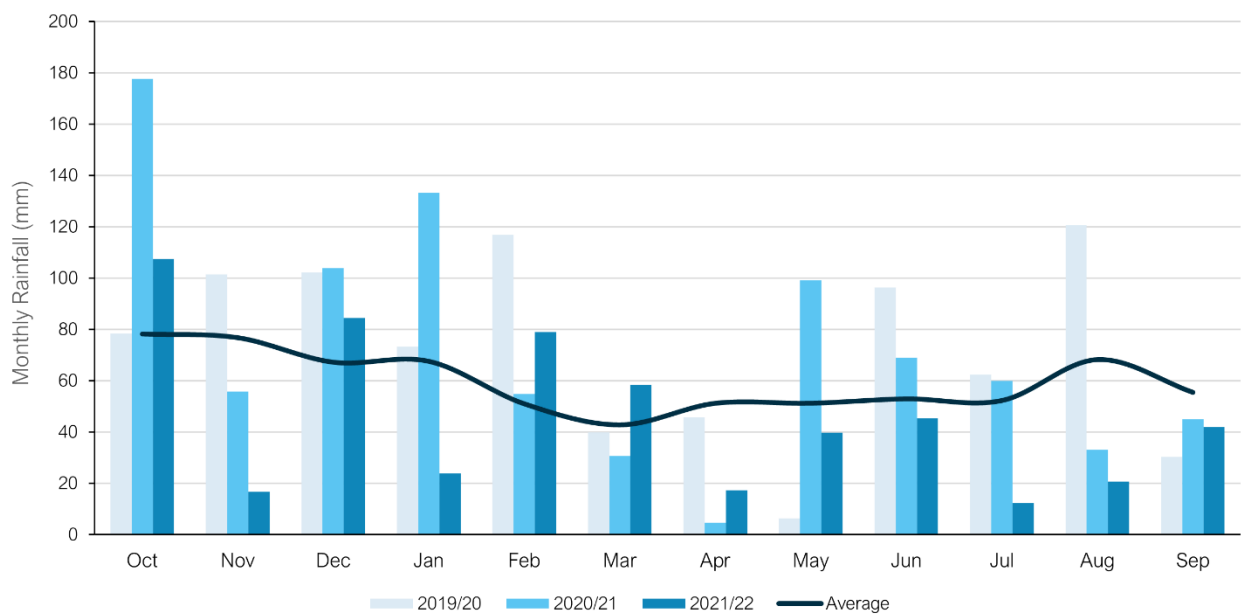
Figure 2 – Monthly Rainfall Performance

Representative Radar rainfall has been used to generate monthly data at catchment level for comparison with average data generated by local Met Office Weather Station Records. Figure 2 presents the comparison of this data for the last three hydrological years to support longer term trends within the local system.

Average Values taken from Met Office Weather Station at Rothamsted based on the period 1991-2020

The total rainfall for the 2021/22 hydrological year is 22% below the annual average total. Total rainfall values are presented in Table 3 below.

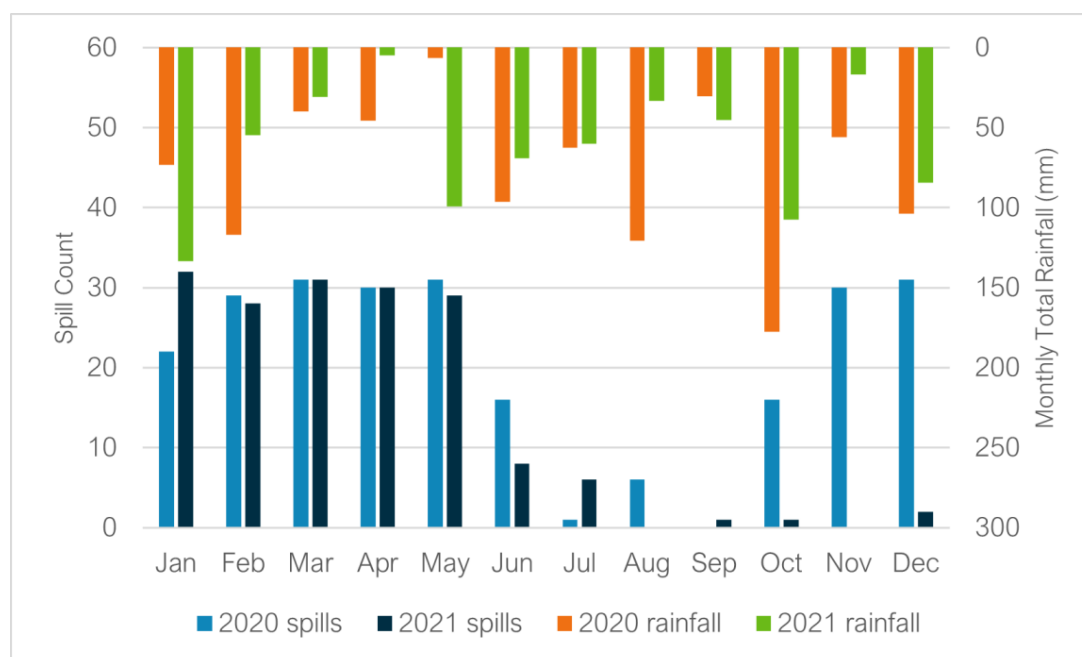
Figure 8 – EDM Monthly Performance

A critical part of the assessment of EDM performance and its relation to groundwater inundation is to review the month-on-month spill performance, against previous years and the monthly total rainfall values to give context to the performance. Note a spill frequency of 243 is stated for 2020, which is higher than the published spill count of 52. The data has been revalidated/corrected and the revised spill count of 243 will be included in re-submission to the EA. Figure 8 below presents the EDM performance trend and rainfall for recent years.

The data suggests a wider relationship between groundwater/river level, rainfall, and network performance. Despite broad similar rainfall, significantly more spills were recorded at Berkhamsted STW in December 2020, compared to December 2021. The indicator sites suggest groundwater levels in the catchment were higher in December 2020.

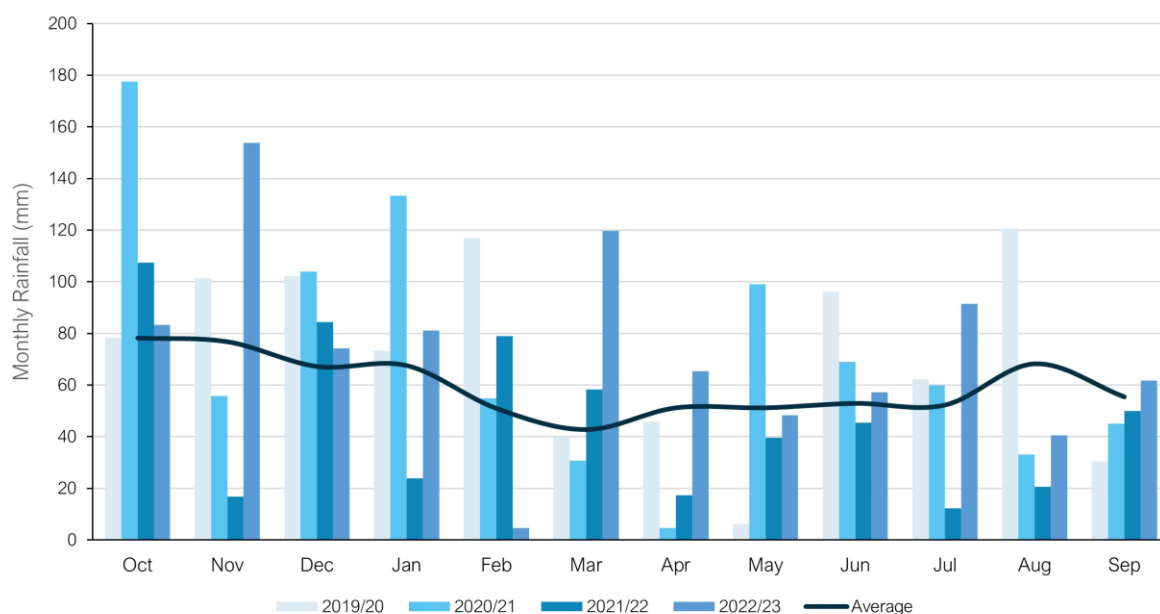
Figure 2 – Monthly Rainfall Performance

Representative Radar rainfall has been used to generate monthly data at catchment level for comparison with average data generated by local Met Office Weather Station Records. Figure 2 presents the comparison of this data for the last four hydrological years to support longer term trends within the local system.

Average Values taken from Met Office Weather Station at Rothamsted based on the period 1991-2020

The total rainfall for the 2022/23 hydrological year is 23% above the annual average total. Total rainfall values are presented in Table 3 below.

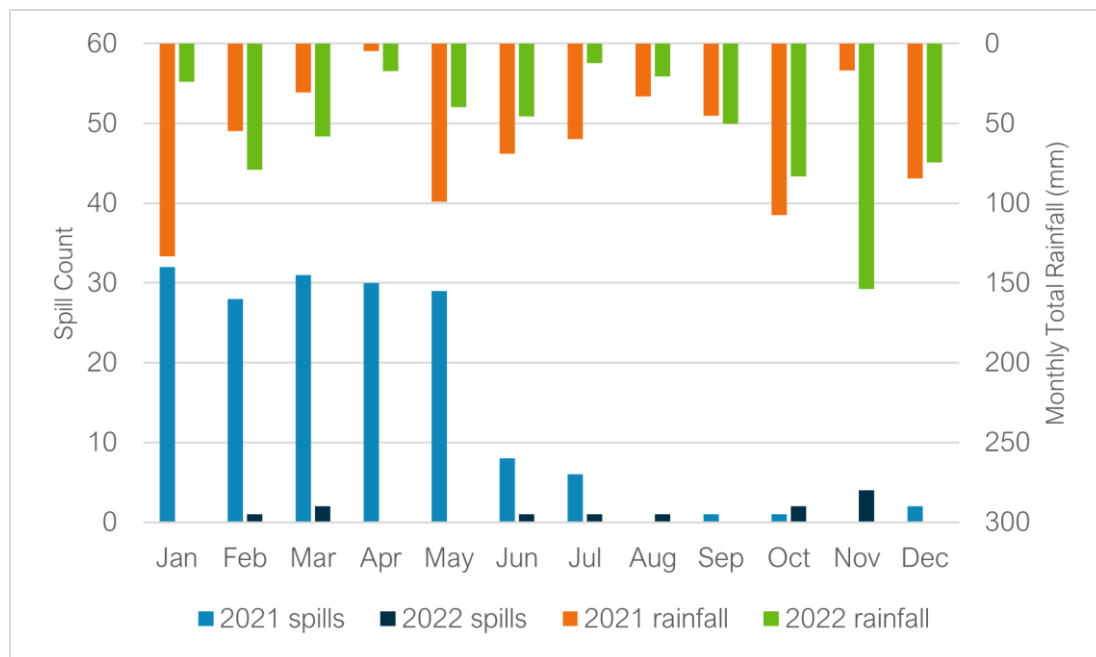
Figure 8 – EDM Monthly Performance

Figure 8 below presents the EDM performance trend and rainfall for recent years.

The data suggests a wider relationship between rainfall, elevated groundwater levels, and spill frequency. Significantly more spills were recorded at Berkhamsted STW between the months of January to June 2021, compared to the same period in 2022. The indicator site data shown in Figure 5, suggests groundwater levels in the catchment were higher January – June 2021, compared to the same period in 2022. Only 12 spills were recorded in the year 2022, compared to 168 in 2021, with Figure 6 suggesting groundwater levels in the catchment were at normal or below normal levels throughout 2022.

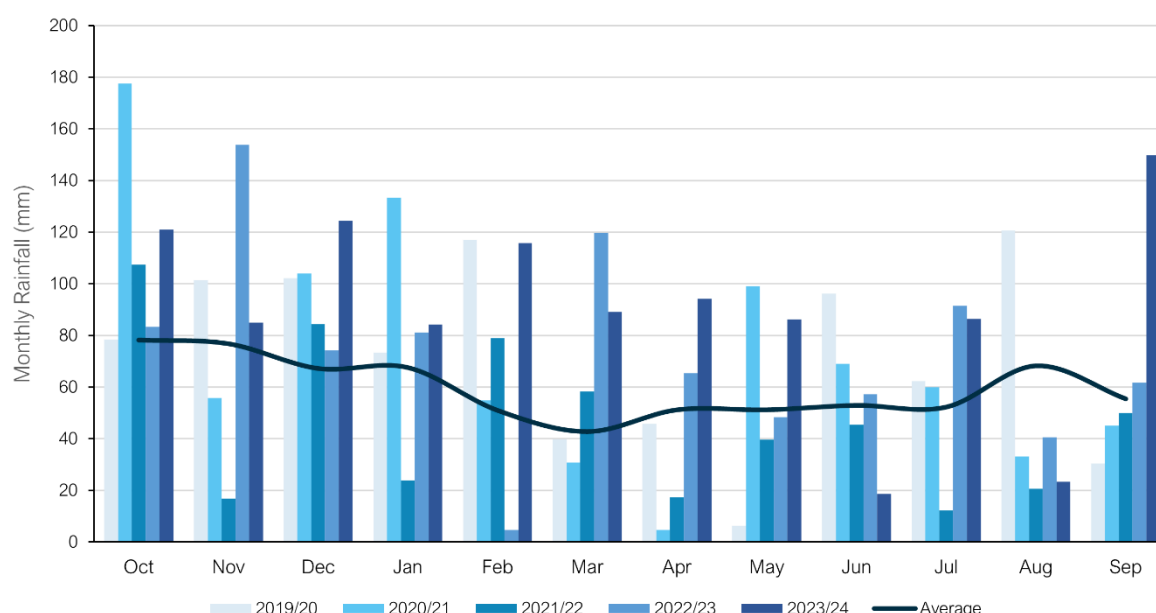
Figure 2 – Monthly Rainfall Data

Representative Radar rainfall has been used to generate monthly data at catchment level for comparison with average data generated by local Met Office Weather Station Records. Figure 2 presents the comparison of this data for the last five hydrological years to support longer term trends within the local system.

Average Values taken from Met Office Weather Station at Rothamsted based on the period 1991-2020

The total rainfall for the 2023/24 hydrological year is 51% above the annual average total. Total rainfall values are presented in Table 3 below.

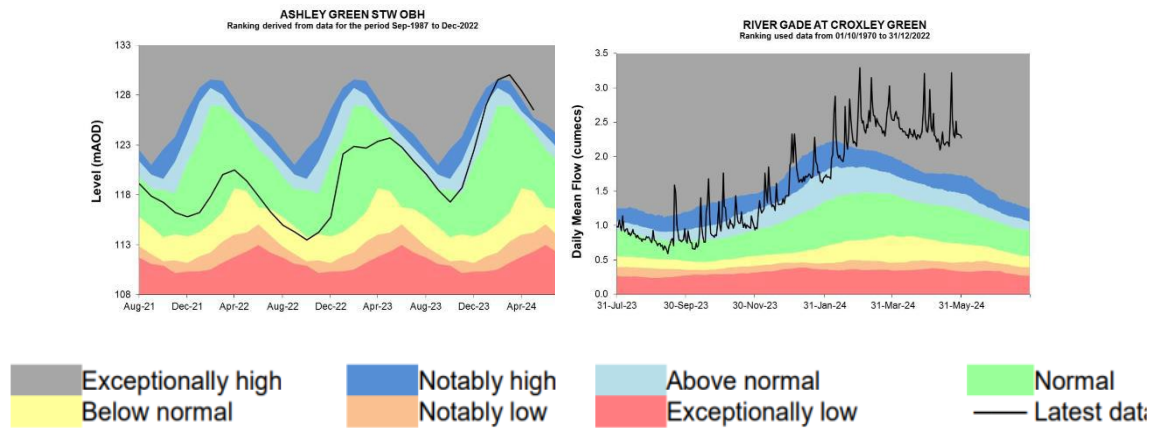
Figure 6 – Water Situation Report

In addition to these specific stations, the wider groundwater context is illustrated in the Water Situation Report for Chilterns – East – Colne. The nearest groundwater reference station is Ashley Green STW. This site showed groundwater levels in the normal range throughout 2023. Groundwater levels rise towards the end of the year, reaching notably and exceptionally high levels in 2024. This can be seen in Figure 6 alongside the river indicator located at Croxley Green on the River Gade.

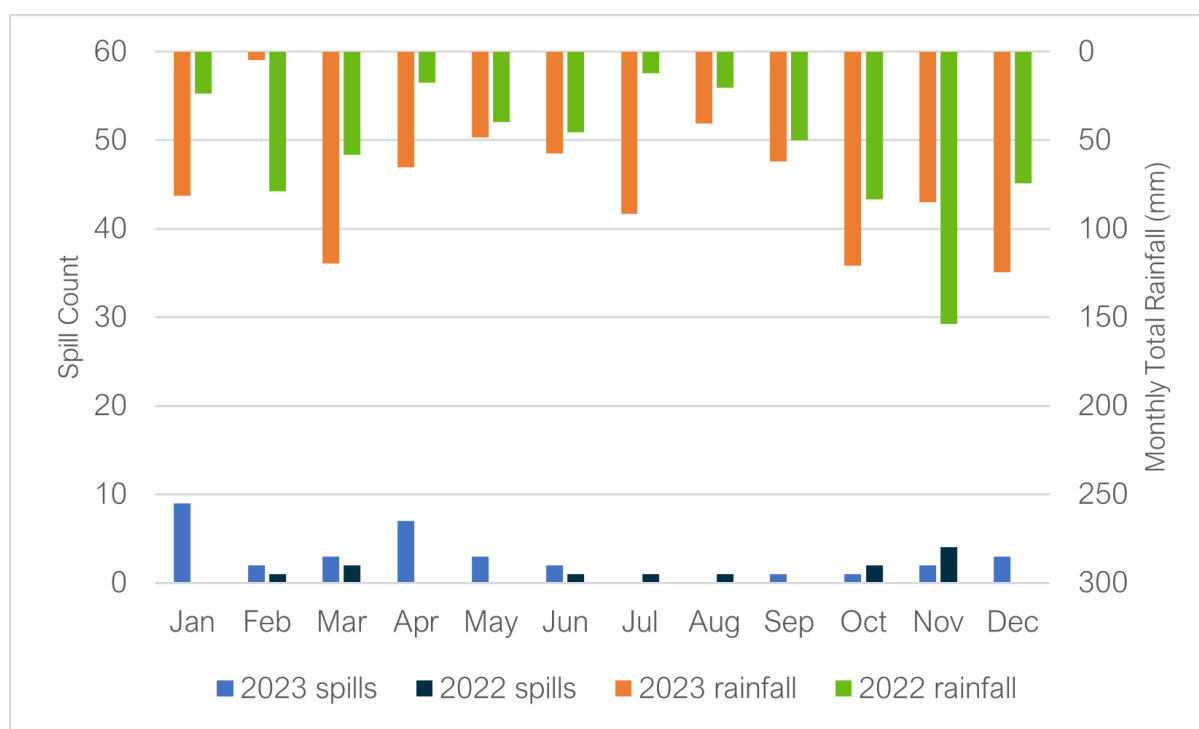
Figure 8 – EDM Monthly Performance 'Berkhamsted STW'

Figure 8 below presents the EDM performance trend and rainfall for recent years.

The data suggests a wider relationship between rainfall, elevated groundwater levels, and spill frequency. Significantly more spills were recorded January – May 2023, compared to the same period in 2022. The indicator site data shown in Figures 5 and 6, suggests that groundwater levels in the catchment were higher over these months in 2023. Furthermore, despite significantly more rainfall in February 2022, more spills were recorded in February 2023 and groundwater levels were higher in this month than in 2022. Spills were recorded across the summer months in both 2022 and 2023, indicating spills occurring in the catchment during prolonged or intense rainfall events, outside of periods of elevated groundwater levels.

Note that an upgrade was completed at Berkhamsted STW in 2023 to provide a major increase in treatment capacity. The number of spills that occurred in December 2023 does appear to be relatively low, considering that the indicator site data shown in Figures 5 and 6 suggests that groundwater levels in the catchment became elevated during this period. Overall, however, limited data is currently available to understand the potential impact of the upgrade on spill frequency at Berkhamsted STW. The EDM data for 2024 will be analysed once available to provide an improved understanding, as the indicator site data shown in Figures 5 and 6, suggests that groundwater levels in the catchment reached high levels during 2024.

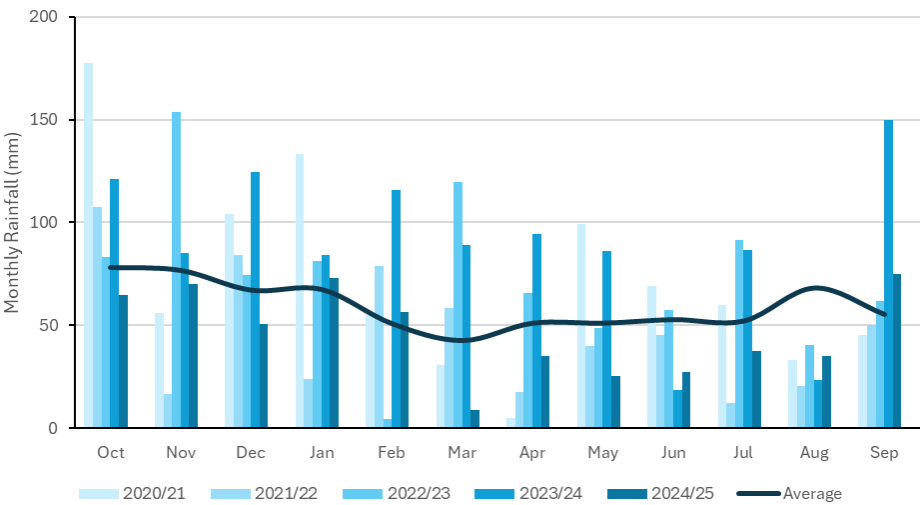
Figure 1: Monthly rainfall data 2020/21 to 2024/25

Figures 1 to 5 illustrate the relationship between rainfall and spills at CSOs. As shown in Figure 1, the decrease in rainfall from 2023/24 to 2024/25 correlates with reduced river levels (Figures 2 and 3), as well as a decline in the number and duration of CSO spills shown in Figure 5.

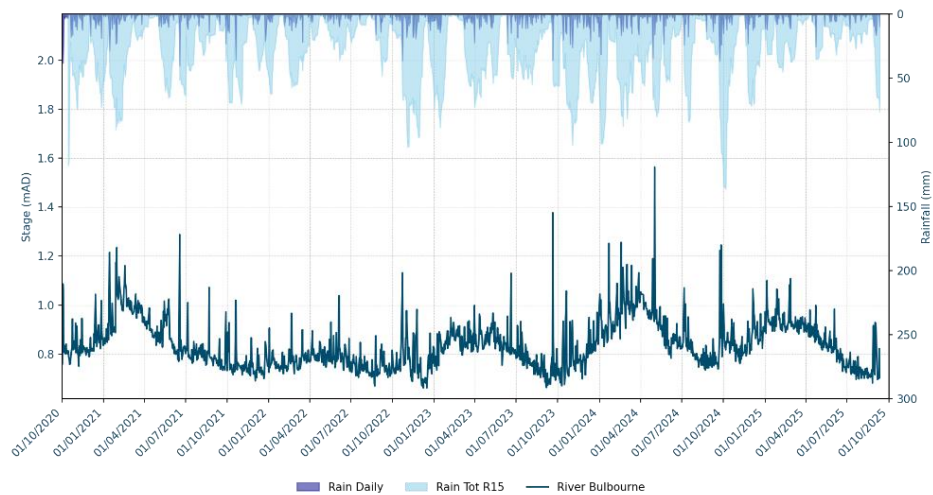
Figure 2: River Level data for River Bulbourne, Hemel Hempstead, Old Fishery Lane

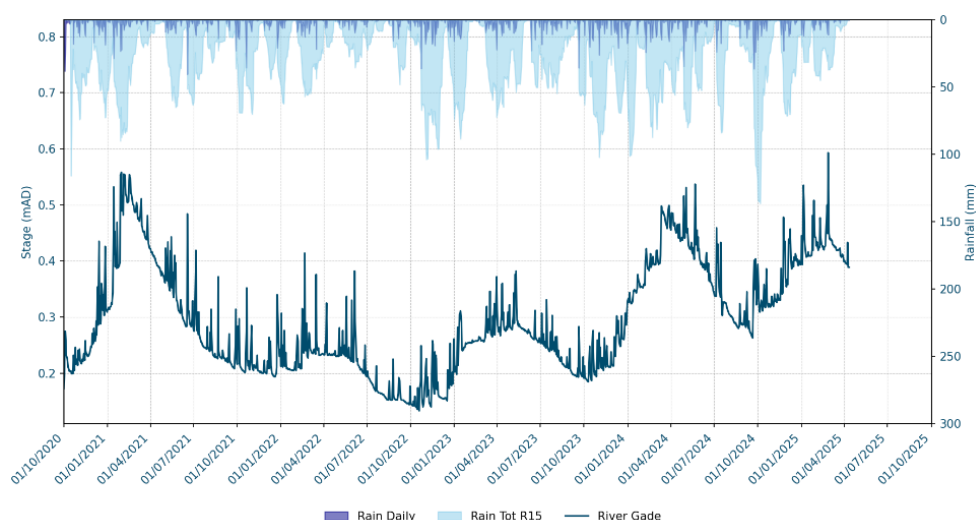
Figure 3: River Level data for River Gade Hemel Hempstead, Bury Mill

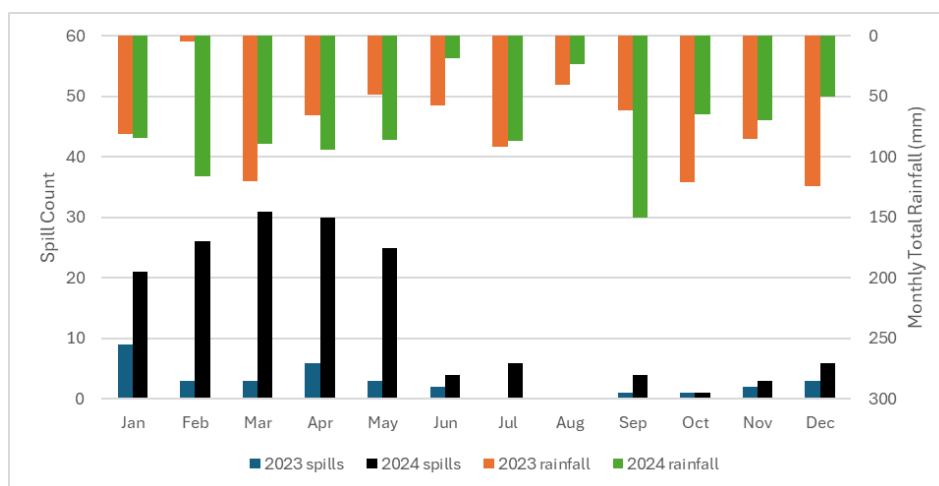
Figure 5: Monthly rainfall data versus monthly spill count for 2023 and 2024 – Berkhamsted STW

Table 1 below details the last 2 years performance of overflows in the catchment. To assess EDM performance and its relation to groundwater infiltration, a review of the month-on-month spill performance in 2023 and 2024 against the monthly total rainfall values has been undertaken, as observed in Figure 5.

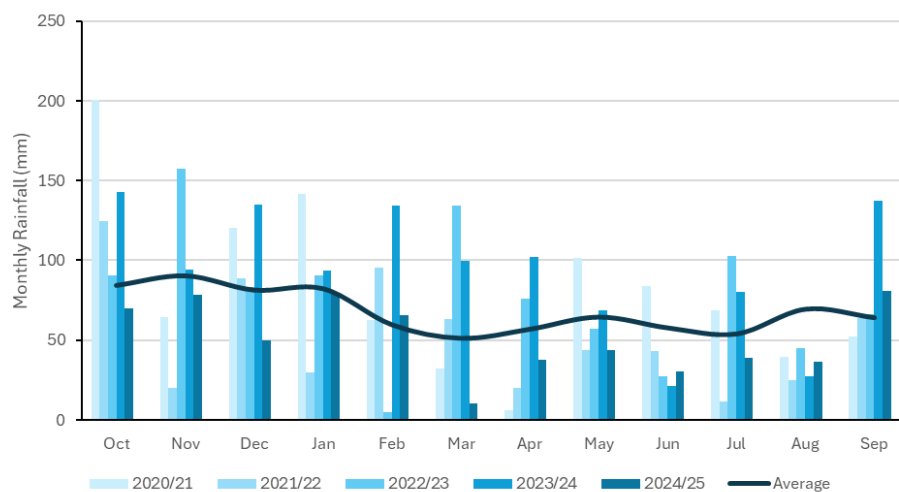
Figure 1: Monthly rainfall data 2020/21 to 2024/25

Figures 1 to 5 illustrate the relationship between rainfall and spills at CSOs. As shown in Figure 1, there is decrease in rainfall from 2023/24 to 2024/25. However, river levels follow a similar pattern as previous year (Figures 2 and 3), along with a decline in both the number and duration of CSO spills shown in Figure 5.

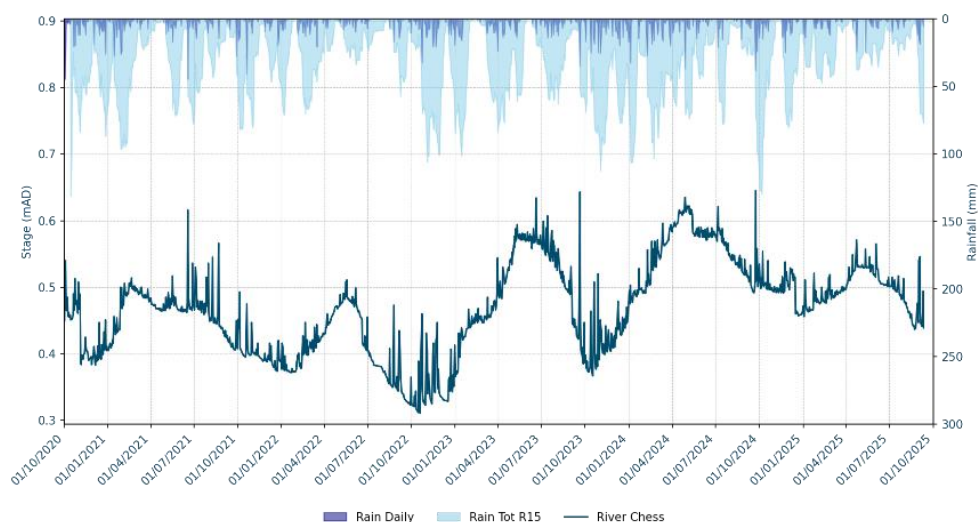
Figure 2: River Level data for River Chesh, Chesham

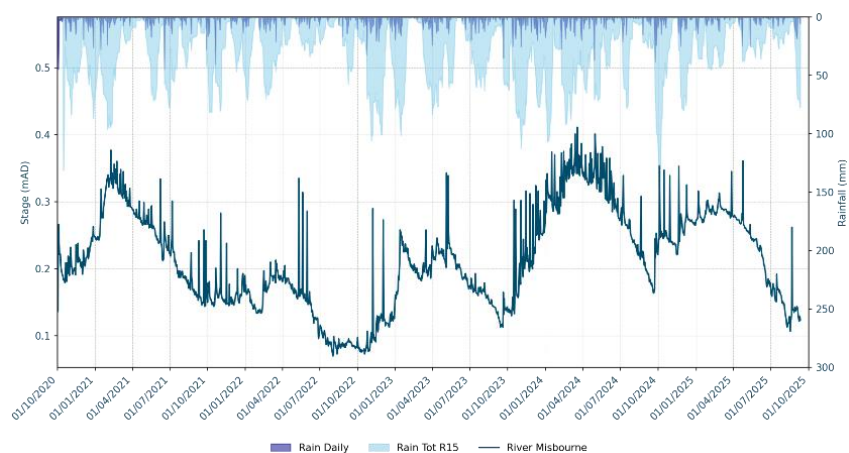
Figure 3: River Level data for River Misbourne, Missenden

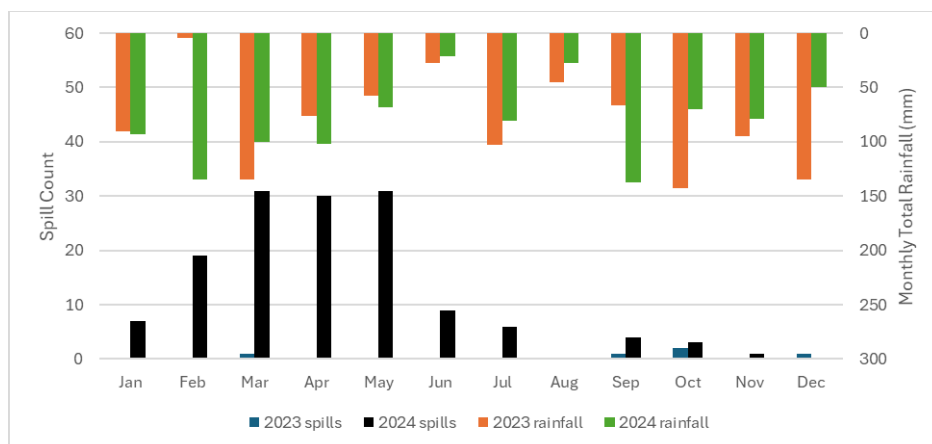
Figure 5: Monthly rainfall data versus monthly spill count for 2023 and 2024 – Chesham STW

Table 1 below details the last 2 years performance of overflows in the catchment. To assess EDM performance and its relation to groundwater infiltration, a review of the month-on-month spill performance in 2023 and 2024 against the monthly total rainfall values has been undertaken, as observed in Figure 5.

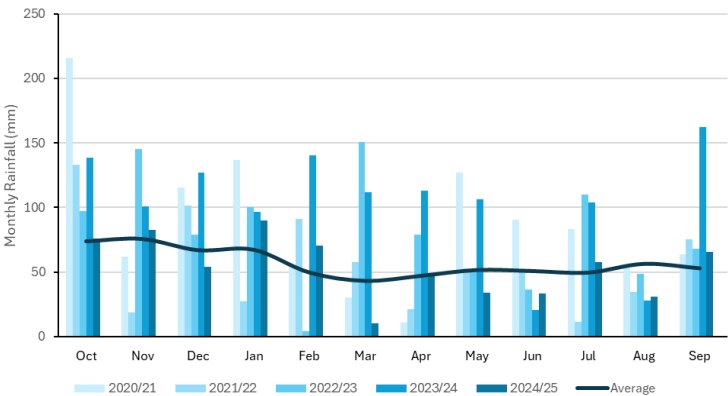
Figure 1: Monthly rainfall data 2020/21 to 2024/25

Figures 1 to 7 illustrate the relationship between rainfall and CSO spills. As shown in Figure 1, the reduction in rainfall from 2023/24 to 2024/25. However, river levels follow a similar pattern as previous year (Figures 2 to 5), along with a decline in both the number and duration of CSO spills shown in Figure 7.

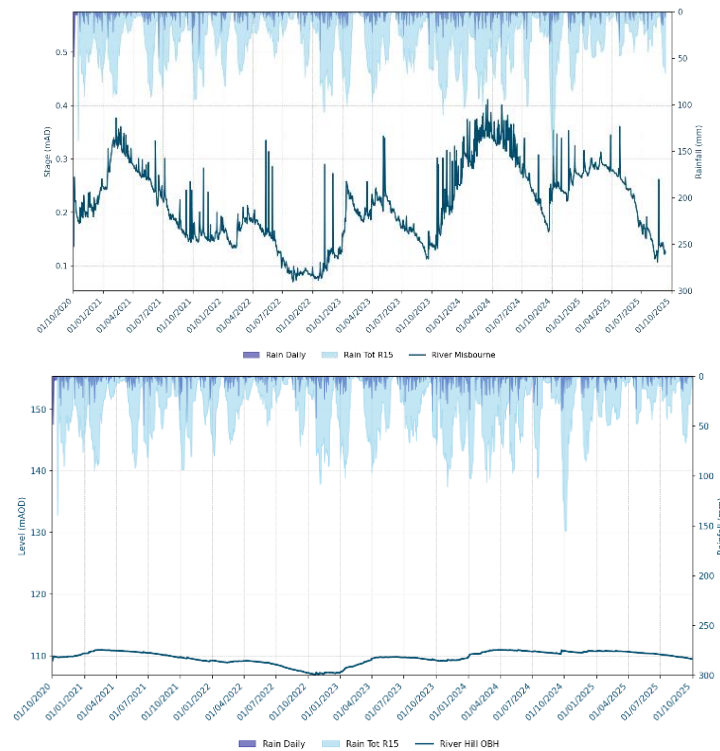
Figure 4: River Level data for River Misbourne, Missenden / Figure 5: River Level data for River Hill OBH

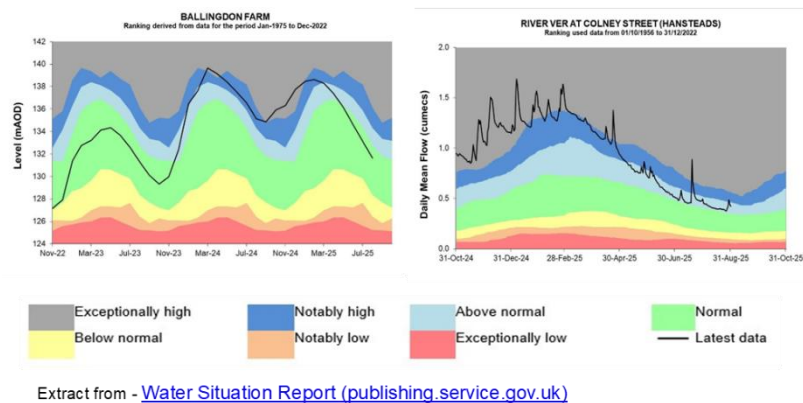
Figure 6: Ground Water situation Report

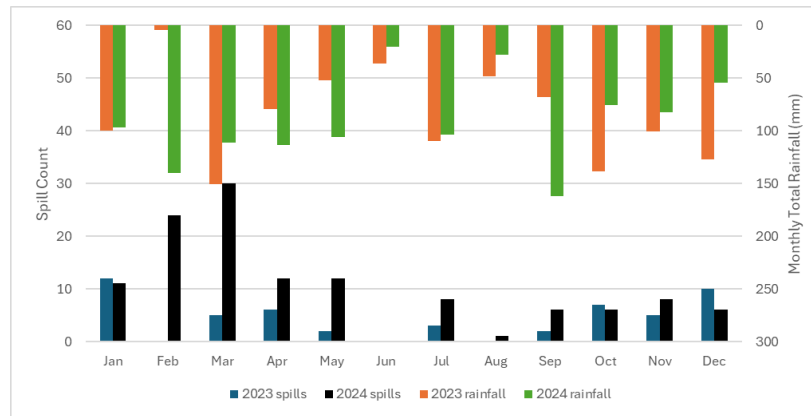
Figure 7: Monthly rainfall data versus monthly spill count for 2023 and 2024– Maple Lodge STW

Table 1 below details the last 2 years performance of overflows in the catchment. To assess EDM performance and its relation to groundwater infiltration, a review of the month-on-month spill performance in 2023 and 2024 against the monthly total rainfall values has been undertaken, as observed in Figure 7.

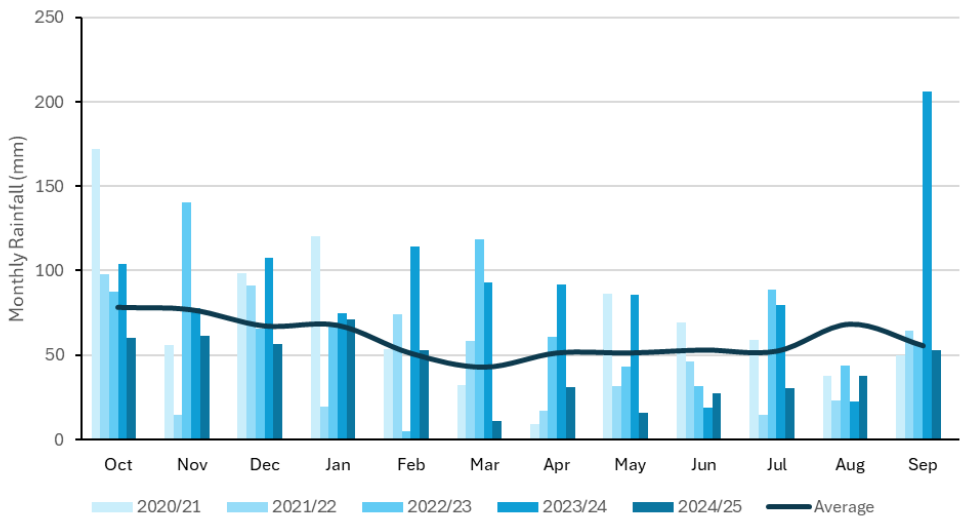
Figure 1: Monthly rainfall data 2020/21 to 2024/25

Figures 1 to 5 illustrate the relationship between rainfall and CSO spills. As shown in Figure 1, the decrease in rainfall from 2023/24 to 2024/25. However, River levels follow a similar pattern as previous year (Figures 2), along with a decline in both the number and duration of CSO spills shown in Figure 5.

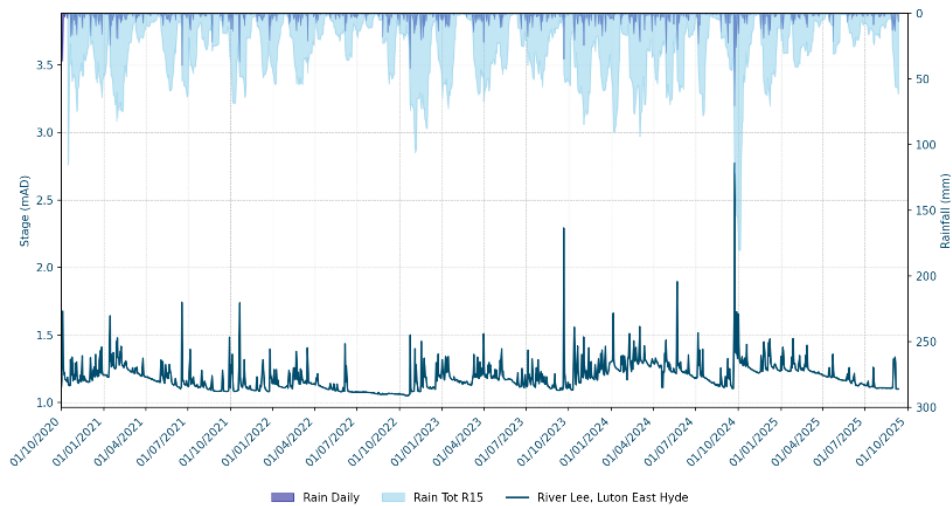
Figure 2: River Level data for River Lee, Luton East Hyde

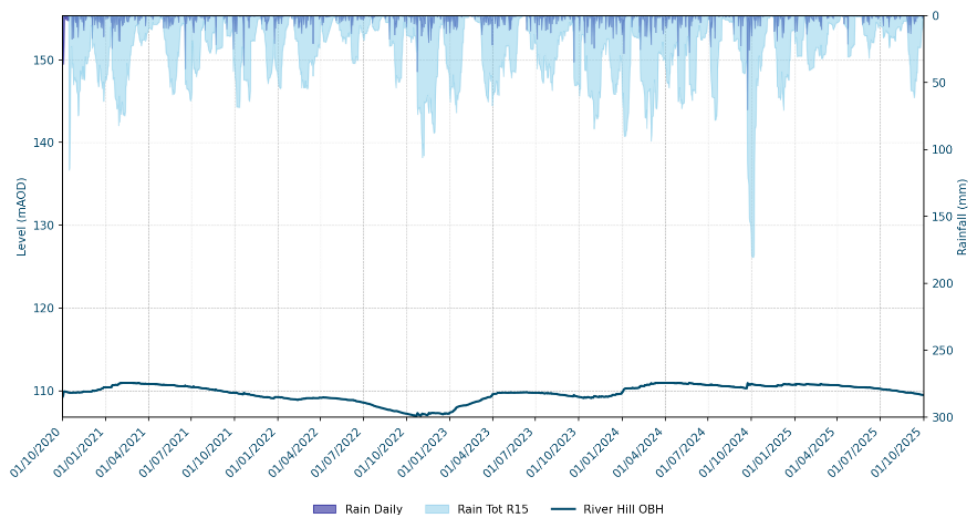
Figure 3: River Level data for River Hill OBH

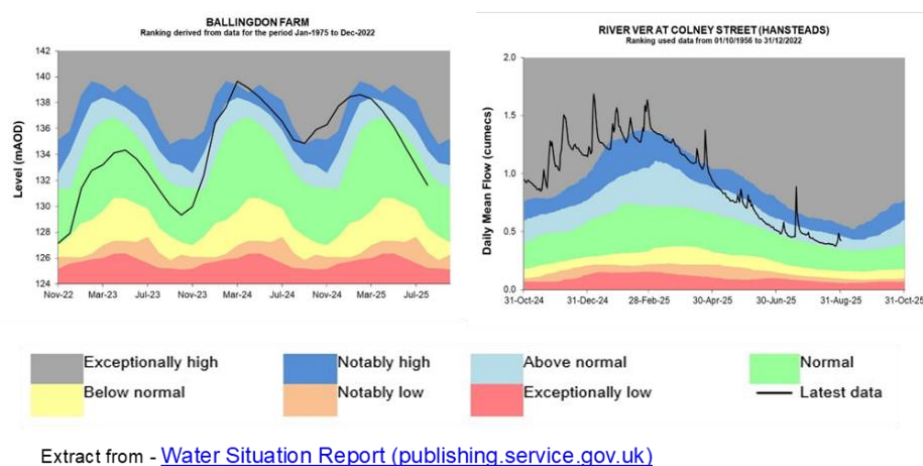
Figure 4: Ground Water situation Report

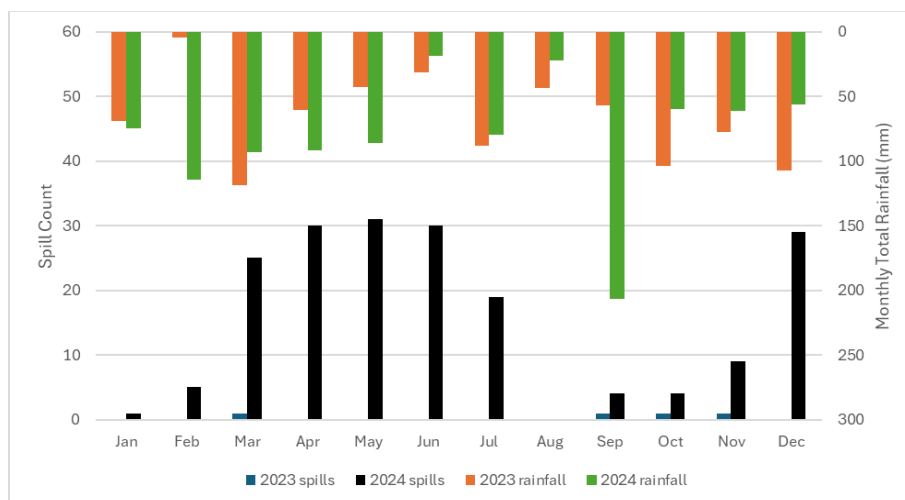
Figure 5: Monthly rainfall data versus monthly spill count for 2023 and 2024– Markyate STW

Table 1 below details the last 2 years performance of overflows in the catchment. To assess EDM performance and its relation to groundwater infiltration, a review of the month-on-month spill performance in 2023 and 2024 against the monthly total rainfall values has been undertaken, as observed in Figure 5.
