# Groundwater Impacted System Management Plan

Milton-under-Wychwood, River Evenlode

April 2021

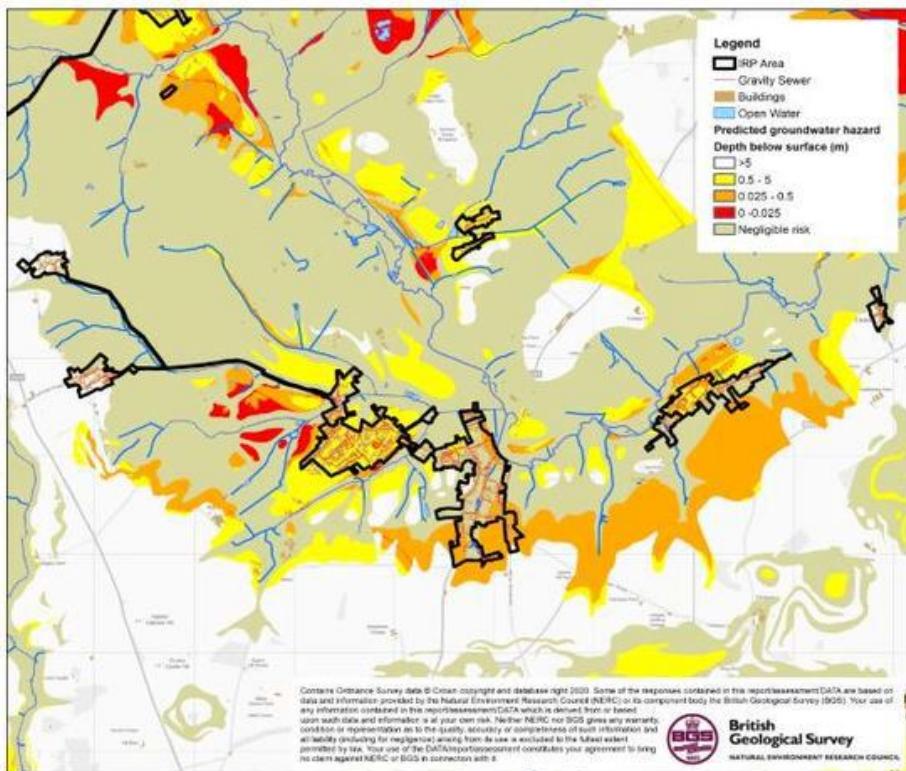
Figure 1.0 – Milton-under-Wychwood catchment

The Milton-under-Wychwood system lies on the River Evenlode, in Oxfordshire, England, approximately 11km north west of Witney. The Milton-under-Wychwood system serves a population equivalent<sup>3</sup> of 4,183 with a predominantly separate sewerage network totaling some 42km in length excluding private drains and sewers. The extent of the catchment is shown in Figure 1.0 above and includes the villages of Idbury, Fifield, Milton-under-Wych-wood, Shipton-under-Wychwood, Lyneham, Ascott-under-Wychwood and Chilson.

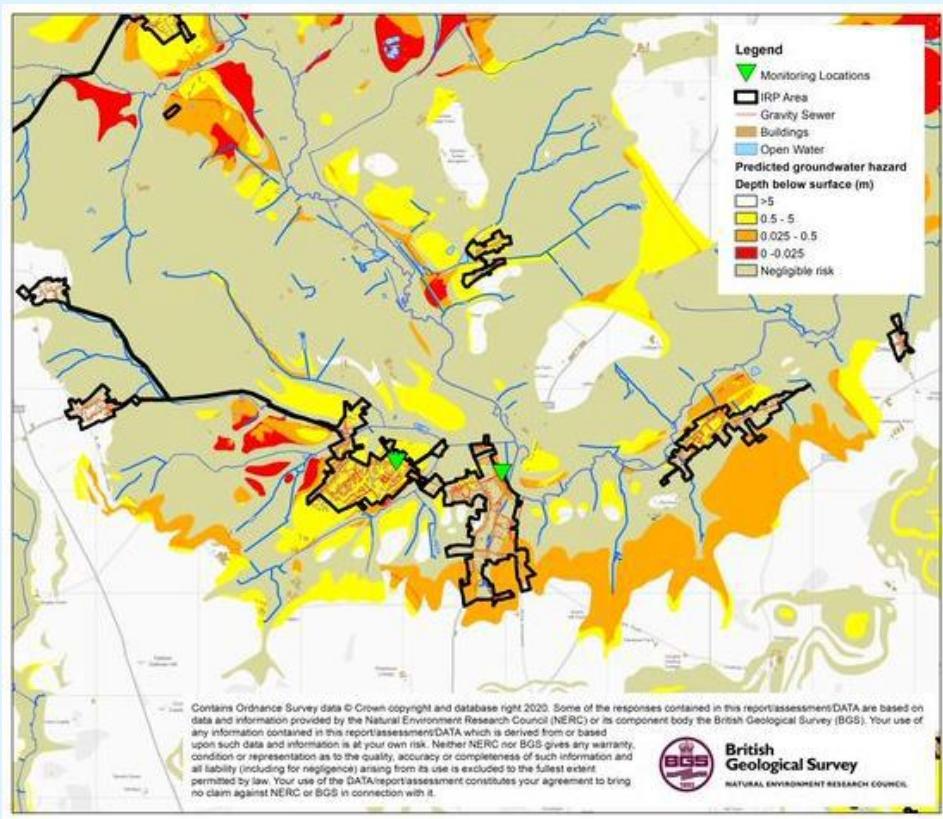
Figure 2.0 – Milton-under-Wychwood monitoring and infiltration zones

Key to bringing the impact of groundwater infiltration under control is an enhanced monitoring regime. We have identified and have installed several telemetered depth monitor locations around the Milton-under-Wychwood system – see Figure 2.0.

We engaged with JBA Consulting to develop plans for Milton-under-Wychwood that identify zones of groundwater risk, see Figure 2.0. These zones are modelled areas where the groundwater has been determined to be above the sewer and hence pose a potential risk for groundwater ingress.

Sewer Depth Monitors were installed in the catchment in 2020 (see Figure 2.0). These devices are telemetered and provide real time data on the level of flow in the sewer.

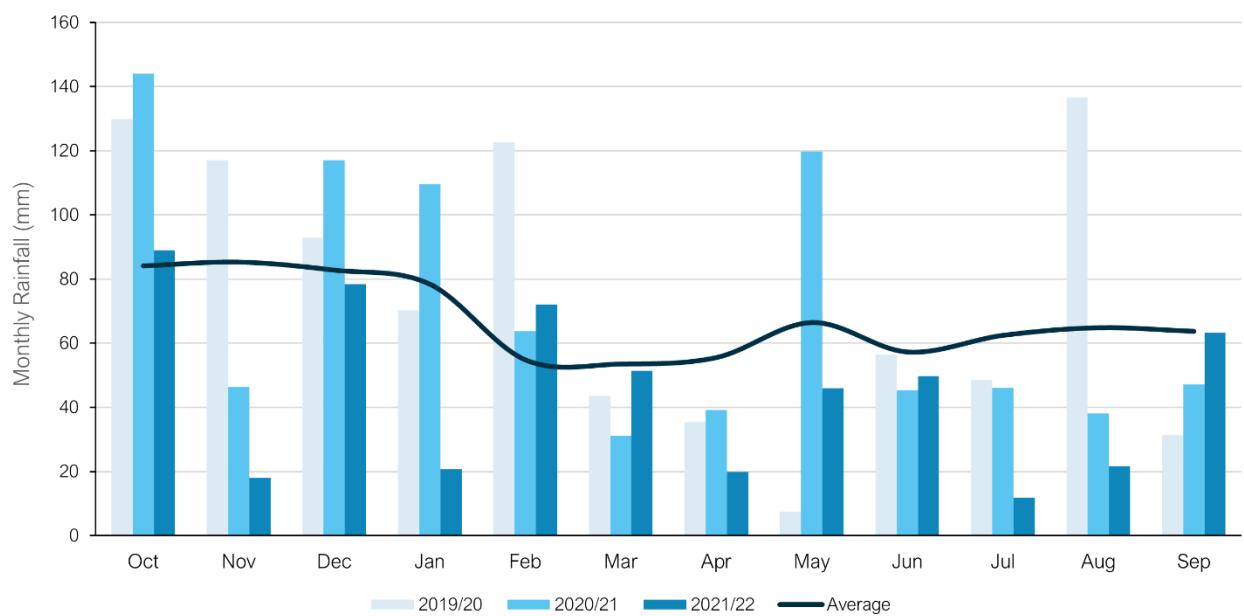
Figure 2 – Monthly Rainfall Performance

Representative Radar rainfall has been used to generate monthly data at catchment level for comparison with average data generated by local Met Office Weather Station Records. Figure 2 presents the comparison of this data for the last three hydrological years to support longer term trends within the local system.

Average Values taken from Met Office Weather Station at Little Rissington based on the period 1991-2020

The total rainfall for the 2021/22 hydrological year is 32% below the annual average total. Total rainfall values are presented in Table 3 below.

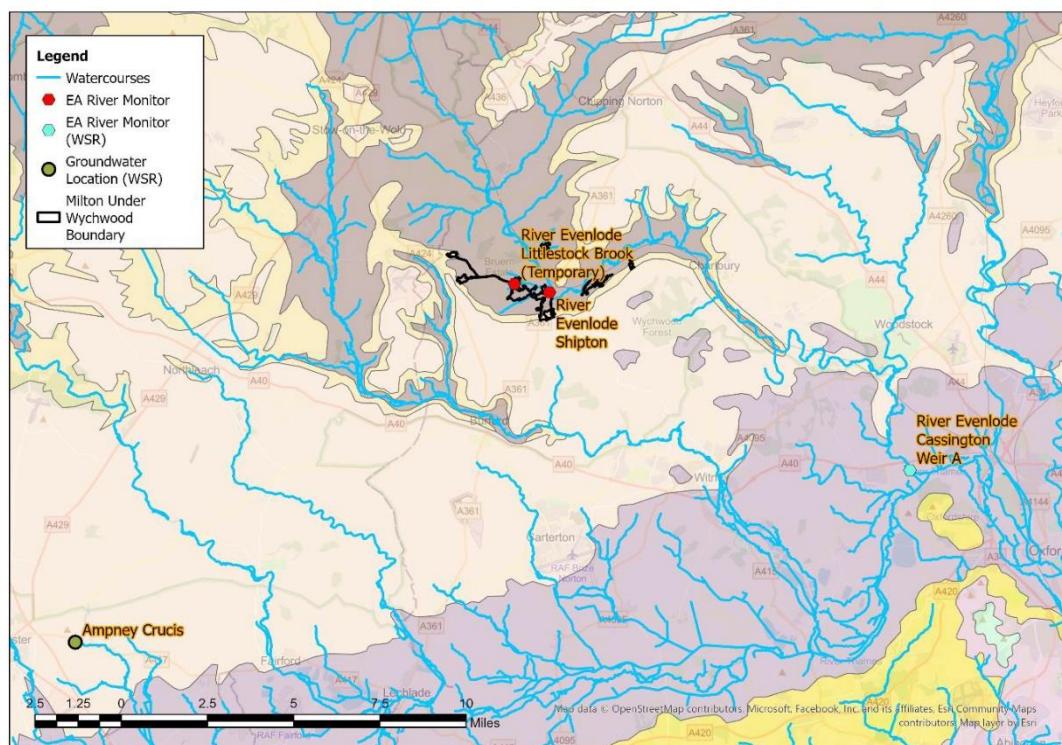
Figure 4 – Local Monitoring Stations

These sites are illustrated in the figure below, alongside the closest groundwater reference station and closest gauging station from the Water Situation Report.

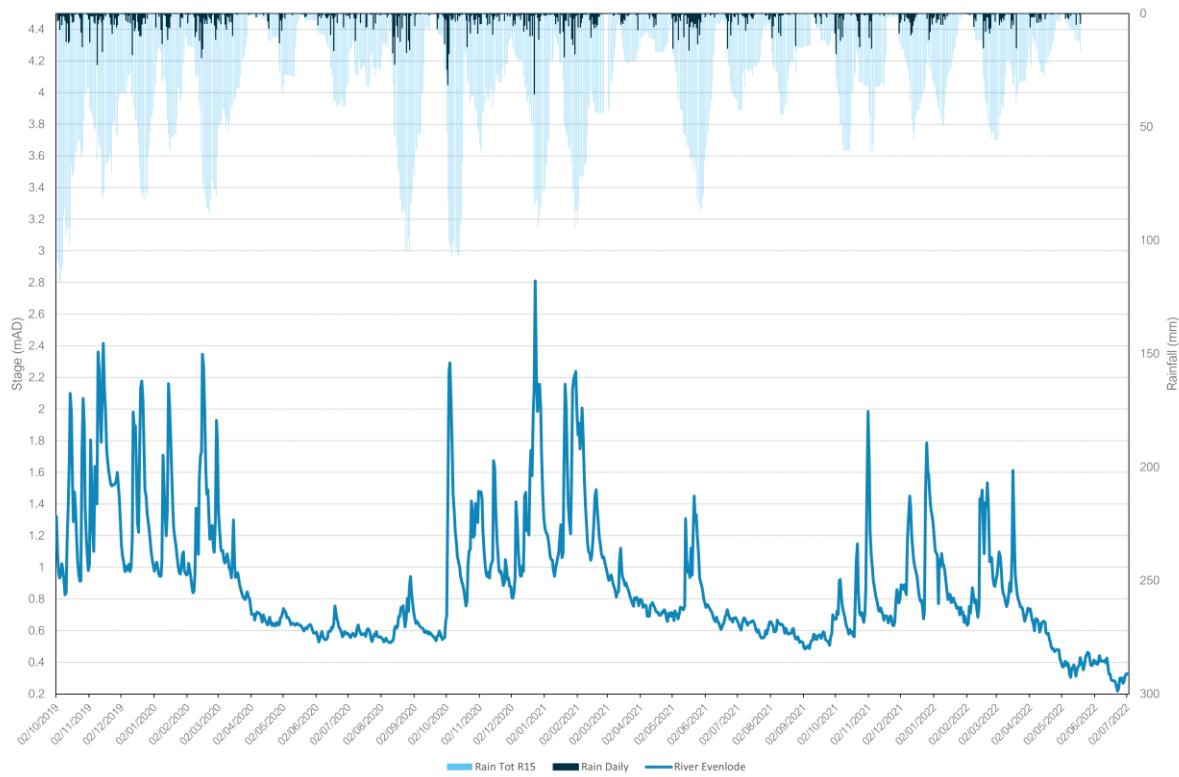
Figure 5A – River Evenlode, Shipton

The following figures represent the last three hydrological years of level information at the indicator sites to build a picture of the relative conditions prevalent in the current year. It is presented against both the daily total rainfall values for the catchment and a rolling 15-day total rainfall.

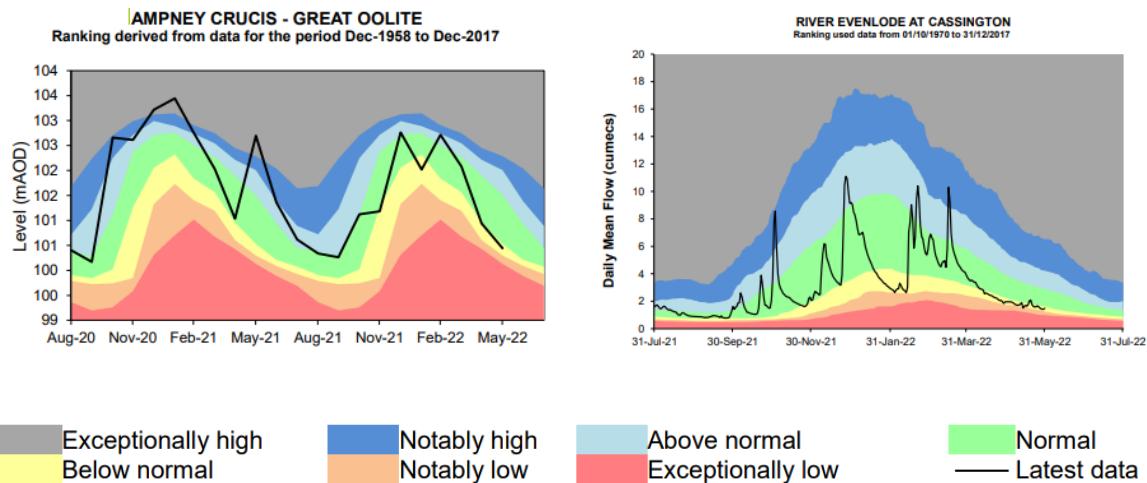
Figure 6 – Water Situation Report

In addition to these specific stations, the wider groundwater context is illustrated in the Water Situation Report for Cotswold East. The nearest groundwater reference station is Ampney Crucis. This site shows generally lower overall groundwater than the previous year, particularly evident during the winter months. This can be seen in the figure below alongside the river indicator location at Cassington on the River Evenlode.

Extract from - [Water Situation Report \(publishing.service.gov.uk\)](https://publishing.service.gov.uk)

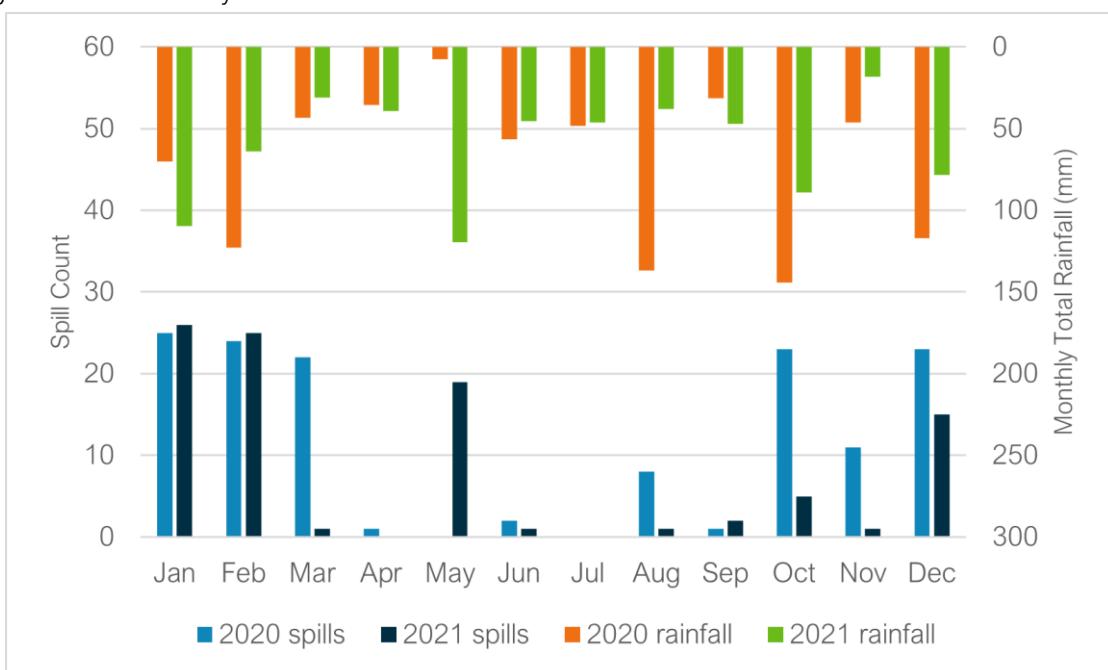
Figure 8 – EDM Monthly Performance

A critical part of the assessment of EDM performance and its relation to groundwater inundation is to review the month-on-month spill performance, against previous years and the monthly total rainfall values to give context to the performance. Figure 8 below presents the EDM performance trend and rainfall for recent years.

The trend in spill performance across the two recorded years does show variation in spills, with a focus on spills during the autumn and winter months. The data suggests a wider relationship between rainfall, elevated groundwater levels and spill frequency. A slower tail off in spills is evident within the first half of 2020, when the indicator sites suggest groundwater levels in the catchment were higher than within the first half of 2021.

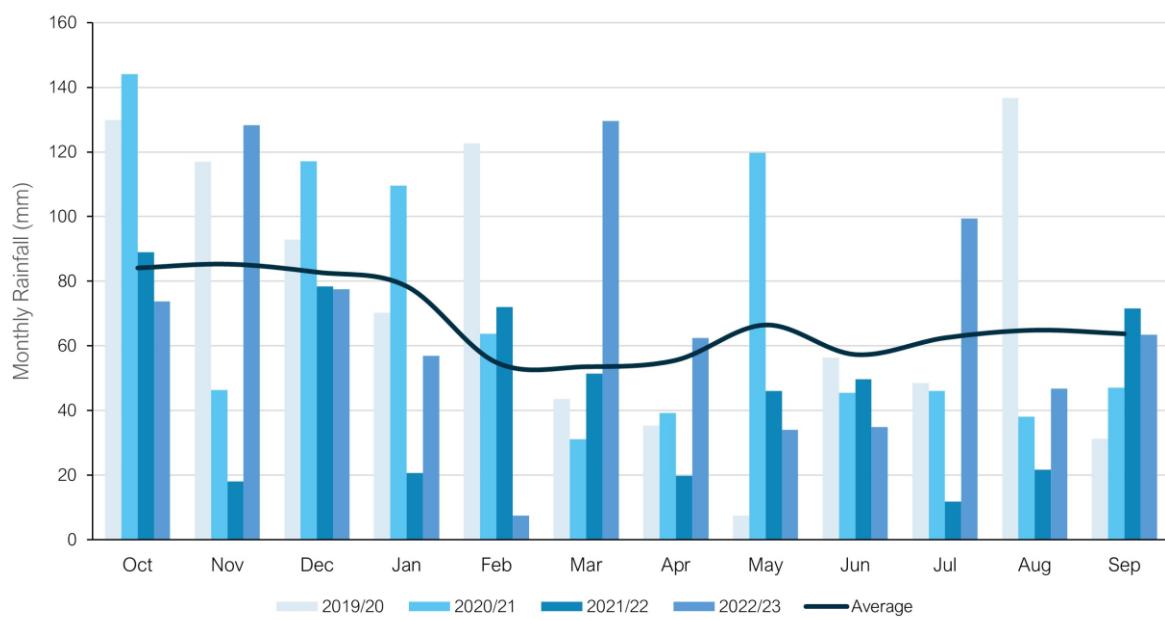
Figure 2 – Monthly Rainfall Performance

Representative Radar rainfall has been used to generate monthly data at catchment level for comparison with average data generated by local Met Office Weather Station Records. Figure 2 presents the comparison of this data for the last four hydrological years to support longer term trends within the local system.

Average Values taken from Met Office Weather Station at Little Rissington based on the period 1991-2020

The total rainfall for the 2022/23 hydrological year is 1% above the annual average total. Total rainfall values are presented in Table 3 below.

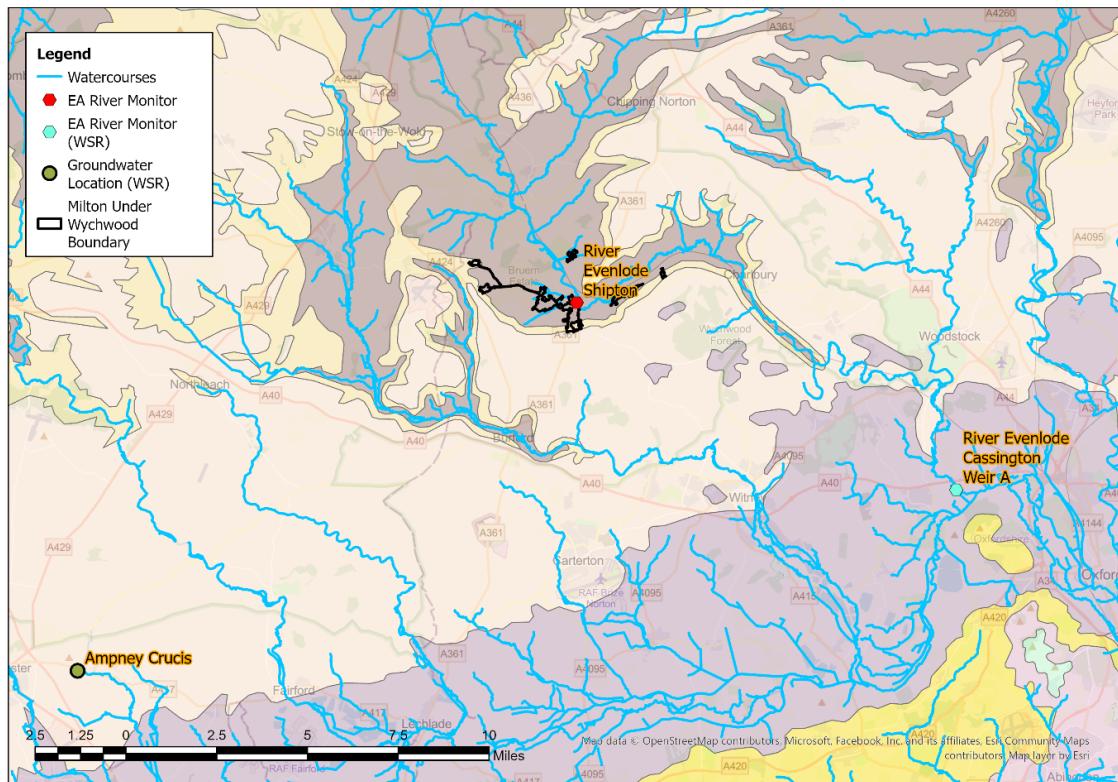
Figure 4 – Local Monitoring Stations

This site is illustrated in the figure below, alongside the closest groundwater reference station and closest gauging station from the Water Situation Report.

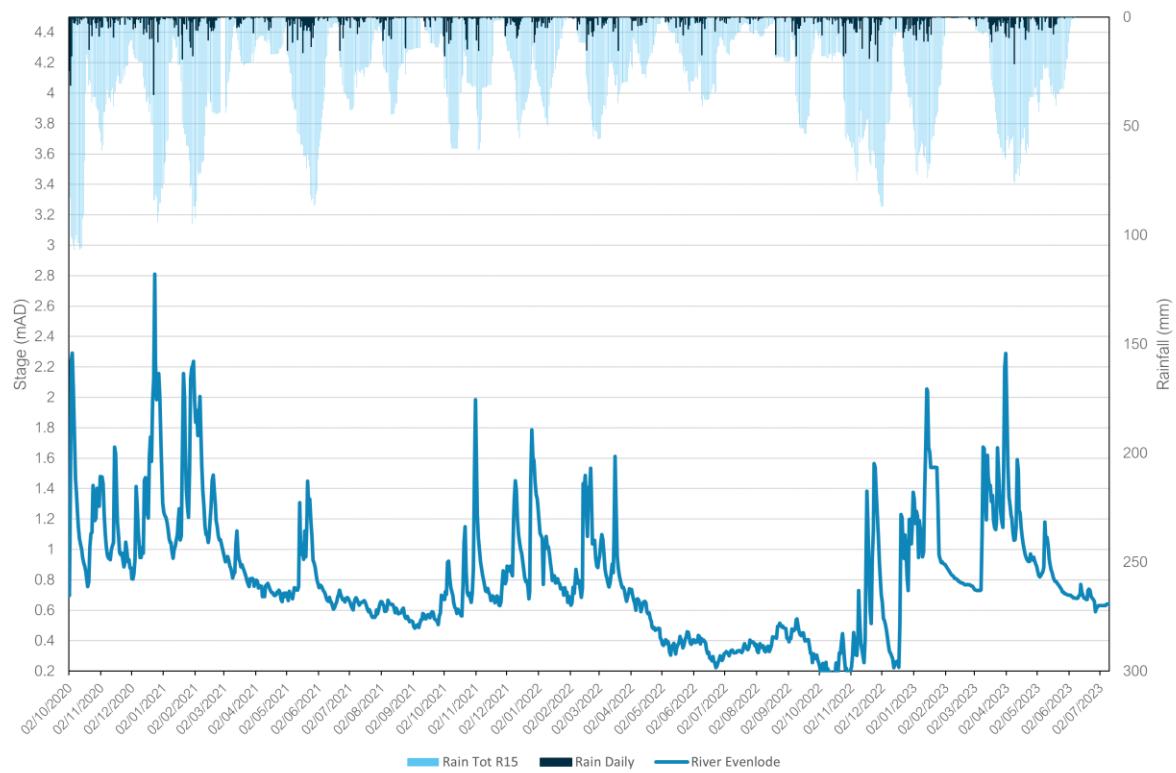
Figure 5A – River Evenlode, Shipton

The following figures represent the last three hydrological years of level information at the indicator sites to build a picture of the relative conditions prevalent in the current year. It is presented against both the daily total rainfall values for the catchment and a rolling 15 day total rainfall.

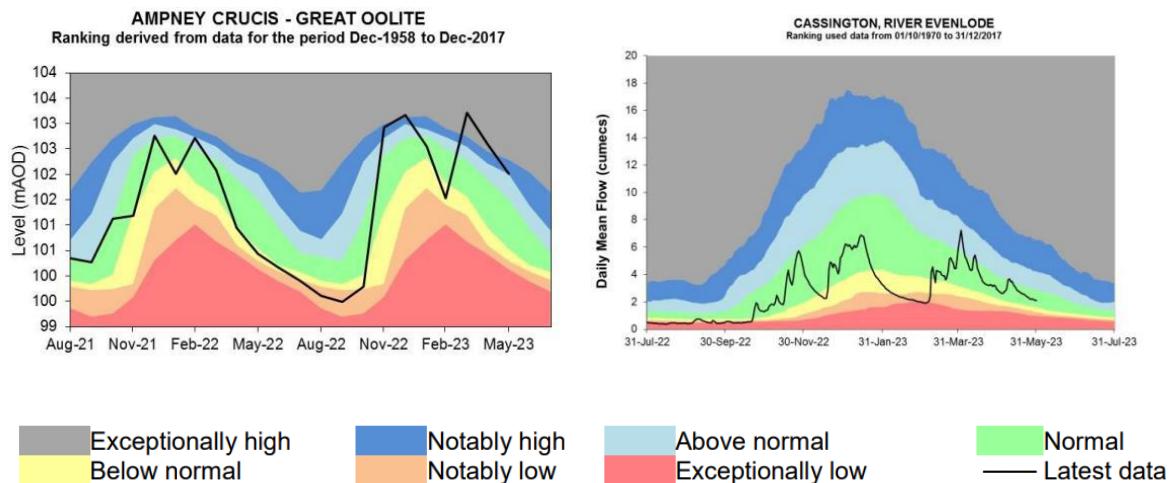
Figure 6 – Water Situation Report

In addition to this specific station, the wider groundwater context is illustrated in the Water Situation Report for Cotswold East. The nearest groundwater reference station is Ampney Crucis. This site shows groundwater levels were generally at normal, below normal, or notably low levels in 2022. Groundwater levels have generally been higher in 2023, reaching above normal, notably high, and exceptionally high levels. This can be seen in the figure below alongside the river indicator location at Cassington on the River Evenlode.

Extract from - [Water Situation Report \(publishing.service.gov.uk\)](https://www.publishing.service.gov.uk)

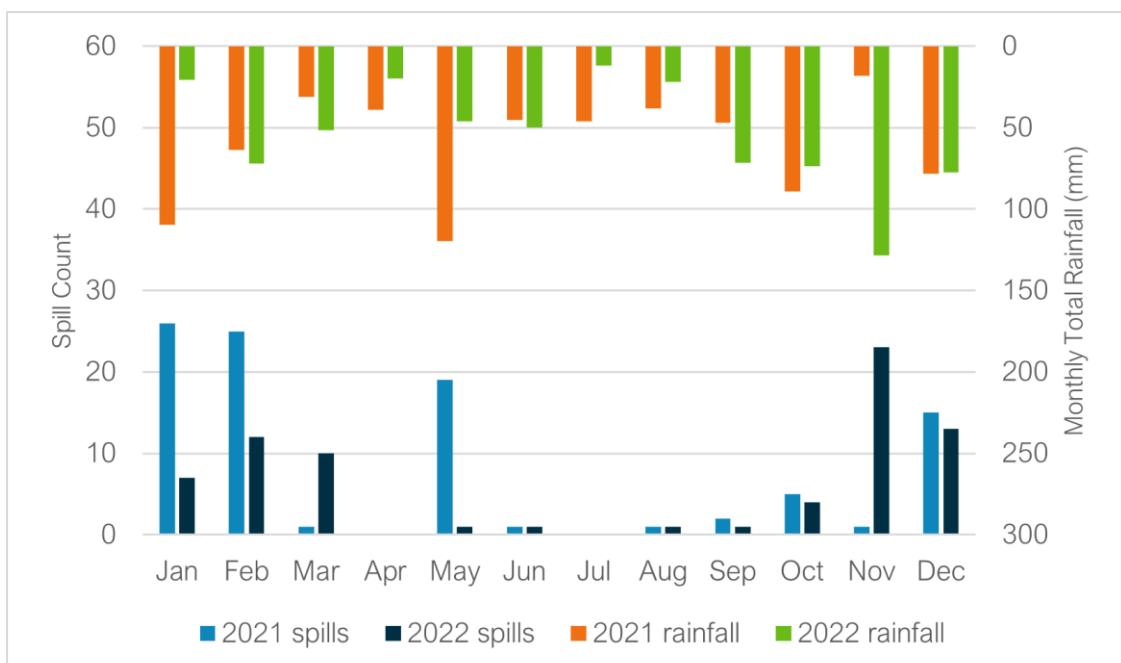
Figure 8 – EDM Monthly Performance

A critical part of the assessment of EDM performance and its relation to groundwater infiltration is to review the month-on-month spill performance, against previous years and the monthly total rainfall values to give context to the performance. Figure 8 below presents the EDM performance trend and rainfall for recent years.

The trend in spill performance across the two recorded years does show variation in spills, with a focus on spills during the autumn and winter months. The data suggests a wider relationship between rainfall, elevated groundwater levels and spill frequency. Despite broadly similar rainfall totals, significantly more spills were recorded at Milton-under-Wychwood STW in February 2021 compared to February 2022. The indicator site data shown in Figure 5, suggests groundwater levels in the catchment were higher in February 2021. In November 2022, a significantly higher number of spills were recorded in comparison to November 2021, with Figure 6 suggesting groundwater levels in the catchment reached notably high levels during the period.

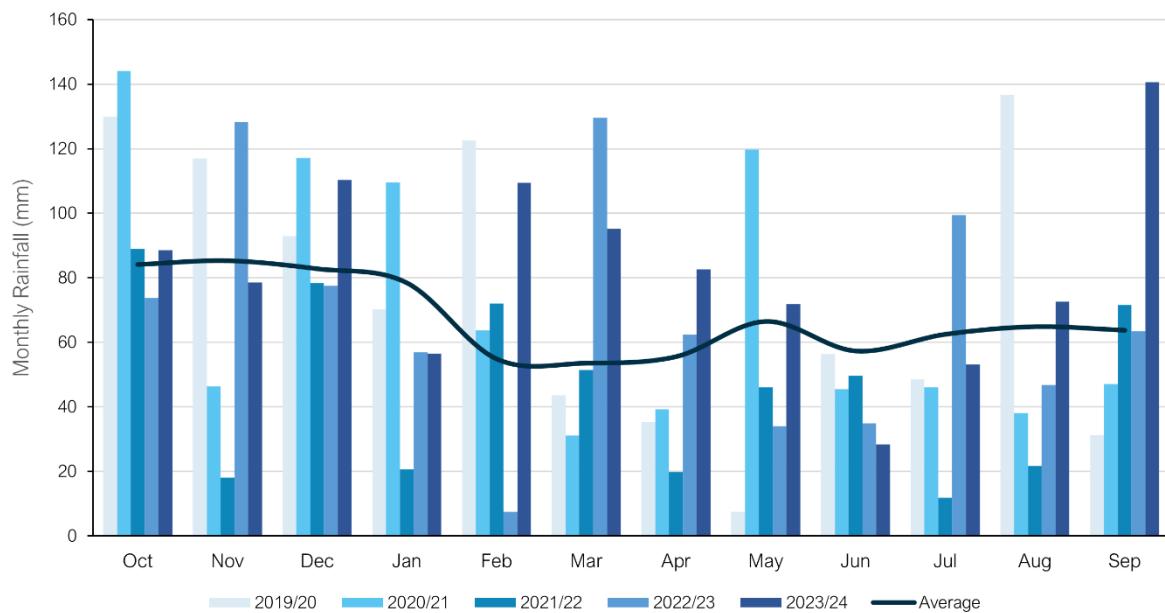
Figure 2 – Monthly Rainfall Data

Representative Radar rainfall has been used to generate monthly data at catchment level for comparison with average data generated by local Met Office Weather Station Records. Figure 2 presents the comparison of this data for the last five hydrological years to support longer term trends within the local system.

Average Values taken from Met Office Weather Station at Little Rissington based on the period 1991-2020

The total rainfall for the 2023/24 hydrological year is 22% above the annual average total. Total rainfall values are presented in Table 3 below.

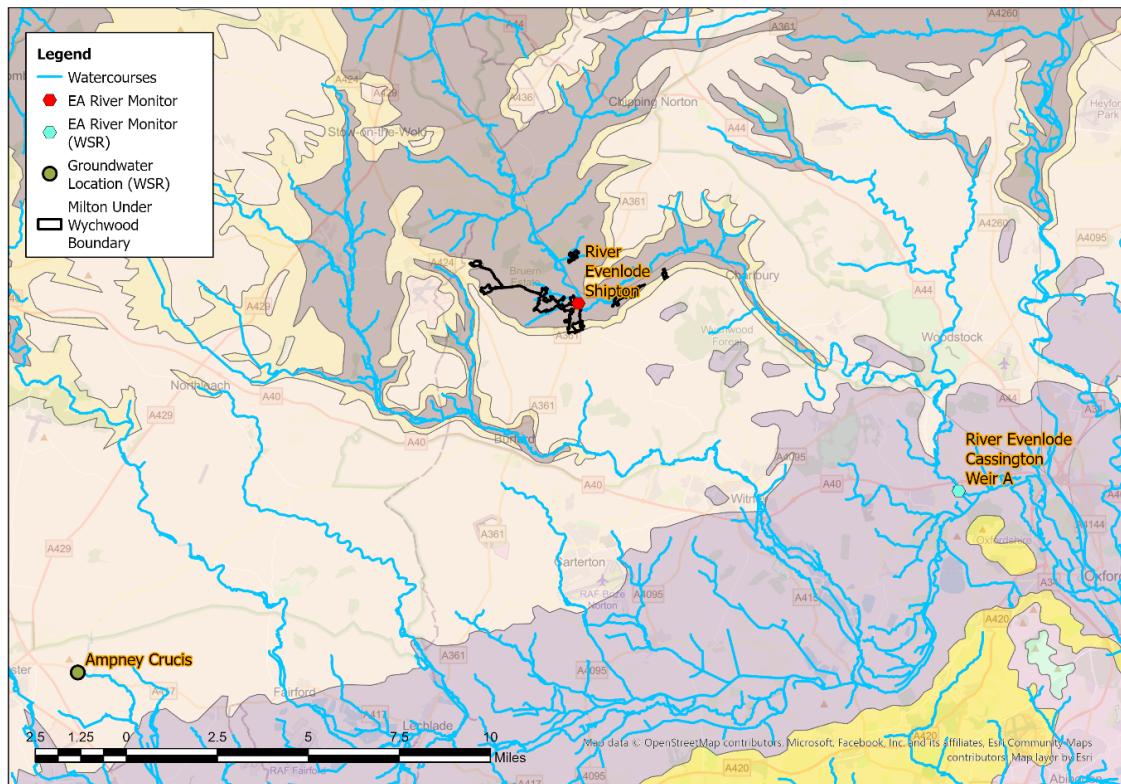
Figure 4 – Local Monitoring Stations

This site is illustrated in Figure 4, alongside the closest groundwater reference station and closest gauging station from the Water Situation Report.

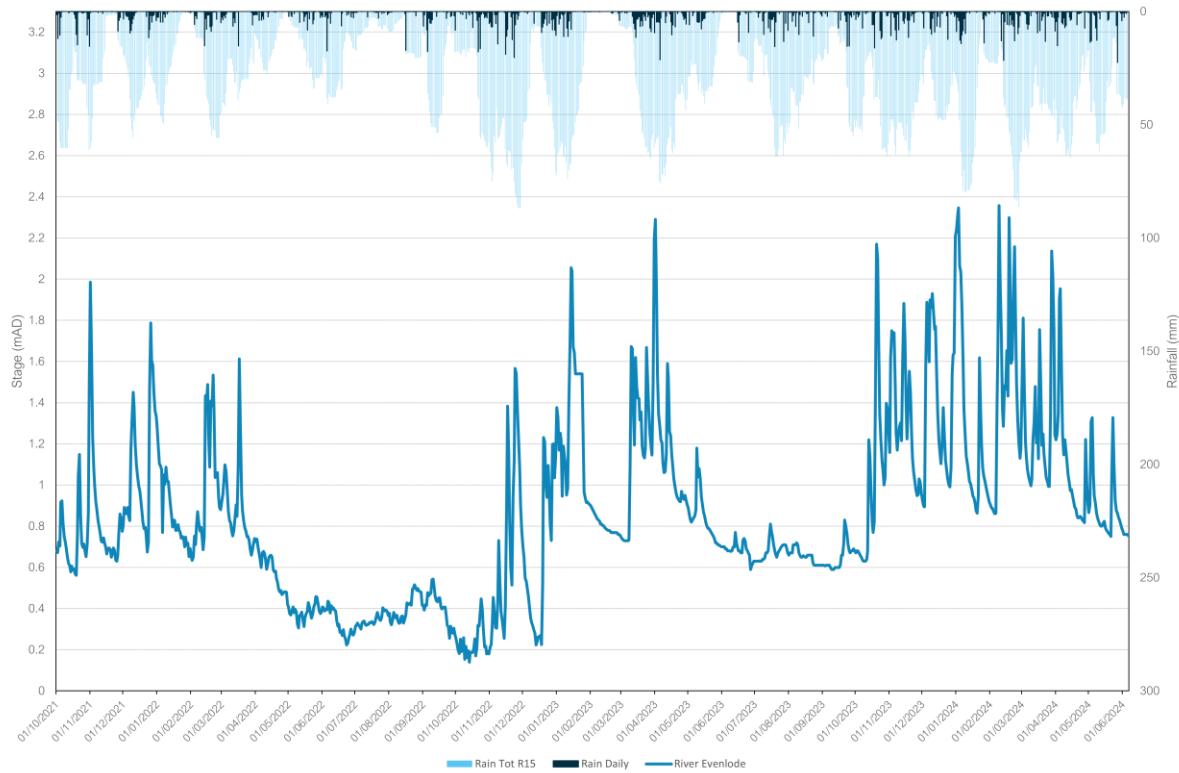
Figure 5A – River Evenlode, Shipton

Figure 5A represents the last three hydrological years of level information at the indicator site to build a picture of the relative conditions prevalent in the current year. It is presented against both the daily total rainfall values for the catchment and a rolling 15 day total rainfall.

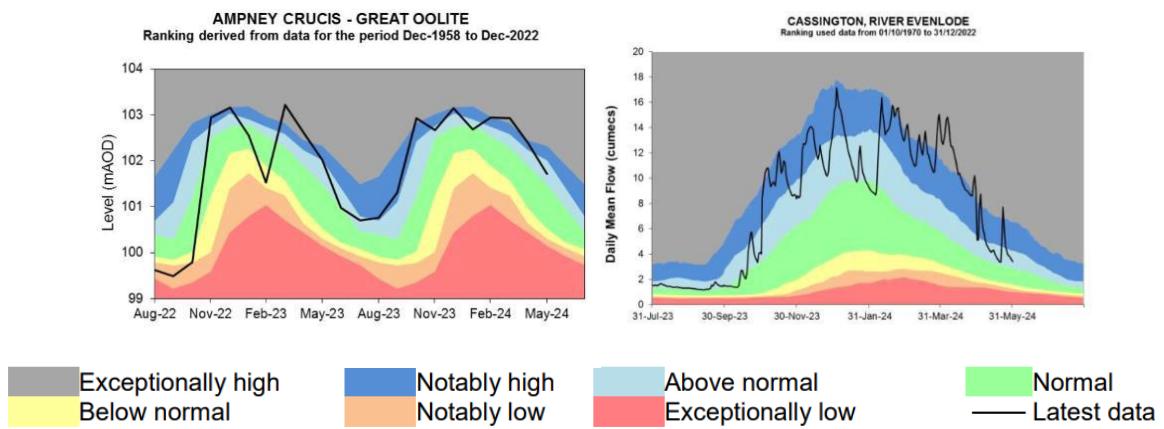
Figure 6 – Water Situation Report

In addition to this specific station, the wider groundwater context is illustrated in the Water Situation Report for Cotswolds East. The nearest groundwater reference station is Ampney Crucis. This site shows groundwater levels to vary throughout 2023, being observed at below normal, normal and above normal levels, peaking at exceptionally high levels around April 2023. Groundwater levels in 2024 have consistently been observed at above normal, notably high and exceptionally high levels. This can be seen in Figure 6 alongside the river indicator location at Cassington on the River Evenlode.

Extract from - [Water Situation Report \(publishing.service.gov.uk\)](https://publishing.service.gov.uk)

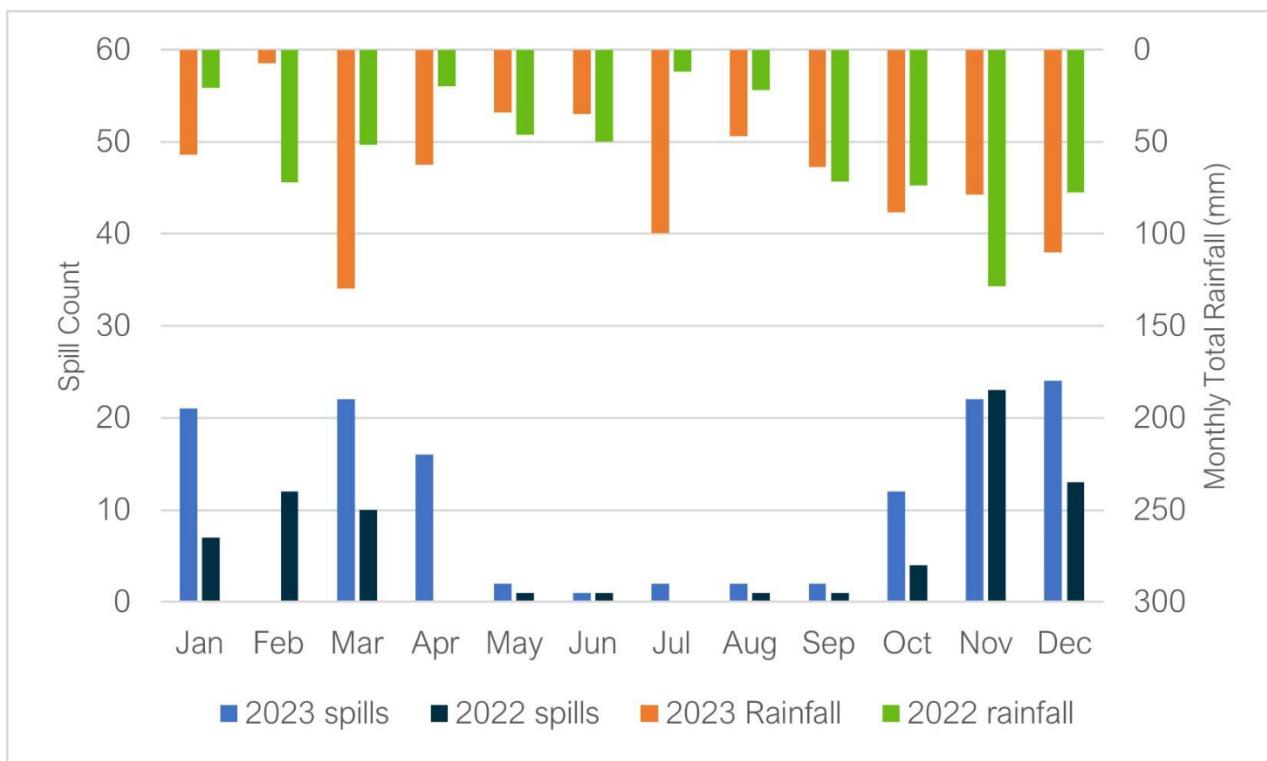
Figure 8 – EDM Monthly Performance

A critical part of the assessment of EDM performance and its relation to groundwater infiltration is to review the month-on-month spill performance, against previous years and the monthly total rainfall values to give context to the performance. Figure 8 below presents the EDM performance trend and rainfall for recent years.

The trend in spill performance across the two recorded years does show variation in spills, with a focus on spills during winter, spring and autumn months. The data suggests a wider relationship between elevated groundwater and spill frequencies. The highest peaks in spills for 2023 can be seen in January, March, April and October - December, when the indicator site data shown in Figures 5 and 6 suggests groundwater levels in the catchment became elevated and were generally higher than the equivalent months in 2022, when lower spill frequencies were generally observed. Summer spills were also recorded across 2022 and 2023 which indicates spills occurring in the catchment due to intense or prolonged rainfall events, outside of periods of elevated groundwater levels.

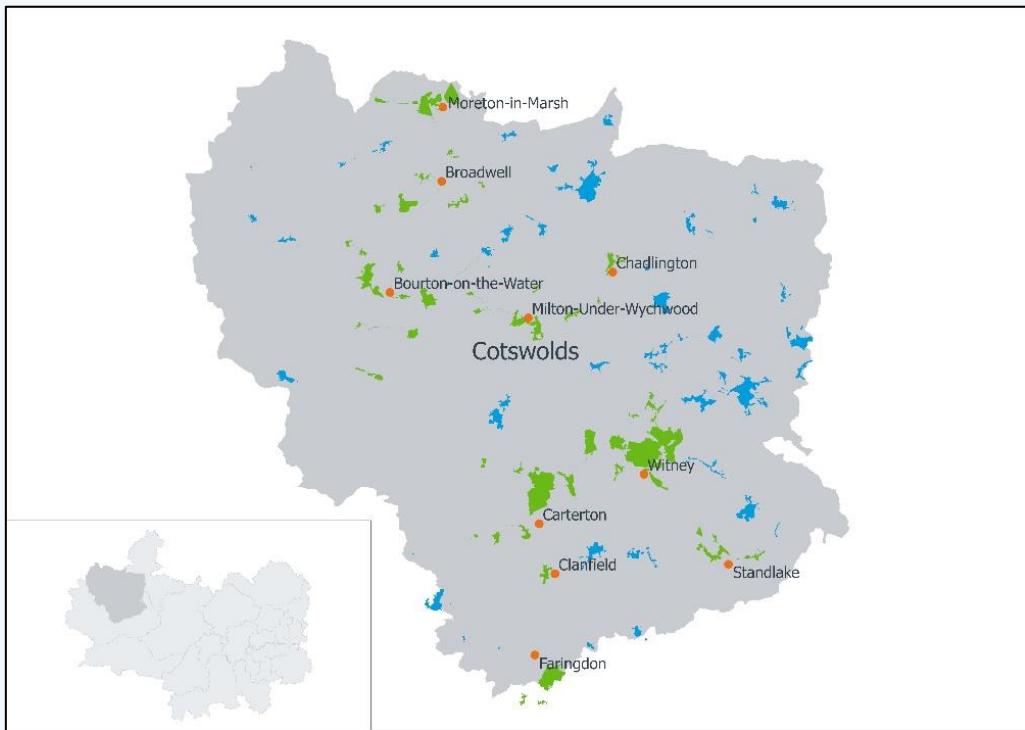
Figure 2: Location of Sewer Systems Within the Cotswold River Basin

Sewer System	Associated River / Stream	Relationship to the River Thames
Bourton-on-the-Water STW	River Windrush	Direct tributaries of the River Thames
Broadwell STW	Broadwell Brook	Indirect tributary of the River Thames via Great Brook
Carterton STW	Shill Brook, River Windrush	Shill Brook indirect tributary of the River Thames via Great Brook. River Evenlode direct tributary of the River Thames.
Chadlington STW	River Evenlode	Direct tributary of the River Thames
Clanfield STW	Clanfield Brook	Indirect tributary of the River Thames via Broadwell Brook then Great Brook.
Faringdon STW	Faringdon Brook	Indirect tributary of the River Thames via the River Ock
Milton-Under-Wychwood STW	River Evenlode	Direct tributary of the River Thames
Moreton-in-Marsh STW	River Evenlode	Direct tributary of the River Thames
Standlake STW	River Windrush	Direct tributary of the River Thames
Witney STW	River Windrush	Direct tributary of the River Thames

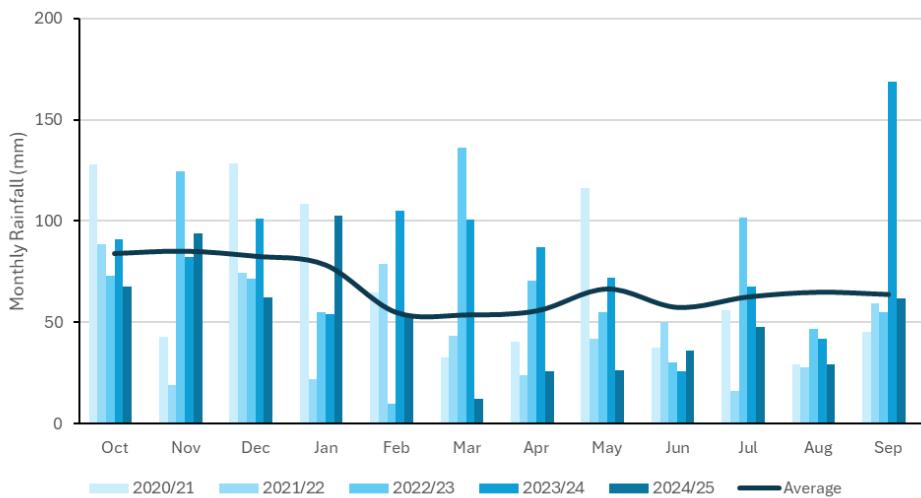
Figure 1: Monthly rainfall data 2020/21 to 2024/25

Figures 1 to 5 illustrate the relationship between rainfall and CSO spills. As shown in Figure 1, the decrease in rainfall from 2023/24 to 2024/25 correlates with reduced river levels (Figures 2 and 3), as well as a decline in the number and duration of CSO spills shown in Figure 5.

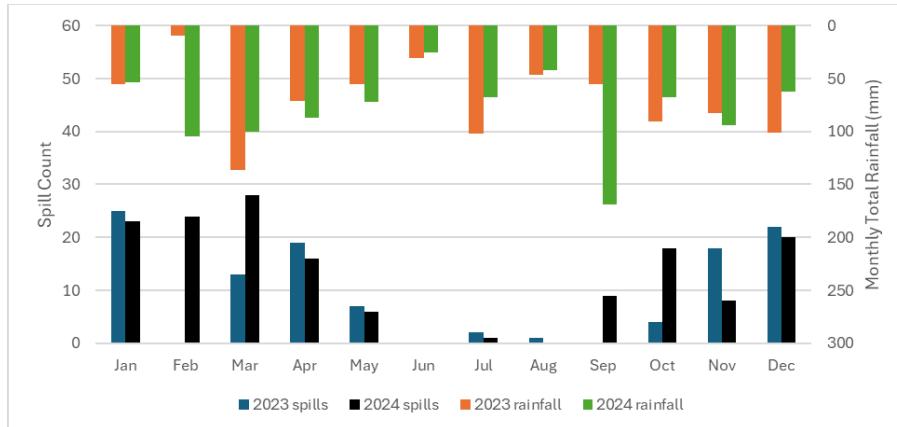
Figure 5: Monthly rainfall data versus monthly spill count for 2023 and 2024 – Bourton-on-the-Water STW

Table 1 below details the last 2 years performance of overflows in the catchment. To assess EDM performance and its relation to groundwater infiltration, a review of the month-on-month spill performance in 2023 and 2024 against the monthly total rainfall values has been undertaken, as observed in Figure 5.

Event Duration Monitoring	2023		2024		
	Overflow	Annual Spills	Duration (hours)	Annual Spills	Duration (hours)
Bourton-on-the-Water STW		110	1565.25	153	2583.15

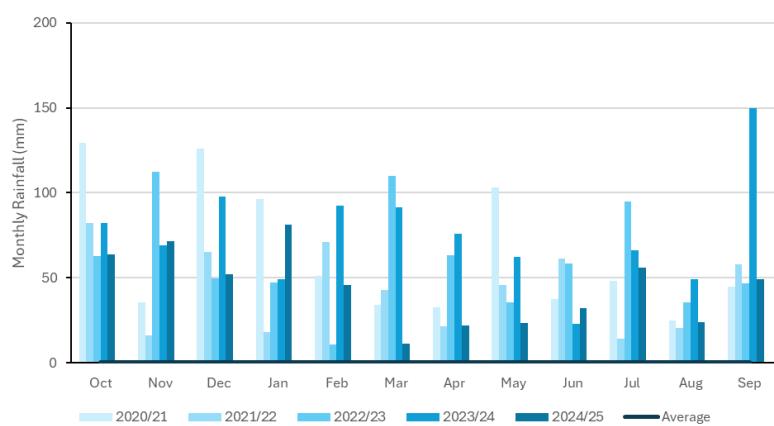
Figures 1 and 2 illustrate the relationship between rainfall and spills at CSOs. Figure 1 displays the reduced rainfall recorded in 2024/25 compared to 2023/24. Figure 2 represents a decreased number and duration of CSO spills from 2023/24 to 2024/25

Figure 1: Monthly rainfall data 2020/21 to 2024/25

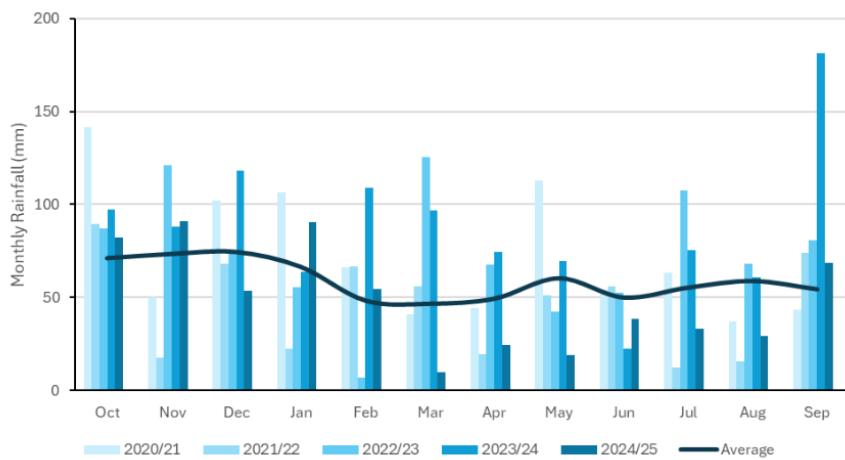
Figures 1 to 5 illustrate the relationship between rainfall and CSO spills at indicator sites. As shown in Figure 1, the decrease in rainfall from 2023/24 to 2024/25 correlates with the decline in the number and duration of CSO spills shown in Figure 5. However, river and groundwater levels (Figures 2 and 3) have remained consistent with previous years.

Figure 1: Monthly rainfall data 2020/21 to 2024/25

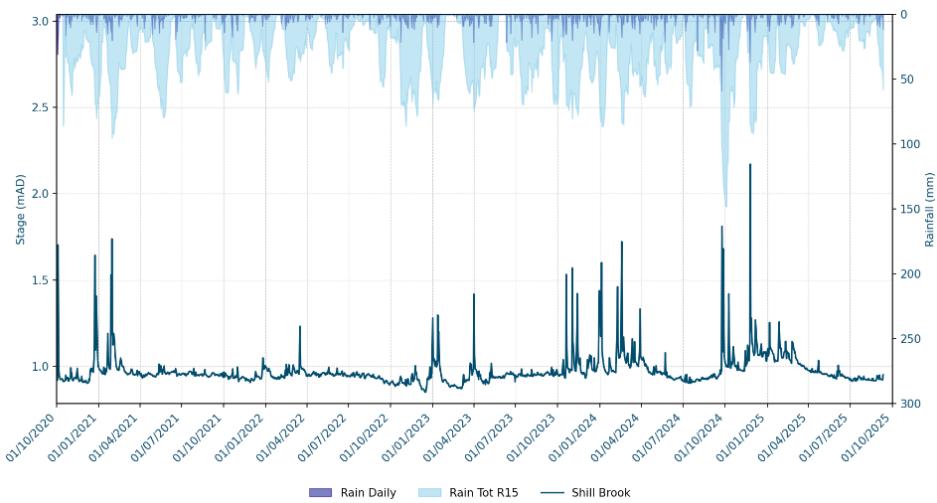
Figure 2: River Level data for Shill Brook, Bampton

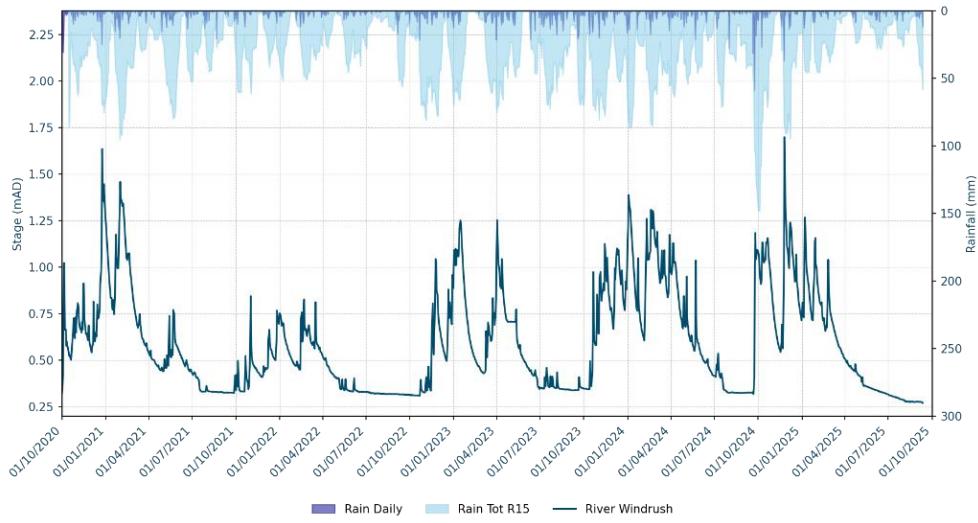
Figure 3: River Level data for River Windrush, Worsham

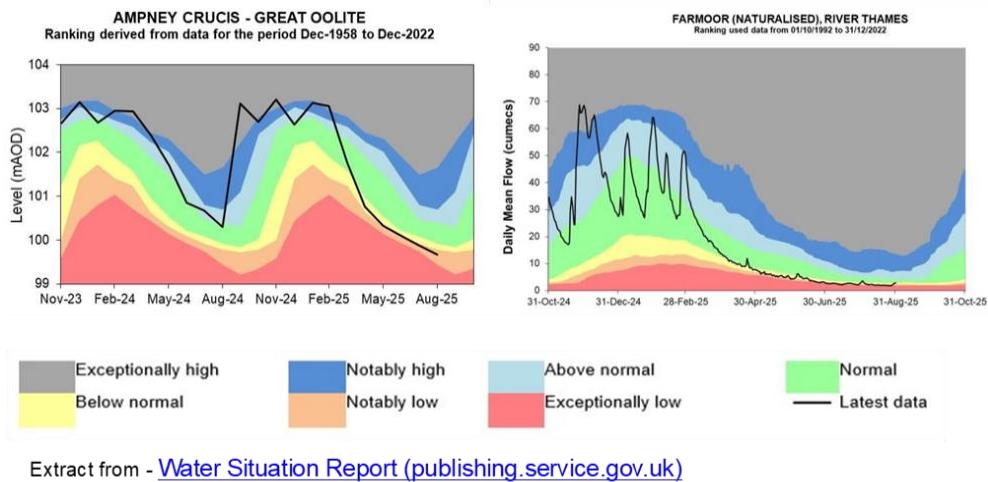
Figure 4: Ground Water situation Report

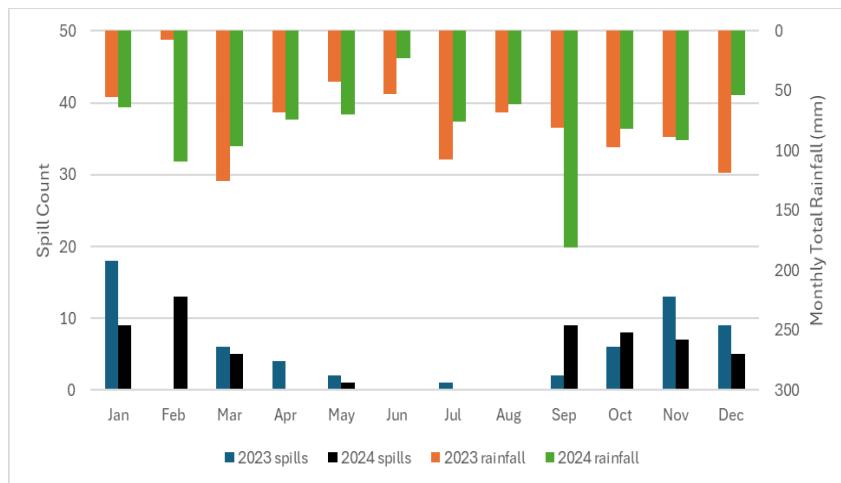
Table 1 below details the last 2 years performance of overflows in the catchment. To assess EDM performance and its relation to groundwater infiltration, a review of the month-on-month spill performance in 2023 and 2024 against the monthly total rainfall values has been undertaken, as observed in Figure 5.

Figure 5: Monthly rainfall data versus monthly spill count for 2023 and 2024 – Carterton STW

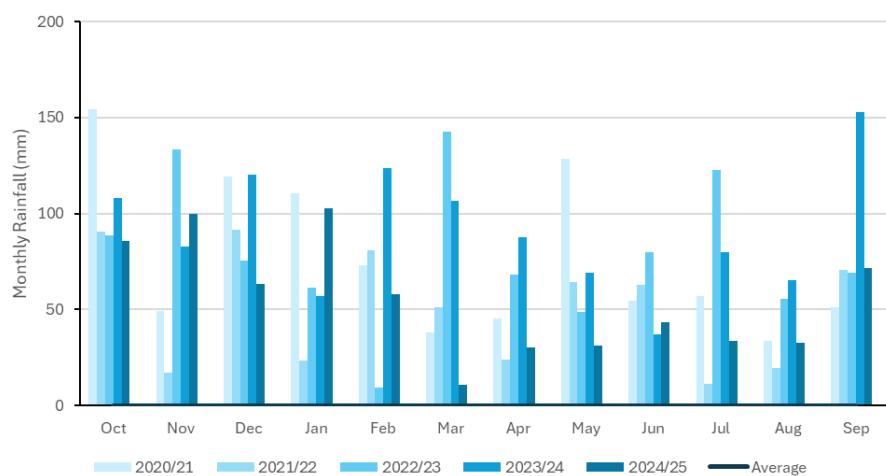
Figures 1 and 2 illustrate the relationship between rainfall and spills at CSOs. There is a decrease in rainfall from 2023/24 to 2024/25 shown in Figure 1; this broadly correlates to fewer and shorter spills at the CSOs, shown in Figure 2.

Figure 1: Monthly rainfall data 2020/20 to 2024/25

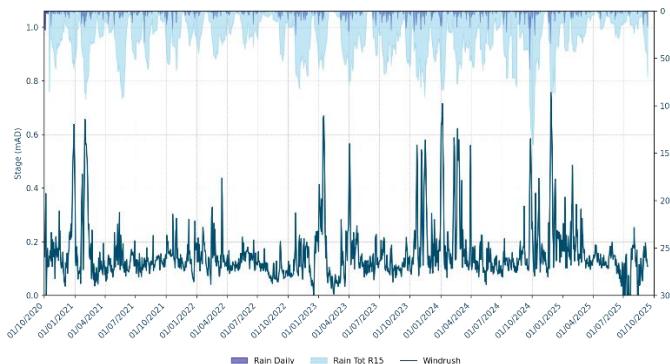
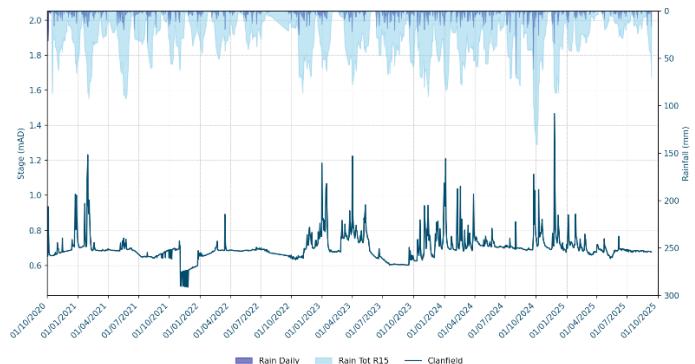
Figures 1 to 6 illustrate the relationship between rainfall and CSO spills at indicator sites. As shown in Figure 1, rainfall decreases from 2023/24 to 2024/25, however river levels remain fairly consistent (Figures 2 to 4). There is a reduction in both the frequency and duration of CSO spills shown in Figure 6.

Figure 2: River Level data for Windrush at Worsham / Figure 3: River Level data for Clanfield Brook at Clanfield

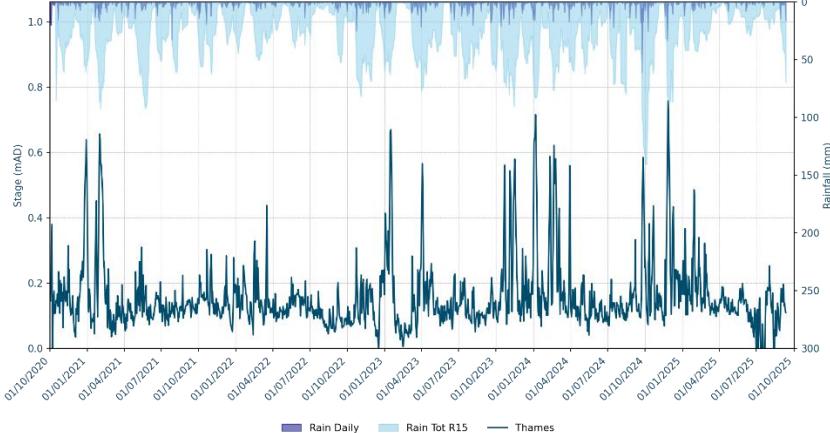
Figure 4: River Level data for River Thames at Radcot Lock

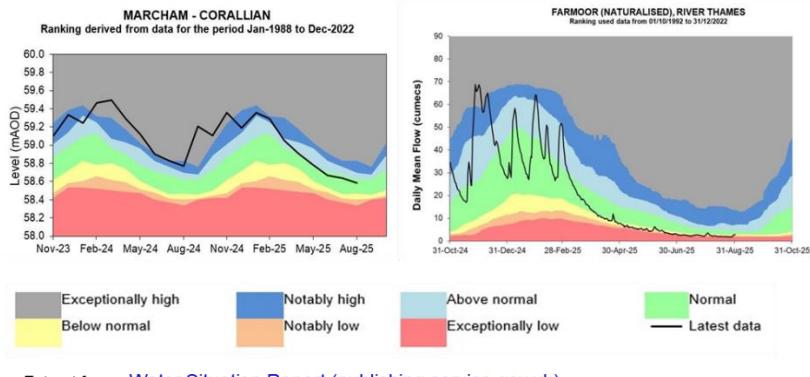
Figure 5: Ground Water situation Report
