# Groundwater Impacted System Management Plan

Milton-under-Wychwood, River Evenlode

April 2021

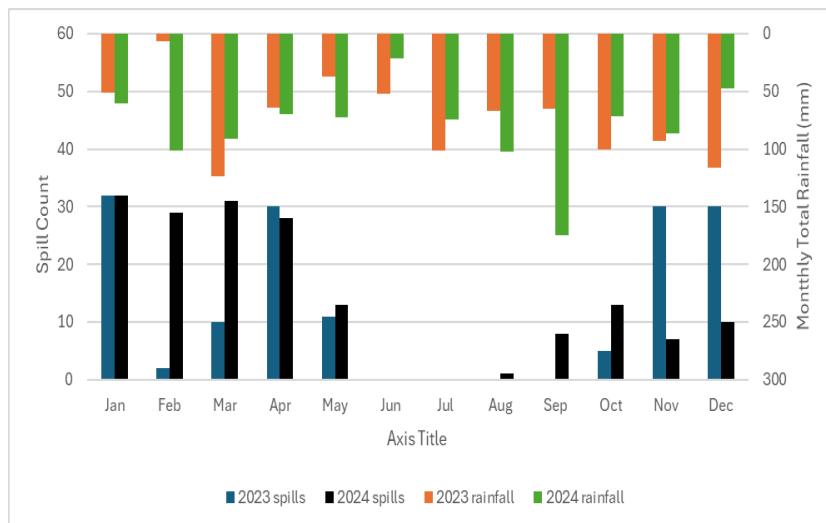
Table 1 below details the last 2 years performance of overflows in the catchment. To assess EDM performance and its relation to groundwater infiltration, a review of the month-on-month spill performance in 2023 and 2024 against the monthly total rainfall values has been undertaken, as observed in Figure 6.

Figure 6: Monthly rainfall data versus monthly spill count for 2023 and 2024 – Clanfield STW

Figures 1 to 6 illustrate the relationship between rainfall and CSO spills at indicator sites. As shown in Figure 1, rainfall decreases from 2023/24 to 2024/25, however river levels remain fairly consistent (Figures 2 to 4). There is a reduction in both the frequency and duration of CSO spills shown in Figure 6.

A review of river level data over 2023/24 has increased compared to previous years. The number and duration of spills have increased in 2024 compared to 2023. The higher number of annual spills and river levels could be a result of the increased rainfall in 2024 (seen in Figure 6). Moreover, there is a slight drop in groundwater levels for 2024/2025 compared to the groundwater levels of the previous year, but the effect of this decrease will be analysed when 2025 spill data is published.

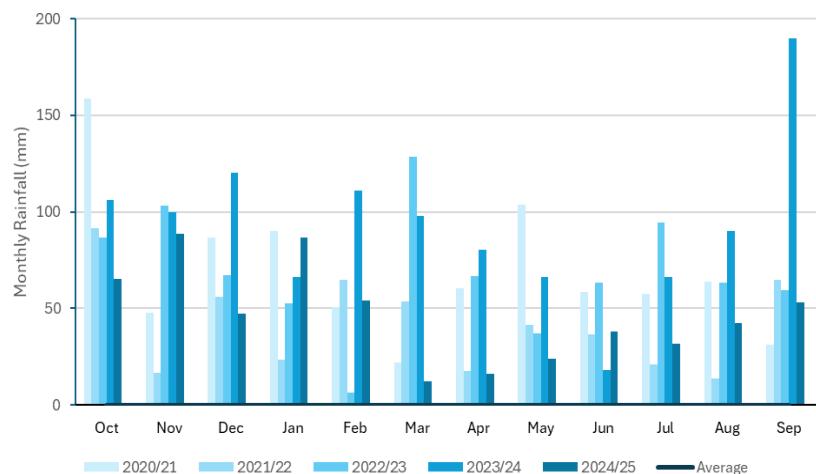
Figures 1 to 2 illustrate the relationship between rainfall and spills at CSOs. Figure 1 shows a decrease in rainfall from 2023/24 into 2024/25, correlating to fewer and shorter spills at the CSOs, shown in Figure 2.

Figure 1: Monthly rainfall data 2020/21 to 2024/25

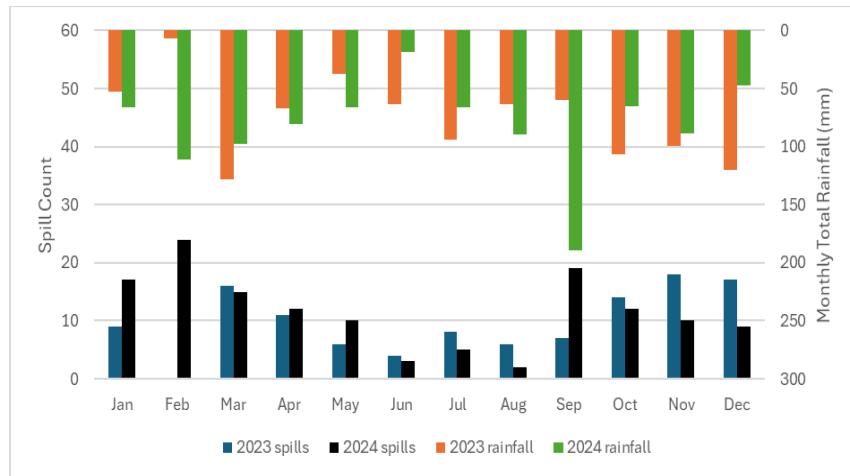
Table 1 below details the last 2 years performance of overflows in the catchment. To assess EDM performance and its relation to groundwater infiltration, a review of the month-on-month spill performance in 2023 and 2024 against the monthly total rainfall values has been undertaken, as observed in Figure 2.

Figure 2: Monthly rainfall data versus monthly spill count for 2023 and 2024 – Faringdon STW

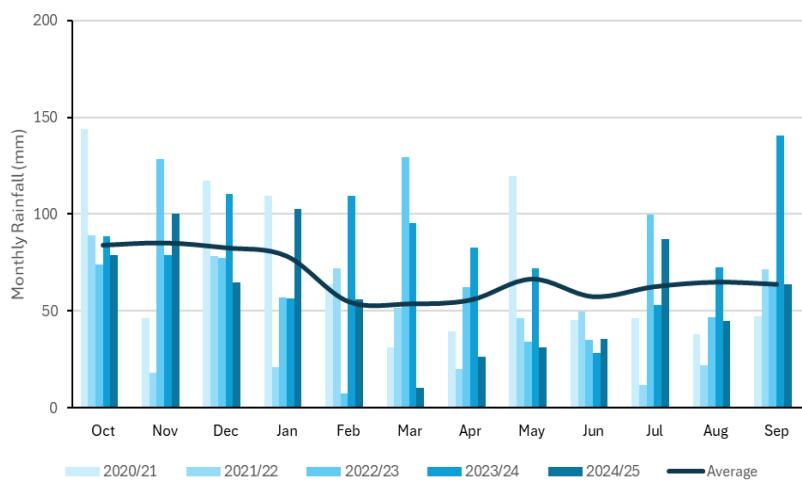
Figures 1 and 4 illustrate the relationship between rainfall and CSO spills at indicator sites. As shown in Figure 1, the decrease in rainfall from 2023/24 to 2024/25 correlates with decrease in the number and duration of CSO spill events shown in Figure 4. River levels remain consistent between 2023/24 and 2024/25 observing Figure 2.

Figure 1: Monthly rainfall data 2020/21 to 2024/25

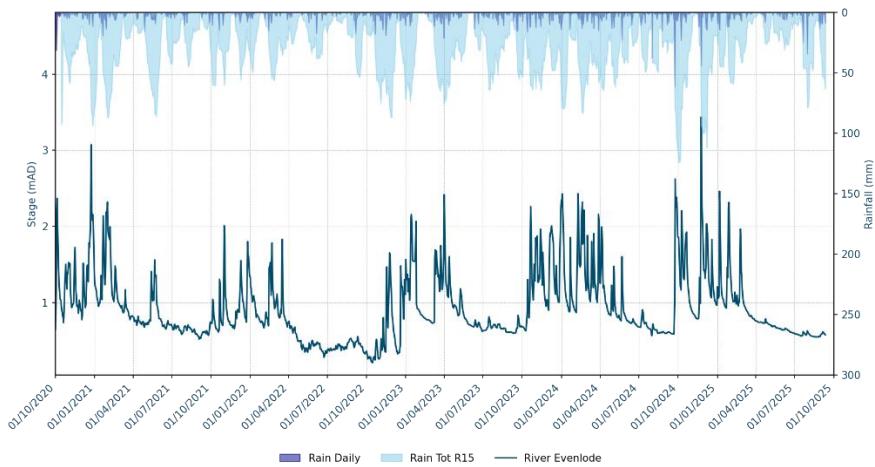
Figure 2: River Level data for River Evenlode, Shipton

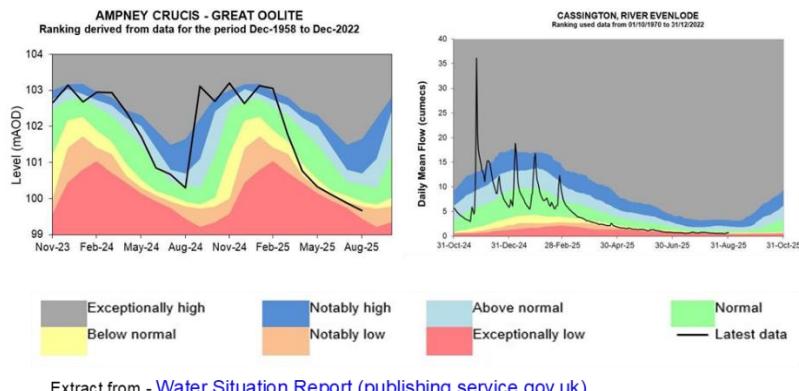
Figure 3: Ground Water situation Report

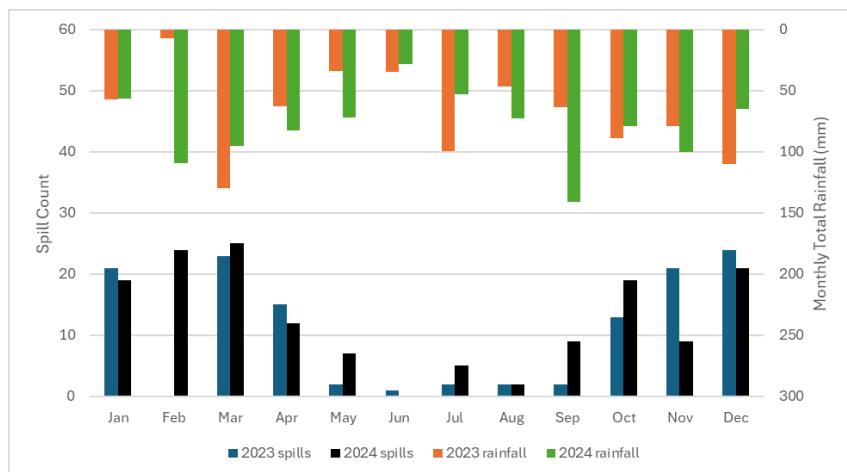
Table 1 below details the last 2 years performance of overflows in the catchment. To assess EDM performance and its relation to groundwater infiltration, a review of the month-on-month spill performance in 2023 and 2024 against the monthly total rainfall values has been undertaken, as observed in Figure 4.

Figure 4: Monthly rainfall data versus monthly spill count for 2023 and 2024 – Milton-under-Wychwood STW

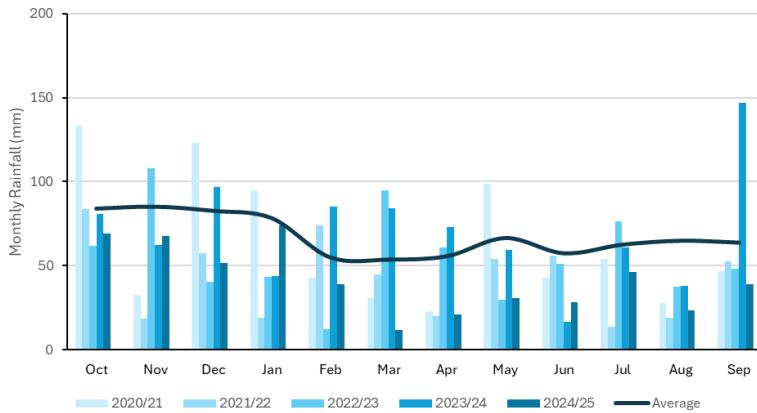
Figures 1 to 6 illustrate the relationship between rainfall and CSO spills at indicator sites. As observed in Figure 1, there is a decrease in rainfall from 2023/24 to 2024/25. However, recorded river level data follows a similar profile between 2023/24 and 2024/25 observing Figures 2 and 3. Additionally, there is no spills data for 2025.

Figure 1: Monthly rainfall data 2020/21 to 2024/25

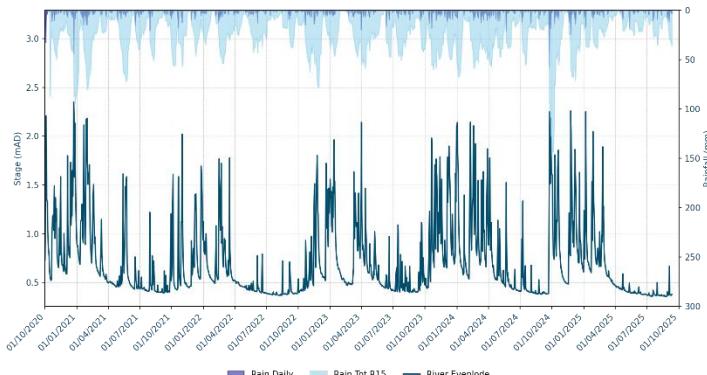
Figure 2: River Level data for River Evenlode, Evenlode Bridge

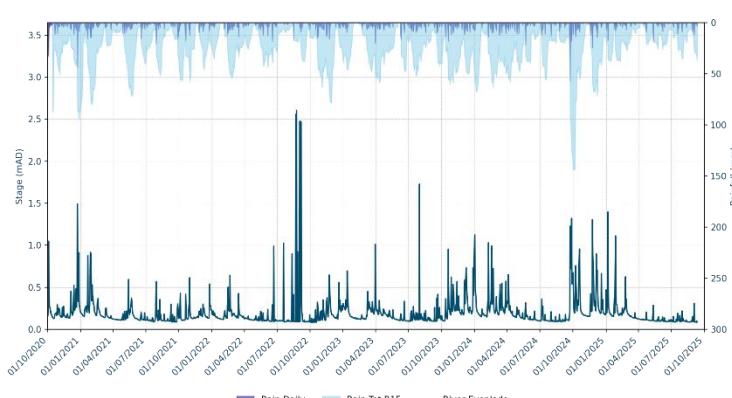
Figure 3: River Level data for River Evenlode, Moreton-in-Marsh

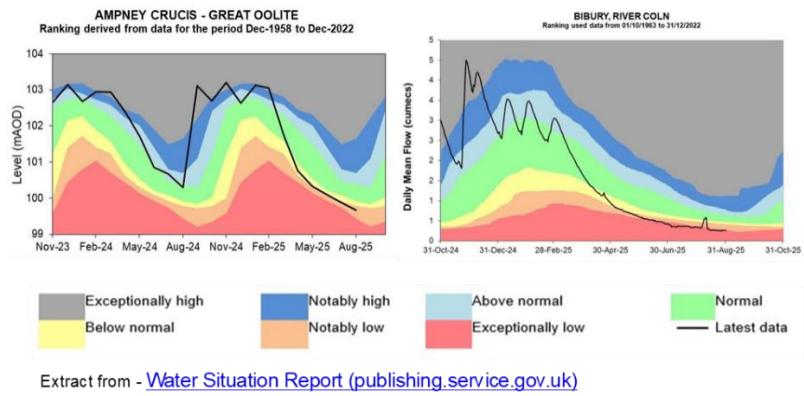
Figure 4: Ground Water situation Report

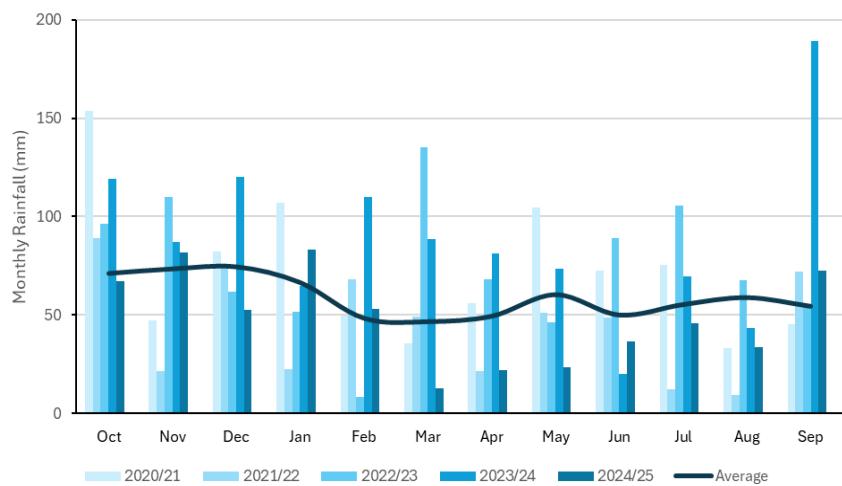
Figures 1 to 4 illustrate the relationship between rainfall and CSO spills at indicator sites. As shown in Figure 1, the decrease in rainfall from 2023/24 to 2024/25 correlates with fewer CSO spills, as shown in Figure 4. Observing the river levels in Figure 2, there is a slight decrease in 2024/25 from 2023/24.

Figure 1: Monthly rainfall data 2020/21 to 2024/25

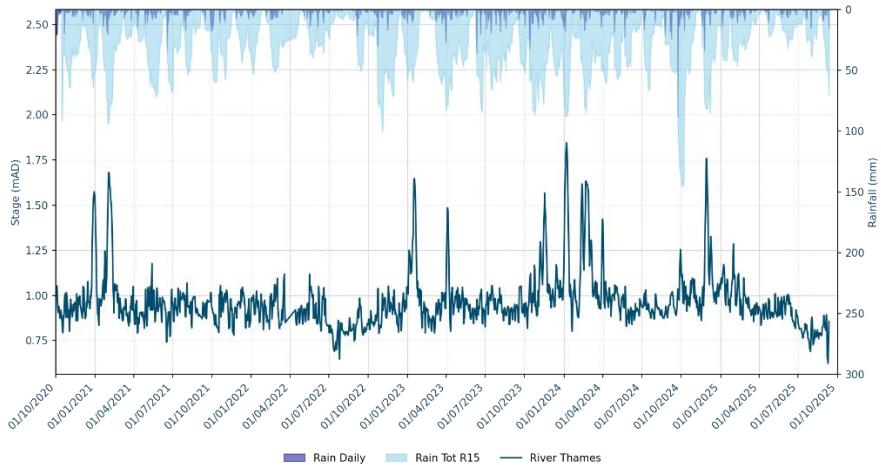
Figure 2: River Level data for River Thames, Farmoor

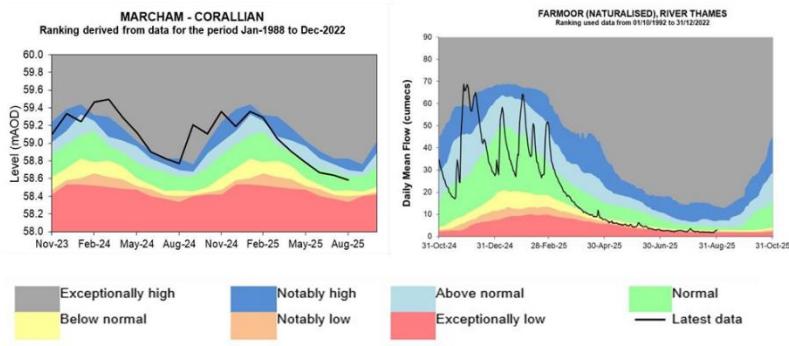
Extract from - [Water Situation Report \(publishing.service.gov.uk\)](https://www.publishing.service.gov.uk)

Figure 3: Ground Water situation Report

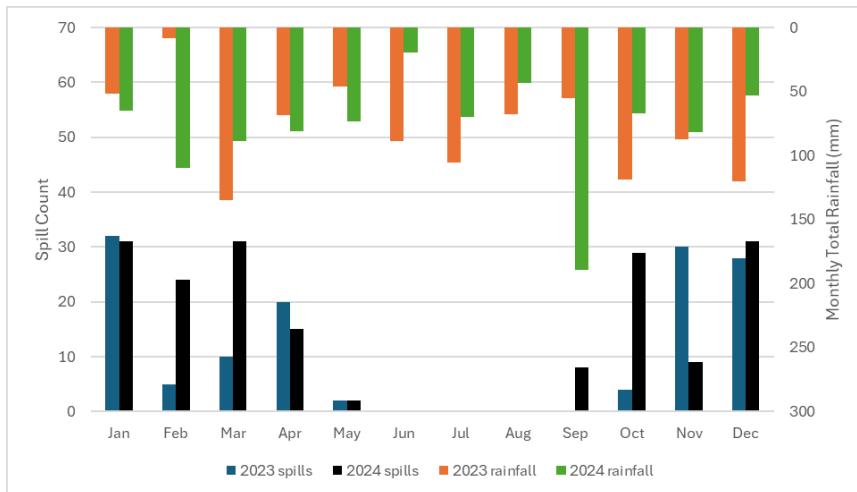
Table 1 below details the last 2 years performance of overflows in the catchment. To assess EDM performance and its relation to groundwater infiltration, a review of the month-on-month spill performance in 2023 and 2024 against the monthly total rainfall values has been undertaken, as observed in Figure 4.

Figure 4: Monthly rainfall data versus monthly spill count for 2023 and 2024 – Standlake STW

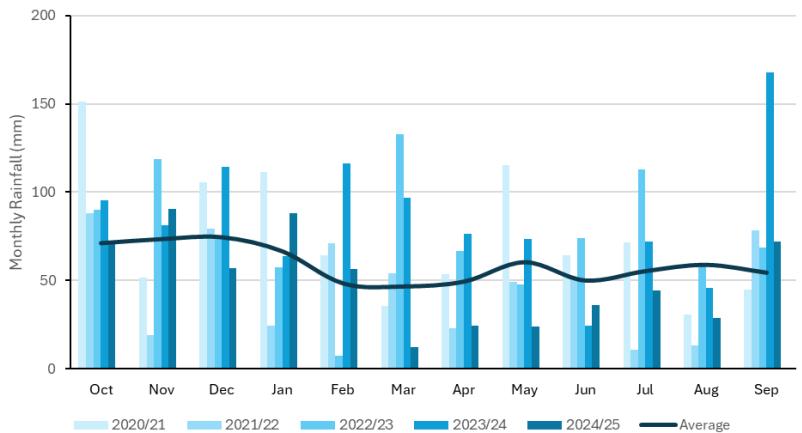
Figures 1 to 5 illustrate the relationship between rainfall and CSO spills at indicator sites. As shown in Figure 1, the decrease in rainfall from 2023/24 to 2024/25 correlates with fewer CSO spills, as presented in Figure 5. River levels (Figures 2 and 3) remained consistent.

Figure 1: Monthly rainfall data 2020/21 to 2024/25

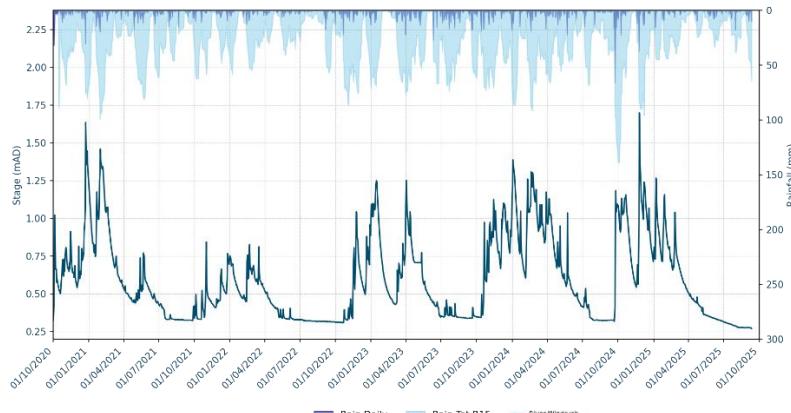
Figure 2: River Level data for River Windrush, Worsham

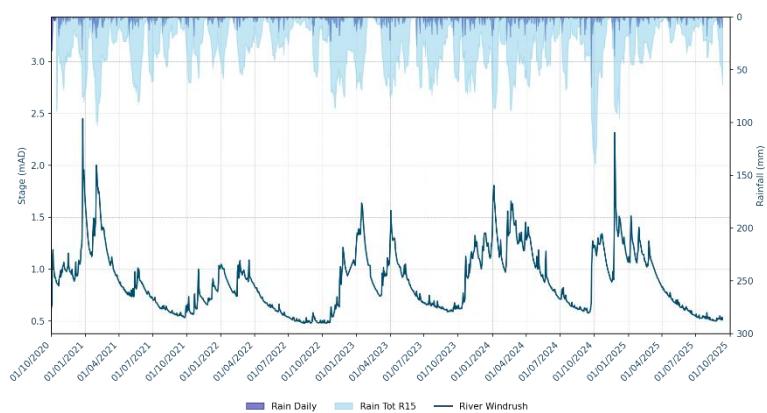
Figure 3: River Level data for River Windrush, Witney

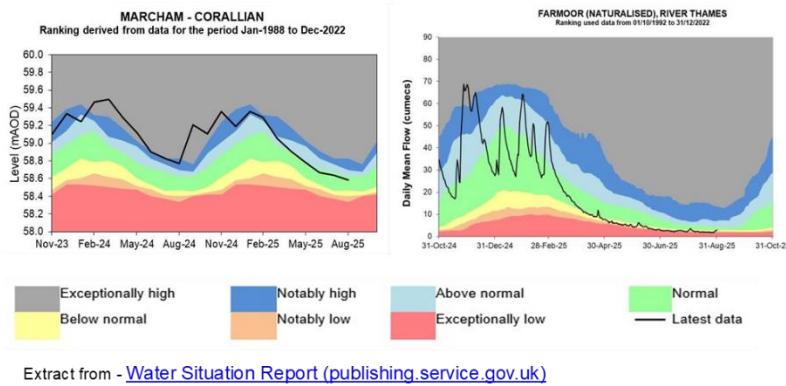
Figure 4: Ground Water situation Report

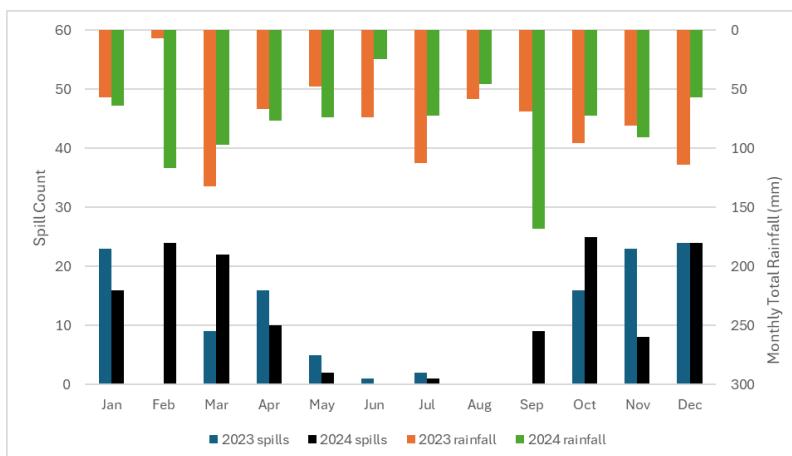
Table 1 below details the last 2 years performance of overflows in the catchment. To assess EDM performance and its relation to groundwater infiltration, a review of the month-on-month spill performance in 2023 and 2024 against the monthly total rainfall values has been undertaken, as observed in Figure 5.

Figure 5: Monthly rainfall data versus monthly spill count for 2023 and 2024 – Witney STW
