Groundwater Impacted System Management Plan

Milton-under-Wychwood, River Evenlode

April 2021

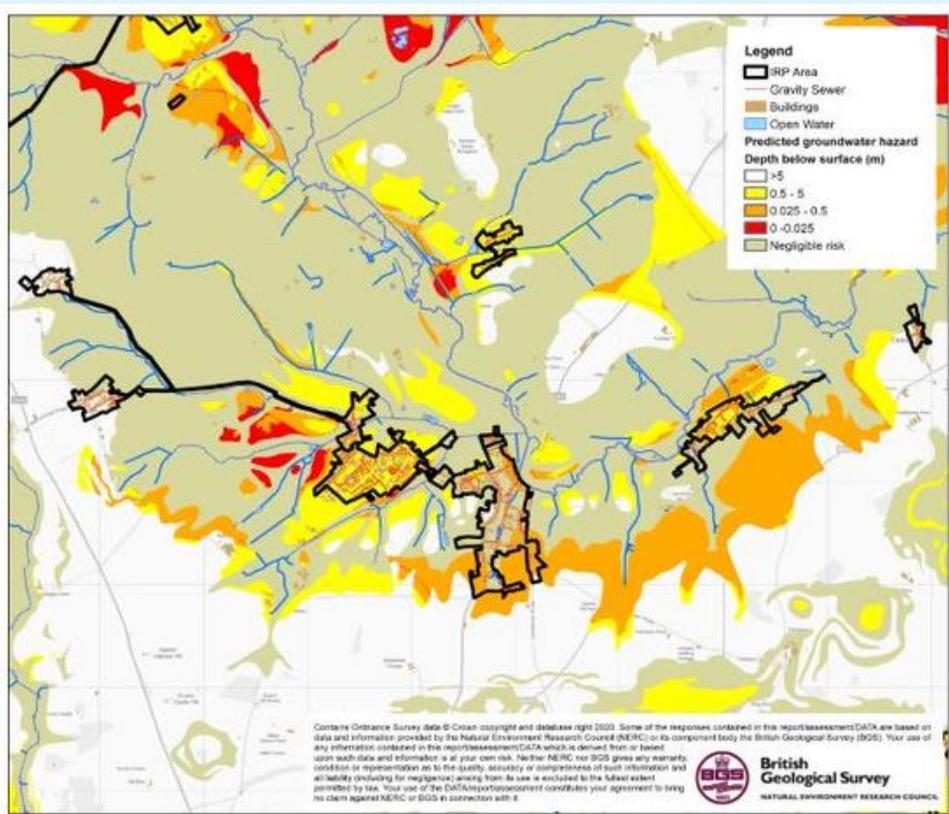
Figure 1.0 – Milton-under-Wychwood catchment

The Milton-under-Wychwood system lies on the River Evenlode, in Oxfordshire, England, approximately 11km north west of Witney. The Milton-under-Wychwood system serves a population equivalent³ of 4,183 with a predominantly separate sewerage network totaling some 42km in length excluding private drains and sewers. The extent of the catchment is shown in Figure 1.0 above and includes the villages of Idbury, Fifield, Milton-under-Wychwood, Shipton-under-Wychwood, Lyneham, Ascott-under-Wychwood and Chilson.

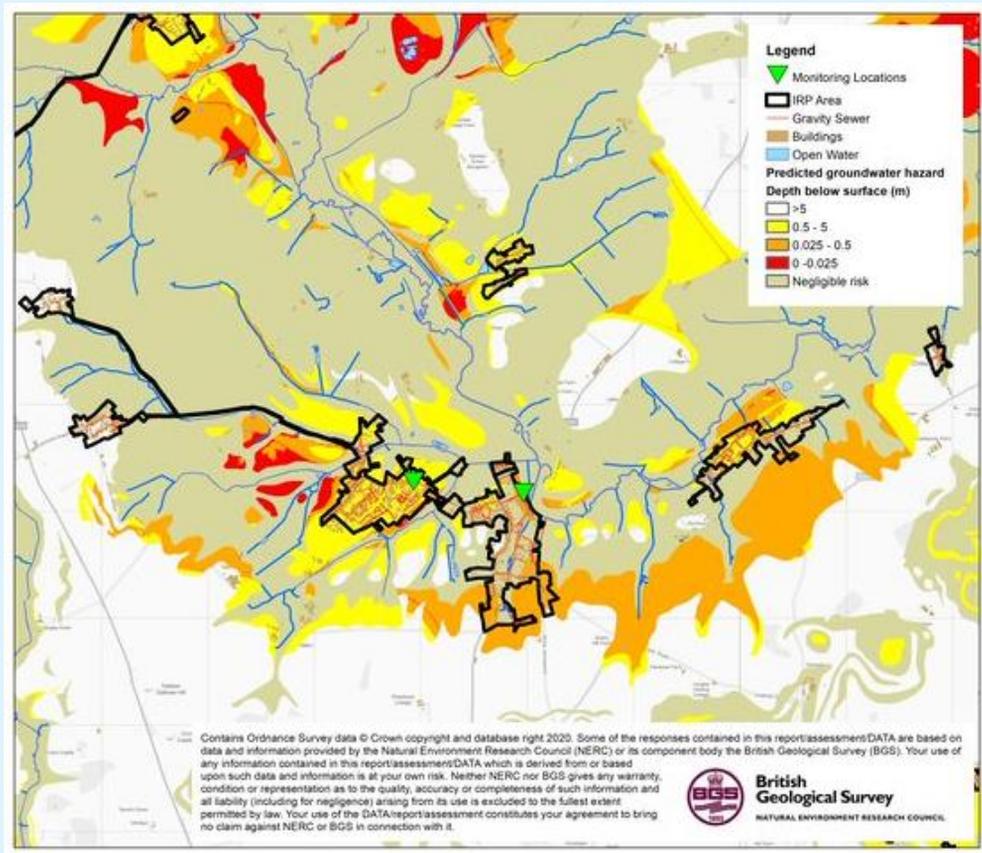
Figure 2.0 – Milton-under-Wychwood monitoring and infiltration zones

Key to bringing the impact of groundwater infiltration under control is an enhanced monitoring regime. We have identified and have installed several telemetered depth monitor locations around the Milton-under-Wychwood system – see Figure 2.0.

We engaged with JBA Consulting to develop plans for Milton-under-Wychwood that identify zones of groundwater risk, see Figure 2.0. These zones are modelled areas where the groundwater has been determined to be above the sewer and hence pose a potential risk for groundwater ingress.

Sewer Depth Monitors were installed in the catchment in 2020 (see Figure 2.0). These devices are telemetered and provide real time data on the level of flow in the sewer.

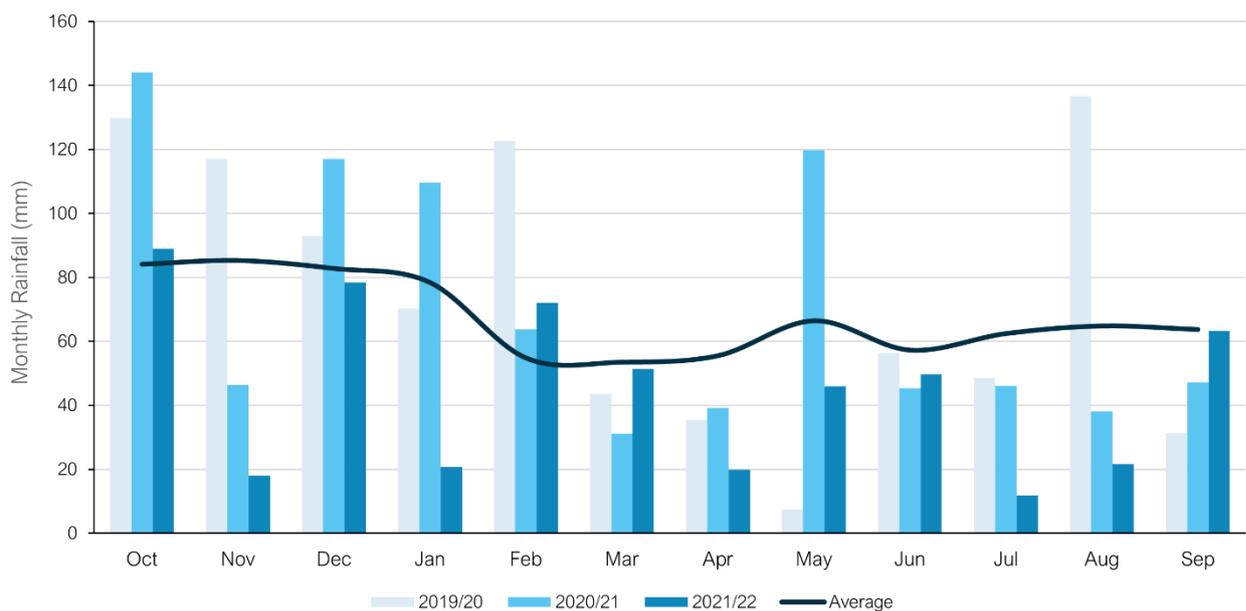
Figure 2 – Monthly Rainfall Performance

Representative Radar rainfall has been used to generate monthly data at catchment level for comparison with average data generated by local Met Office Weather Station Records. Figure 2 presents the comparison of this data for the last three hydrological years to support longer term trends within the local system.

Average Values taken from Met Office Weather Station at Little Rissington based on the period 1991-2020

The total rainfall for the 2021/22 hydrological year is 32% below the annual average total. Total rainfall values are presented in Table 3 below.

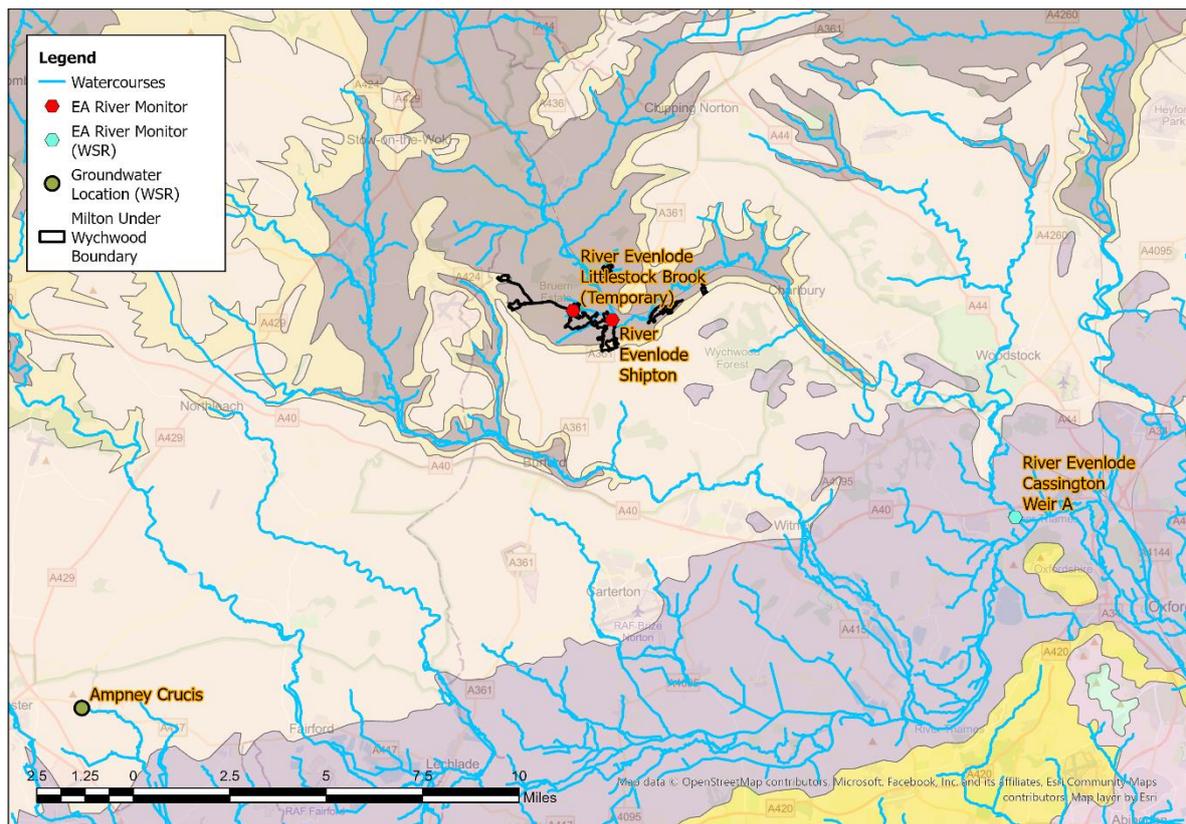
Figure 4 – Local Monitoring Stations

These sites are illustrated in the figure below, alongside the closest groundwater reference station and closest gauging station from the Water Situation Report.

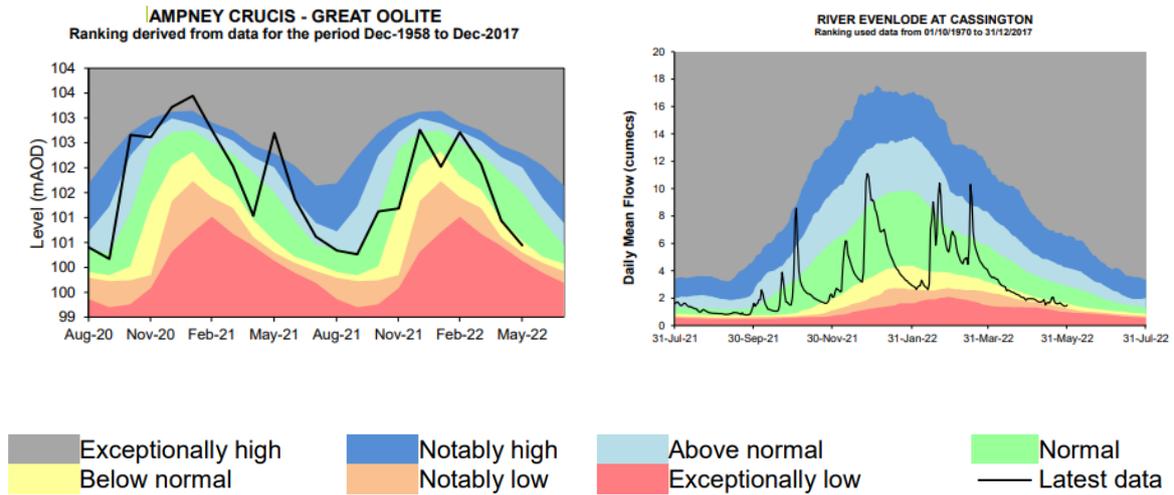
Figure 6 – Water Situation Report

In addition to these specific stations, the wider groundwater context is illustrated in the Water Situation Report for Cotswold East. The nearest groundwater reference station is Ampney Crucis. This site shows generally lower overall groundwater than the previous year, particularly evident during the winter months. This can be seen in the figure below alongside the river indicator location at Cassington on the River Evenlode.

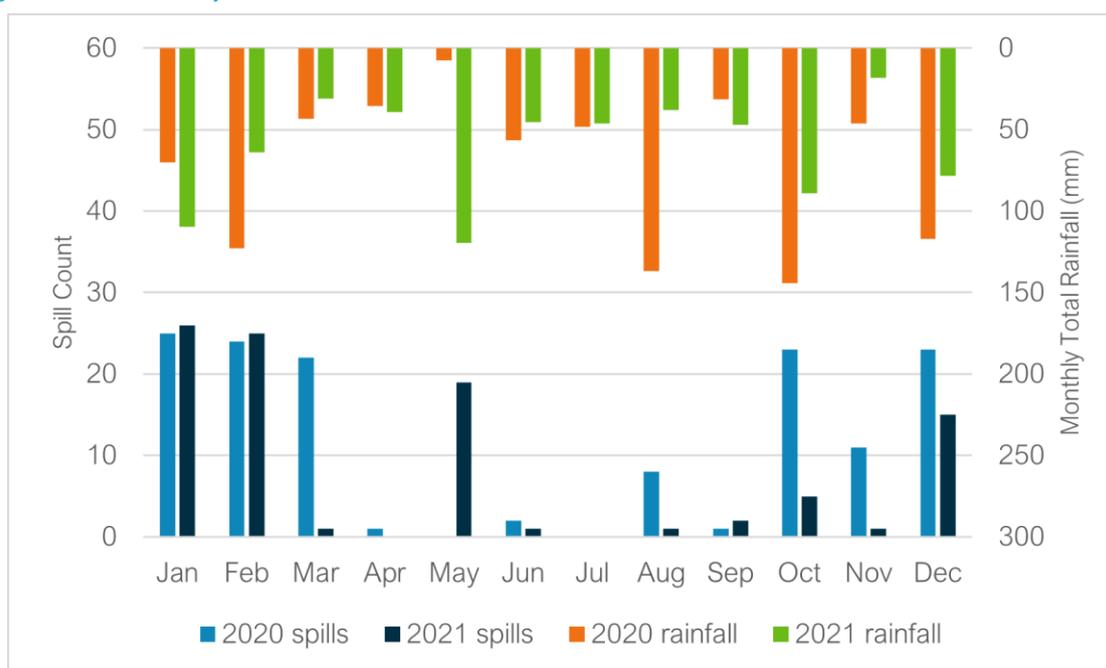
Figure 8 – EDM Monthly Performance

A critical part of the assessment of EDM performance and its relation to groundwater inundation is to review the month-on-month spill performance, against previous years and the monthly total rainfall values to give context to the performance. Figure 8 below presents the EDM performance trend and rainfall for recent years.

The trend in spill performance across the two recorded years does show variation in spills, with a focus on spills during the autumn and winter months. The data suggests a wider relationship between rainfall, elevated groundwater levels and spill frequency. A slower tail off in spills is evident within the first half of 2020, when the indicator sites suggest groundwater levels in the catchment were higher than within the first half of 2021.

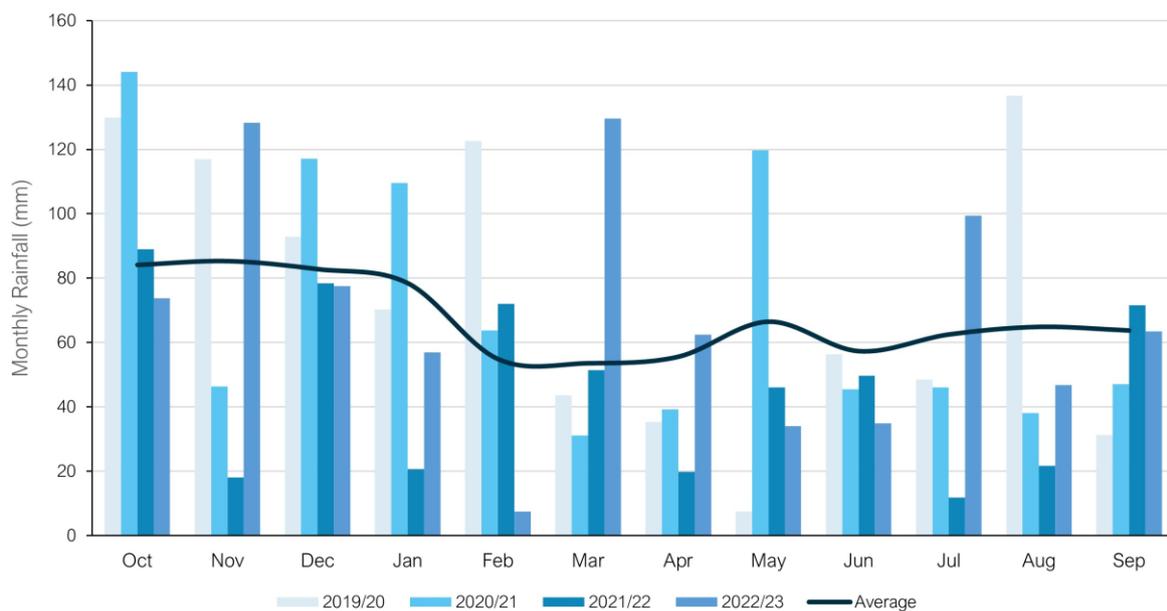
Figure 2 – Monthly Rainfall Performance

Representative Radar rainfall has been used to generate monthly data at catchment level for comparison with average data generated by local Met Office Weather Station Records. Figure 2 presents the comparison of this data for the last four hydrological years to support longer term trends within the local system.

Average Values taken from Met Office Weather Station at Little Rissington based on the period 1991-2020

The total rainfall for the 2022/23 hydrological year is 1% above the annual average total. Total rainfall values are presented in Table 3 below.

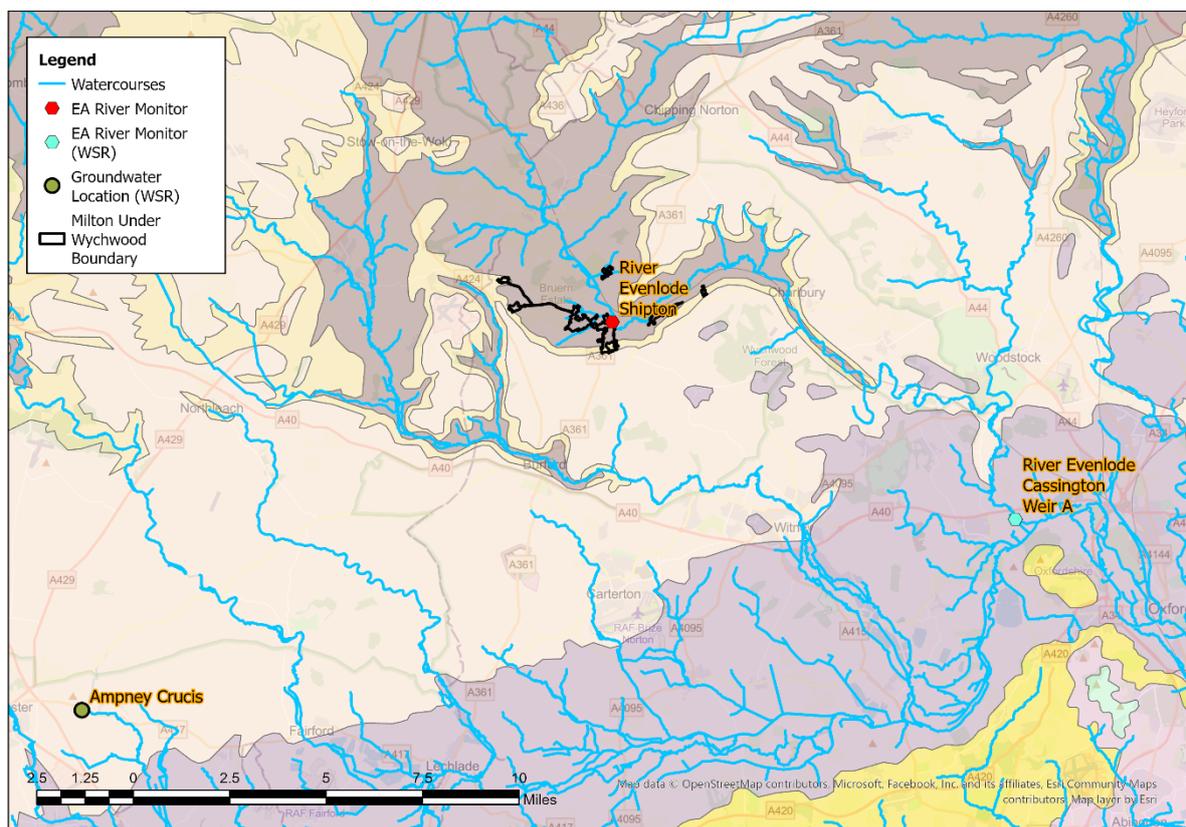
Figure 4 – Local Monitoring Stations

This site is illustrated in the figure below, alongside the closest groundwater reference station and closest gauging station from the Water Situation Report.

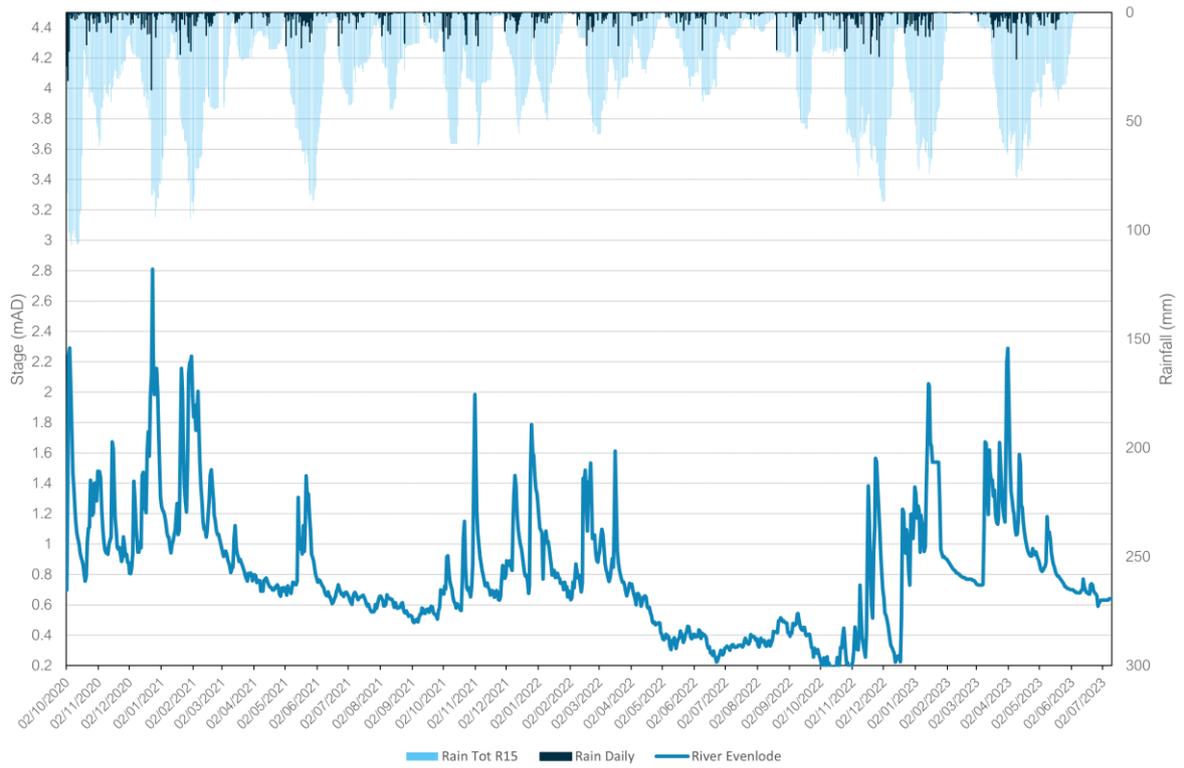
Figure 5A – River Evenlode, Shipton

The following figures represent the last three hydrological years of level information at the indicator sites to build a picture of the relative conditions prevalent in the current year. It is presented against both the daily total rainfall values for the catchment and a rolling 15 day total rainfall.

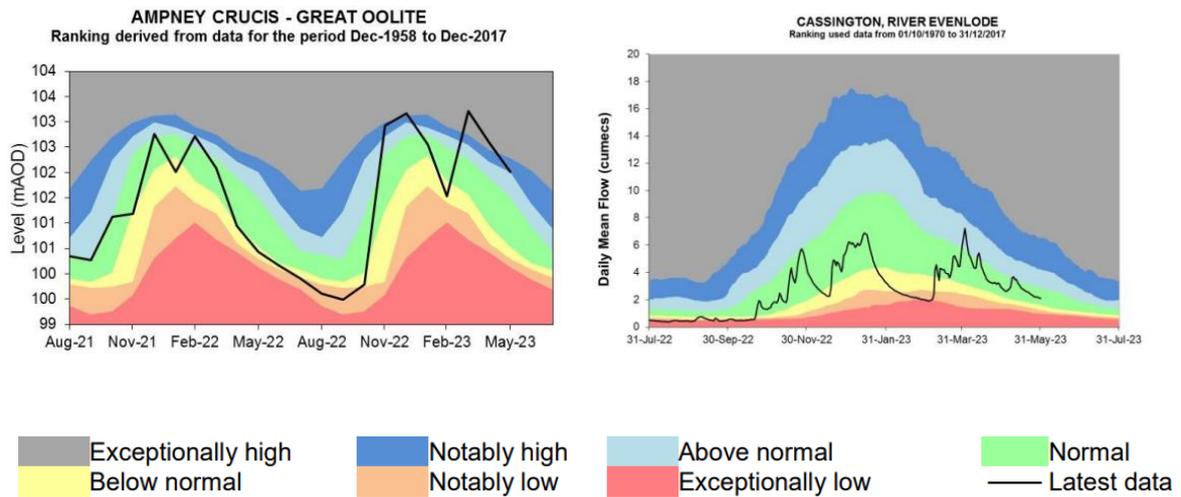
Figure 6 – Water Situation Report

In addition to this specific station, the wider groundwater context is illustrated in the Water Situation Report for Cotswold East. The nearest groundwater reference station is Ampney Crucis. This site shows groundwater levels were generally at normal, below normal, or notably low levels in 2022. Groundwater levels have generally been higher in 2023, reaching above normal, notably high, and exceptionally high levels. This can be seen in the figure below alongside the river indicator location at Cassington on the River Evenlode.

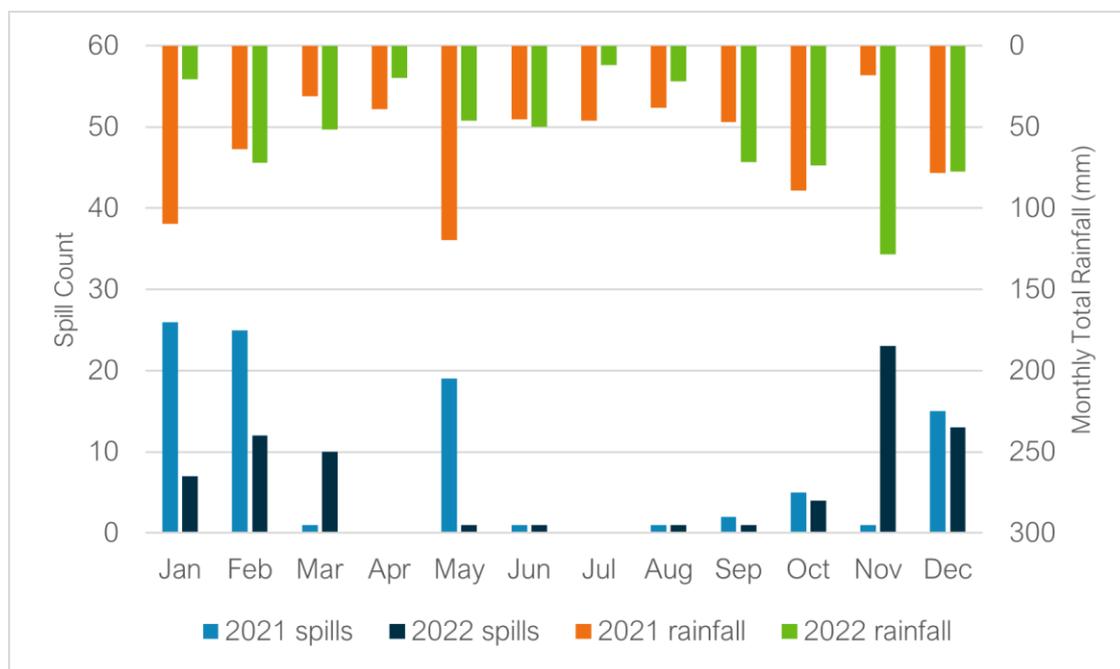
Figure 8 – EDM Monthly Performance

A critical part of the assessment of EDM performance and its relation to groundwater infiltration is to review the month-on-month spill performance, against previous years and the monthly total rainfall values to give context to the performance. Figure 8 below presents the EDM performance trend and rainfall for recent years.

The trend in spill performance across the two recorded years does show variation in spills, with a focus on spills during the autumn and winter months. The data suggests a wider relationship between rainfall, elevated groundwater levels and spill frequency. Despite broadly similar rainfall totals, significantly more spills were recorded at Milton-under-Wychwood STW in February 2021 compared to February 2022. The indicator site data shown in Figure 5, suggests groundwater levels in the catchment were higher in February 2021. In November 2022, a significantly higher number of spills were recorded in comparison to November 2021, with Figure 6 suggesting groundwater levels in the catchment reached notably high levels during the period.

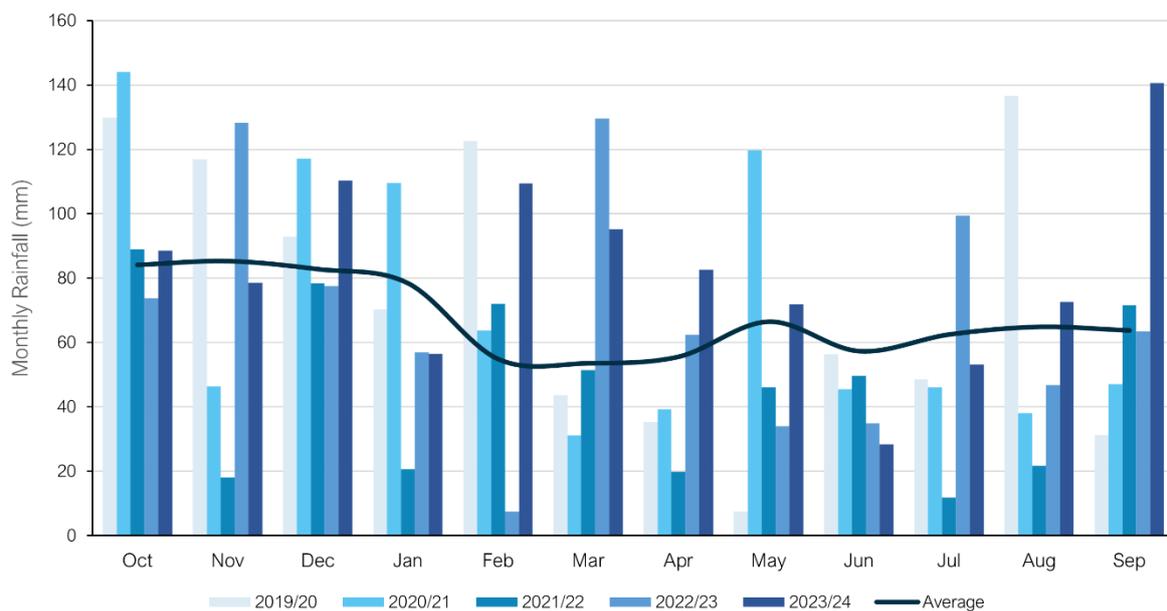
Figure 2 – Monthly Rainfall Data

Representative Radar rainfall has been used to generate monthly data at catchment level for comparison with average data generated by local Met Office Weather Station Records. Figure 2 presents the comparison of this data for the last five hydrological years to support longer term trends within the local system.

Average Values taken from Met Office Weather Station at Little Rissington based on the period 1991-2020

The total rainfall for the 2023/24 hydrological year is 22% above the annual average total. Total rainfall values are presented in Table 3 below.

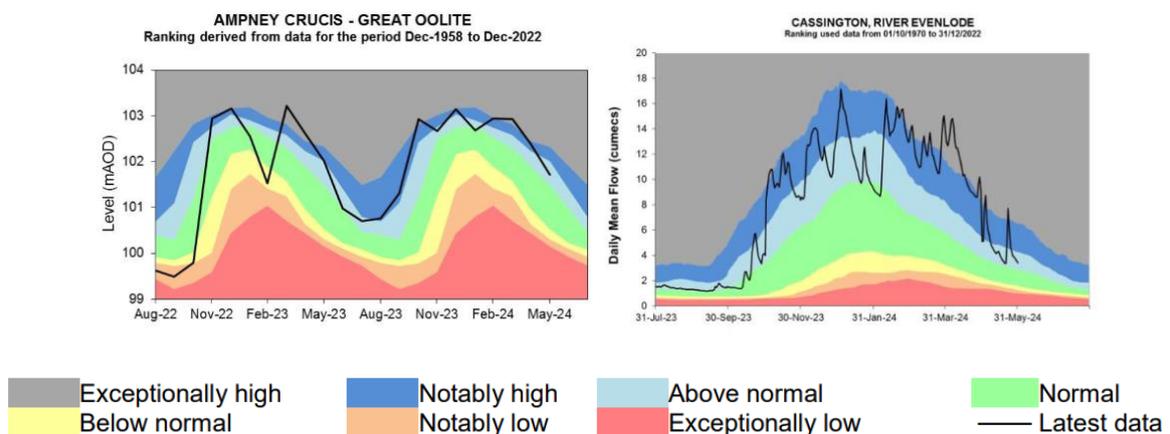
Figure 6 – Water Situation Report

In addition to this specific station, the wider groundwater context is illustrated in the Water Situation Report for Cotswolds East. The nearest groundwater reference station is Ampney Crucis. This site shows groundwater levels to vary throughout 2023, being observed at below normal, normal and above normal levels, peaking at exceptionally high levels around April 2023. Groundwater levels in 2024 have consistently been observed at above normal, notably high and exceptionally high levels. This can be seen in Figure 6 alongside the river indicator location at Cassington on the River Evenlode.

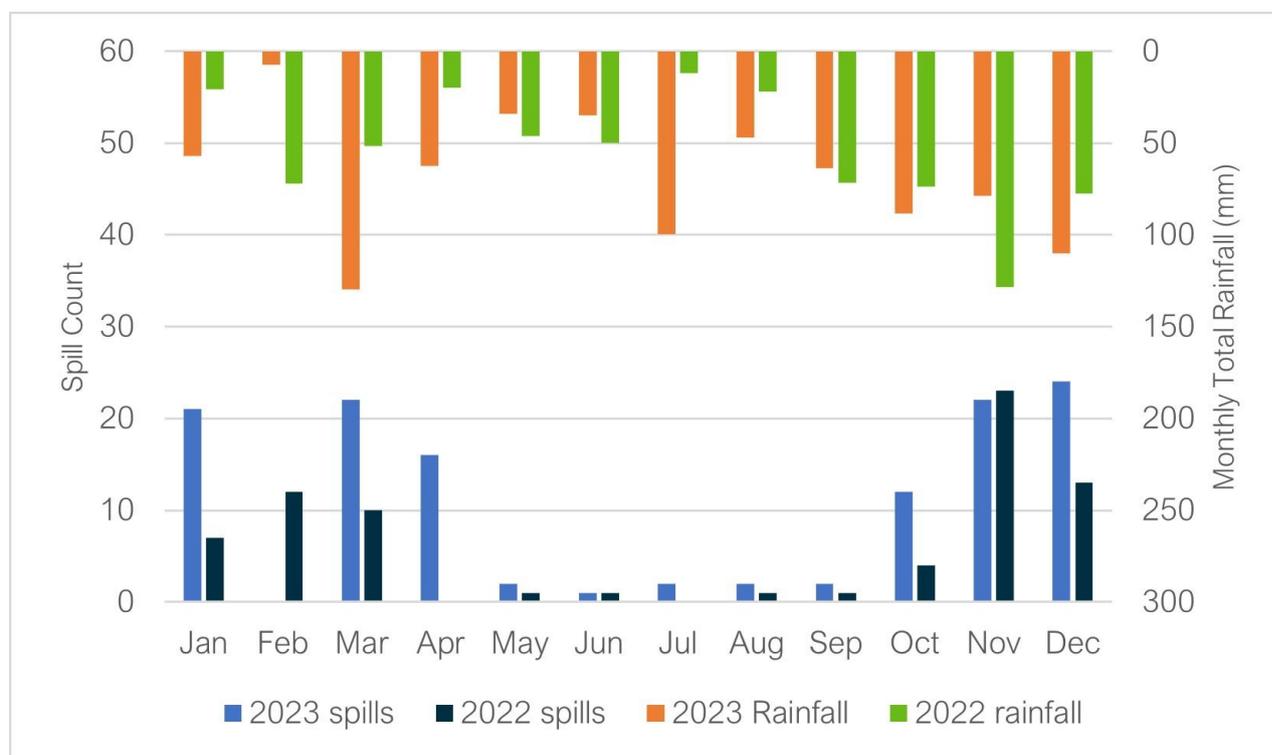
Figure 8 – EDM Monthly Performance

A critical part of the assessment of EDM performance and its relation to groundwater infiltration is to review the month-on-month spill performance, against previous years and the monthly total rainfall values to give context to the performance. Figure 8 below presents the EDM performance trend and rainfall for recent years.

The trend in spill performance across the two recorded years does show variation in spills, with a focus on spills during winter, spring and autumn months. The data suggests a wider relationship between elevated groundwater and spill frequencies. The highest peaks in spills for 2023 can be seen in January, March, April and October - December, when the indicator site data shown in Figures 5 and 6 suggests groundwater levels in the catchment became elevated and were generally higher than the equivalent months in 2022, when lower spill frequencies were generally observed. Summer spills were also recorded across 2022 and 2023 which indicates spills occurring in the catchment due to intense or prolonged rainfall events, outside of periods of elevated groundwater levels.
