Groundwater Impacted System Management Plan

Bentley, River Wey

April 2021

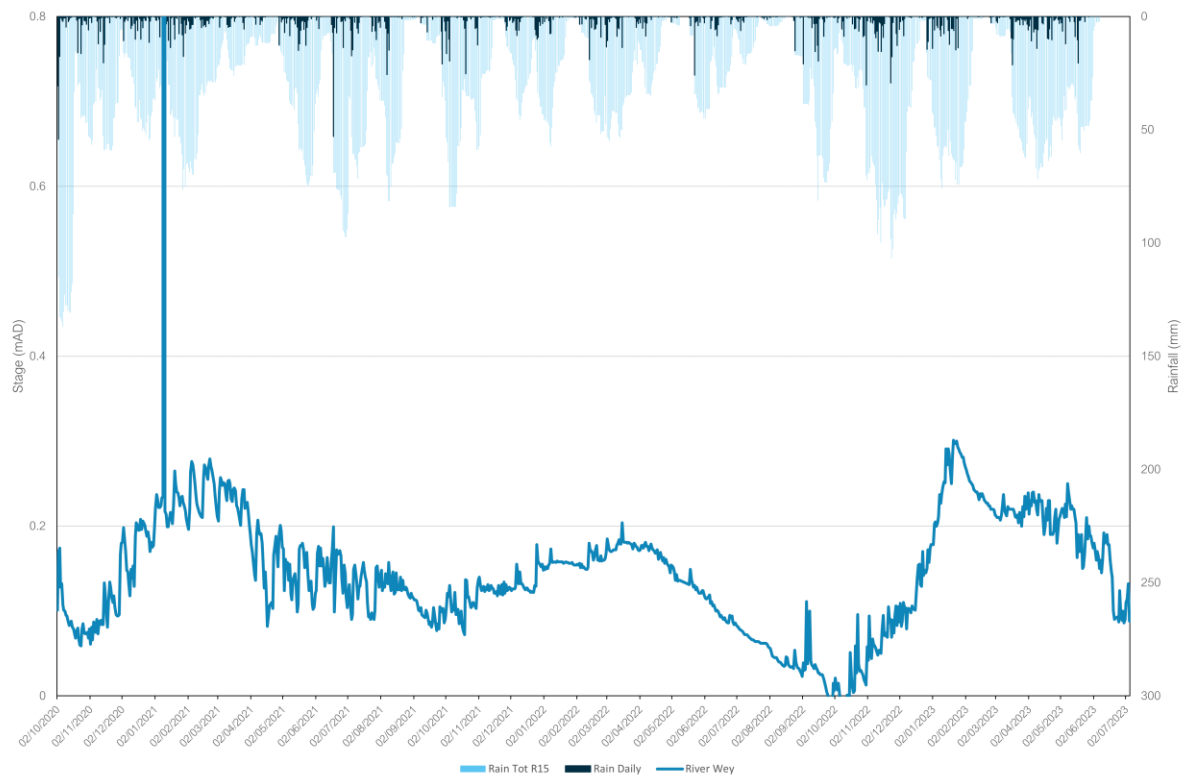
The following figures represent the last three hydrological years of level information at the indicator sites to build a picture of the relative conditions prevalent in the current year. It is presented against both the daily total rainfall values for the catchment and a rolling 15-day total rainfall.

Figure 5A – River Wey, Farnham

Figure 5B – River Wey, Kings Pond

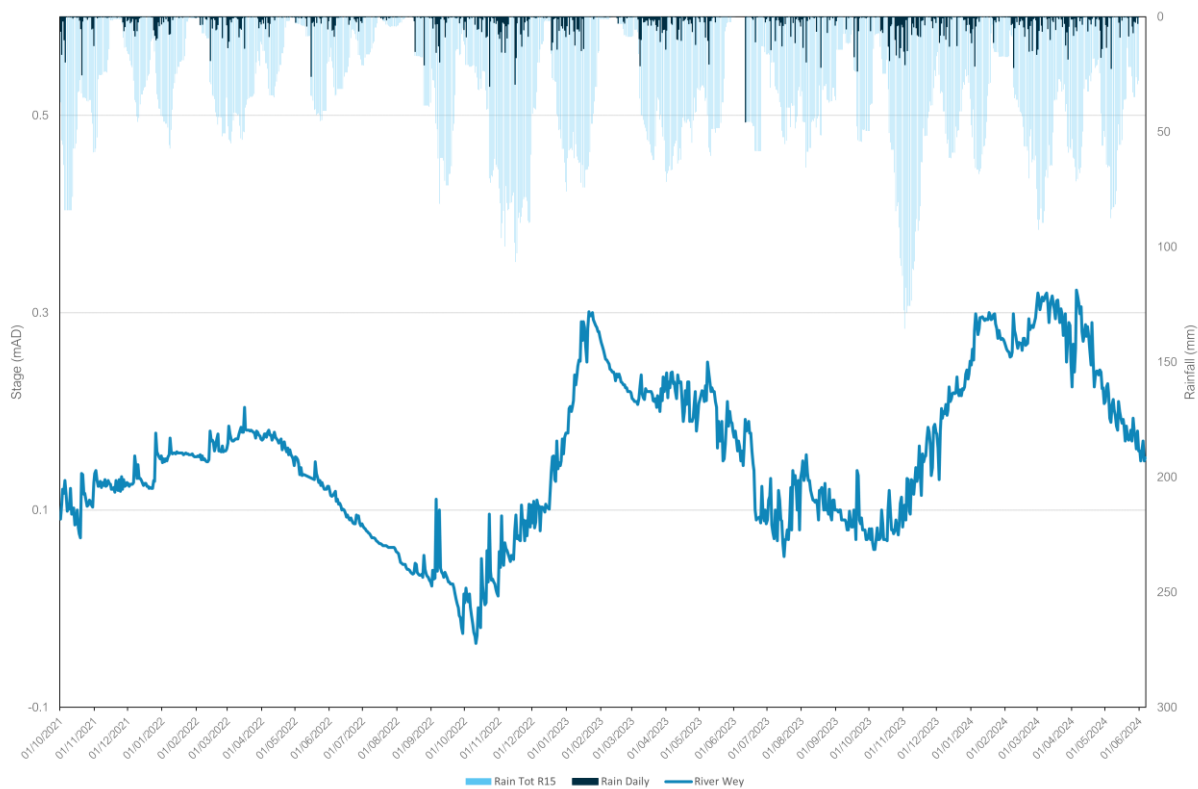
Figures 5A-5B represent the last three hydrological years of level information at the indicator sites to build a picture of the relative conditions prevalent in the current year. It is presented against both the daily total rainfall values for the catchment and a rolling 15-day total rainfall.

Figure 5A – River Wey, Farnham

Figure 5B – River Wey, Kings Pond

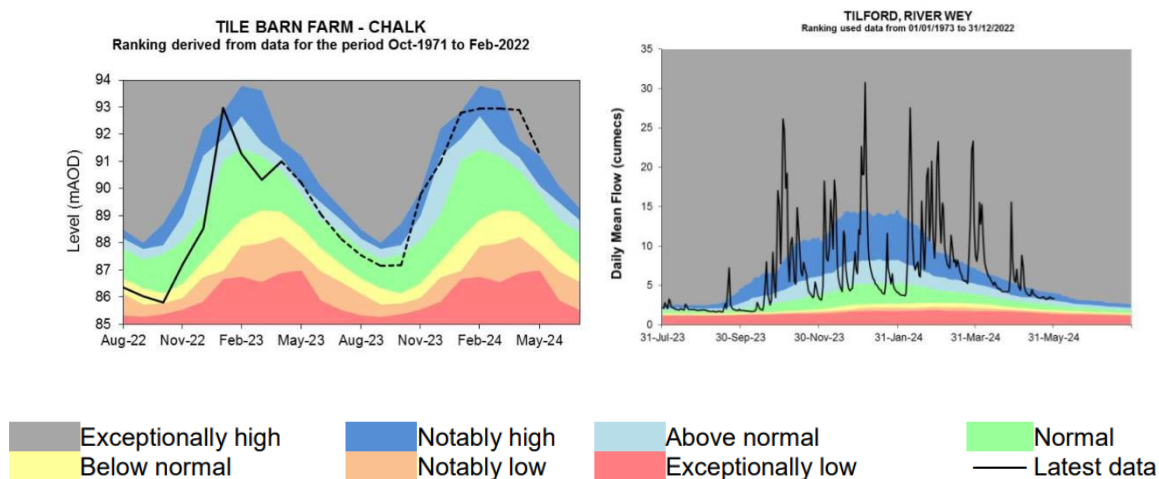
Figure 6 – Water Situation Report

In addition to these specific stations, the wider groundwater context is illustrated in the Water Situation Report for Wey - Greensand. The nearest groundwater reference station is Tile Barn Farm. This site shows groundwater levels in 2024 at notably high levels for a more prolonged period than in 2023, reaching exceptionally high levels in late spring. This can be seen in Figure 6 alongside the river indicator location at Tilford on the River Wey. Note recent groundwater levels at Tile Barn farm have been estimated based on nearby boreholes due to site issues.
