# Groundwater Impacted System Management Plan

Markyate, River Ver

September 2021

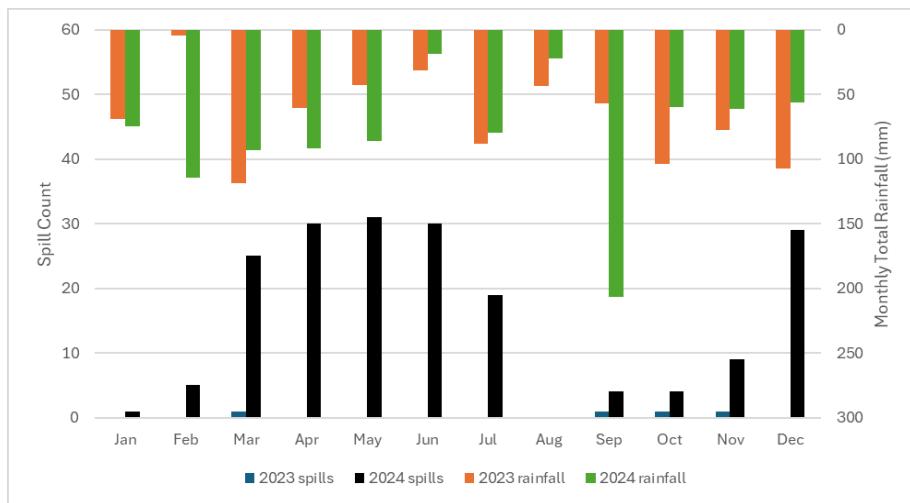
Figure 5: Monthly rainfall data versus monthly spill count for 2023 and 2024– Markyate STW

Figures 1 to 5 illustrate the relationship between rainfall and CSO spills. As shown in Figure 1, the decrease in rainfall from 2023/24 to 2024/25. However, River levels follow a similar pattern as previous year (Figures 2), along with a decline in both the number and duration of CSO spills shown in Figure 5.

Table 1 below details the last 2 years performance of overflows in the catchment. To assess EDM performance and its relation to groundwater infiltration, a review of the month-on-month spill performance in 2023 and 2024 against the monthly total rainfall values has been undertaken, as observed in Figure 5.
