Groundwater Impacted System Management Plan

Ramsbury, River Kennet

December 2020

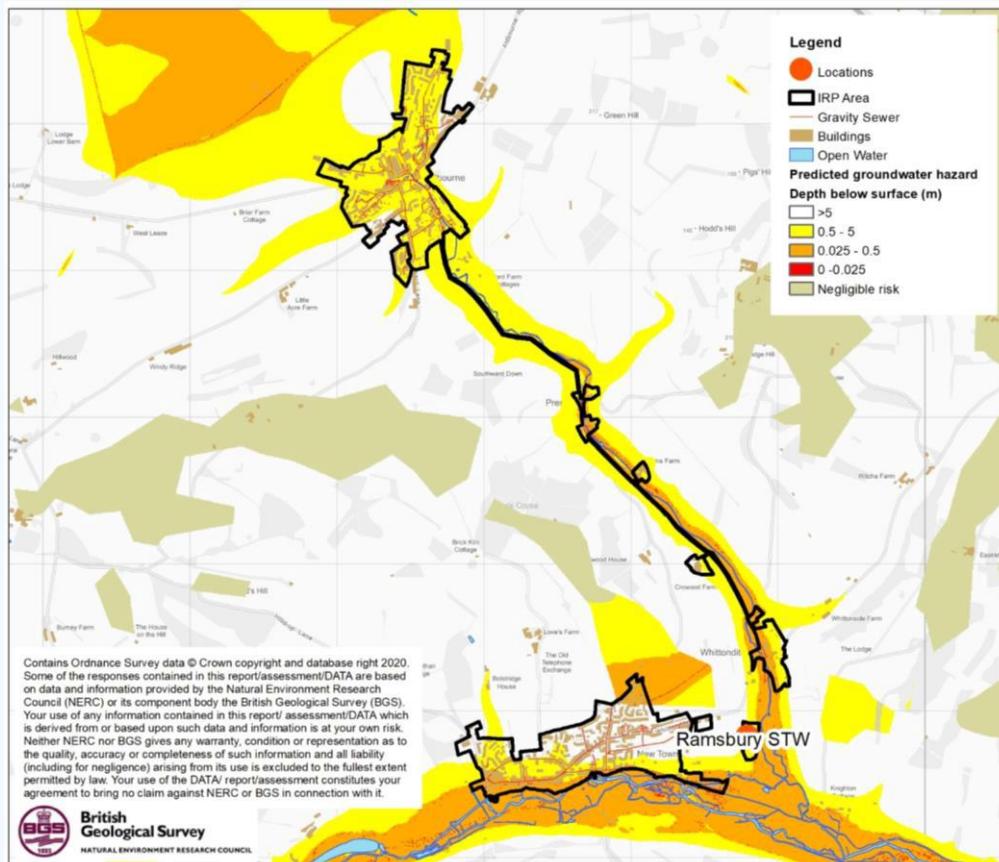
Figure 1.0 – Ramsbury catchment

Ramsbury is located in the Kennet Valley, Wiltshire, England. The nearest towns are Hungerford (4.5 miles East) and Marlborough (5.5 miles West) with Swindon 12 miles to the North West. Ramsbury serves a population equivalent³ of 3,270 with a predominantly separate sewerage network totalling some 17 km in length excluding private drains and sewers. The extent of the catchment is shown in Figure 1.0 above.

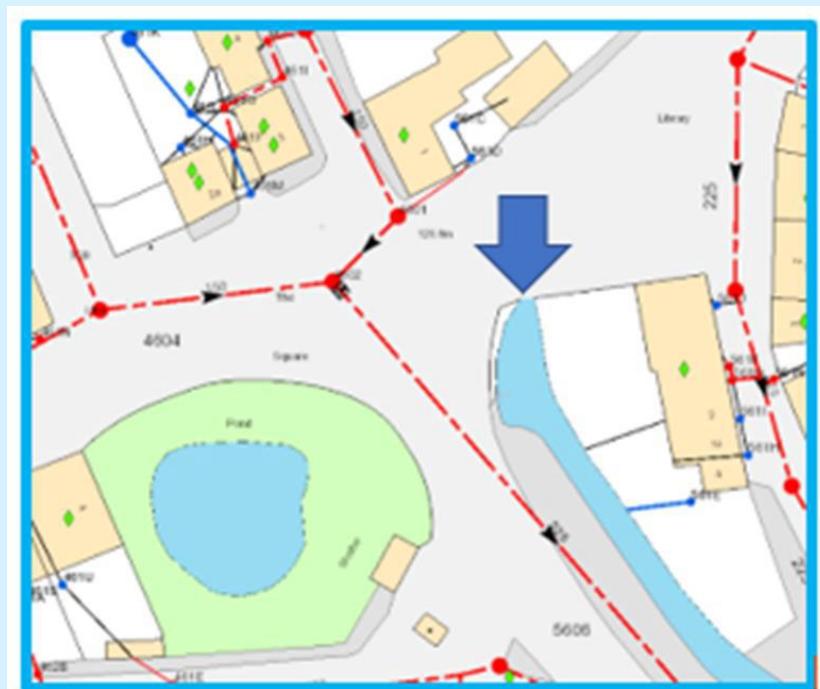
Location

Lottage Road, Aldbourne. The ATAC would be deployed to the carpark to the front of the library, this would then draw flows from the Lottage Road area via MH 5607. Following filtration, it would then pass flow forward via an unmapped culvert MH. Flows from the culvert MH would be discharged to 51°28'45.4"N 1°37'10.8"W (51.479269, -1.619665)

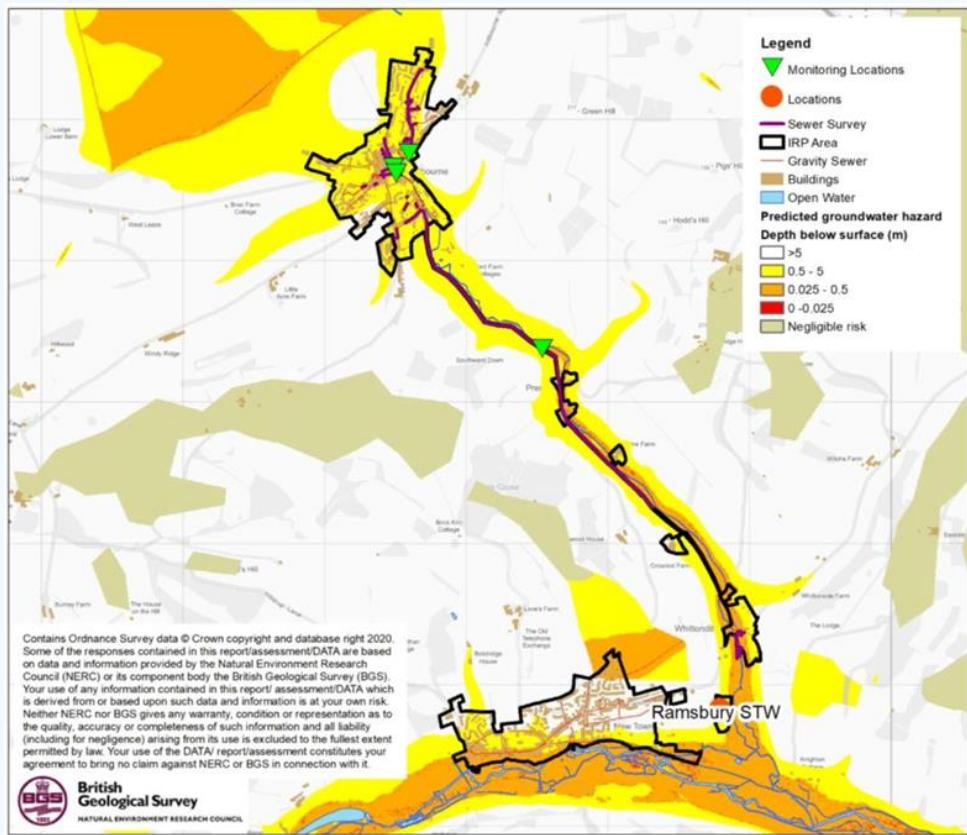
Figure 2.0 – Ramsbury monitoring and infiltration zones

Key to bringing the impact of groundwater infiltration under control will be an enhanced monitoring regime. We have identified and have installed several telemetered depth monitor locations around the Ramsbury system – see Figure 2.0.

We engaged with JBA Consulting to develop plans for Ramsbury that identify zones of groundwater risk, see Figure 2.0. These zones are modelled areas where the groundwater has been determined to be above the sewer and hence pose a potential risk for groundwater ingress.

Sewer Depth Monitors have been installed in the catchment in 2020 (see Figure 2.0), apart from in one location on Drain Hill where we have been unable to access the manhole and there is no alternative location. These devices are telemetered and provide real time data on the level of flow in the sewer.

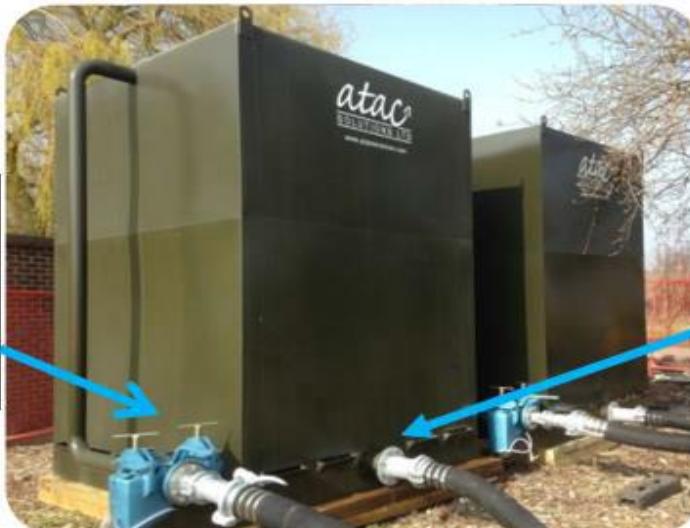
Outside view:

Dirty water entering the filter unit to be treated and then pumped to the top of the unit

Treated water leaving the unit and returning to the environment

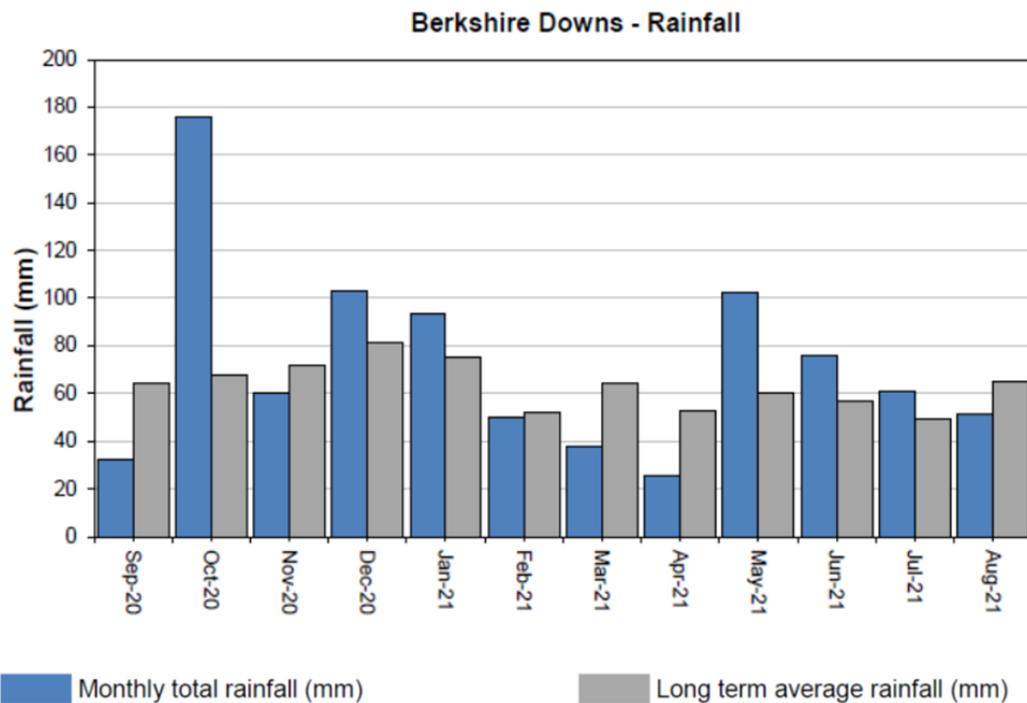
Figure 2 – Monthly rainfall depths local to the system

Ramsbury is situated in the Berkshire Downs water resources area. Figure 2 shows the monthly rainfall total depths against the long-term average rainfall in the location of Marlborough over the period taken from the *Environment Agency Water Situation Report August 2021*.¹

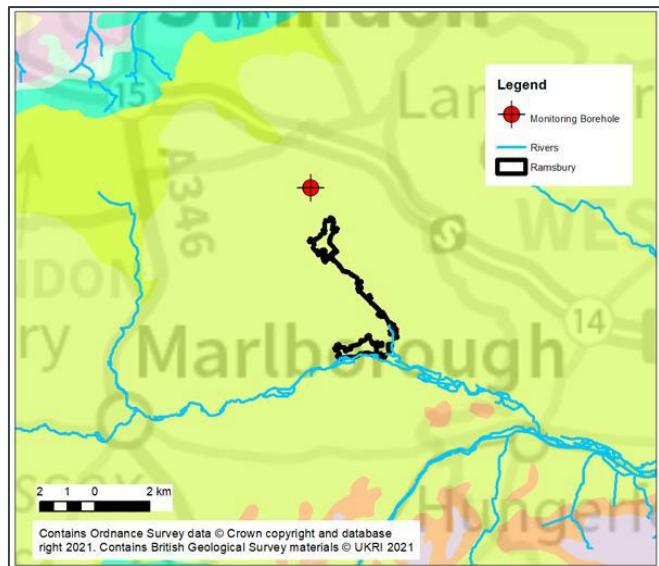
Figure 3 – Location of Wateracre Monitoring Borehole Relative to Ramsbury

Figure 3 shows the location of the British Geological Survey (BGS) monitoring borehole at Wateracre. Figure 4 and 5 present the last year and nine years of groundwater level data. This data shows that generally last winter's groundwater levels have been notably higher than the previous five years and almost as high as the 2012/13 and 2013/14 winter periods.

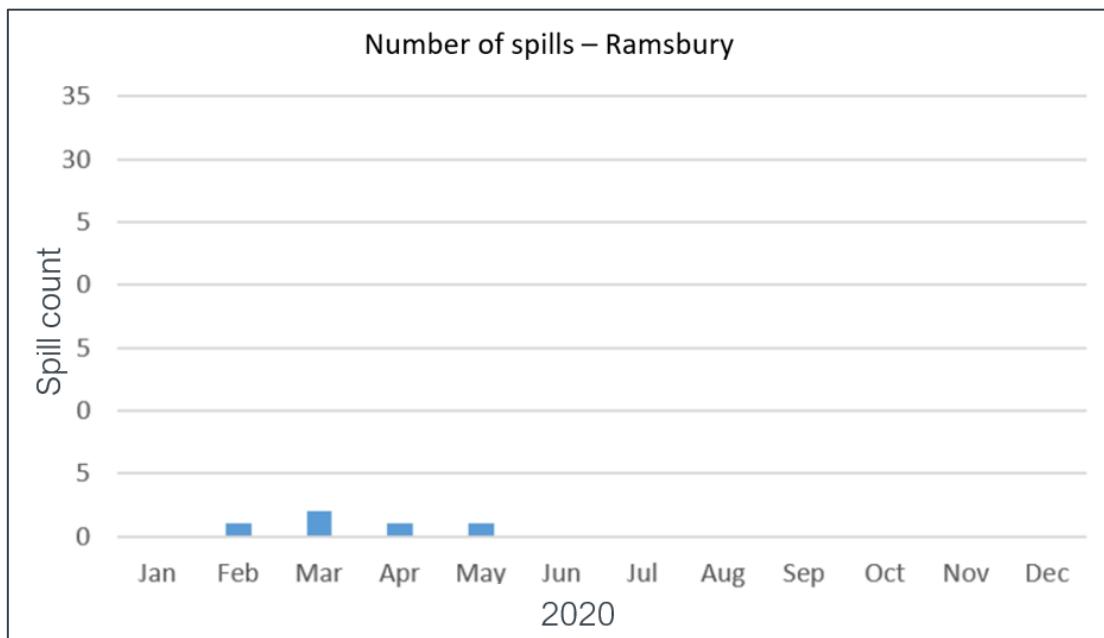
Figure 6 – Number of spills (discharge count) at Ramsbury STW (taken from Event Duration Monitor (EDM) Data).*

Figure 6 shows the number of spills per month from Ramsbury Sewage Treatment Works. The number of spills at this location indicates that the impact of groundwater infiltration at the STW is minimal. Tankering was carried out in the Ramsbury system over the Winter period to minimise the risk of property flooding. Tankers were unable to keep up with the levels of flows experienced, therefore an ATAC bio-filter was deployed to protect properties from flooding as outlined in the original GISMP report.

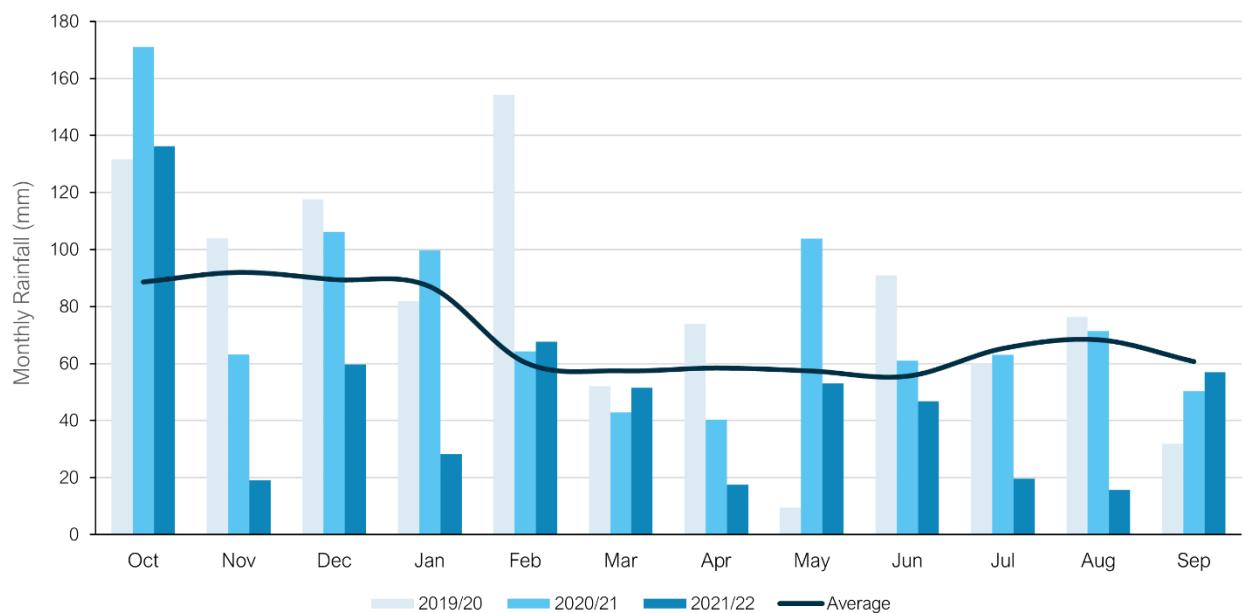
Figure 2: Monthly Rainfall Performance

Representative Radar rainfall has been used to generate monthly data at catchment level for comparison with average data generated by local Met Office Weather Station Records. Figure 2 presents the comparison of this data for the last three hydrological years to support longer term trends within the local system.

(Average Values taken from Met Office Weather Station at Marlborough based on the period 1991-2020)

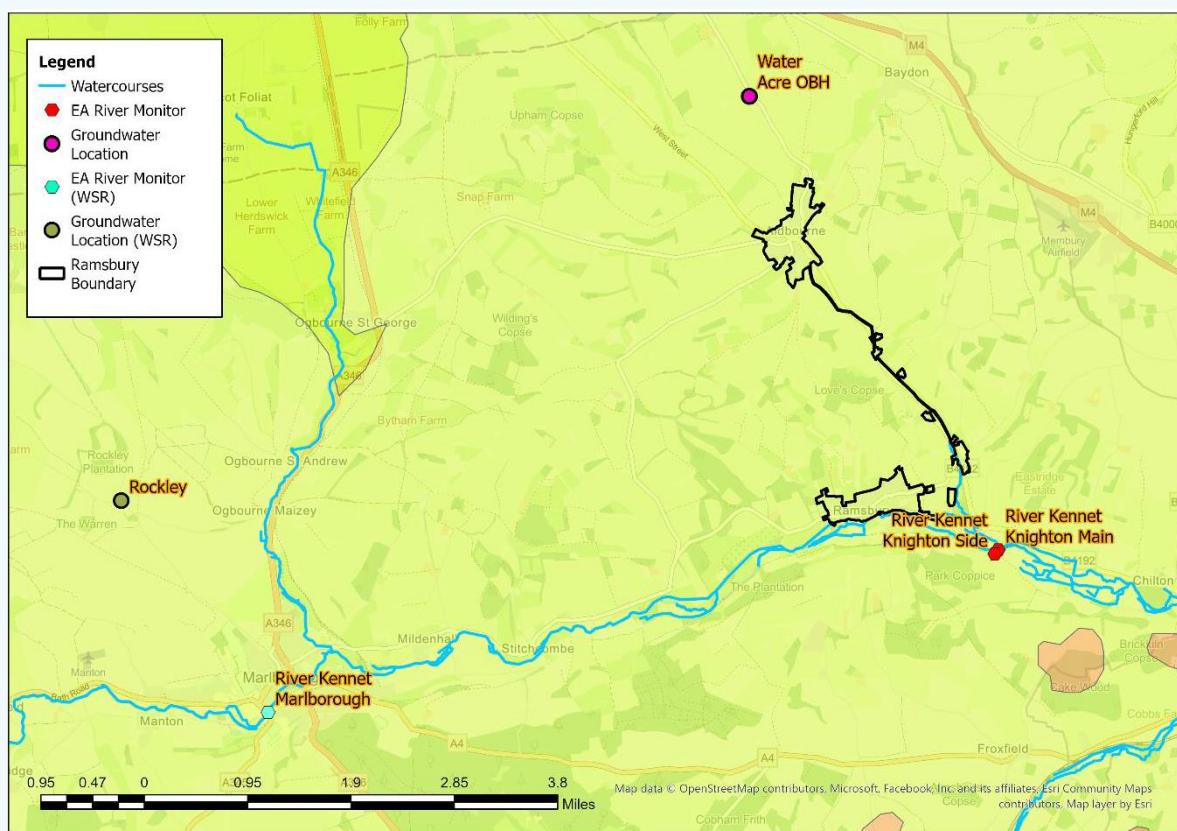
Figure 4: Local Monitoring Stations

- River Kennet, Knighton Main.
- River Kennet, Knighton Side.
- Water Acre OBH.

These sites are illustrated in the figure below, alongside the closest groundwater reference station and closest gauging station from the Water Situation Report.

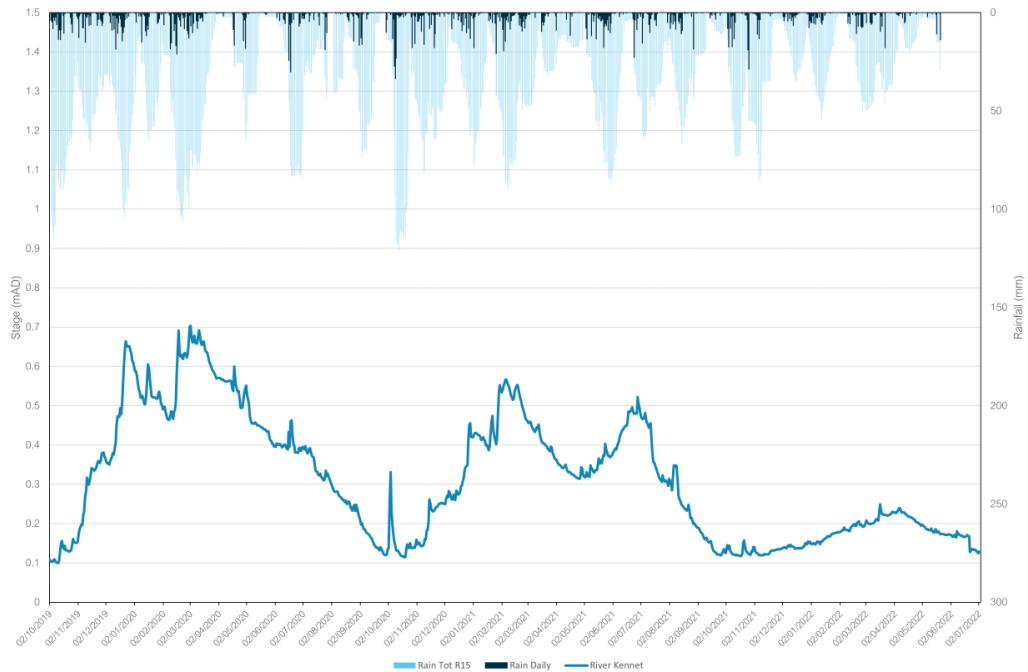
Figure 5A – Kennet, Knighton Main

The following figures represent the last three hydrological years of level information at the indicator sites to build a picture of the relative conditions prevalent in the current year. It is presented against both the daily total rainfall values for the catchment and a rolling 15-day total rainfall.

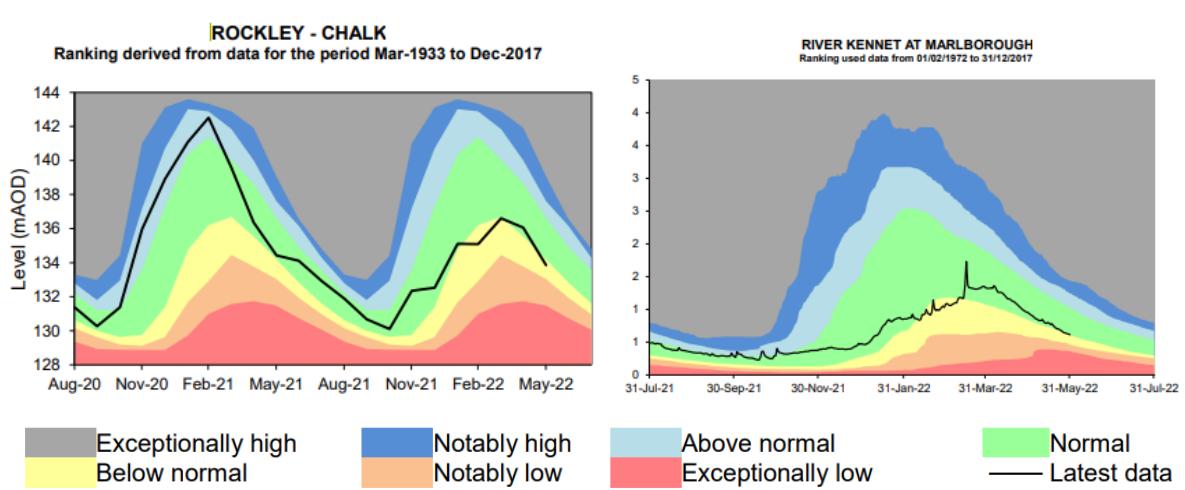
Figure 6 – Water Situation Report

In addition to these specific stations, the wider groundwater context is illustrated in the Water Situation Report for the Berkshire Downs. The nearest groundwater reference station is Rockley. This site shows significantly lower overall groundwater than the previous year. This can be seen in the figure below alongside the river indicator location at Marlborough on the River Kennet.

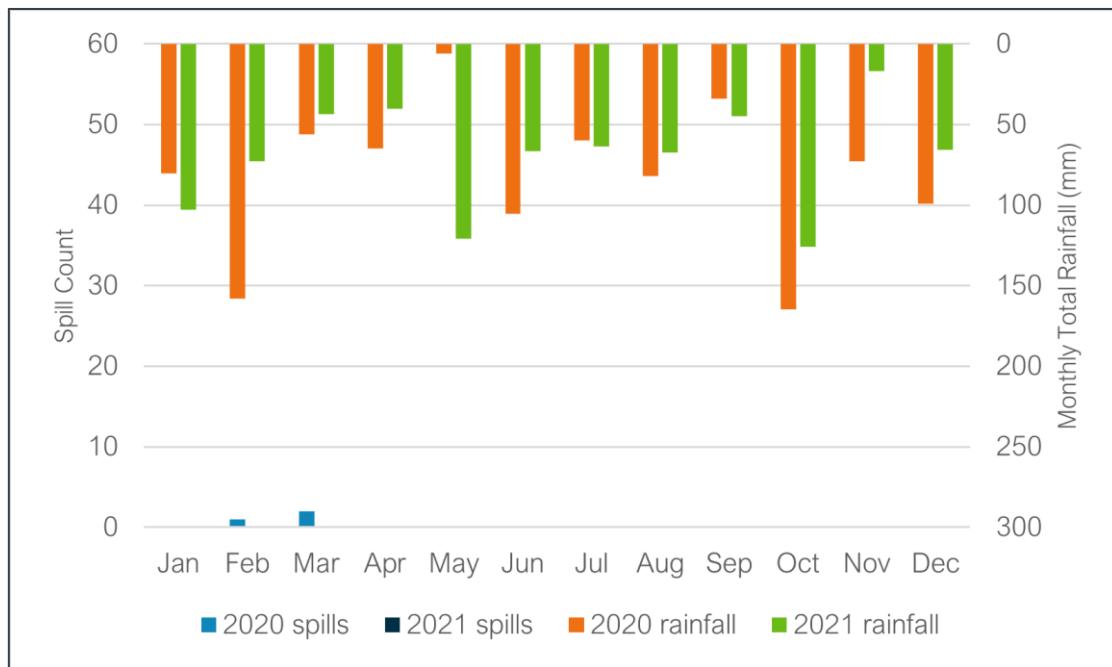
Figure 8 – EDM Monthly Performance

A critical part of the assessment of EDM performance and its relation to groundwater inundation is to review the month-on-month spill performance, against previous years and the monthly total rainfall values to give context to the performance. Figure 8 below presents the EDM performance trend and rainfall for recent years.

The data suggests a wider relationship between rainfall, elevated groundwater levels and spill frequency, as the only spills recorded over the two-year period were in February and March 2020, when the indicator sites suggest groundwater levels in the catchment were particularly elevated.

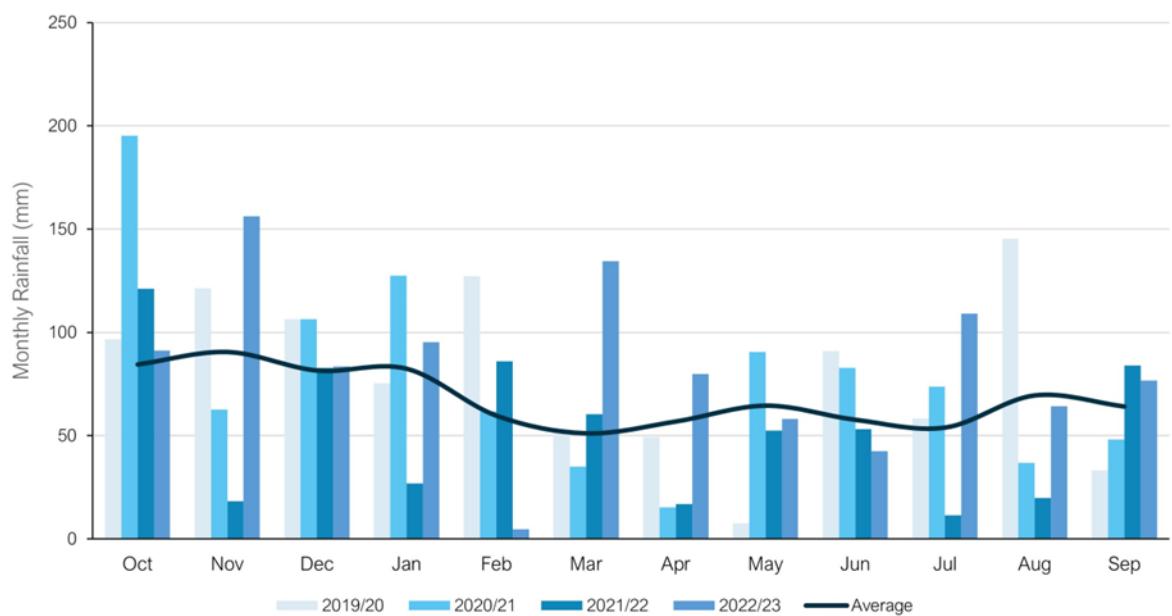
Figure 2: Monthly Rainfall Performance

Representative Radar rainfall has been used to generate monthly data at catchment level for comparison with average data generated by local Met Office Weather Station Records. Figure 2 presents the comparison of this data for the last four hydrological years to support longer term trends within the local system.

(Average Values taken from Met Office Weather Station at Marlborough based on the period 1991-2020)

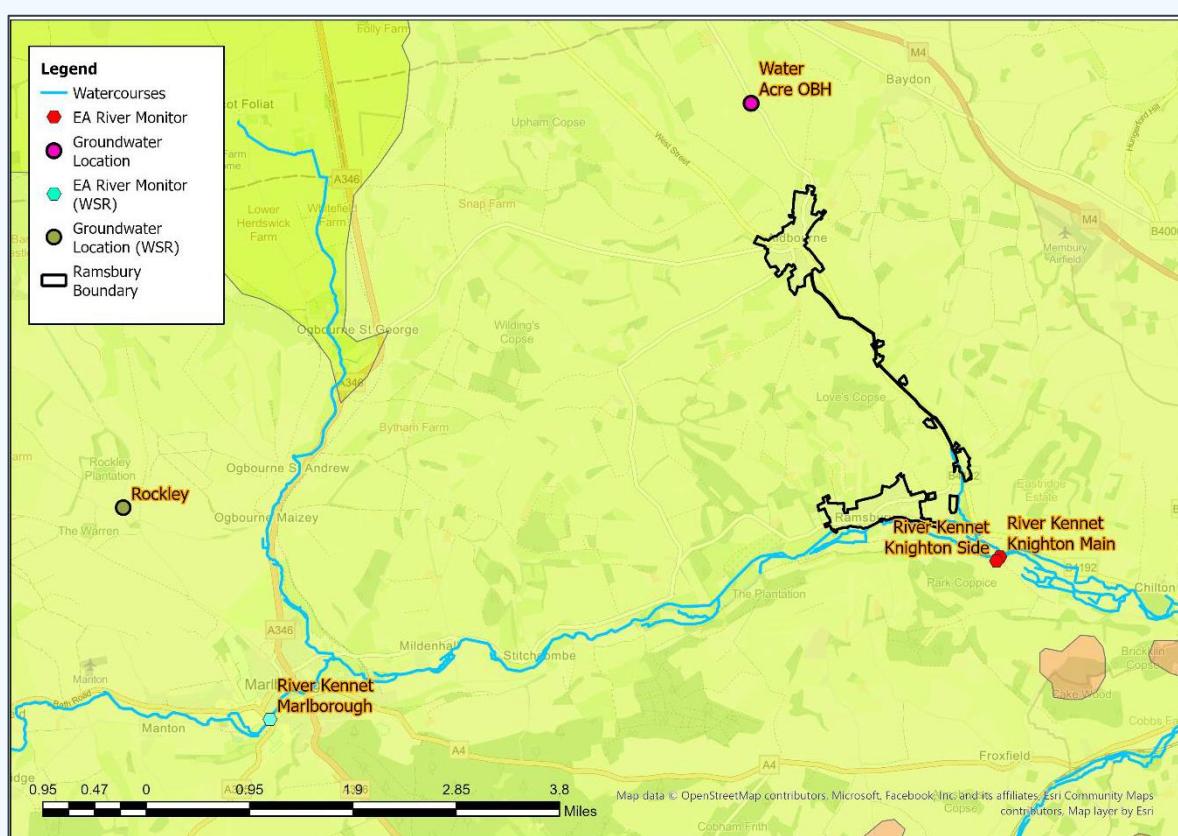
Figure 4: Local Monitoring Stations

- River Kennet, Knighton Main.
- River Kennet, Knighton Side.
- Water Acre OBH.

These sites are illustrated in the figure below, alongside the closest groundwater reference station and closest gauging station from the Water Situation Report.

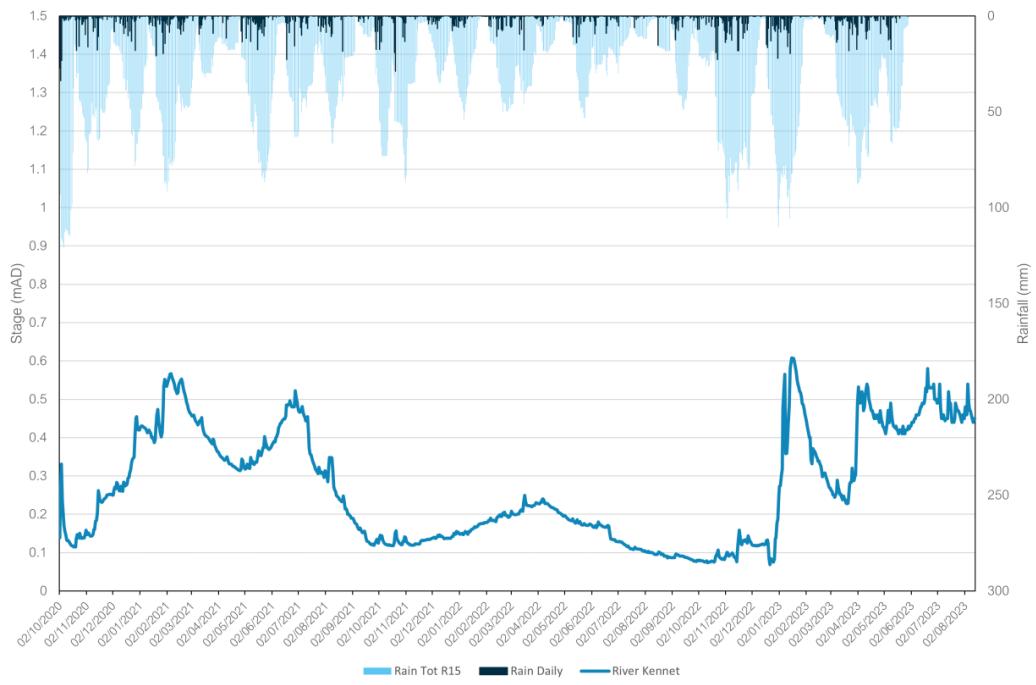
Figure 5A – Kennet, Knighton Main

The following figures represent the last three hydrological years of level information at the indicator sites to build a picture of the relative conditions prevalent in the current year. It is presented against both the daily total rainfall values for the catchment and a rolling 15-day total rainfall.

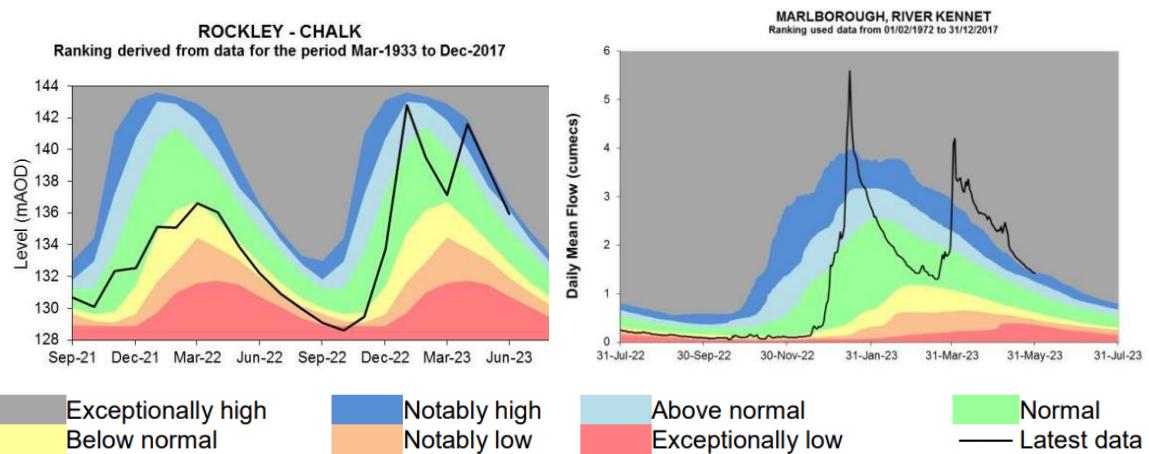
Figure 6 – Water Situation Report

In addition to these specific stations, the wider groundwater context is illustrated in the Water Situation Report for the Berkshire Downs. The nearest groundwater reference station is Rockley. This site shows groundwater levels generally at below normal or notably low levels in 2022, before rising towards the end of the year to reach above normal and notably high levels in 2023. This can be seen in the figure below alongside the river indicator location at Marlborough on the River Kennet.

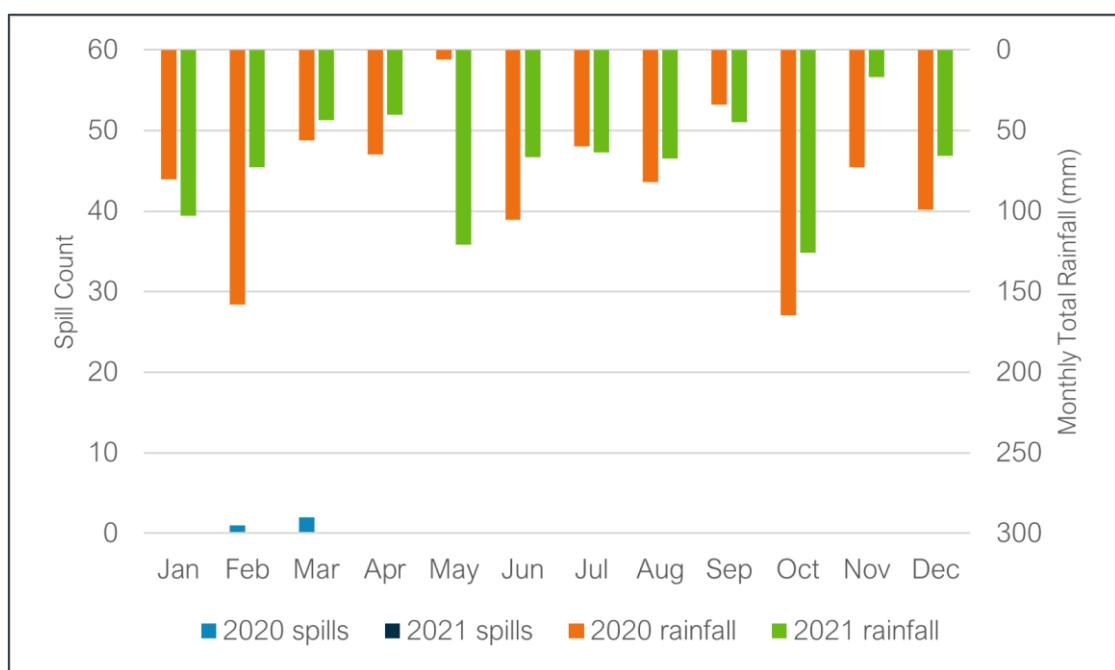
Figure 8 – EDM Monthly Performance

A critical part of the assessment of EDM performance and its relation to groundwater infiltration is to review the month-on-month spill performance, against previous years and the monthly total rainfall values to give context to the performance. Figure 8 below presents the EDM performance trend and rainfall for recent years.

The data suggests a wider relationship between rainfall, elevated groundwater levels and spill frequency, as the only spills recorded over the two-year period were in February and March 2020, when the indicator sites suggest groundwater levels in the catchment were particularly elevated.

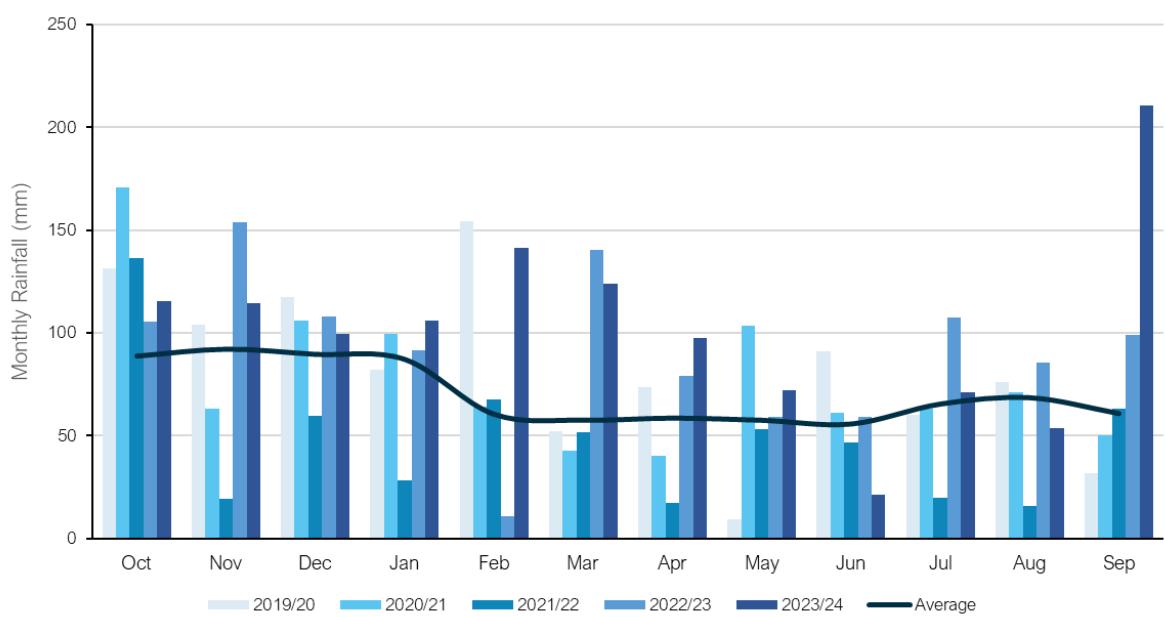
Figure 2: Monthly Rainfall Performance

Representative Radar rainfall has been used to generate monthly data at catchment level for comparison with average data generated by local Met Office Weather Station Records. Figure 2 presents the comparison of this data for the last four hydrological years to support longer term trends within the local system.

(Average Values taken from Met Office Weather Station at Marlborough based on the period 1991-2020)

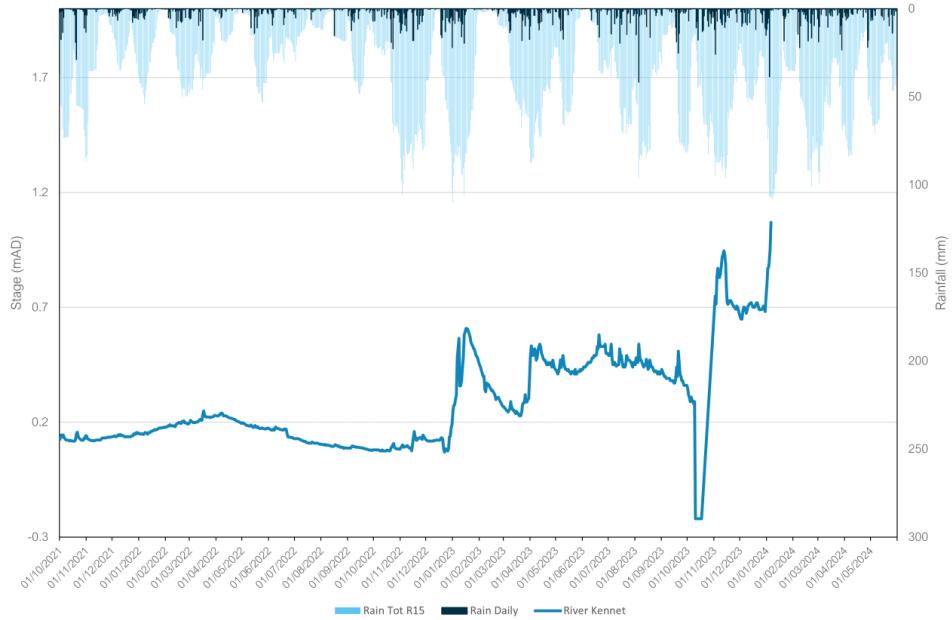
Figure 5A – Kennet, Knighton Main

Figures 5A-5C represent the last three hydrological years of level information at the indicator sites to build a picture of the relative conditions prevalent in the current year. It is presented against both the daily total rainfall values for the catchment and a rolling 15 day total rainfall. Note that no stage data is available for the River Kennet at Knighton Main site post February 2024.

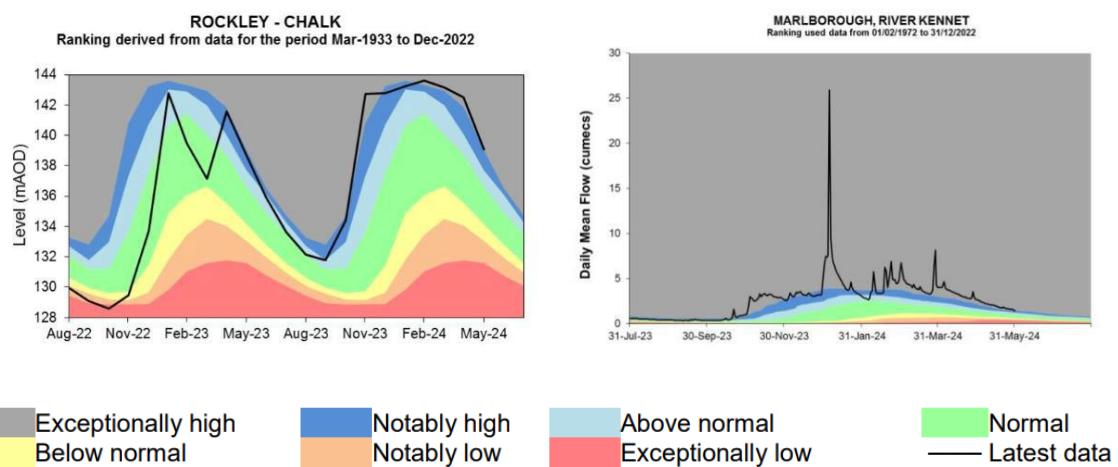
Figure 6 – Water Situation Report

In addition to these specific stations, the wider groundwater context is illustrated in the Water Situation Report for the Berkshire Downs. The nearest groundwater reference station is Rockley. This site shows groundwater levels in 2023 were mostly at above normal / notably high levels, rising to exceptionally high in November. In comparison, groundwater levels in 2024 have consistently been observed at notably/ exceptionally high levels. This can be seen in Figure 6 alongside the river indicator location at Marlborough on the River Kennet.

Extract from - [Water Situation Report \(publishing.service.gov.uk\)](https://publishing.service.gov.uk)

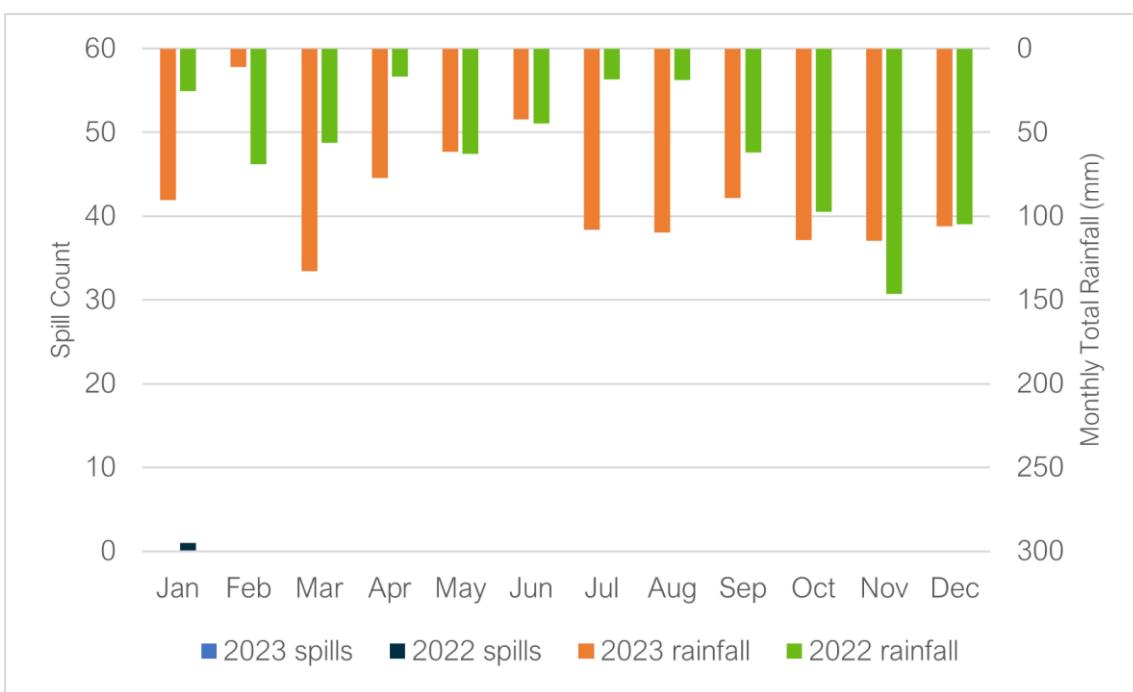
Figure 8 – EDM Monthly Performance

A critical part of the assessment of EDM performance and its relation to groundwater infiltration is to review the month-on-month spill performance, against previous years and the monthly total rainfall values to give context to the performance. Figure 8 below presents the EDM performance trend and rainfall for recent years.

The utility of the last two years of EDM data to suggest a wider relationship between rainfall, elevated groundwater levels and spill frequency is limited, as only one spill was recorded at Ramsbury STW across 2022 and 2023.

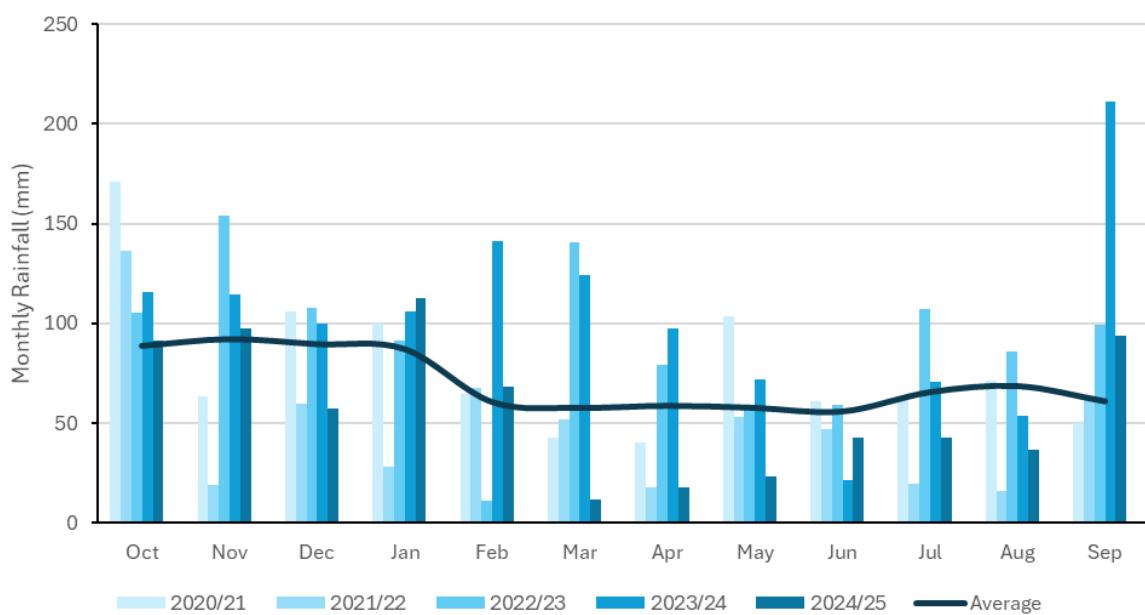
Figure 2: Monthly Rainfall Performance

Representative Radar rainfall has been used to generate monthly data at catchment level for comparison with average data generated by local Met Office Weather Station Records. Figure 2 presents the comparison of this data for the last four hydrological years to support longer term trends within the local system.

(Average Values taken from Met Office Weather Station at Marlborough based on the period 1991-2020)

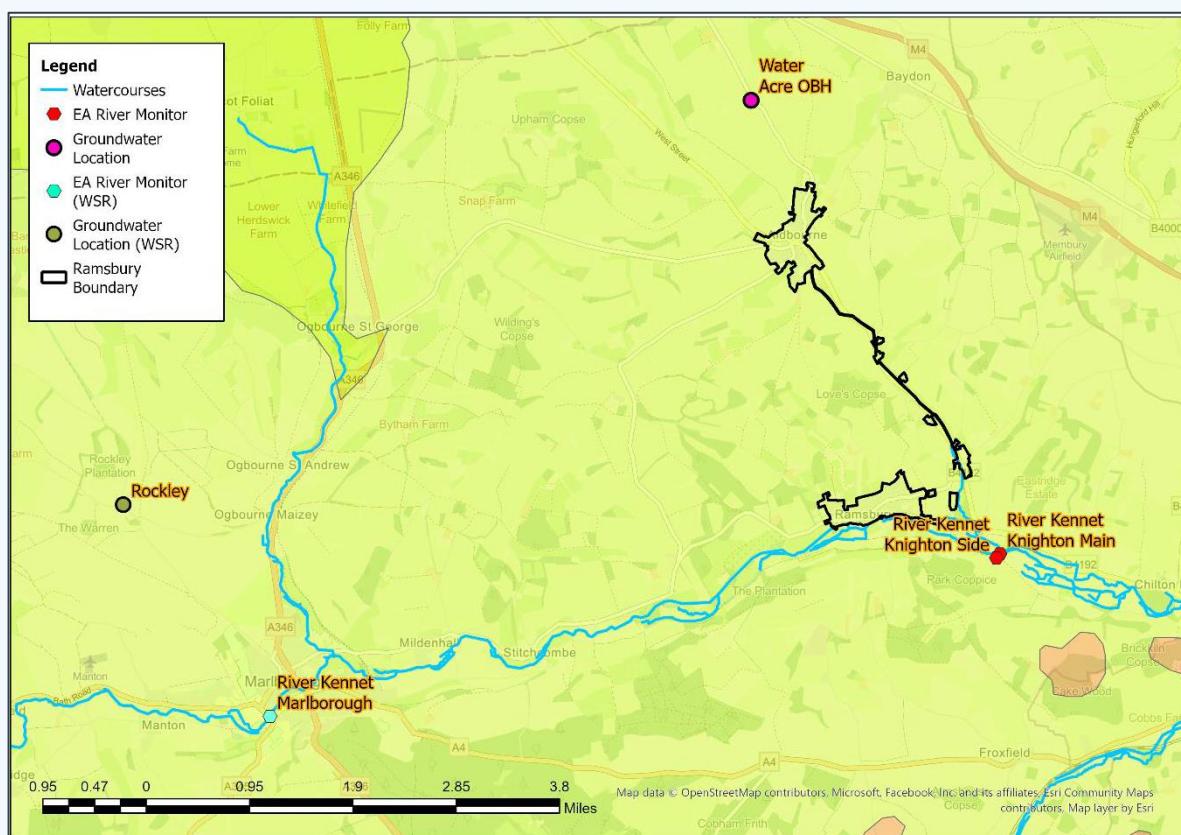
Figure 4: Local Monitoring Stations

- River Kennet, Knighton Main.
- River Kennet, Knighton Side.
- Water Acre OBH.

These sites are illustrated in the figure below, alongside the closest groundwater reference station and closest gauging station from the Water Situation Report.

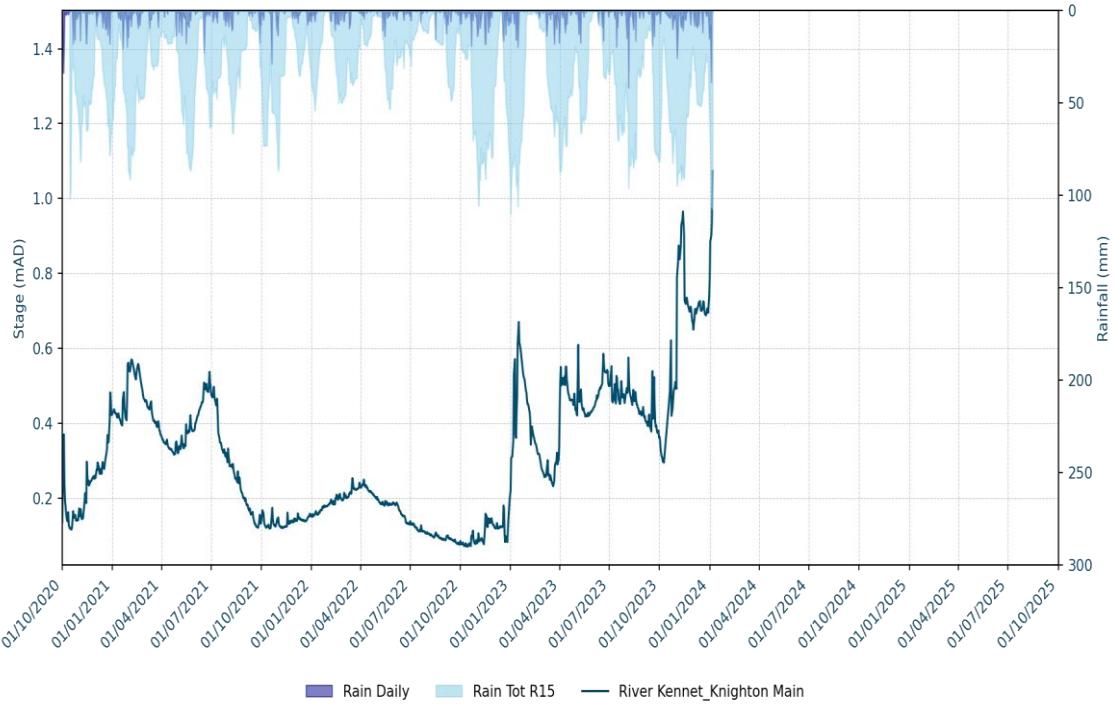
Figure 5A – River Level for River Kennet, Knighton Main

Figures 5A-5C represent the last five hydrological years of level information at the indicator sites to build a picture of the relative conditions prevalent in the current year. It is presented against both the daily total rainfall values for catchment and a rolling 15-day total rainfall. Note that no stage data is available for the River Kennet at Knighton Main site post February 2024.

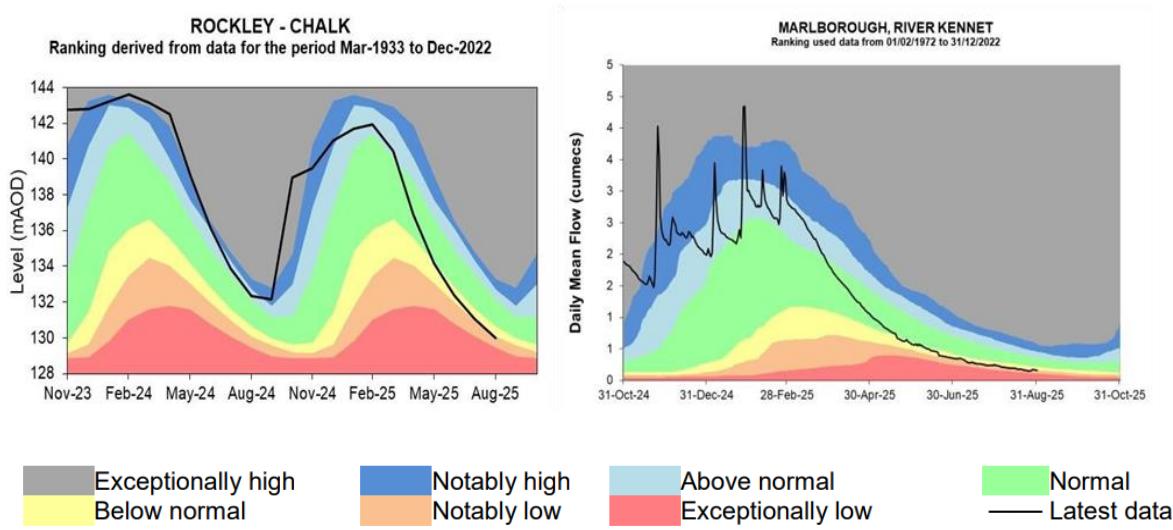
Figure 6 – Ground Water Situation Report

In addition to these specific stations, the wider groundwater context is illustrated in the Water Situation Report for the Berkshire Downs. The nearest groundwater reference station is Rockley. This site shows groundwater levels at this site remained exceptionally high throughout 2024, with a slight decline observed between May and August, though levels still stayed notably high during that period. In 2025, groundwater levels continued to be notably high until mid-year, after which a gradual decline was observed. This can be seen in Figure 6 alongside the river indicator location at Marlborough on the River Kennet.

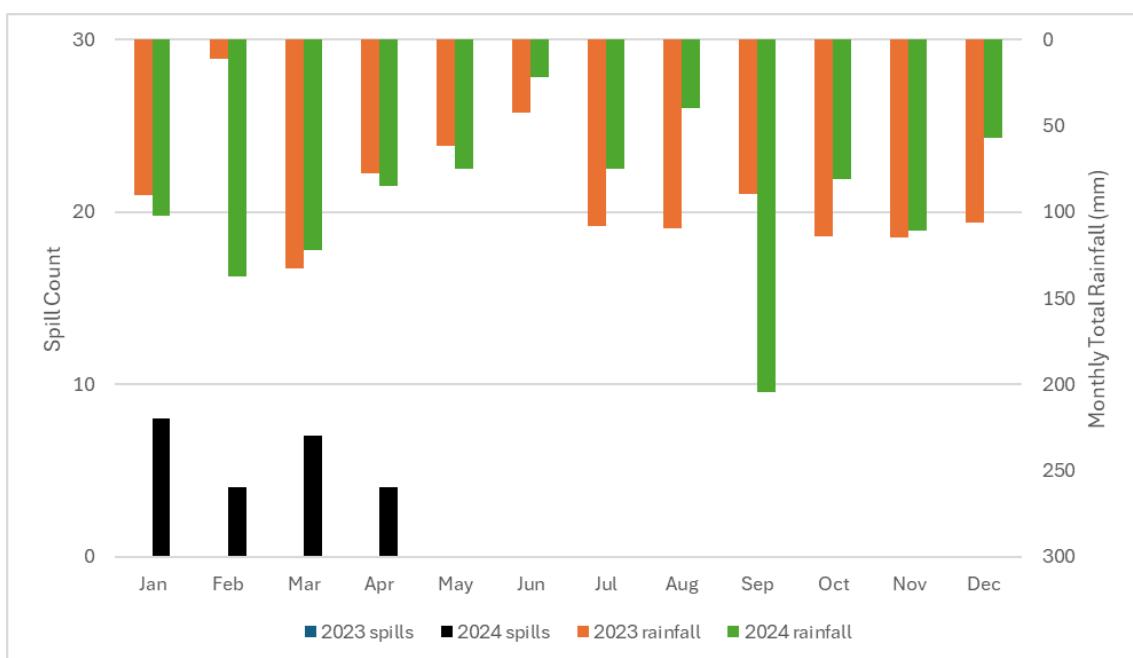
A critical part of the assessment of EDM performance and its relation to groundwater inundation is to review the month-on-month spill performance, against previous years and the monthly total rainfall values to give context to the performance. Figure 8 below presents the EDM performance trend and rainfall for recent years.

Figure 8 – Monthly rainfall data versus monthly spill count for 2023 and 2024 – Ramsbury STW

A total of 23 spills were recorded at Ramsbury STW in 2024, and no spills were recorded in 2023. The utility of the last two years of EDM data to suggest a wider relationship between rainfall, elevated groundwater levels and spill frequency is limited, as no spill was recorded at Ramsbury STW across 2022 and 2023.
