Groundwater Impacted System Management Plan

Wash Water, River Enborne

September 2021

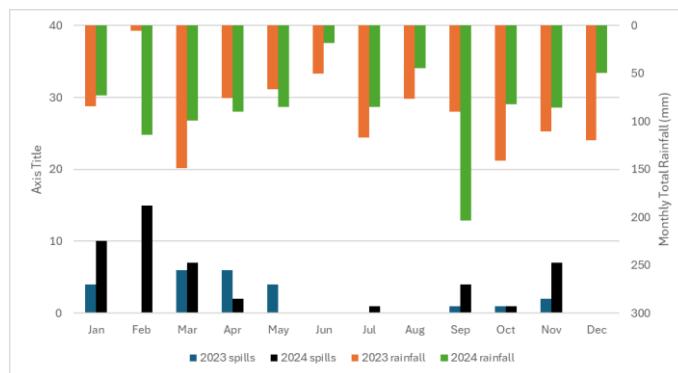
Figure 6: Monthly rainfall data versus monthly spill count for 2023 and 2025 – Reading STW

Table 1 below details the last 2 years performance of overflows in the catchment. To assess EDM performance and its relation to groundwater infiltration, a review of the month-on-month spill performance in 2023 and 2024 against the monthly total rainfall values has been undertaken, as observed in Figure 6.
