Groundwater Impacted System Management Plan

Kingsclere, Kingsclere Brook

September 2021

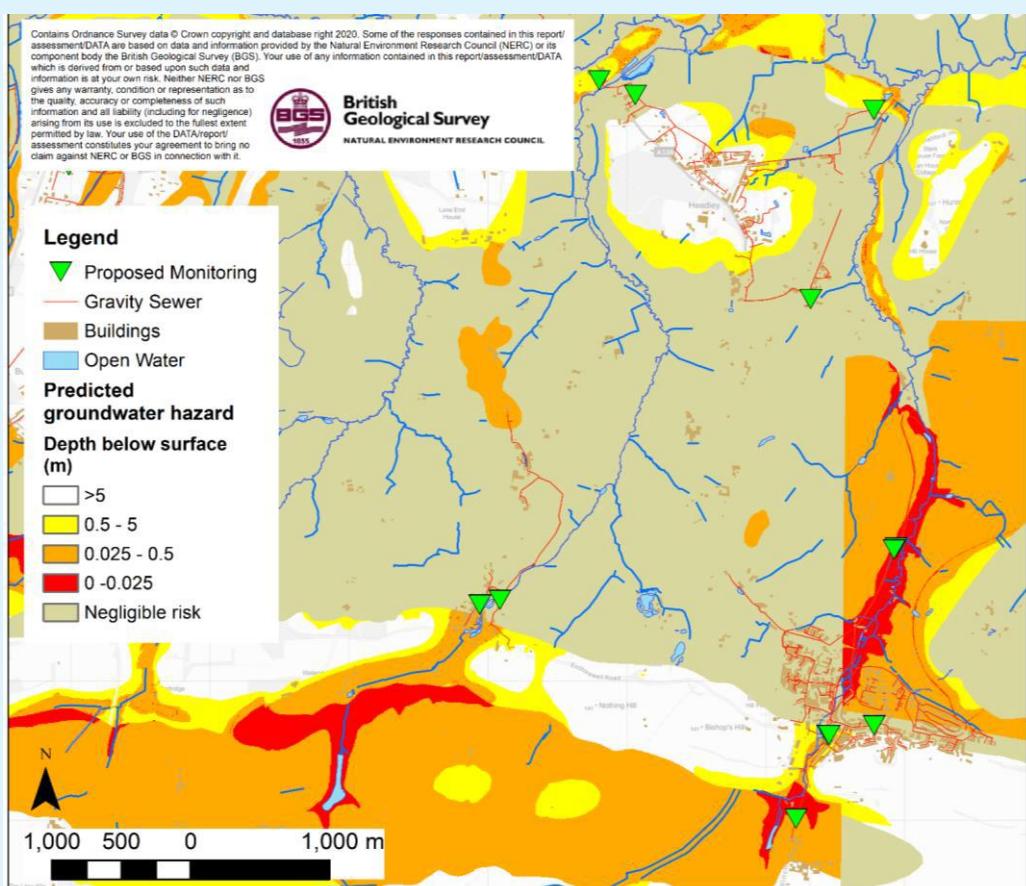
Figure 2.0 – Kingsclere monitoring plan area and infiltration zones

Key to bringing the impact of groundwater infiltration under control is an enhanced monitoring regime. We have identified zones and areas over which telemetered depth monitoring will be installed. Figure 2.0 presents a plan of currently proposed installation locations.

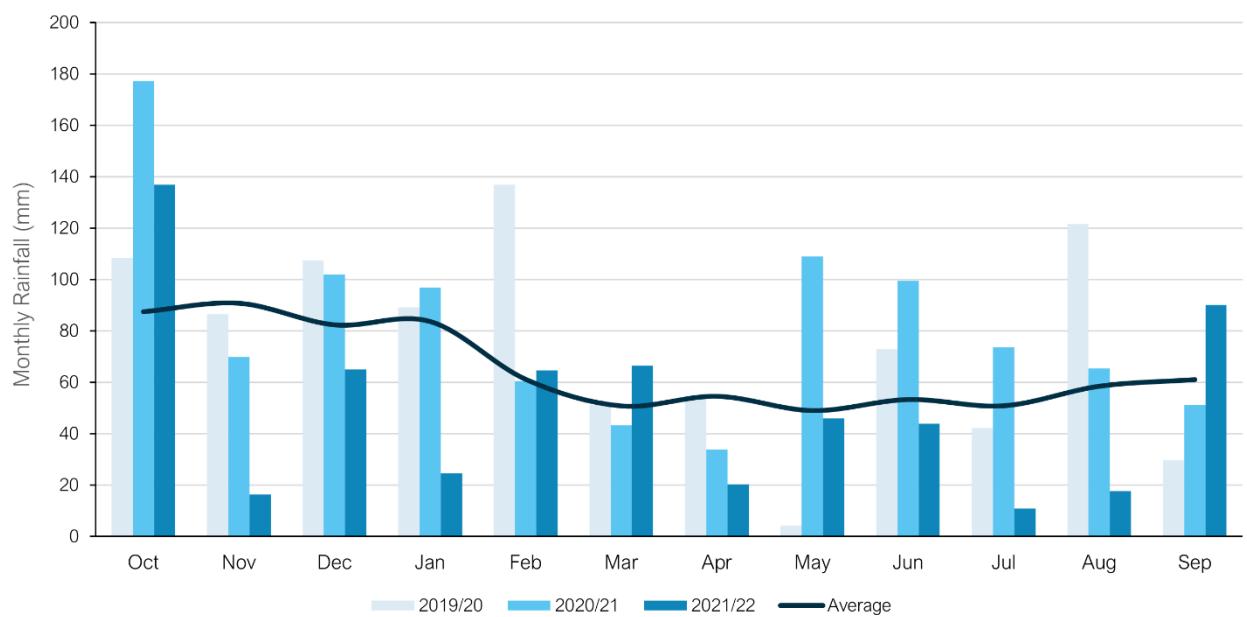
Figure 2 – Monthly Rainfall Performance

Average Values taken from Met Office Weather Station at Odiham based on the period 1991-2020

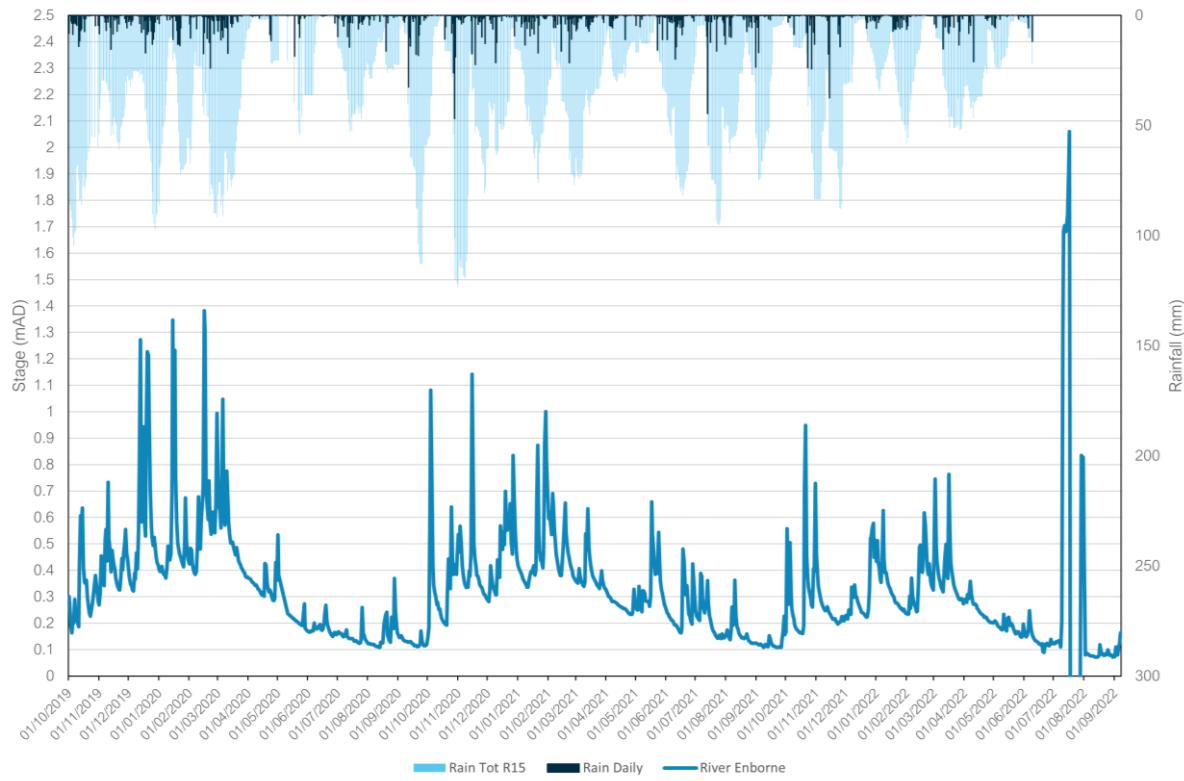
Figure 5A – River Enborne, Brimpton

The following figures represent the last three hydrological years of level information at the indicator sites to build a picture of the relative conditions prevalent in the current year. It is presented against both the daily total rainfall values for the catchment and a rolling 15 day total rainfall.

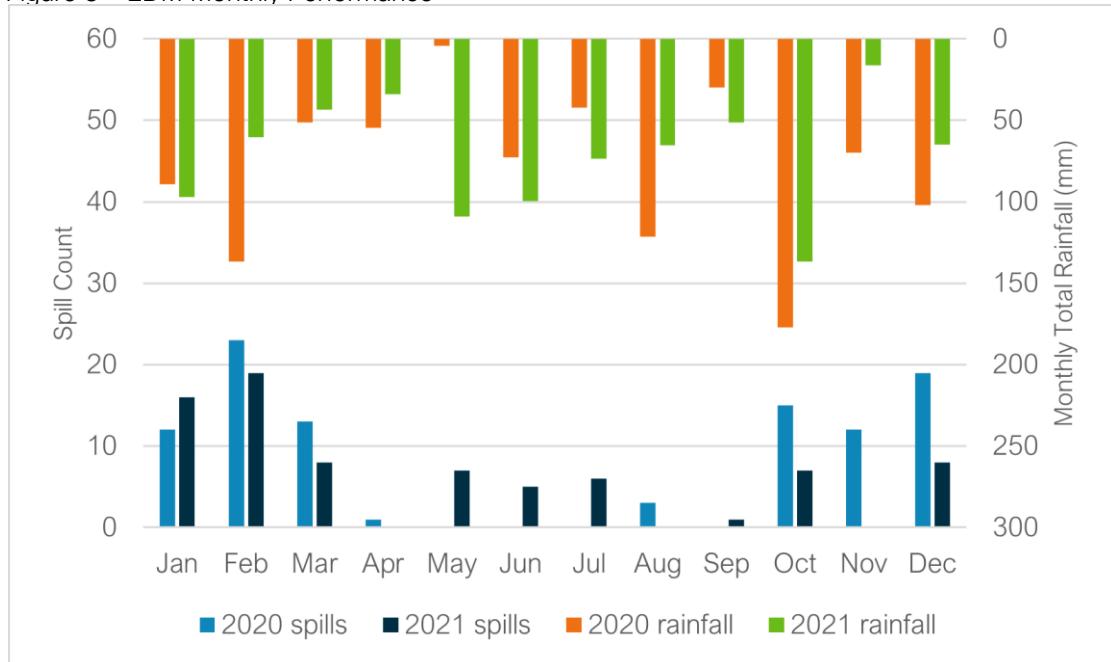
Figure 8 – EDM Monthly Performance

The trend in spill performance across the two recorded years does show variation in spills, with an overall focus on spills during the autumn and winter months. The data therefore suggests a wider relationship between rainfall, elevated groundwater levels and spill frequency. This is particularly evident at the start of the hydrological years, October - December. Significantly more spills were recorded at Kingsclere STW October – December 2020, compared to the same period in 2021, when the indicator sites suggest groundwater levels in the catchment were lower.

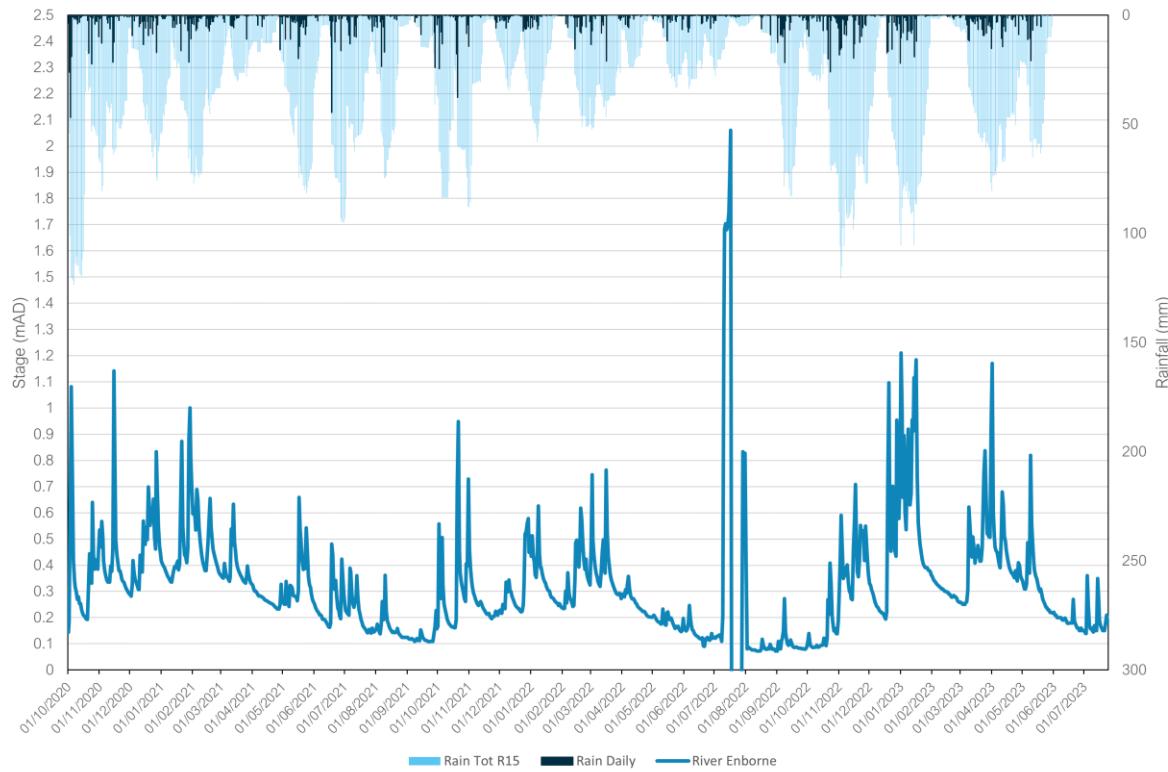
Figure 5A – River Enborne, Brimpton

The following figures represent the last three hydrological years of level information at the indicator sites to build a picture of the relative conditions prevalent in the current year. It is presented against both the daily total rainfall values for the catchment and a rolling 15 day total rainfall.

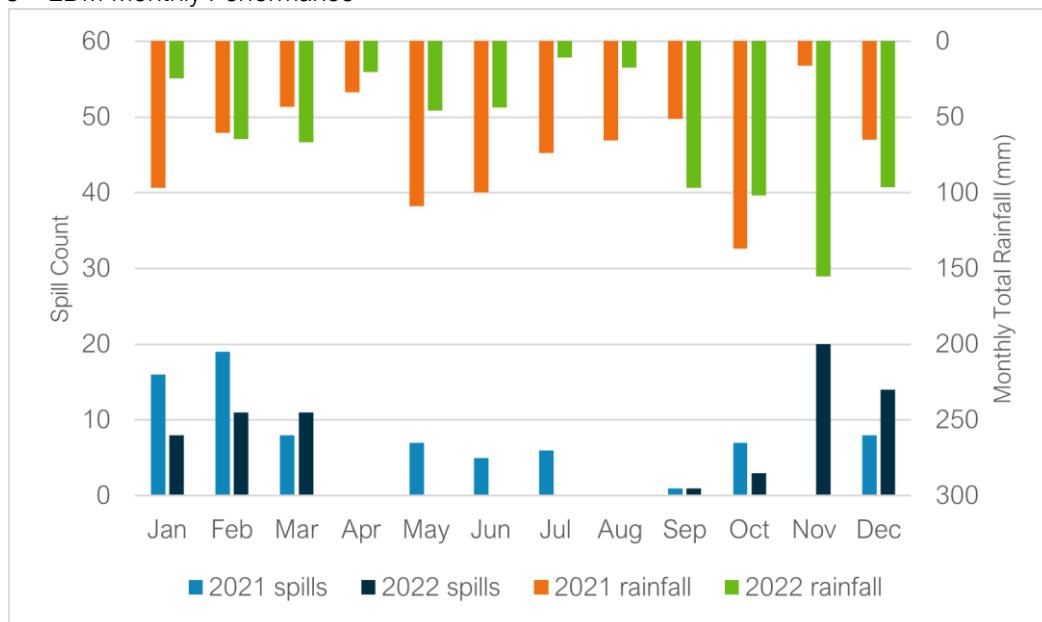
Figure 8 – EDM Monthly Performance

A critical part of the assessment of EDM performance and its relation to groundwater infiltration is to review the month-on-month spill performance, against previous years and the monthly total rainfall values to give context to the performance. Figure 8 below presents the EDM performance trend and rainfall for recent years.

The trend in spill performance across the two recorded years does show variation in spills, with an overall focus on spills during the autumn and winter months. The data suggests a wider relationship between rainfall, elevated groundwater levels and spill frequency. Despite broadly similar rainfall totals, significantly more spills were recorded at Kingsclere STW in February 2021 compared to February 2022. The indicator site data shown in Figure 5, suggests groundwater levels in the catchment were higher in February 2021, with Figure 6 suggesting groundwater levels were just above below normal levels in February 2022. The significant number of summer spills recorded in 2021, is also indicative of spills occurring in the catchment during intense or prolonged rainfall events, outside of periods of significantly elevated groundwater levels.

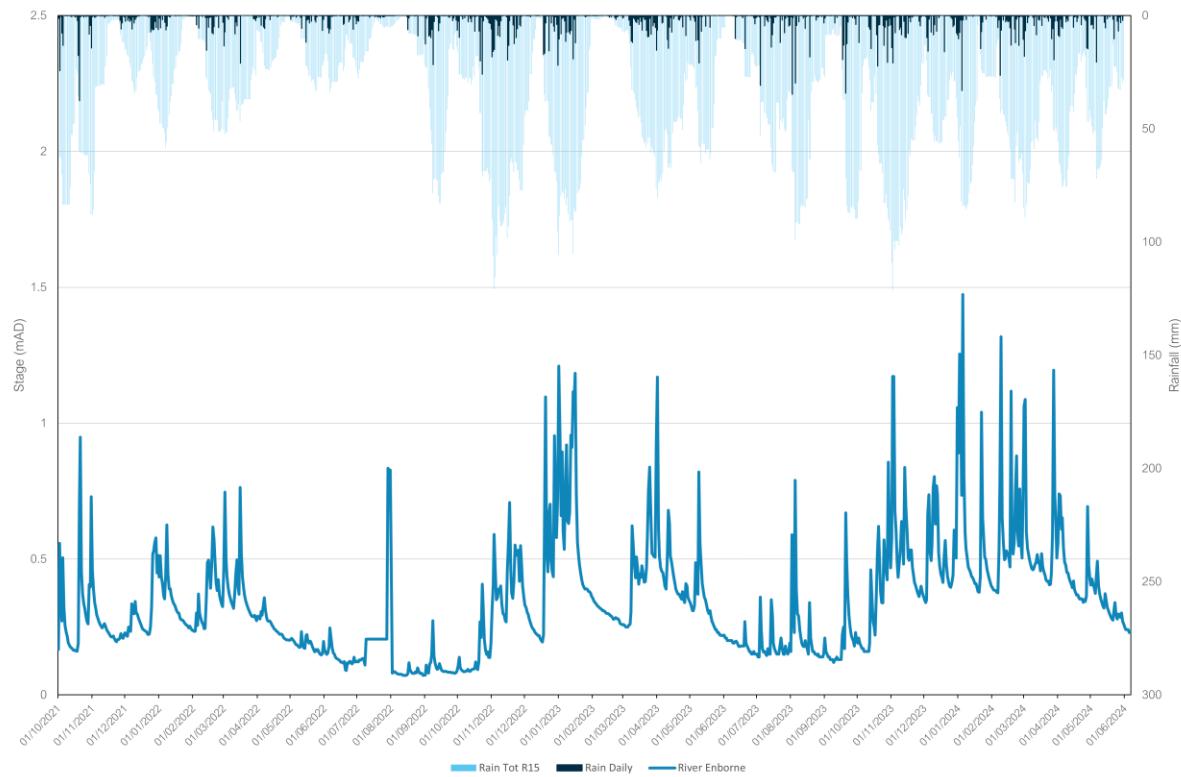
Figure 5A – River Enborne, Brimpton

Figures 5A-5B represent the last three hydrological years of level information at the indicator sites to build a picture of the relative conditions prevalent in the current year. It is presented against both the daily total rainfall values for the catchment and a rolling 15 day total rainfall.

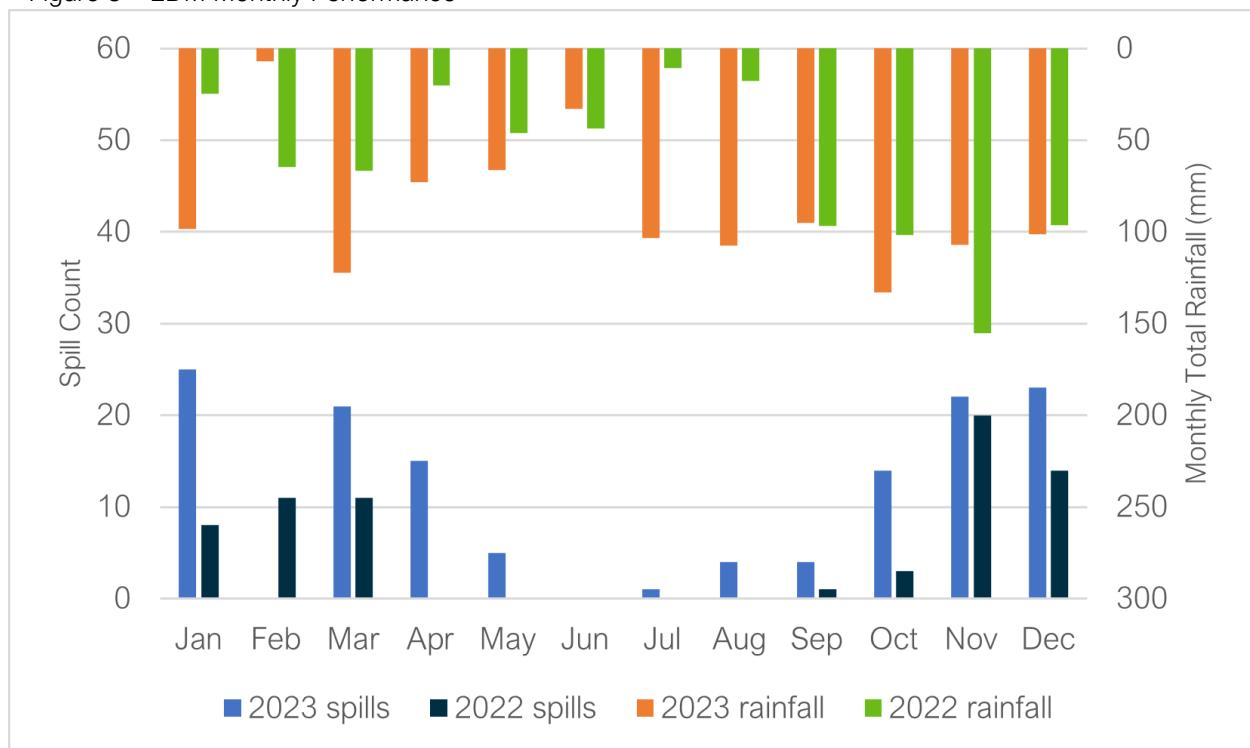
Figure 8 – EDM Monthly Performance

A critical part of the assessment of EDM performance and its relation to groundwater infiltration is to review the month-on-month spill performance, against previous years and the monthly total rainfall values to give context to the performance. Figure 8 below presents the EDM performance trend and rainfall for recent years.

The trend in spill performance across the two recorded years does show variation in spills, with an overall focus on spills during the winter, spring and autumn months. The data suggests a wider relationship between rainfall, elevated groundwater levels and spill frequency. For example, despite broadly similar rainfall totals, significantly more spills were recorded at Kingsclere STW in December 2023. The indicator site data shown in Figure 5, suggests groundwater levels in the catchment were higher in December 2023, compared to the same month in 2022. The significant number of summer spills recorded in 2023, is also indicative of spills occurring in the catchment during intense or prolonged rainfall events, outside of periods of significantly elevated groundwater levels.

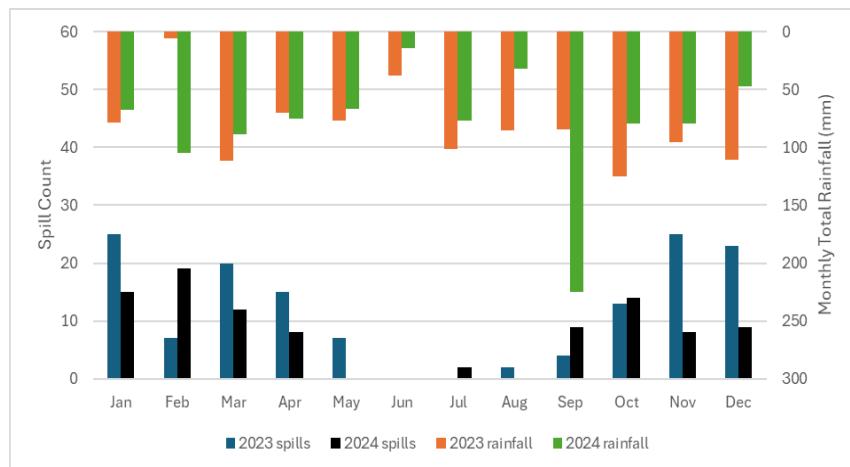
Figure 5: Monthly rainfall data versus monthly spill count for 2023 and 2024 – Burghfield STW

Figures 1 to 5 illustrate the relationship between rainfall and spills at CSOs. As can be seen the decrease in rainfall from 2023/24 into 2024/25, shown in Figure 1; shows a correlation with decreased number and duration of spills at the CSOs shown in Figure 5. However, the river levels remain consistent as shown in Figure 2, and 3.

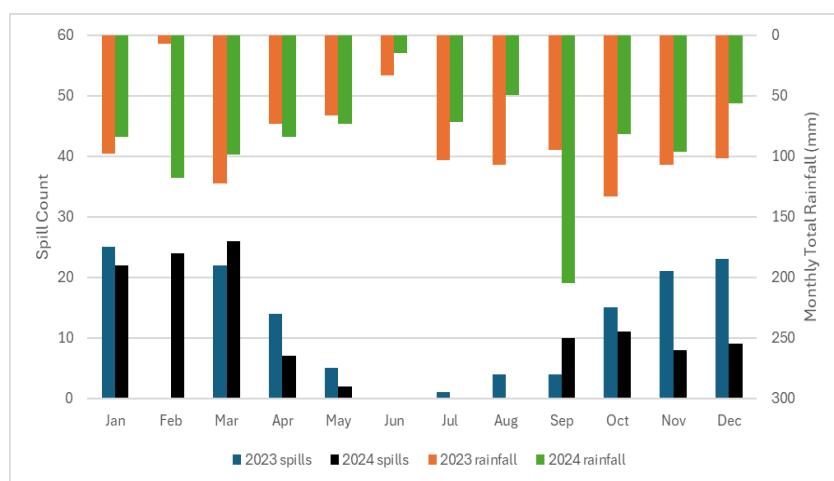
Figure 5: Monthly rainfall data versus monthly spill count for 2023 and 2024 – Kingsclere STW

Figures 1 to 5 illustrate the relationship between rainfall and spills at CSOs. Figure 1 displays the reduction in rainfall from 2023/24 to 2024/25. shows a correlation with decreased number and duration of spills at the CSOs shown in Figure 5. However, the river levels remain consistent as shown in Figures 2 and 3.

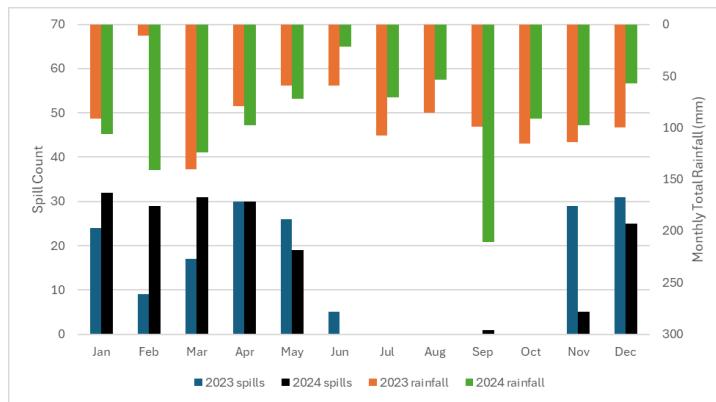
Figure 7: Monthly rainfall data versus monthly spill count for 2023 and 2024 – Marlborough STW

Figures 1 to 8 illustrate the relationship between rainfall and spills at CSOs. Figure 1 displays the decrease in rainfall from 2023/24 into 2024/25, this correlating to decreased groundwater and river levels shown in Figures 2-5, and the decreased number and duration of spills at the CSOs is shown in Figure 7 and Figure 8.
